Seismological and Engineering Effects of the M 7.0 Samos Island (Aegean Sea) Earthquake

Hellenic Association of Earthquake Engineering: Report 2020/02

Geotechnical Extreme Events Reconnaissance Association: Report GEER-069

December 31, 2020

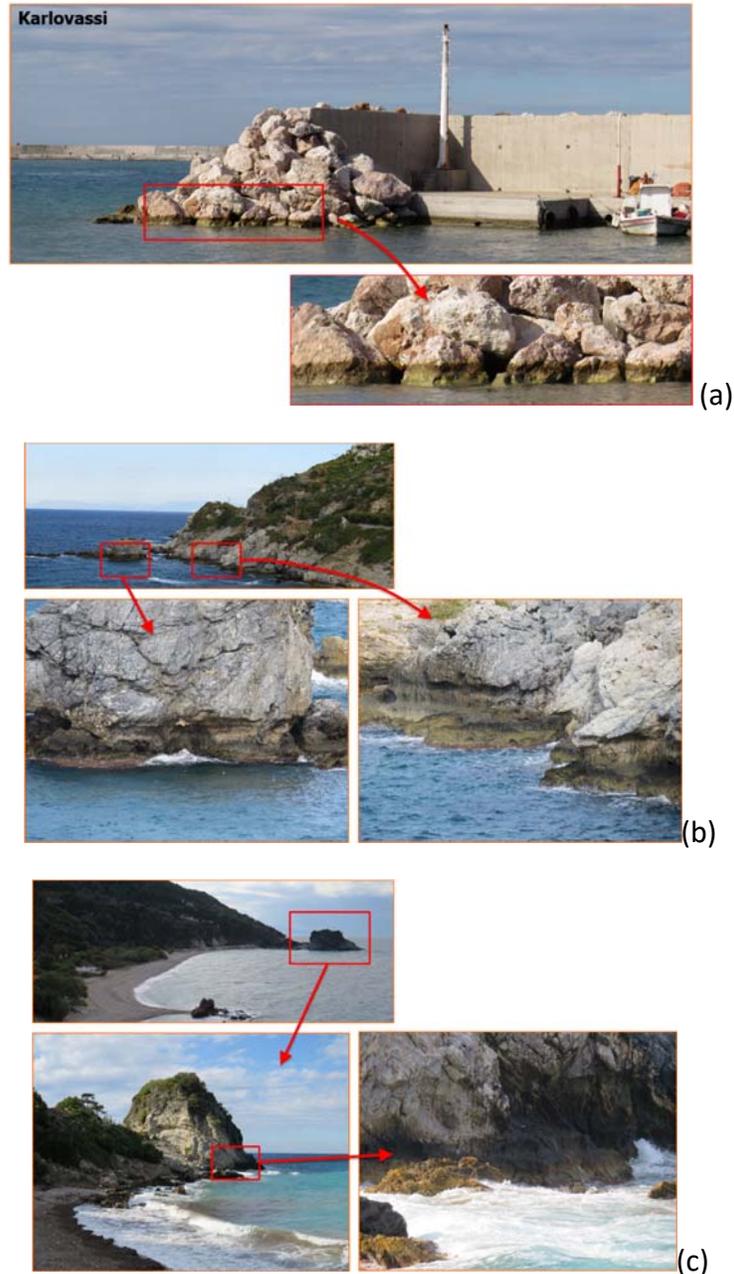
Figure 1.32. Permanent uplift (a) in the Karlovasi coastal area, imprinted not only on protection boulders, but also on the concrete jetty; (b) in the area west of the Karlovasi port imprinted on marbles of the Kerketeas nappe along the rocky promontory in Potami area; c) in the area west of the Karlovasi port imprinted on marbles of the Kerketeas nappe along Punta Promontory.

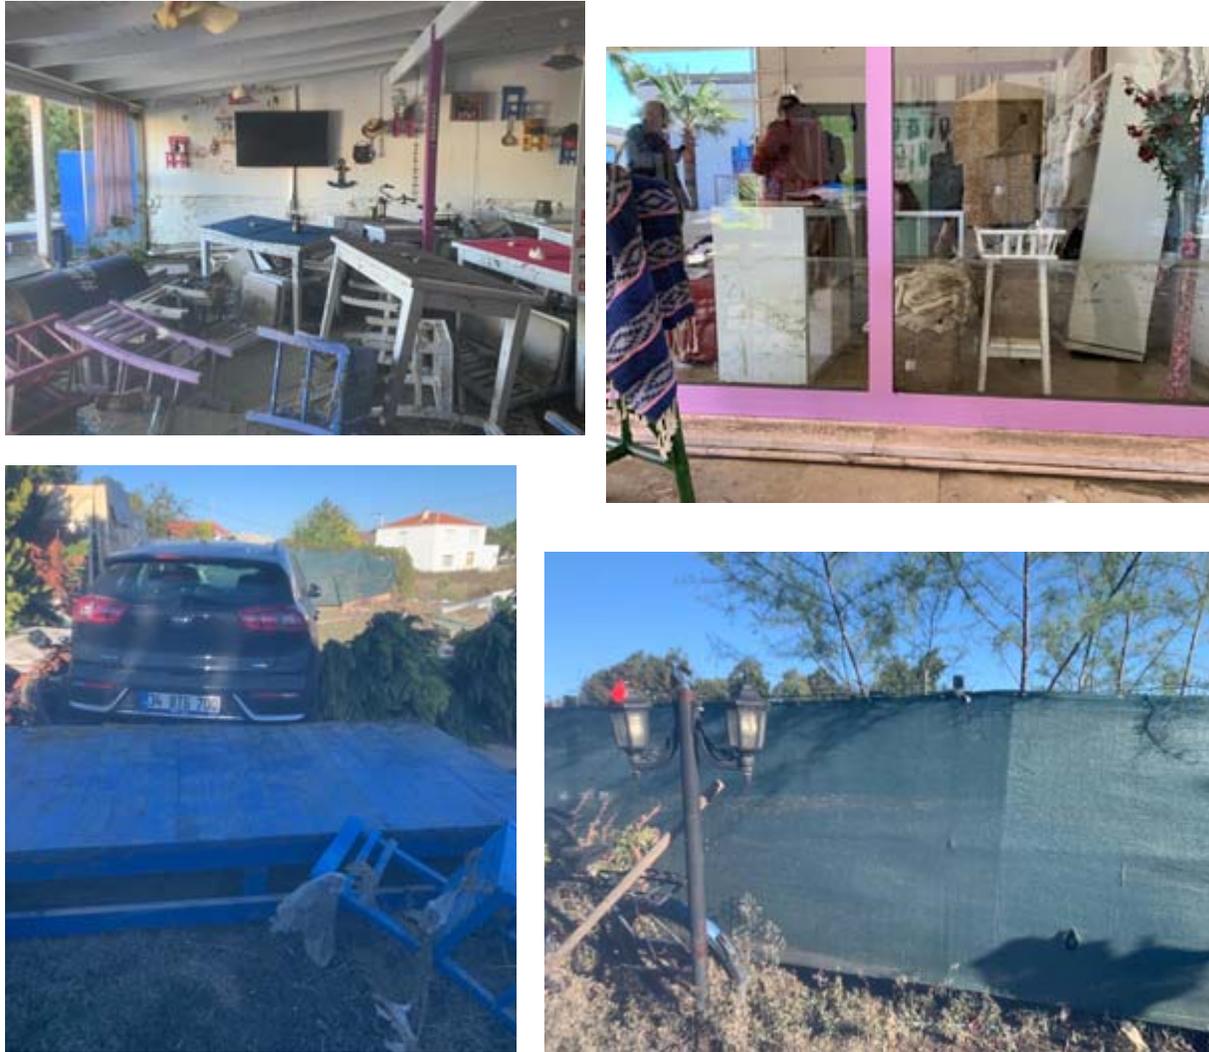
Figure 2.15. Damage on properties and tsunami traces in cafes and shops in Sigacik.

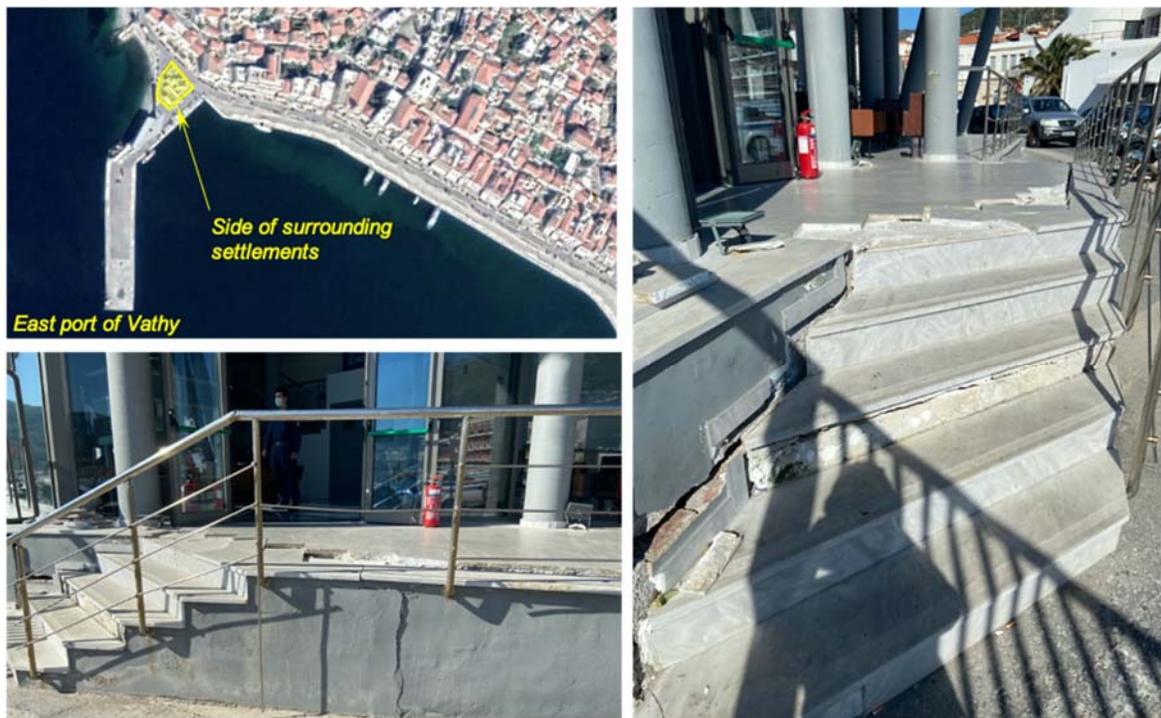
Figure 5.5. Damage observed around the Port authority building in Vathy, Samos (location: 37°45'27.0"N 26°58'15.4"E). The cracks indicate soil settlement/distortion around the building which remained intact and functioning 8 days after the earthquake (8th November 2020) [photos taken by the HAEE reconnaissance team]

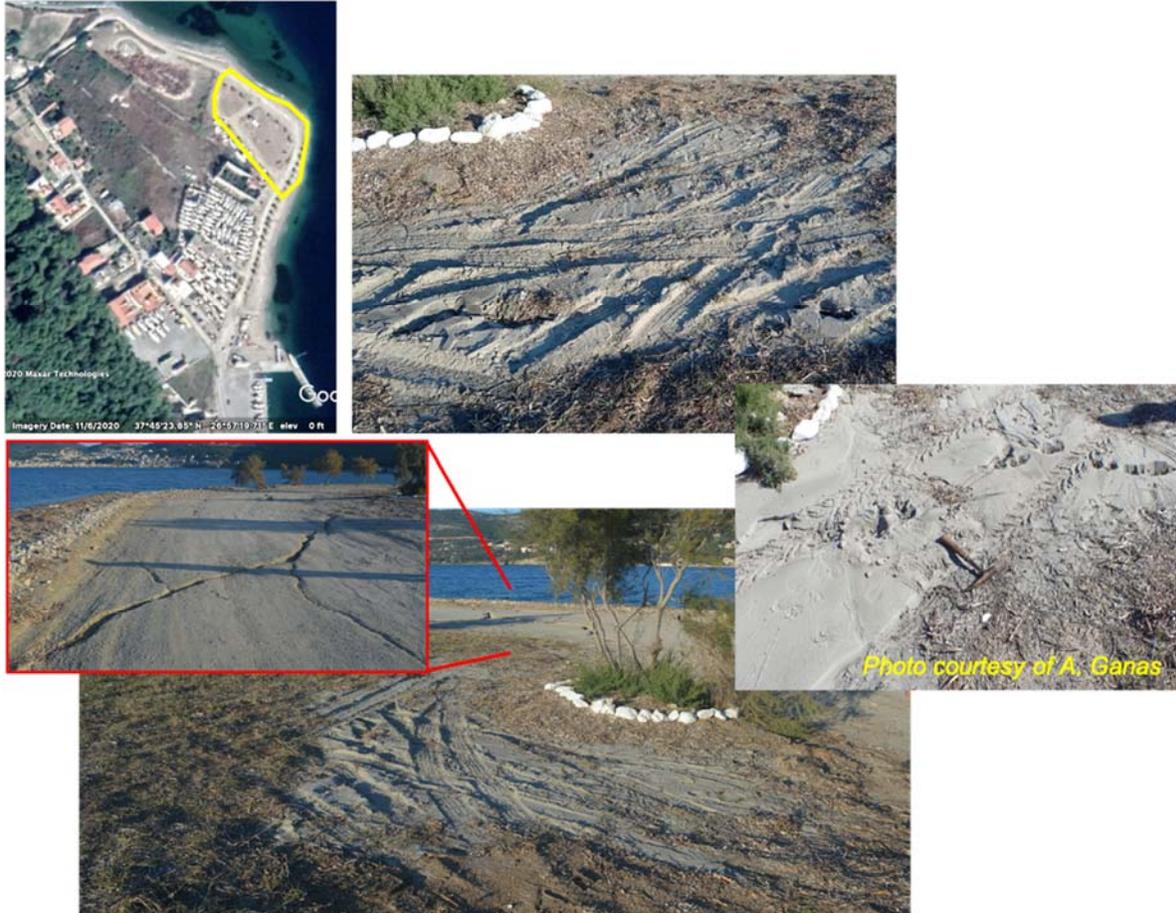
Figure 5.14. Surface manifestations of earthquake-induced soil liquefaction in the form of sand boils in Malagari (location: 37°45'24.6"N 26°57'28.8"E) [photos taken by the HAAE reconnaissance team and Dr. A. Ganas from NOA]

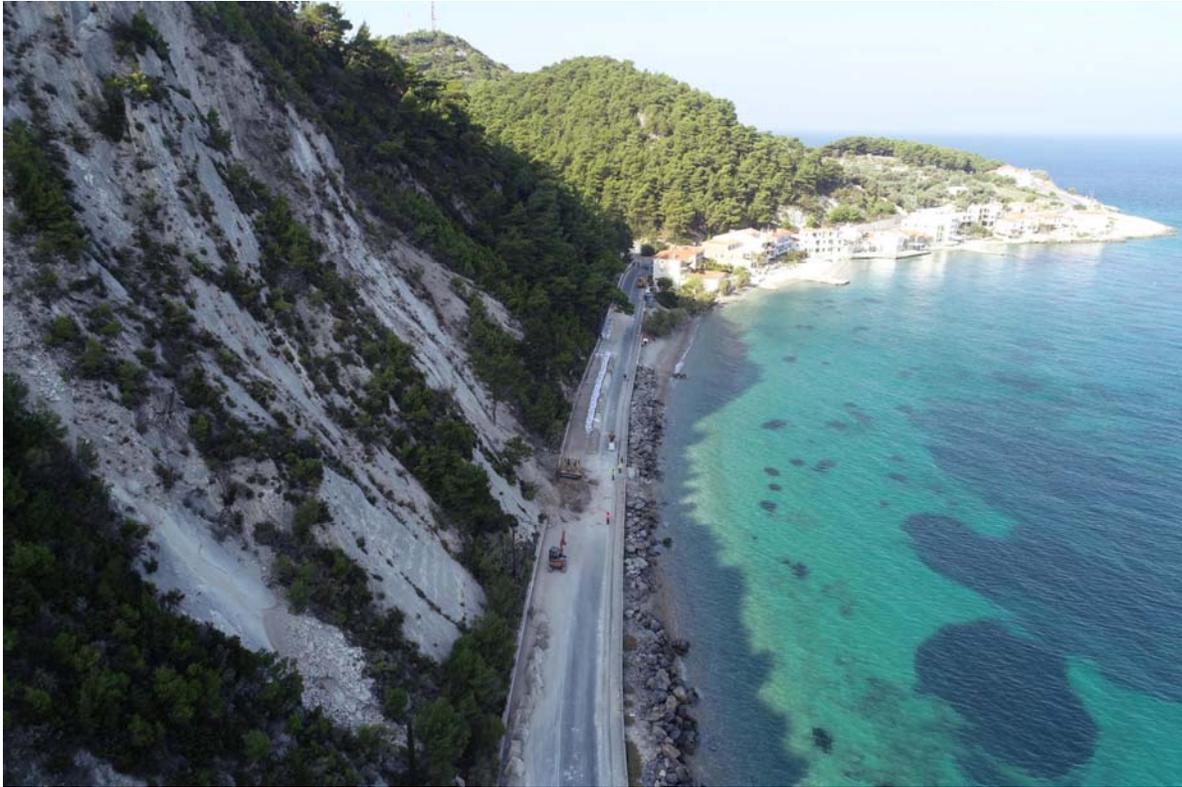
Figure 5.25. Up: A rock slide close to Avlakia region (aerial photograph courtesy of I.N. Spyrou and Prof. K. Ziotopoulou – *to not be reproduced without permission from Prof. Ziotopoulou, 37°47'48.0"N, 26°51'27.7"E*), Bottom – left: a closer view of the above rockslide reported illustrating the rock formation more clearly (picture by HAEE reconnaissance team), Bottom – right: Snapshot from a video recorded during the failure (source: <https://www.cnn.gr/ellada/story/240726/seismos-samos-vinteo-apo-katolisthisi-sta-aylakia>)

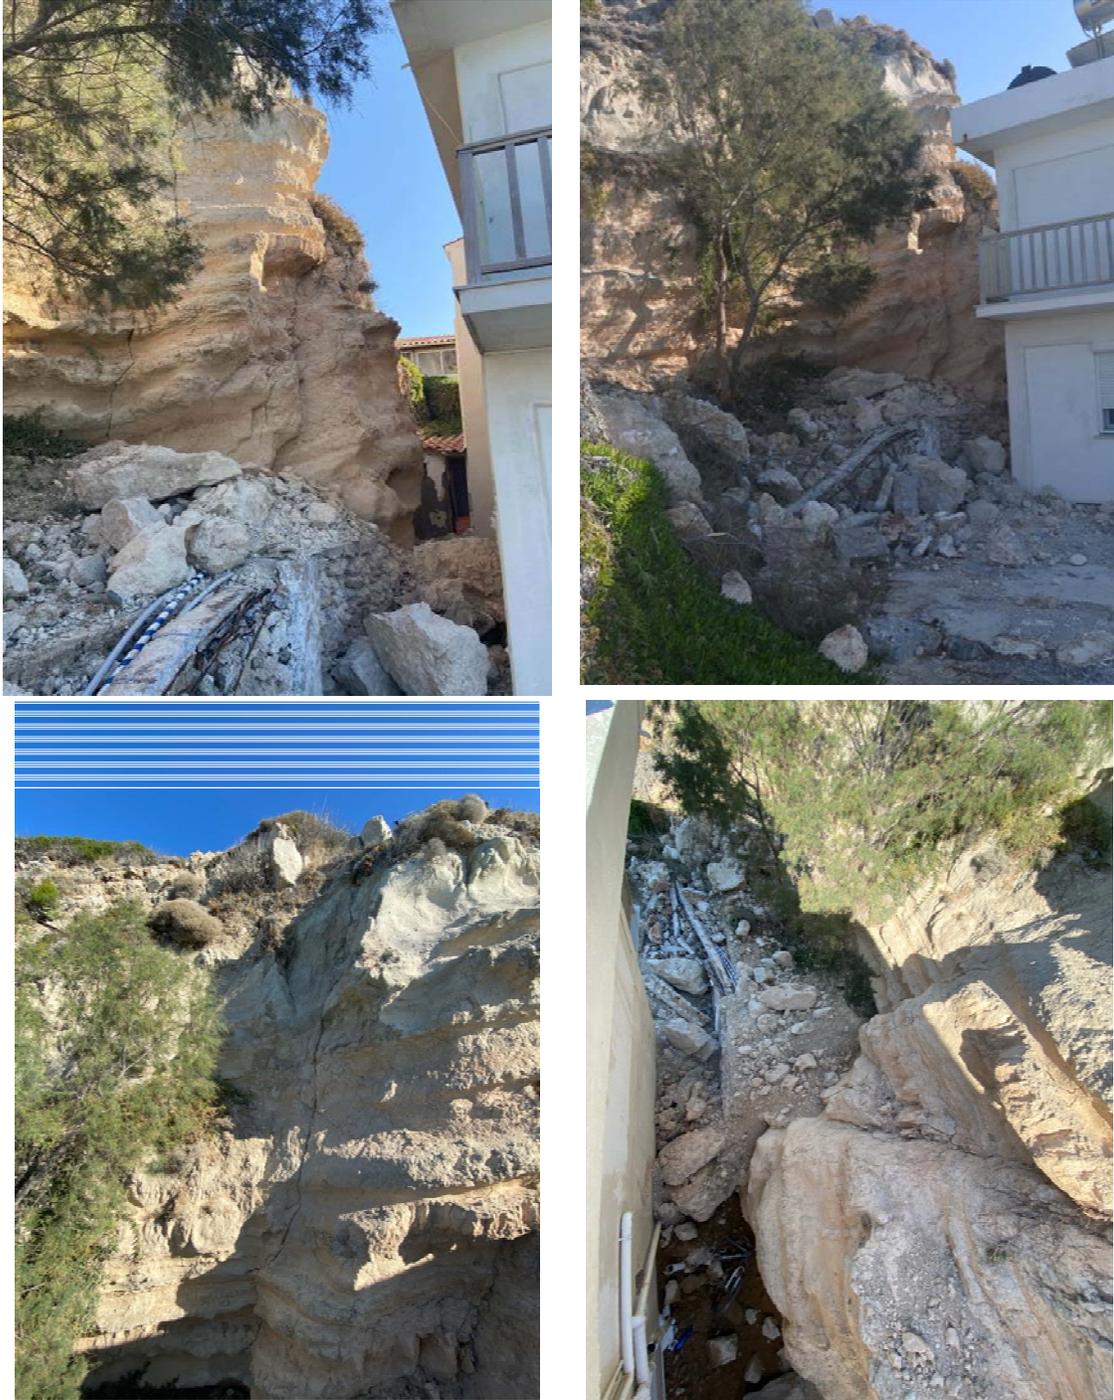
Figure 5.26. Detachment of sandy marls and marly limestones recorded very close to a residential building in the Kokkari region (photos taken by the HAEE reconnaissance team, 37°46'49.9"N, 26°53'35.0"E). Vertical open cracks are visible, clearly susceptible to detachment and overturning.

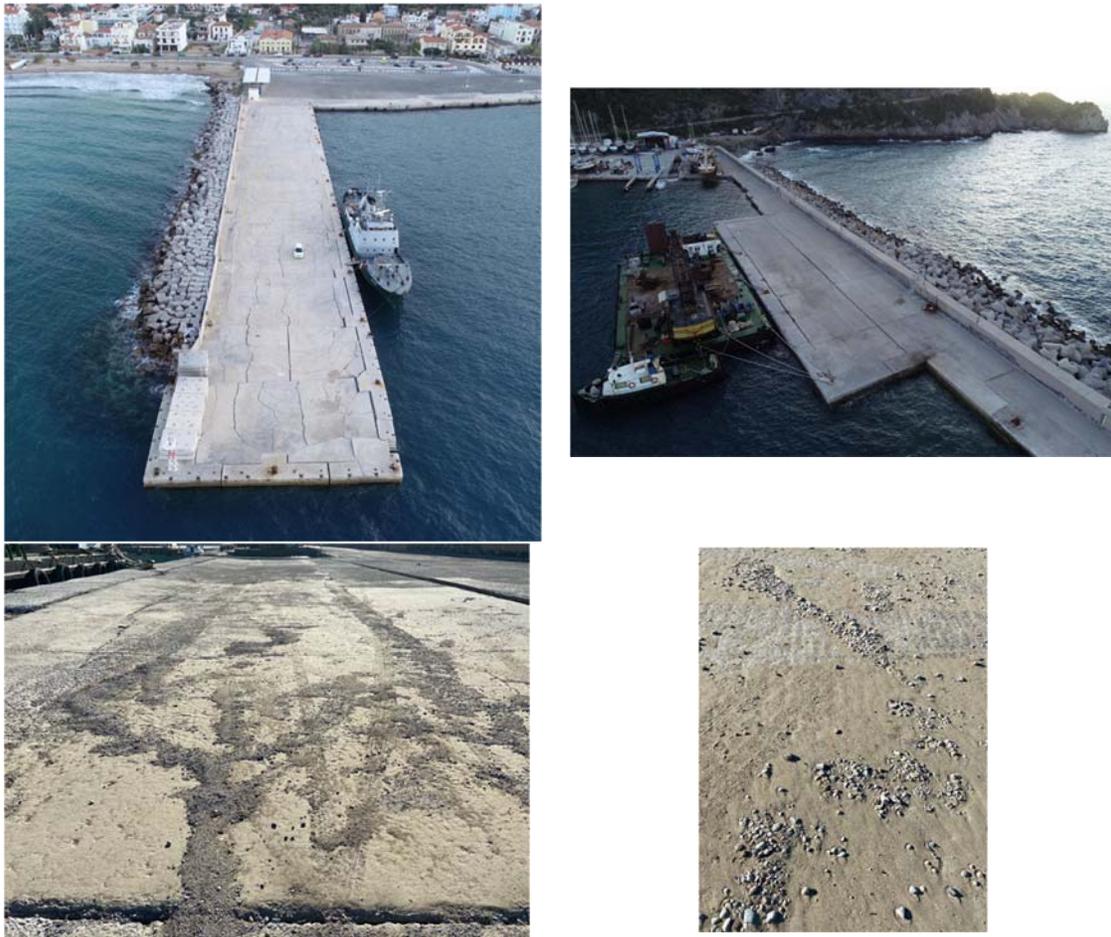
Figure 5.48. (top left) east quay wall of Karlovassi port, (top right) west quay wall of Karlovassi port, (bottom left) ejecta on the west quay wall, presumably product of liquefaction occurrence, and (bottom right) a detailed view of the ejecta, brownish to grey color, mostly sandy and silty with some gravels (aerial photographs courtesy of I.N. Spyrou and Prof. K. Ziotopoulou – *to not be reproduced without permission from Prof. Ziotopoulou*).

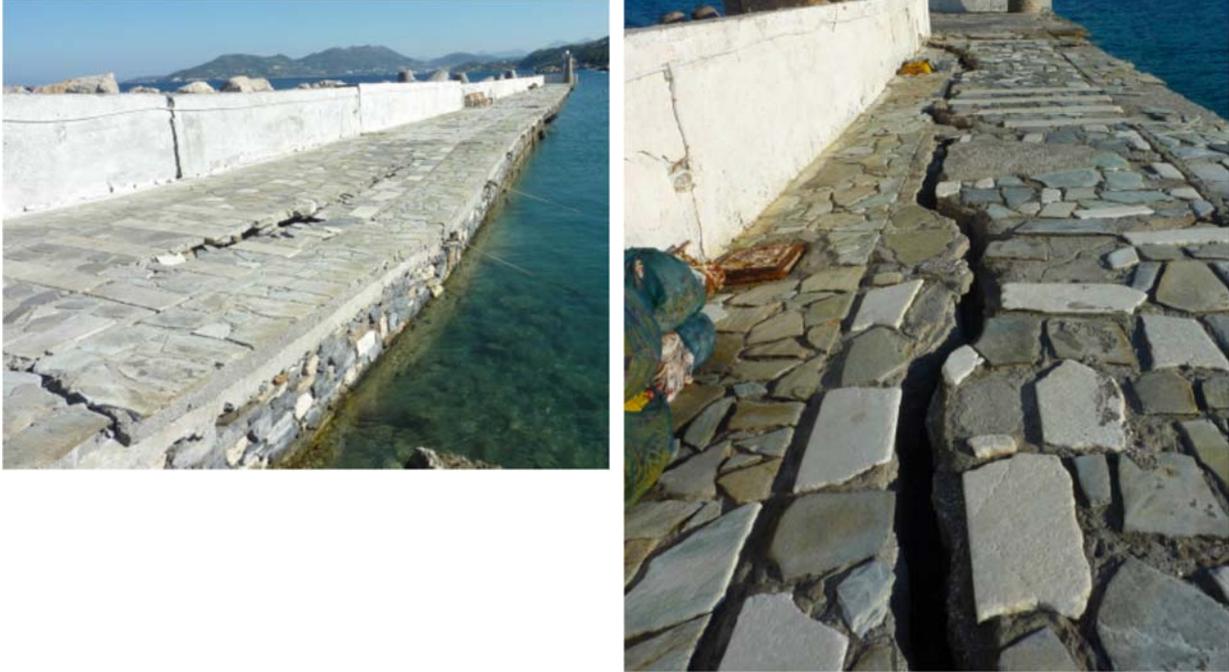
Figure 5.49. (left) clear trends of differential subsidence of the quay wall of Kokkari port with wide open cracks alongside and transversely, (right) close view of an open crack of 10 to 15cm alongside the sea front (HAEE reconnaissance report, 2020).

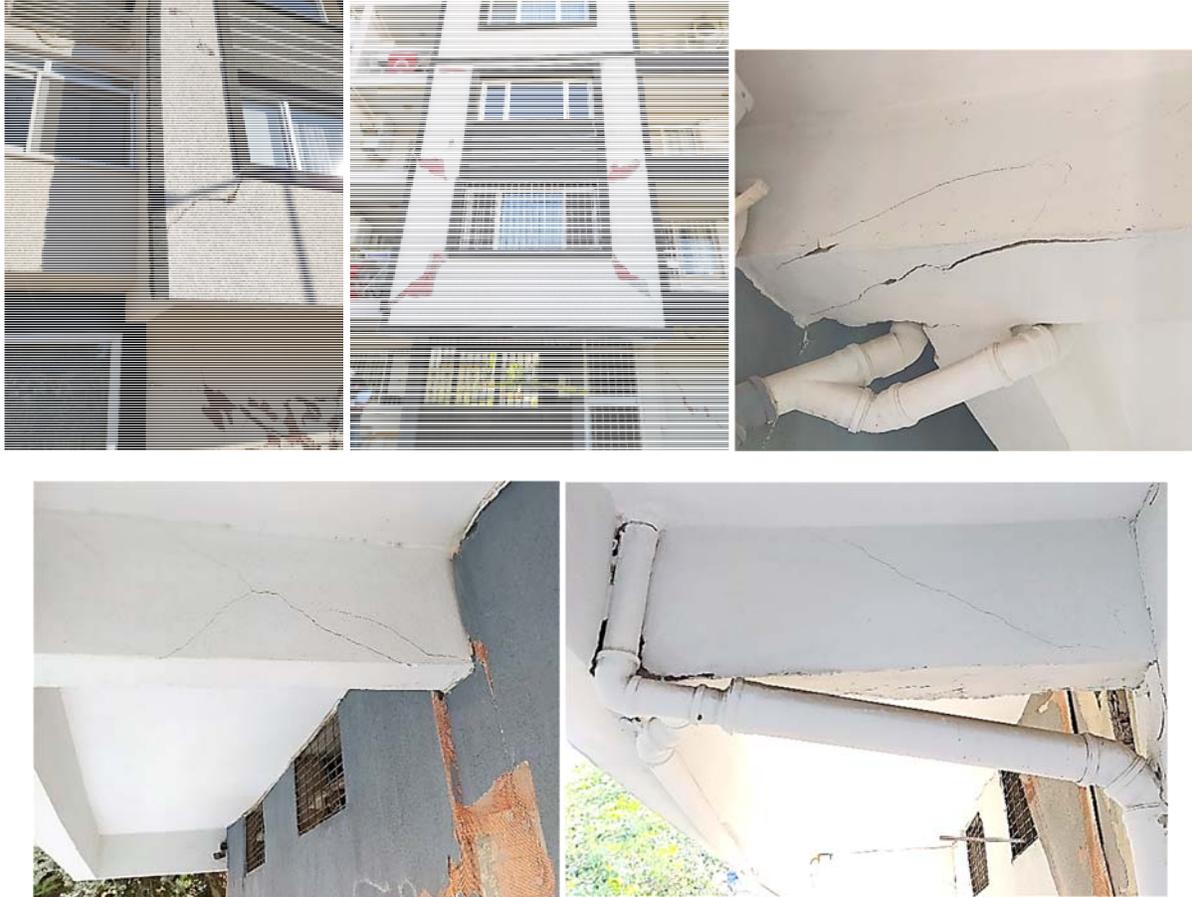
Figure 7.14. Overhang damages

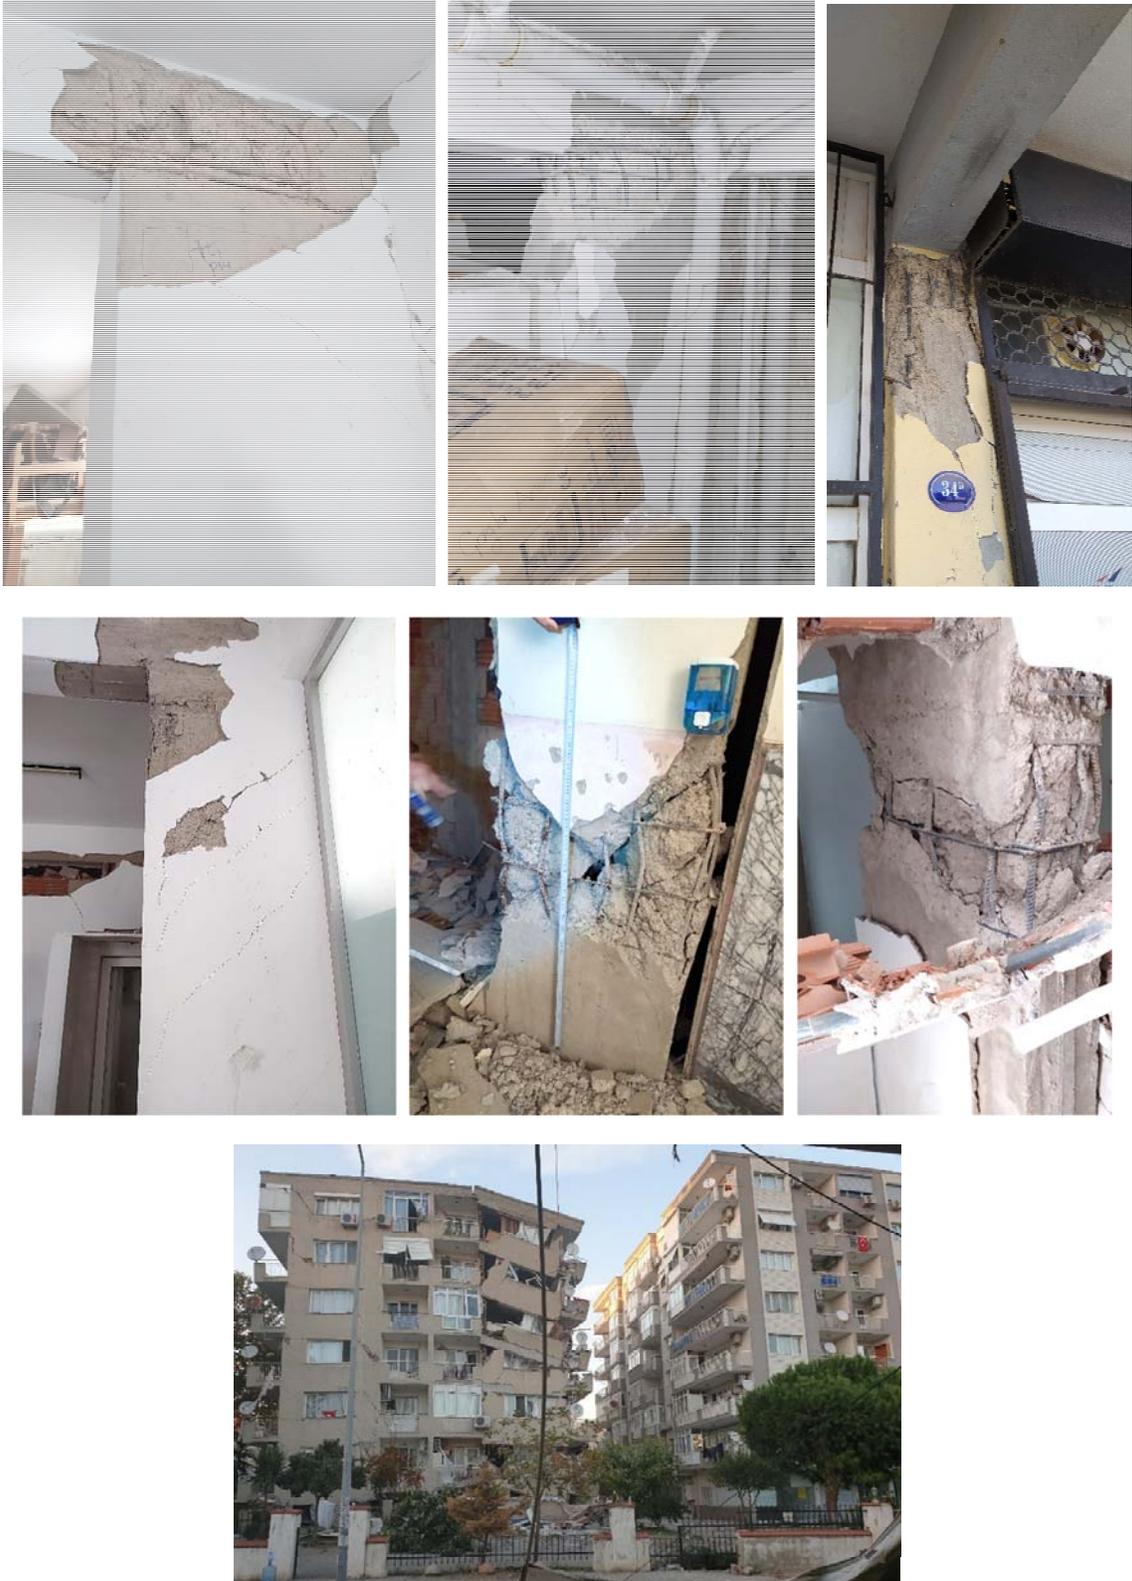
Figure 7.15. Severe column damages

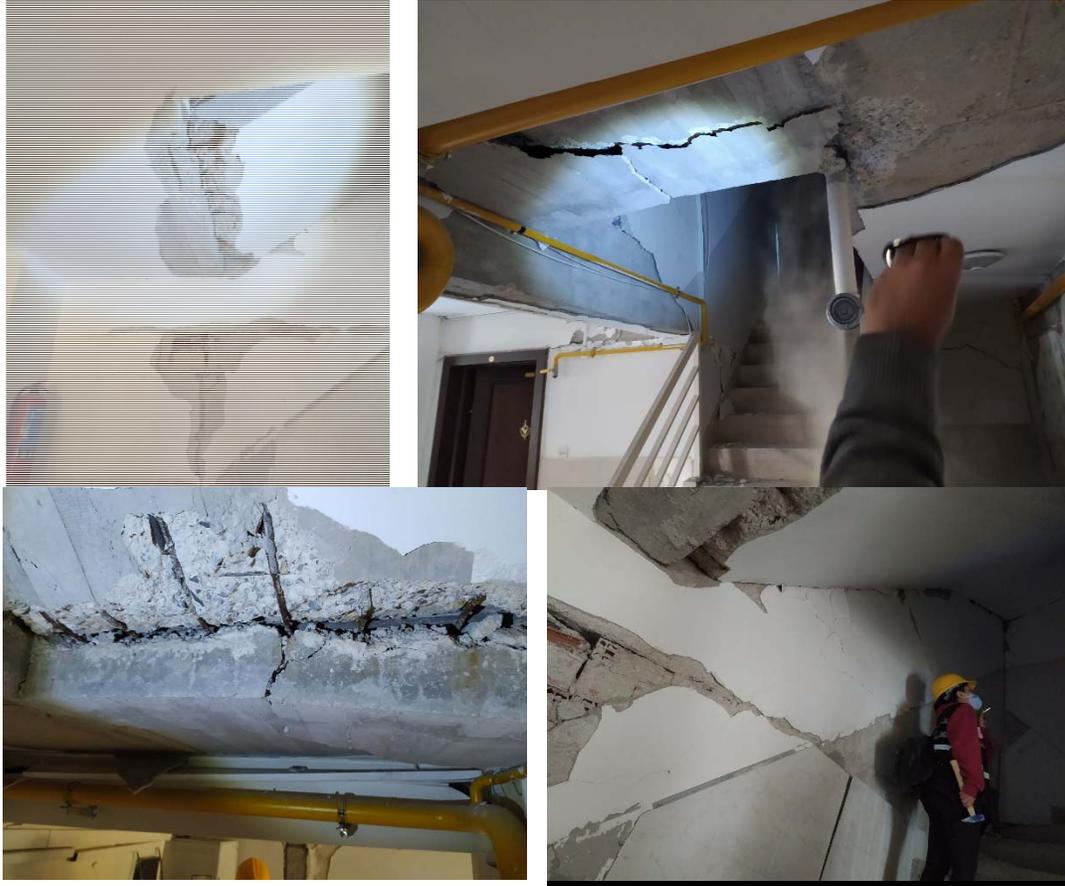
Figure 7.18. Observed staircase damages

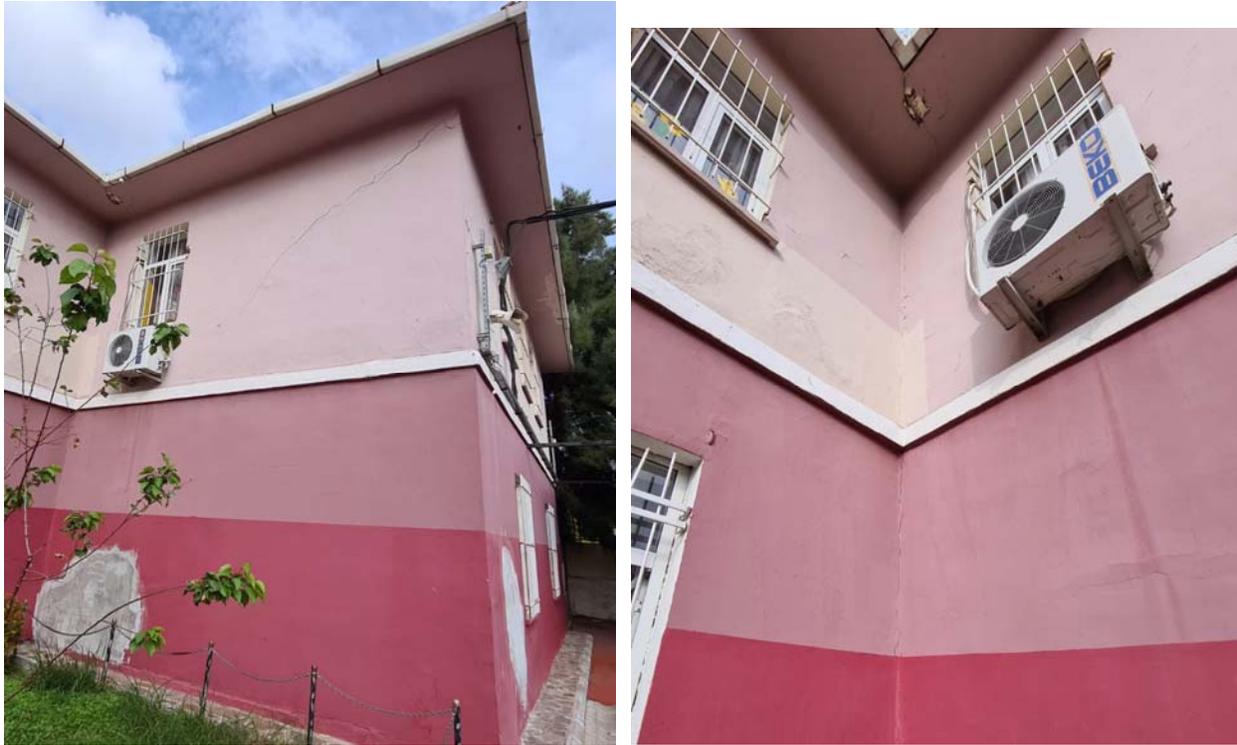
Figure 7.24. Perimeter wall damages in the school building

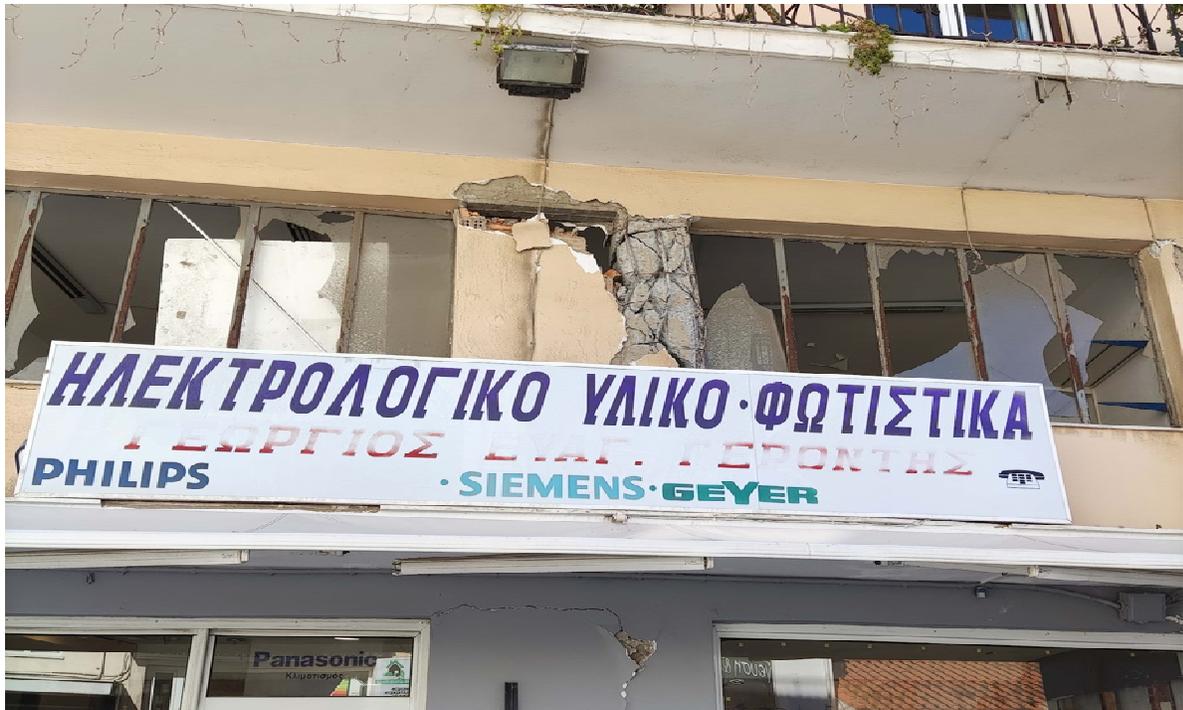
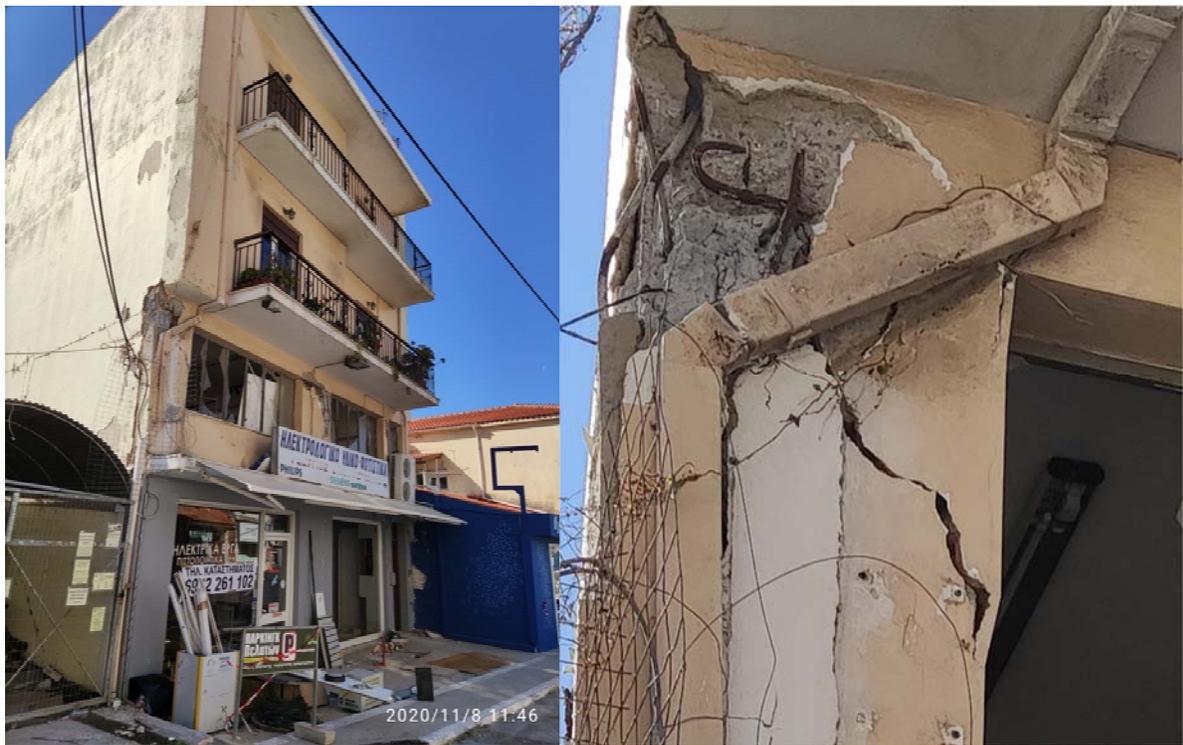
Figure 7.60. Short column (top) and beam-column joint failure of a 4-story building.

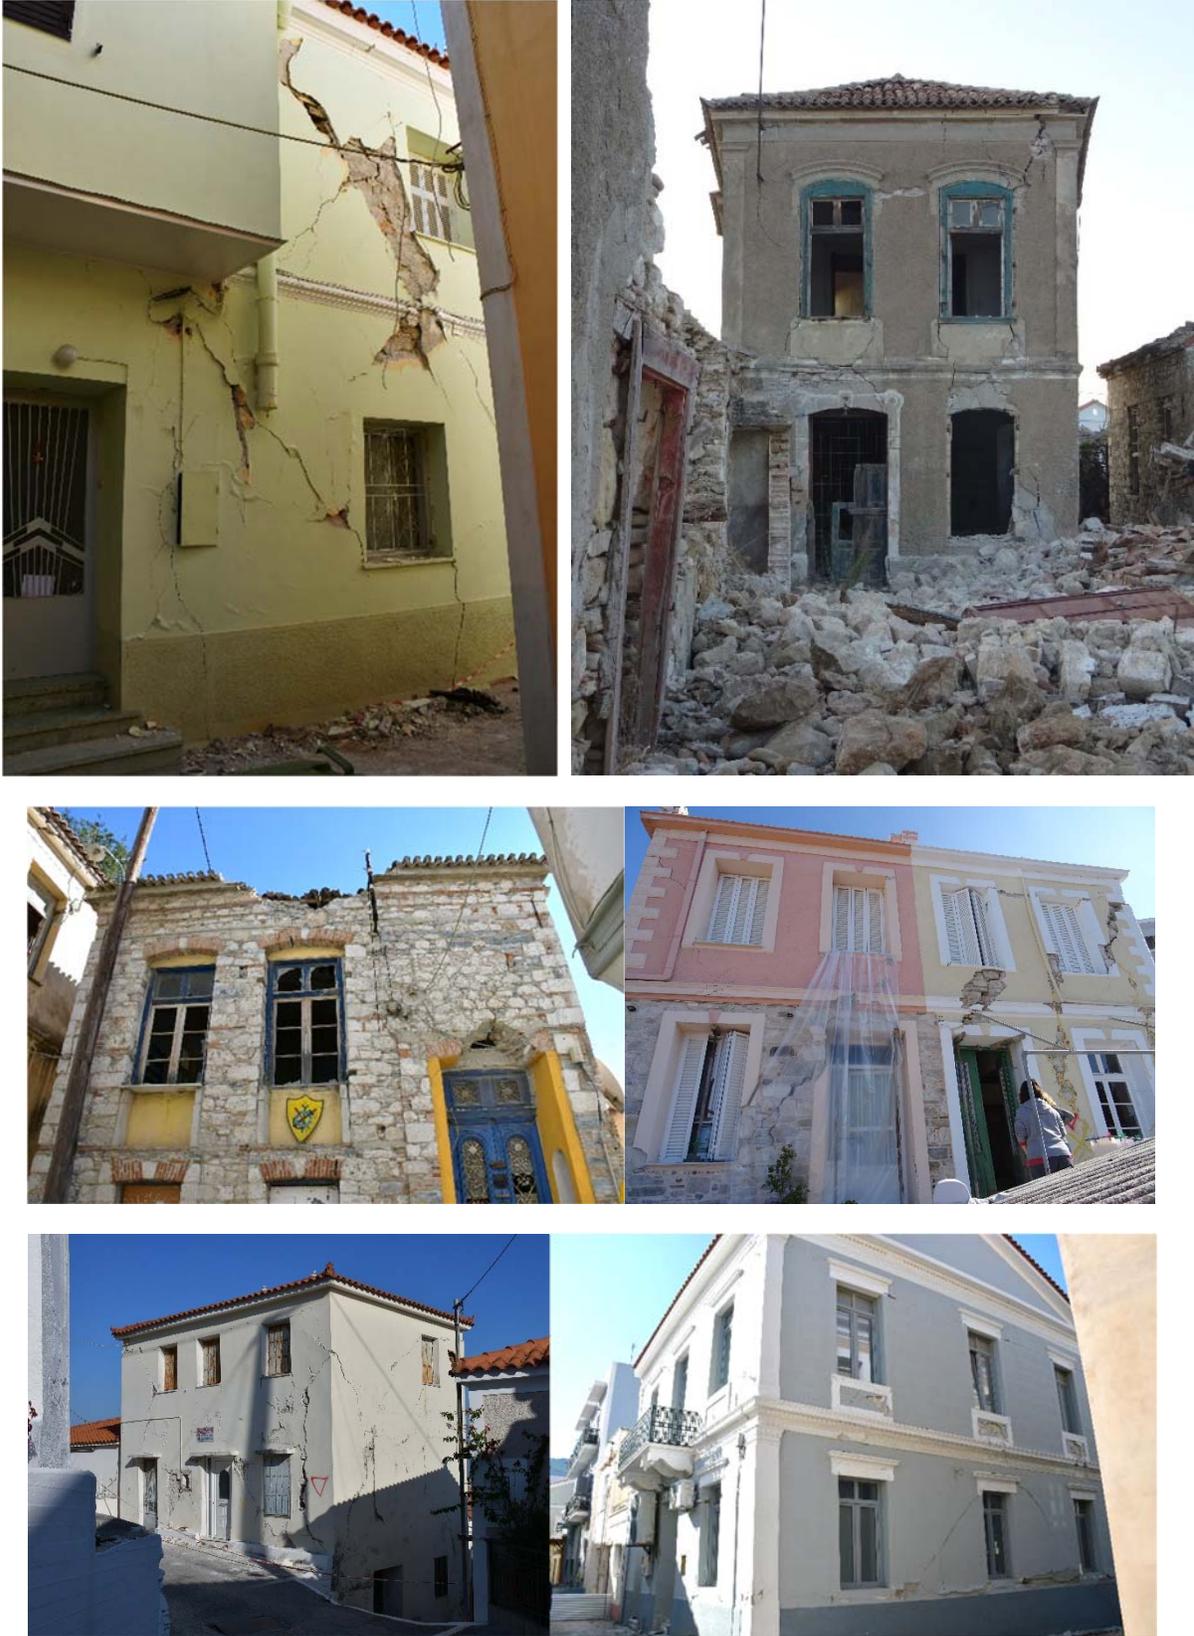
Figure 7.69. In-plane shear damage to walls and lintels.

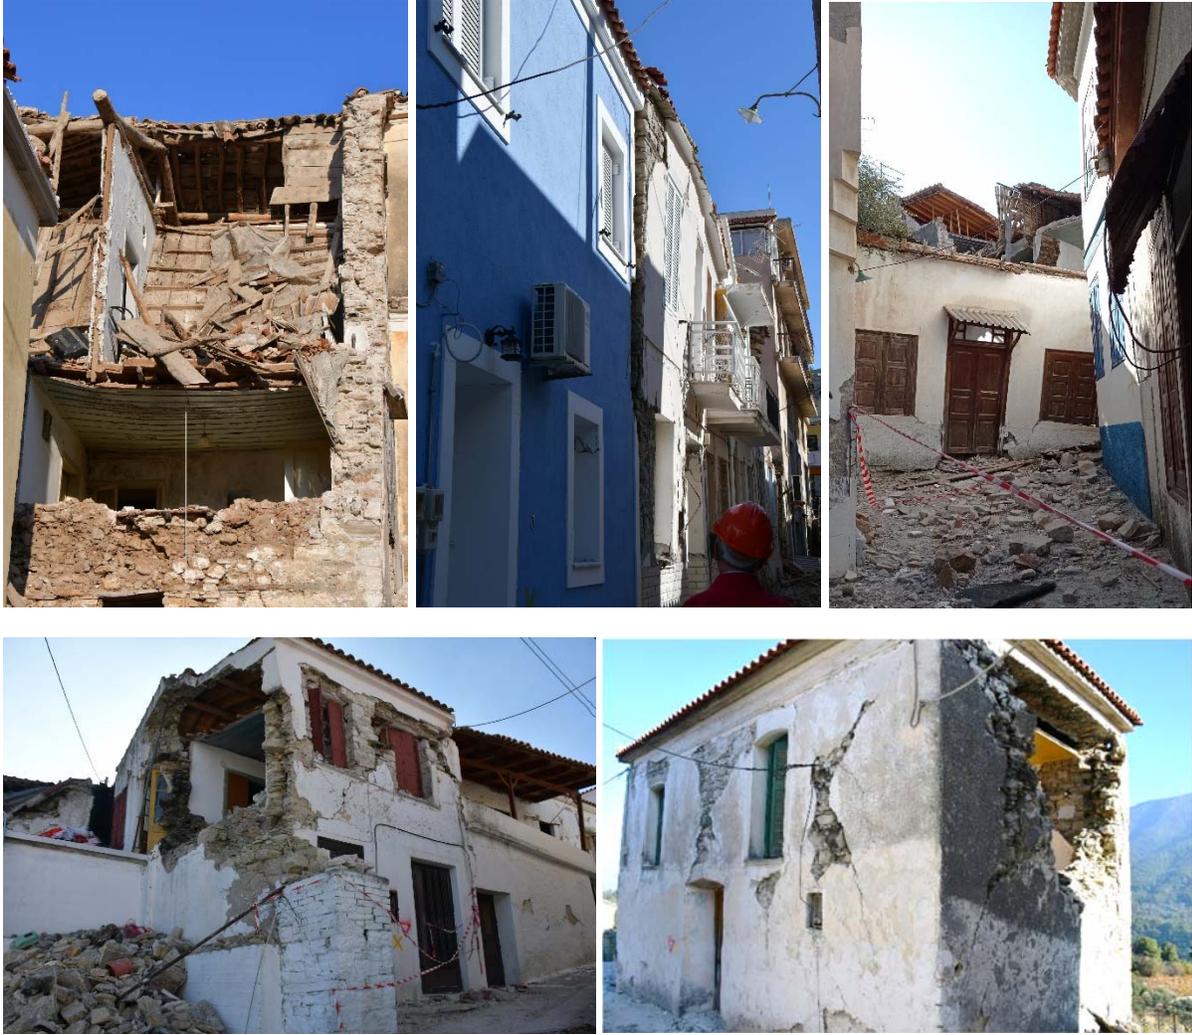
Figure 7.71. Partial collapse of residential masonry buildings.

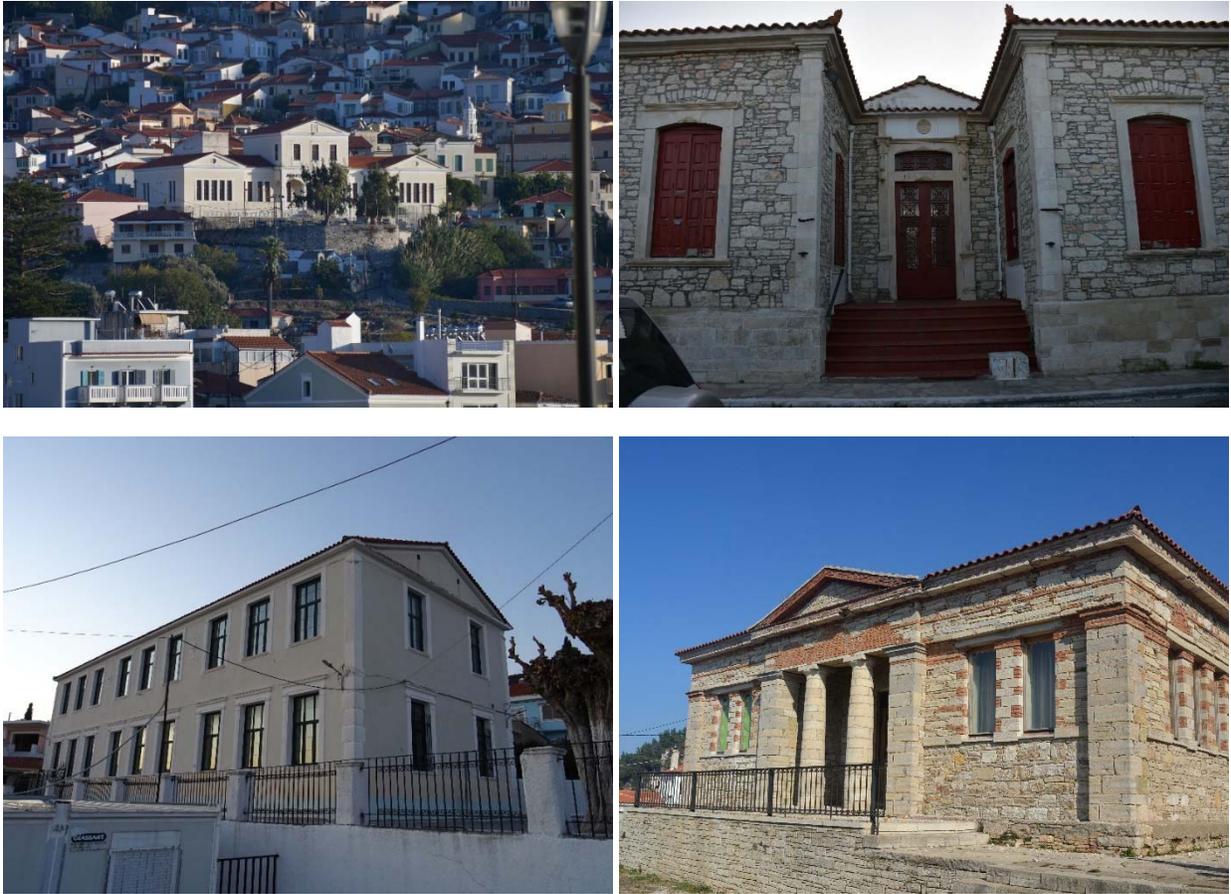
Figure 7.74. School buildings at Vathy. Limited damage was observed.

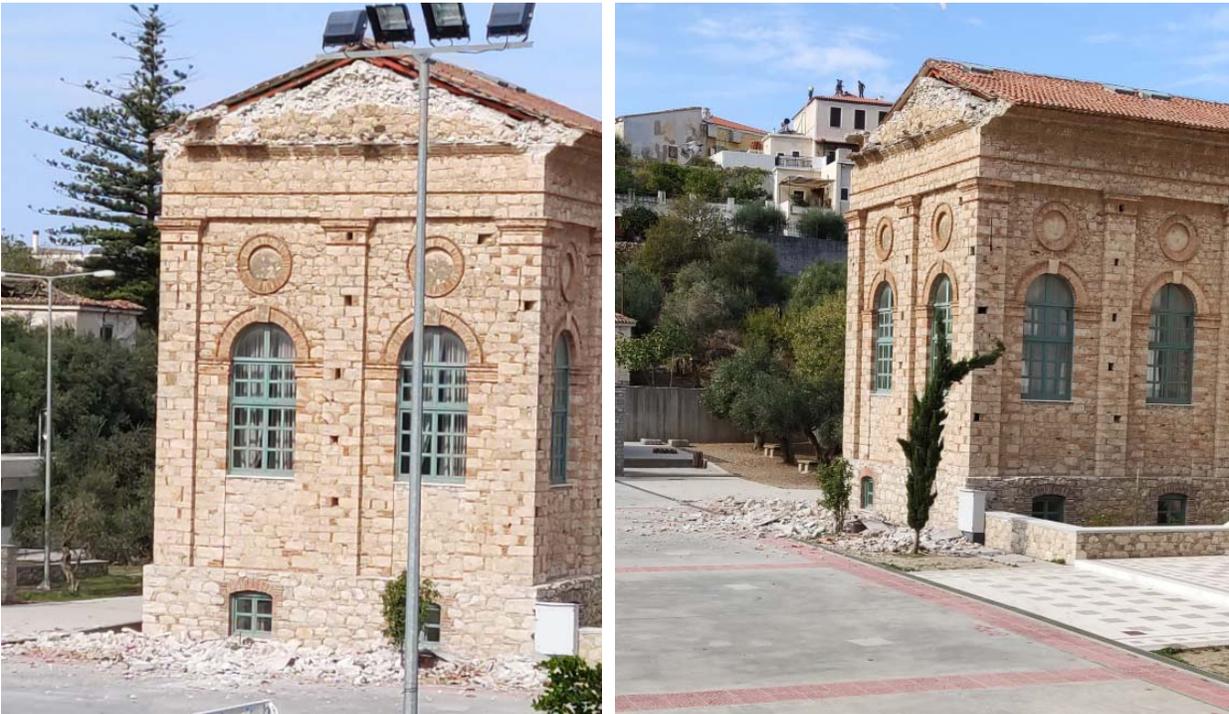
Figure 7.78. Primary school at Karlovassi (Porphyrriad School): damage to the triangular metope and the perimeter eaves, damage to the roof, and cracks inside the building.

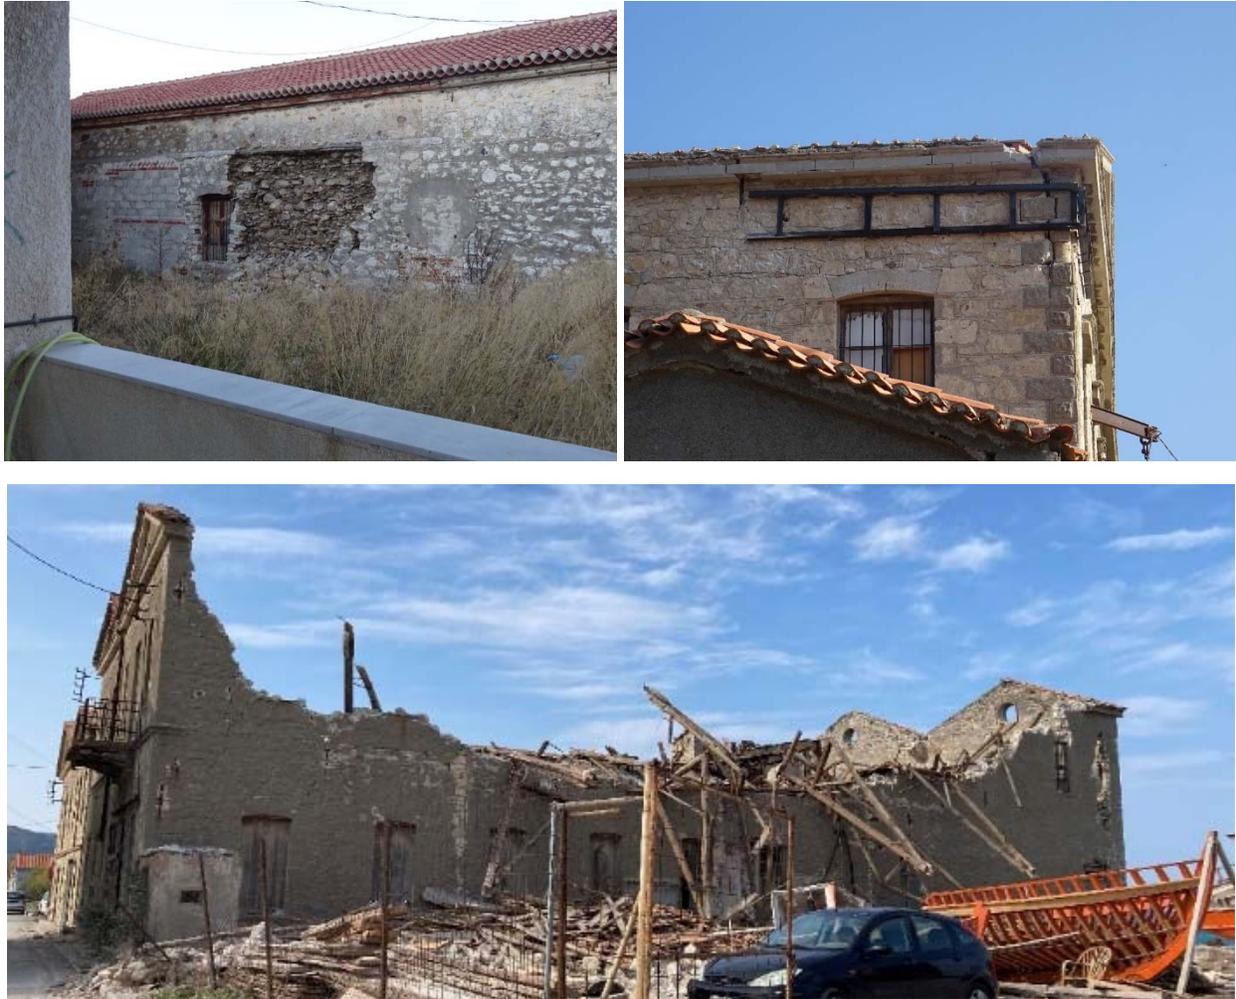
Figure 7.81. Typical damage in tannery buildings at Karlovassi.
