Seismological and Engineering Effects of the M 7.0 Samos Island (Aegean Sea) Earthquake

Hellenic Association of Earthquake Engineering: Report 2020/02

Geotechnical Extreme Events Reconnaissance Association: Report GEER-069

December 31, 2020

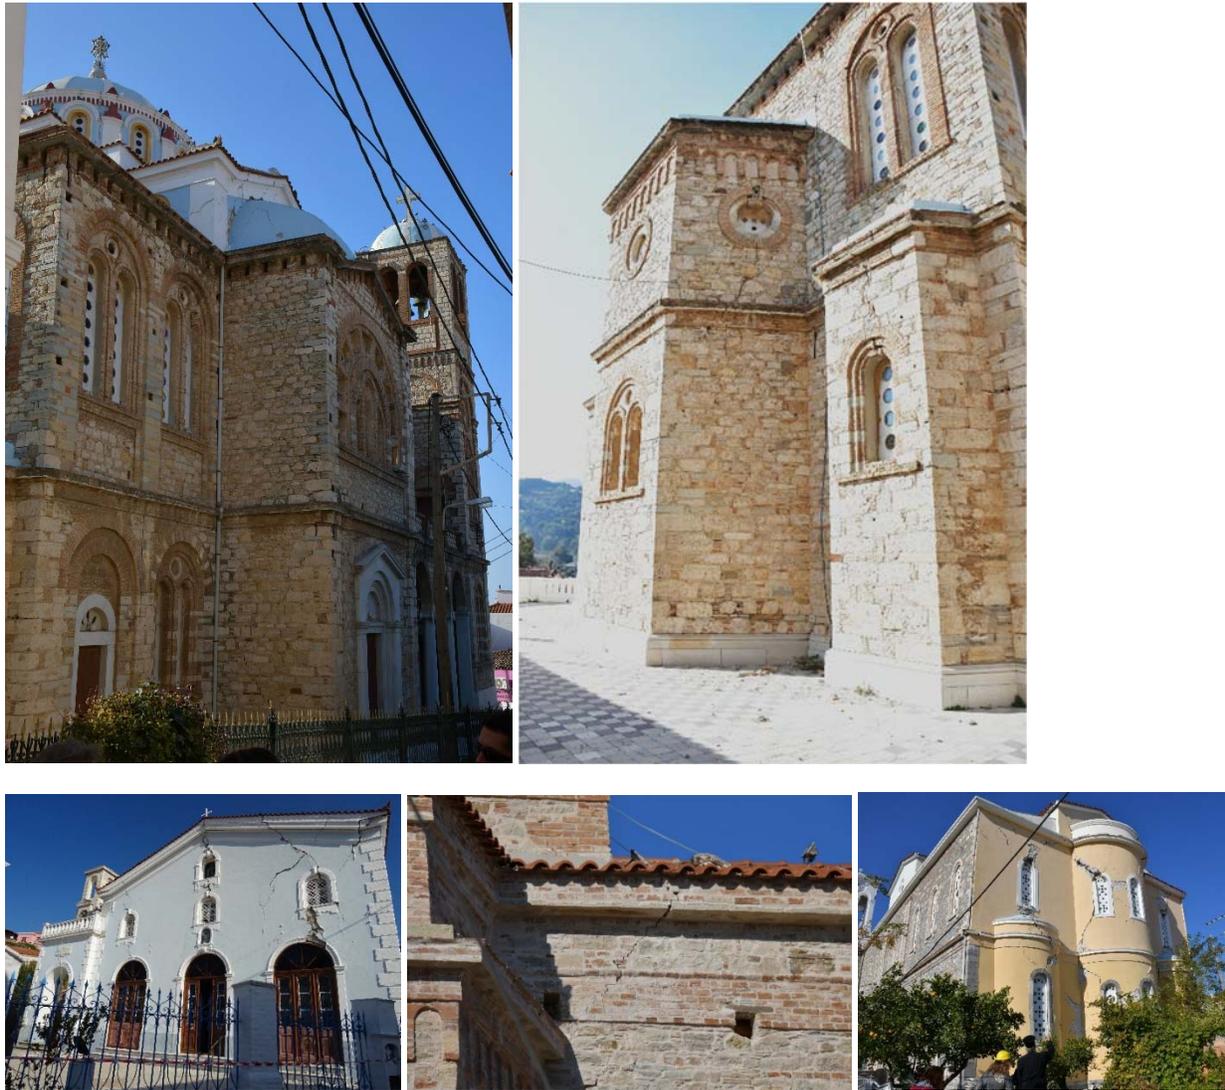
Figure 7.82. Perimeter walls of churches and damage observed.

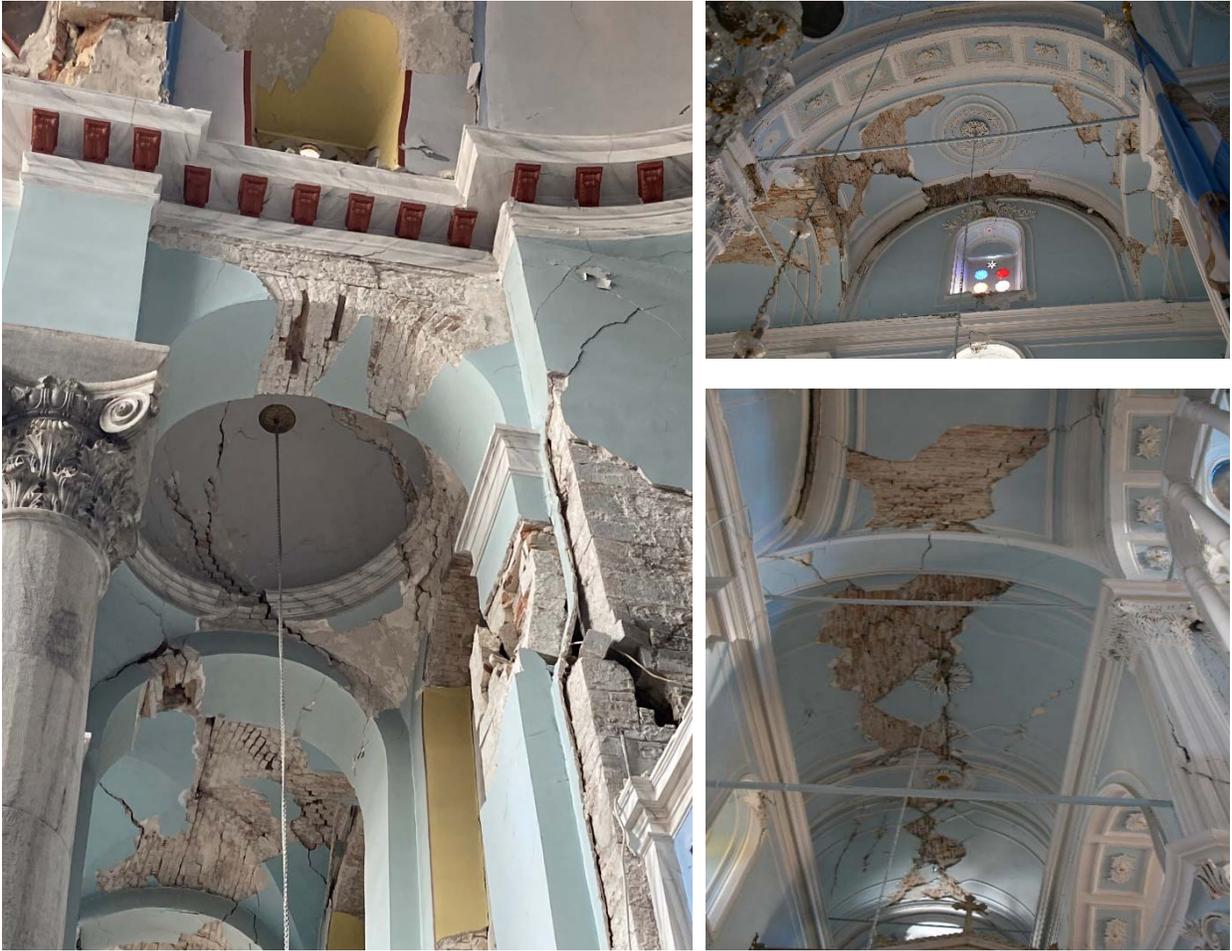
Figure 7.84. Severe damage of dome-and-arches roofs

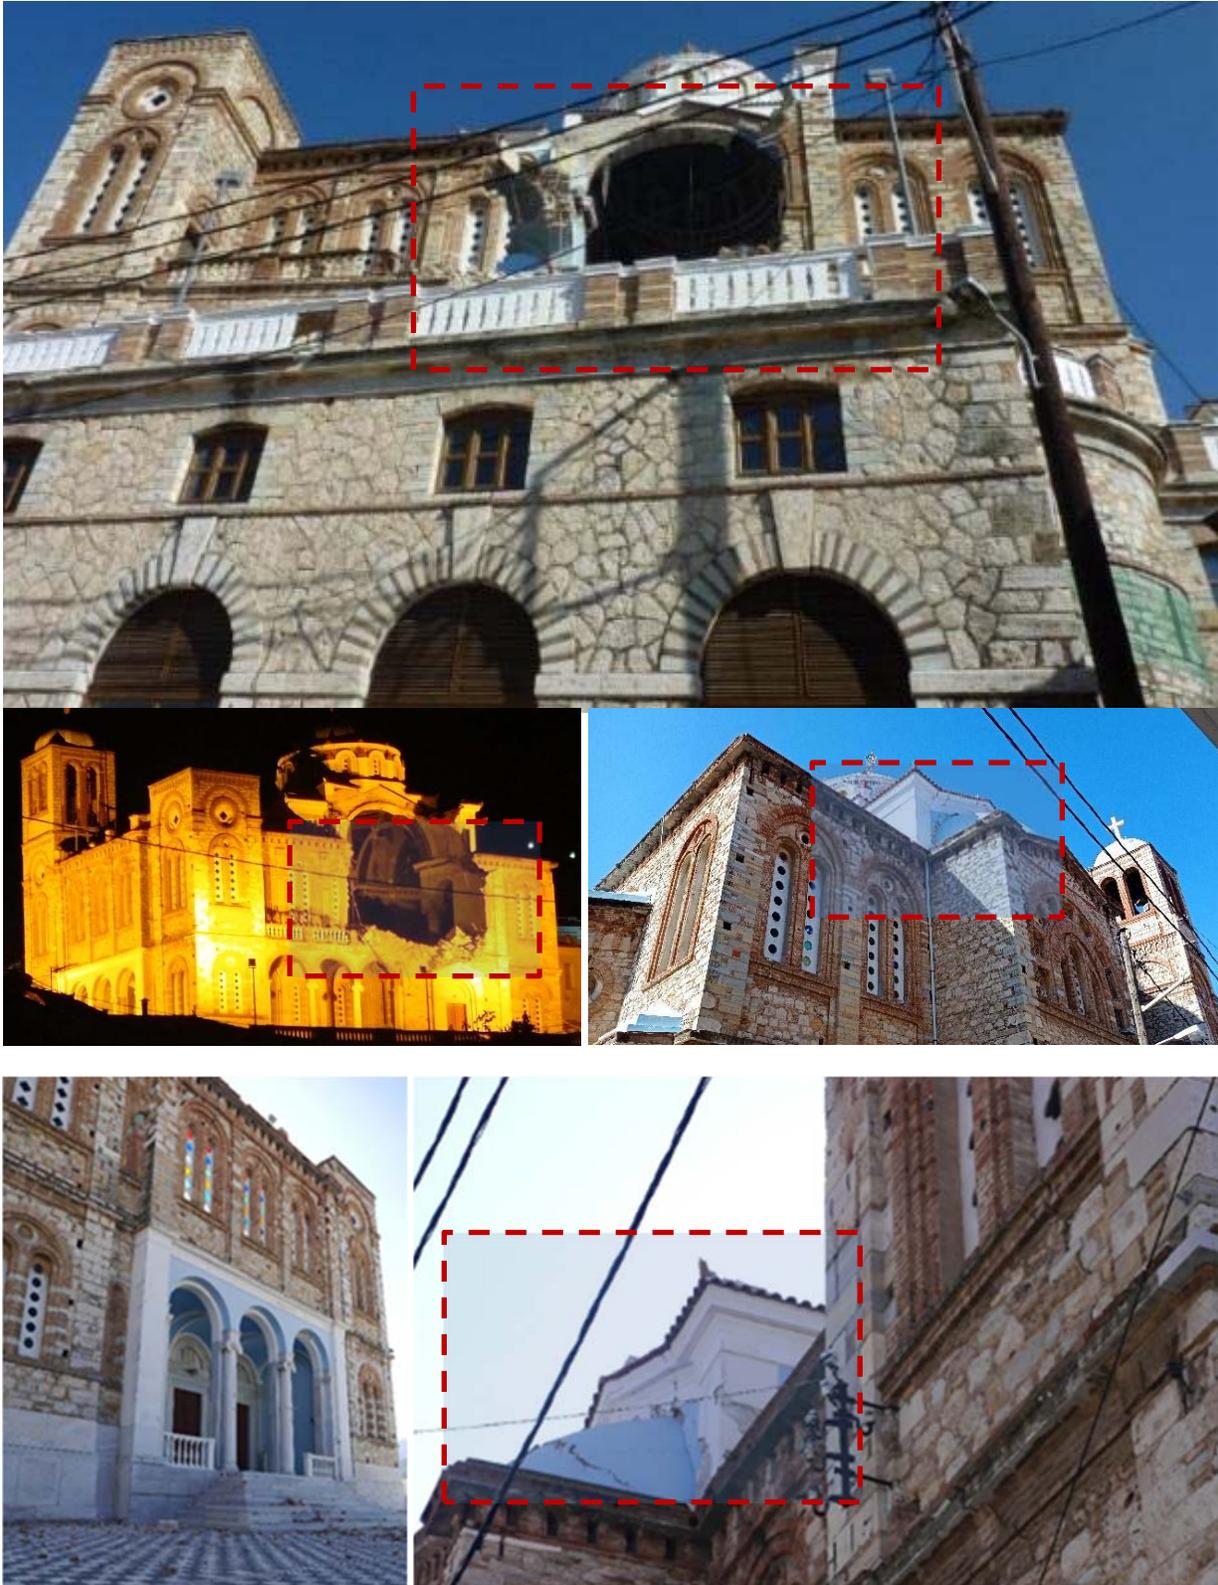
Figure 7.88. Out-of-plane failure of the south lateral wall which supports the dome of the Cathedral of the Assumption of Virgin Mary in Karlovasi. In this particular temple there was a collapse of the roof on the west side of the Temple.

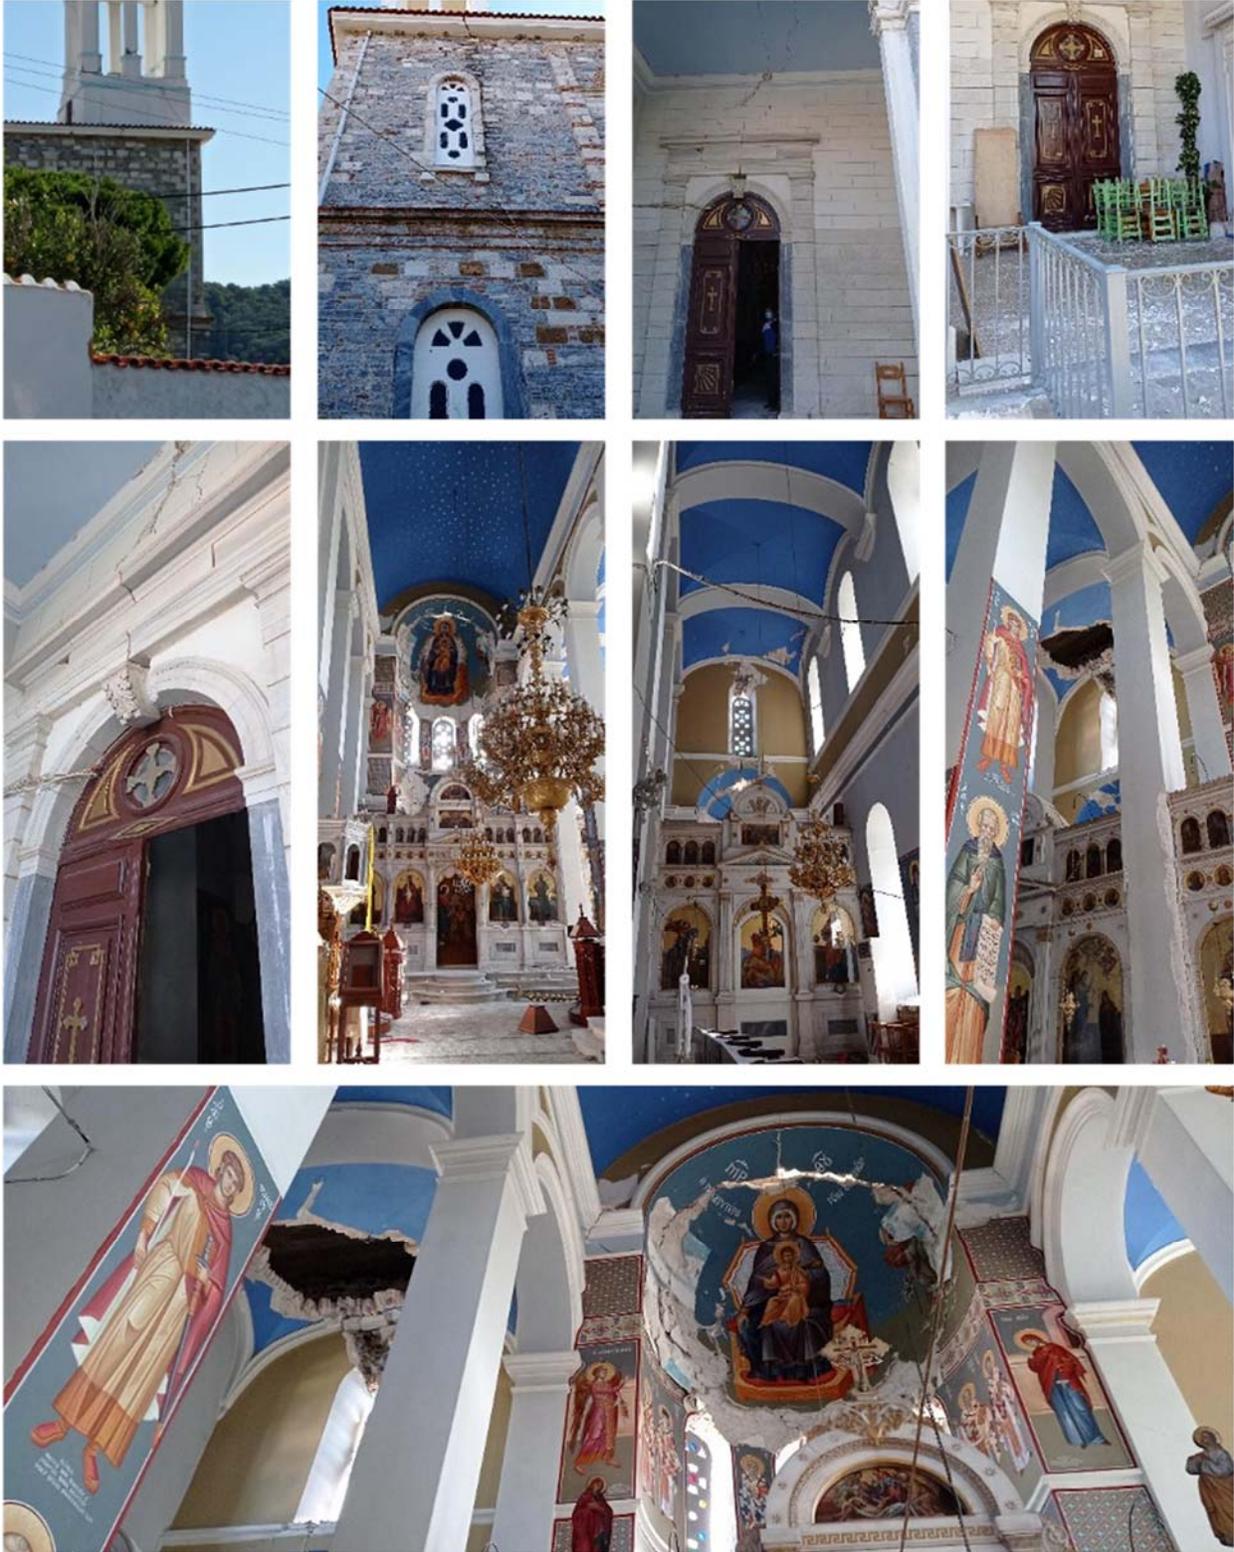
Figure 7.89. Extensive failures at the Church of Agios Nikolaos in Kokkari, the largest Church of Samos. Failure in arches, in the keystone of the two main entrances, cracks and complete failures in domes as well as damages in the bell tower.

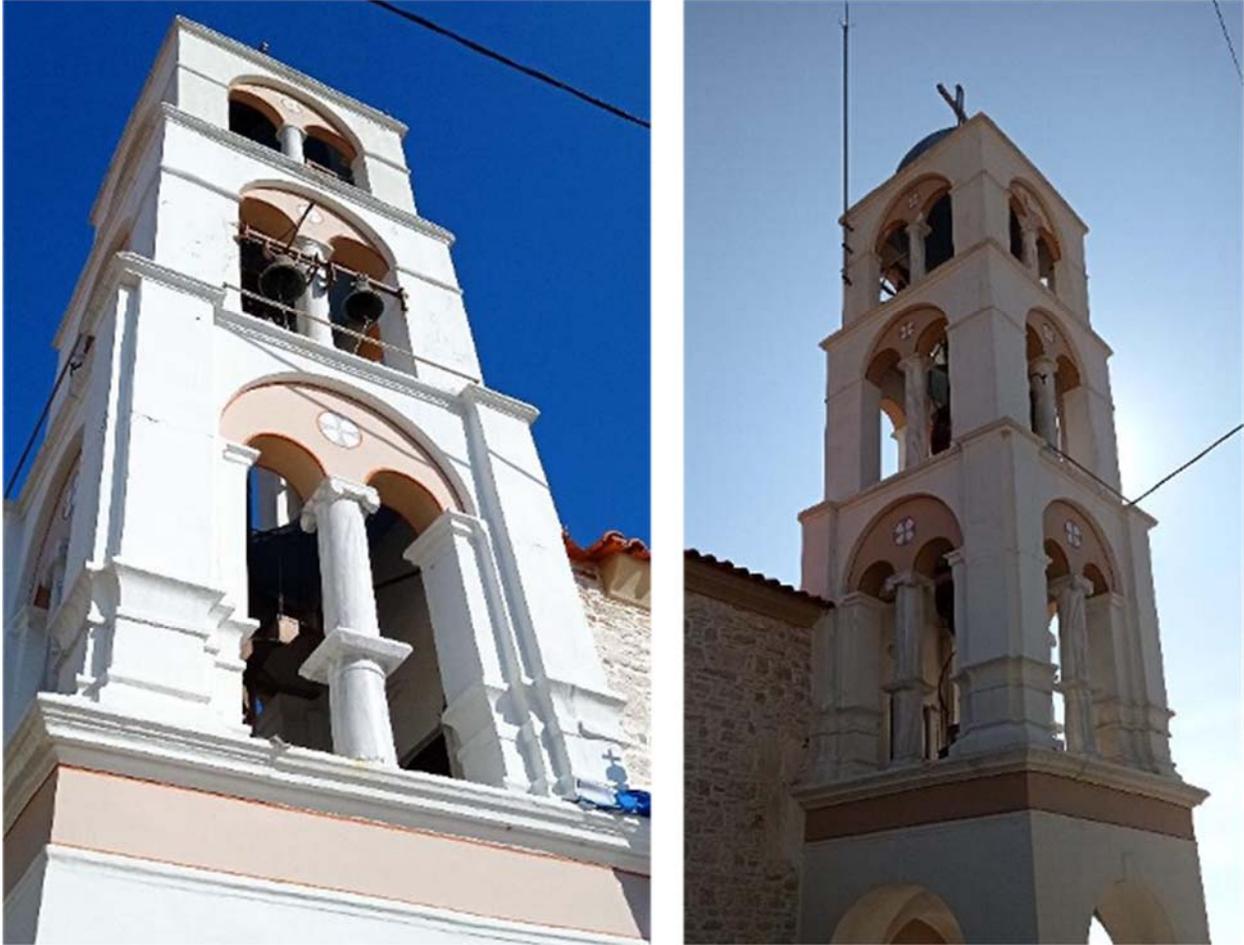
Figure 7.92. Shear failure at the bell tower of the Agia Paraskevi Church at Chora.
