3^ο Επιστημονικό Forum για τη Μείωση της
ΔΙΑΚΙΝΔΥΝΕΥΣΗΣ ΑΠΟ ΚΑΤΑΣΤΡΟΦΕΣ
στην Ελλάδα

Έρευνα για την Ορθολογική Εκτίμηση Σεισμικών Φορτίων Μνημείων Πολιτιστικής Κληρονομιάς

*Σαλονικιός Ν. Θωμάς, Δρ Πολιτικός Μηχανικός, Κύριος Ερευνητής, ΙΤΣΑΚ – ΟΑΣΠ
Επιστημονικός Συντονιστής*

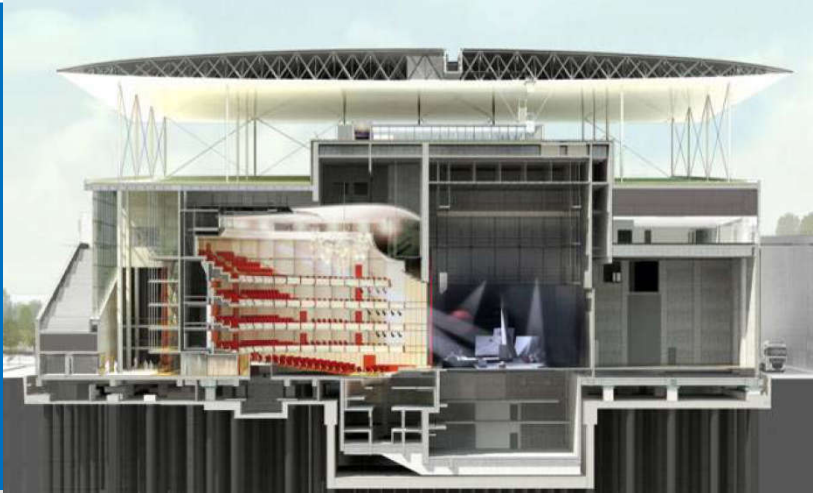
NIARCHOS CANOPY, Athens, Greece, 2016

NIARCHOS CANOPY –
VERTICAL EIGENMODES

<u>Eigenfrequency</u>	Direction	FE model	FFT	Artemis	Artemis		
Number	Axis	Eig/cies Hz	Eig/cies Hz	Eig/cies Hz	Damping	4th	
1 st	Along Y'Y	1.192	1.128	1.126	0.3-0.8%		
2 nd	Along X'X	1.269	1.160	1.167	0.6-1.1%		
3 rd	Around Z'Z	1.739	1.623	1.631	0.3-1.1%		5 th 6 th
4 th	Along Z'Z	2.646	2.459	2.858 2.592	4.6%		
5 th 6 th	Along Z'Z	3.597, 3.636	3.646	3.633 3.628	1.6 – 3.1%		
7 th	Along Z'Z	4.926	4.821	5.911	1.0 - 1.7%		8 th
8 th	Along Z'Z	6.329	6.000	8.326	3.2%-4.1%

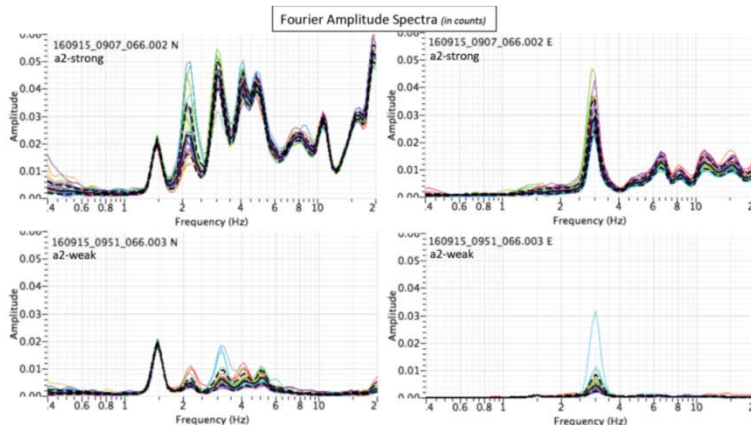
Figure 12. Fourier Amplitude Spectra for record at location CH9 "North" and inverted CH10 "East". Top diagrams represent the situation with mechanical equipment at operation and bottom diagram with equipment off.

Documentation of strength increase without modification of the horizontal stiffness.

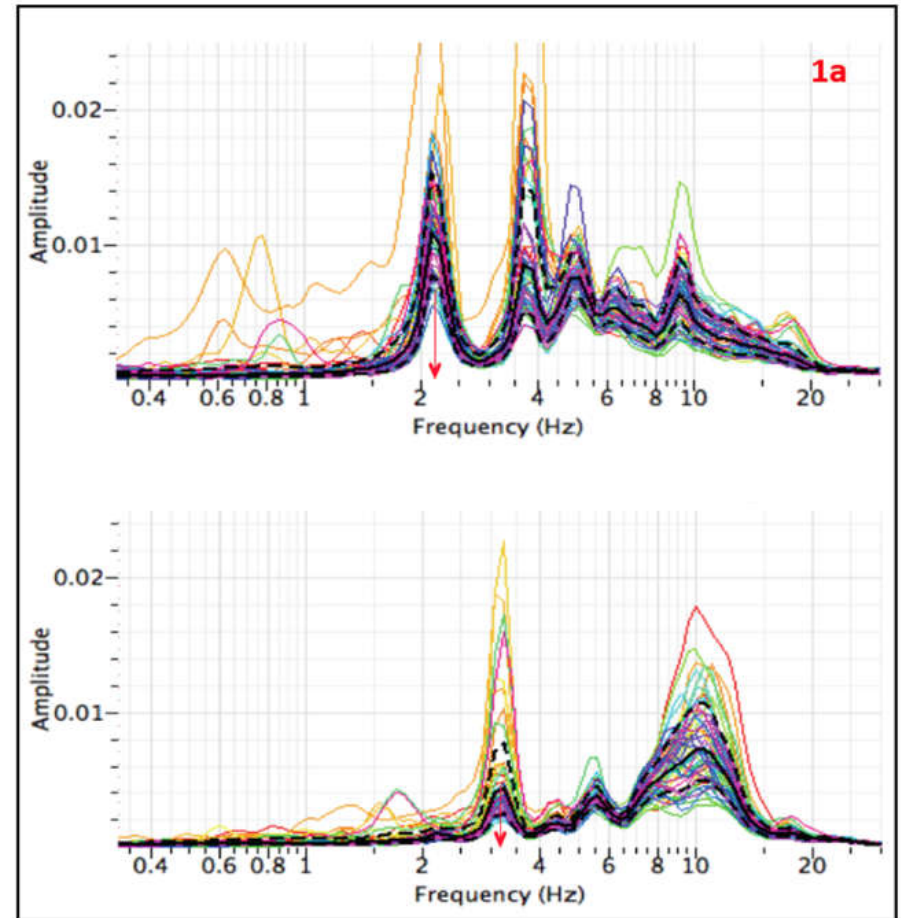
Fig. 11 Fourier amplitude spectra for each time window of 30 s (colored lines), geometric average (solid black line) and ± 1 standard deviation (dashed lines) for the point 1a; north-south (upper) and east-west (down) component. The arrow indicates the fundamental frequency

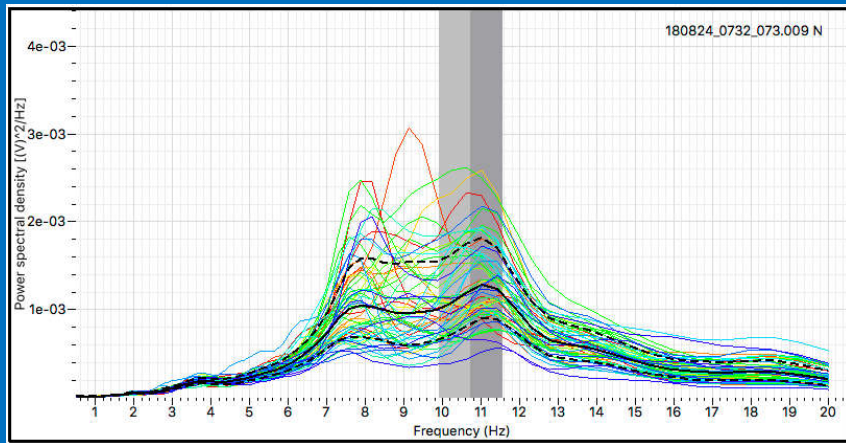
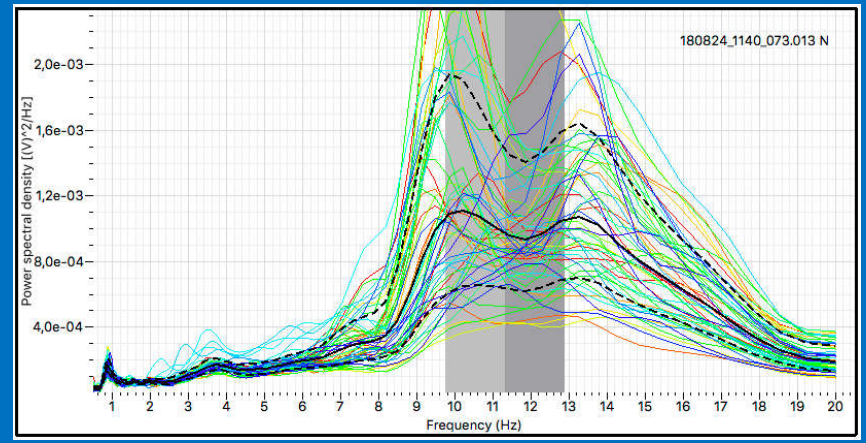
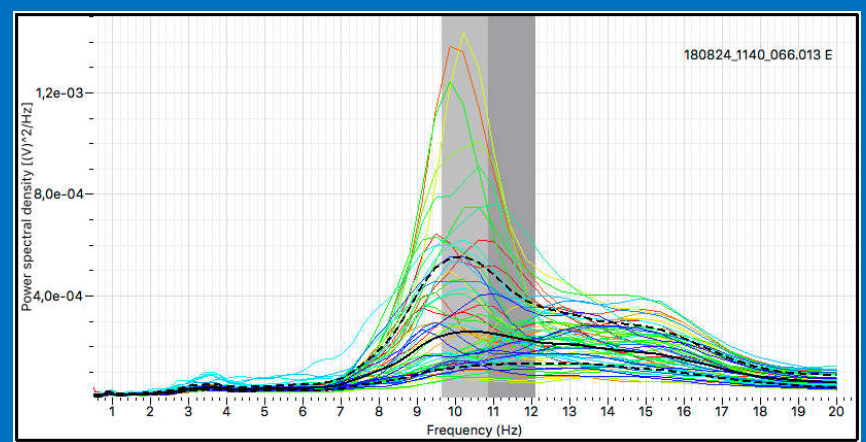
Power spectral density diagrams

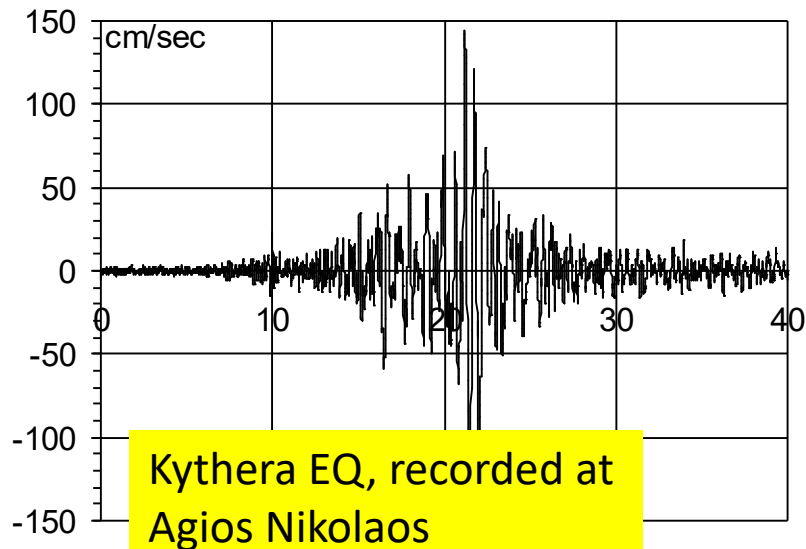
ΣΕΙΣΜΟΣ ΚΥΘΗΡΩΝ, ΚΑΤΑΓΡΑΦΗ ΑΓ. ΝΙΚΟΛΑΟΣ "L"

Kythera EQ, recorded at Agios Nikolaos

EQ	$Sa_{o\max}$	φασματική Sa_{\max}	T	$2.5 \cdot A_o / 1.5$	$(2/3) \cdot Sa_{\max}$
	(1)	(2)	(3)	(4)= $2.5 \cdot 0.24$	(5)= $2/3 \cdot (2)$
Koroni	0.07g	0.31g	0.28sec	$0.6g / 1.5 = 0.4$	0.20g
Kythera	0.15g	0.65g 0.46g	0.55sec 0.32sec	$0.6g / 1.5 = 0.4$	0.43g 0.31g
Achaia - Ilia	0.21g	0.87g	0.18sec	$0.6g / 1.5 = 0.4$	0.57g

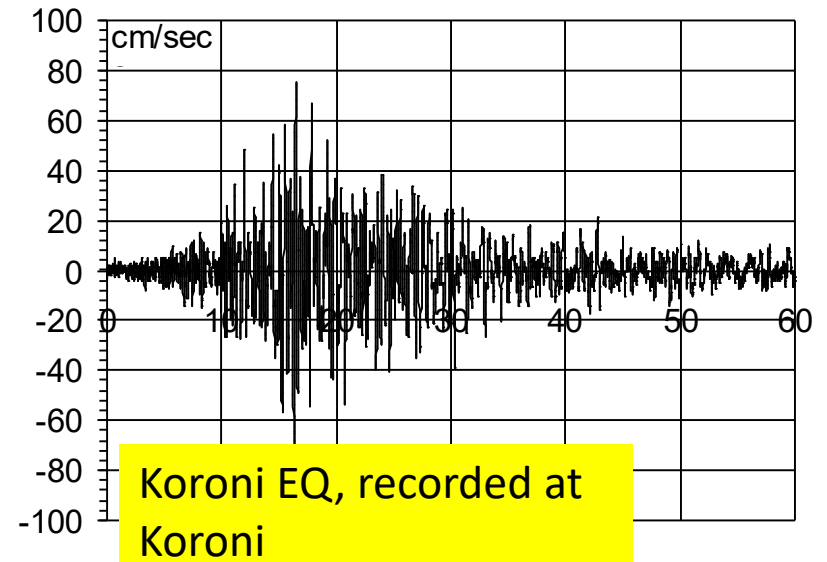
ΣΕΙΣΜΟΣ ΚΟΡΩΝΗΣ, ΚΑΤΑΓΡΑΦΗ ΚΟΡΩΝΗ "L"

Koroni EQ, recorded at Koroni

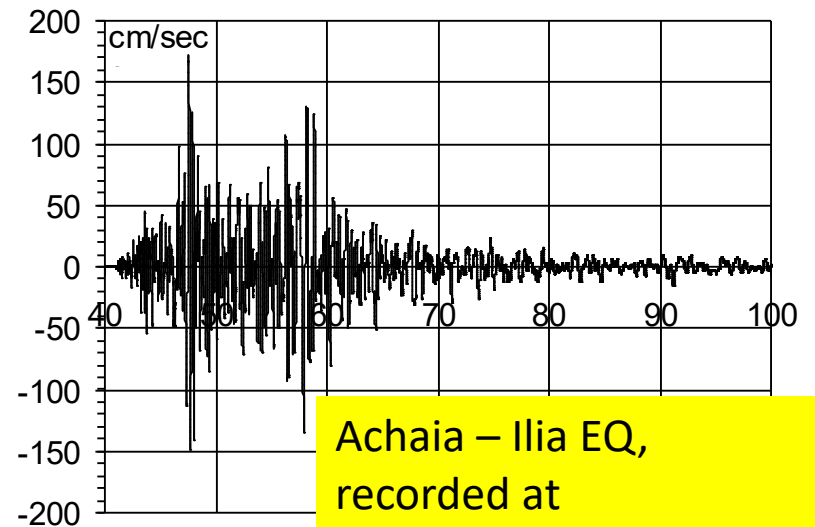
ΣΕΙΣΜΟΣ ΑΧΑΪΑΣ - ΗΛΕΙΑΣ, ΚΑΤΑΓΡΑΦΗ ΒΑΡΘ. "T"

Achaia – Iliia EQ, recorded at Vartholomio
