# Newsletter of **Environmental, Disaster, and Crises Management Strategies**

Issue No. 21 | November 2020

## **The October 30, 2020, Mw 6.9 Samos (Greece) earthquake**

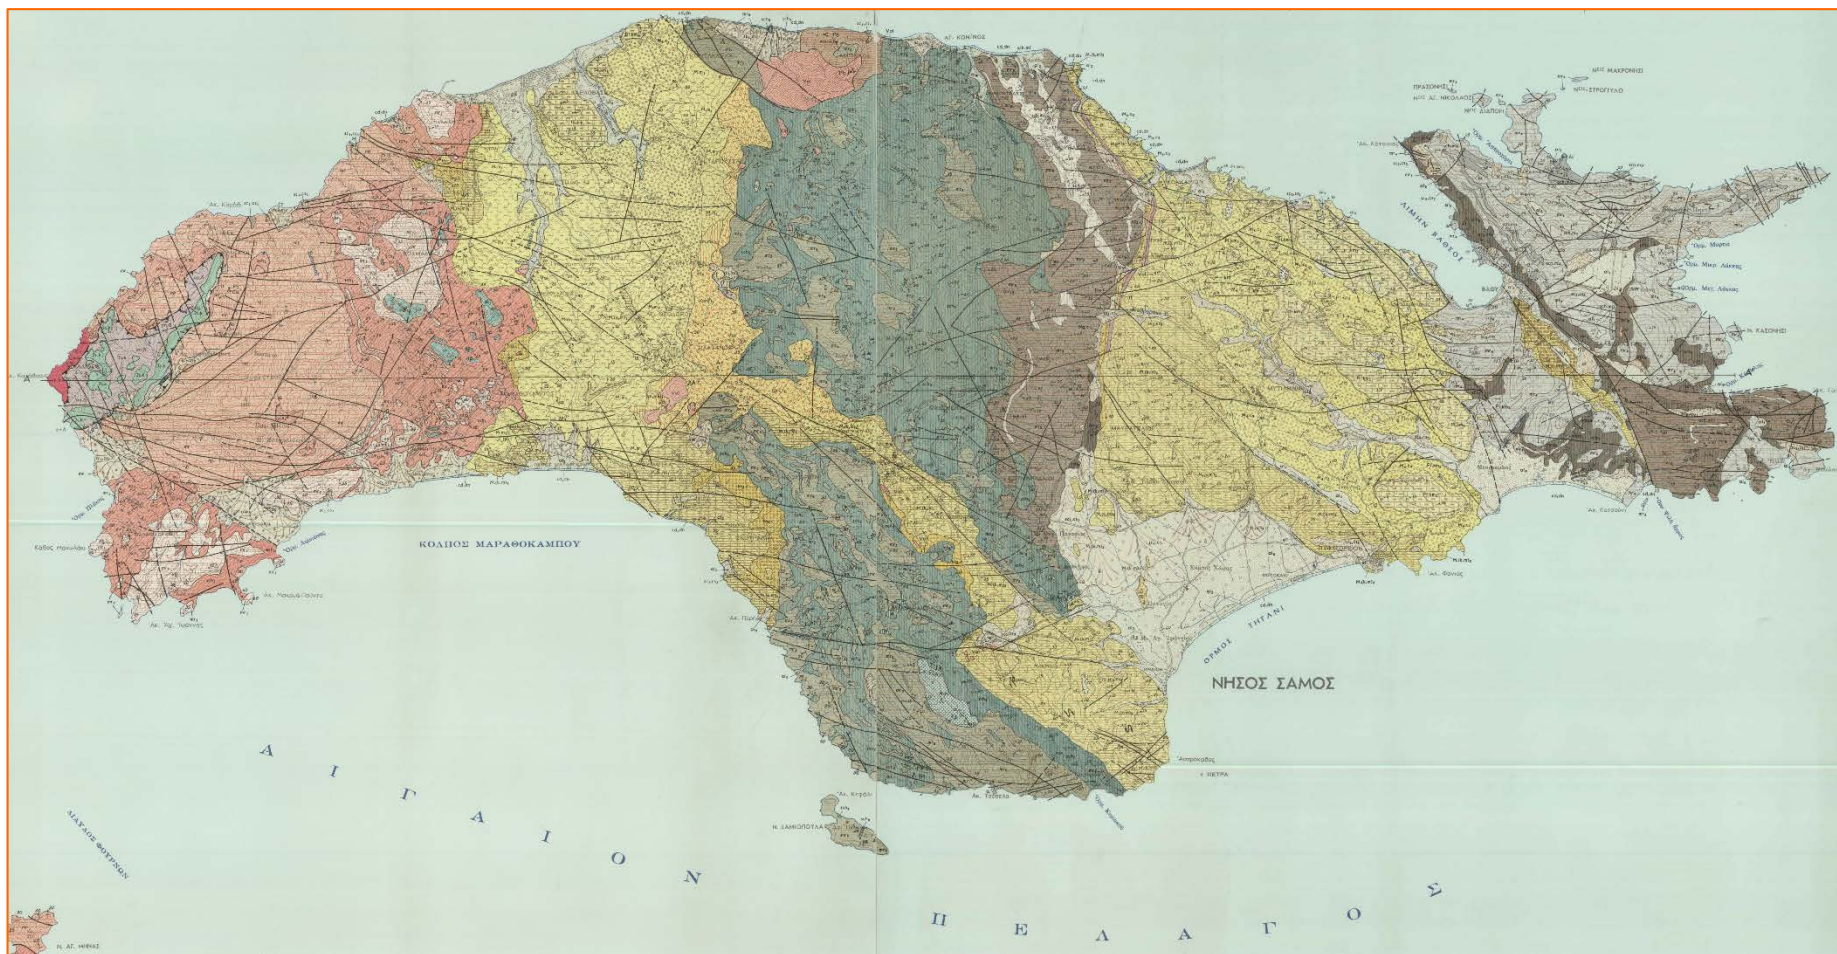
Geological Map of Samos Island  
compiled by *Theodoropoulos (1979)* and published by *Institute of Geology and Mineral Exploration*

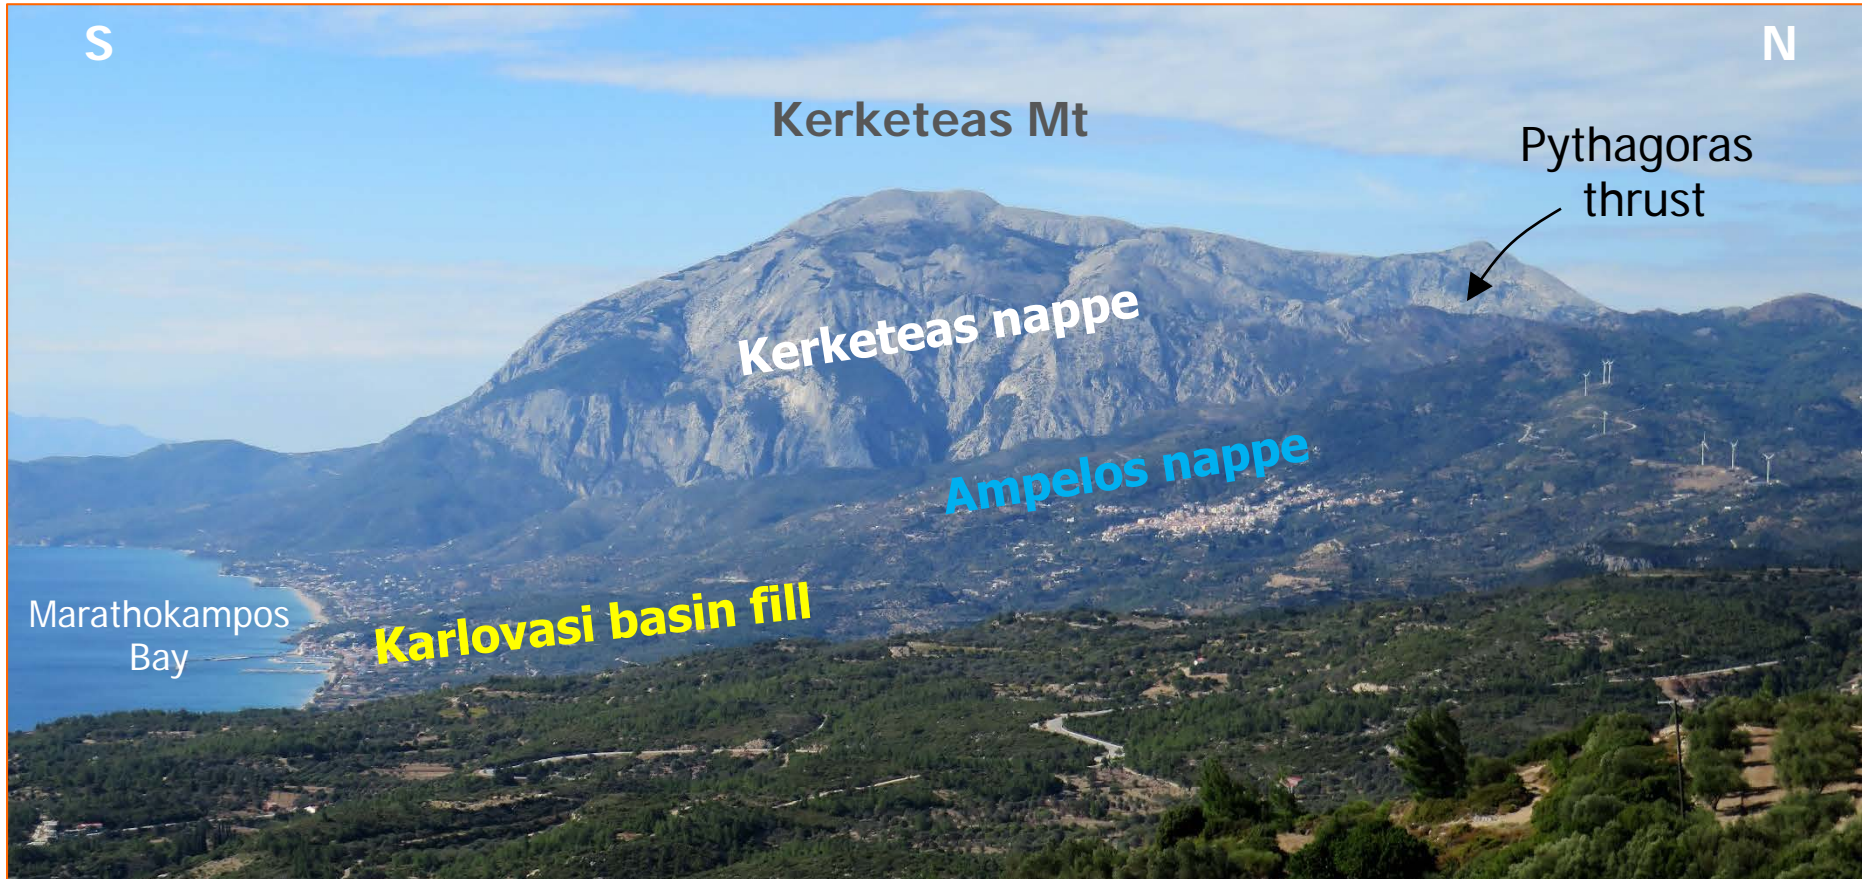
Panoramic view of Kerketeas Mt from the East (Noechori village). It is located at the western part of Samos. It is composed of white to grey, medium to thick bedded and sometimes unbedded, coarse-crystalline marbles, which are strongly faulted. Their visible thickness exceeds 1500 m. Pythagoras thrust is observed at the eastern part of the mountain, separating the Kerketeas nappe from the overlying Ampelos nappe comprising marbles and slates. The Neogene formations of Karlovasi basin can be also observed in the lowland.

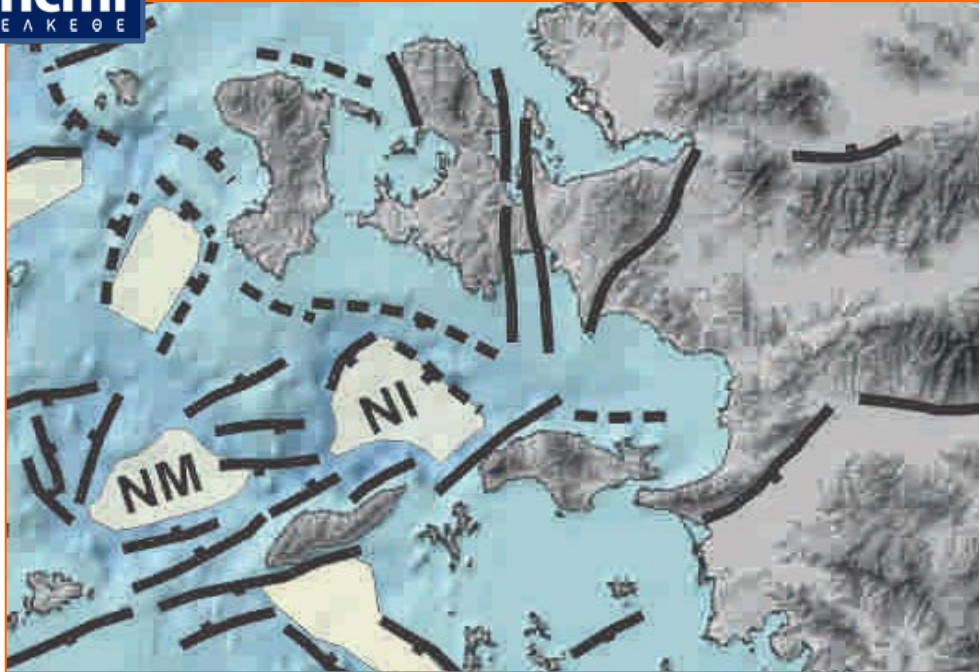
▲ The main basin formed and developed north of Samos is the North Ikaria Basin (NIB) consists of a Plio-Quaternary, wide, asymmetric depression bounded to the south by major en echelon arranged faults, which imply a transcurrent component (Mascle and Martin, 1990).

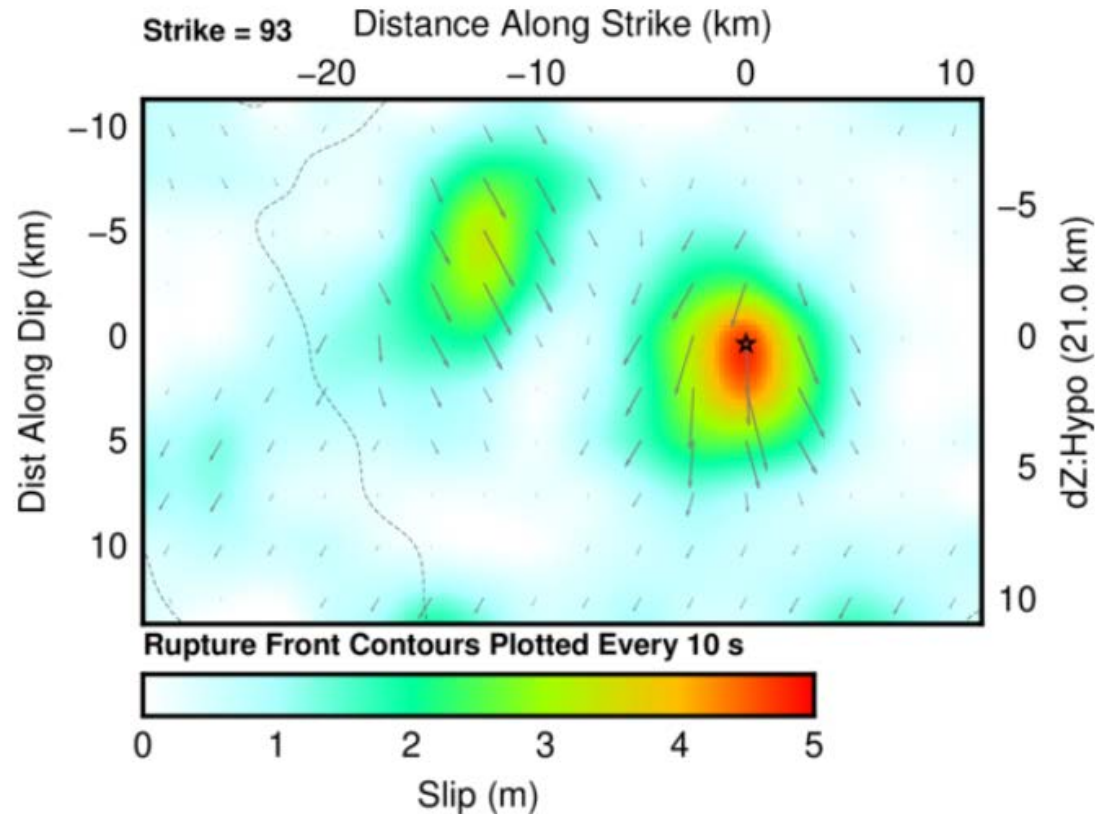
The strike direction is indicated above each fault plane and the hypocenter location is denoted by a star. Slip amplitude is shown in color and the motion direction of the hanging wall relative to the footwall is indicated with arrows. Contours show the rupture initiation time in seconds.

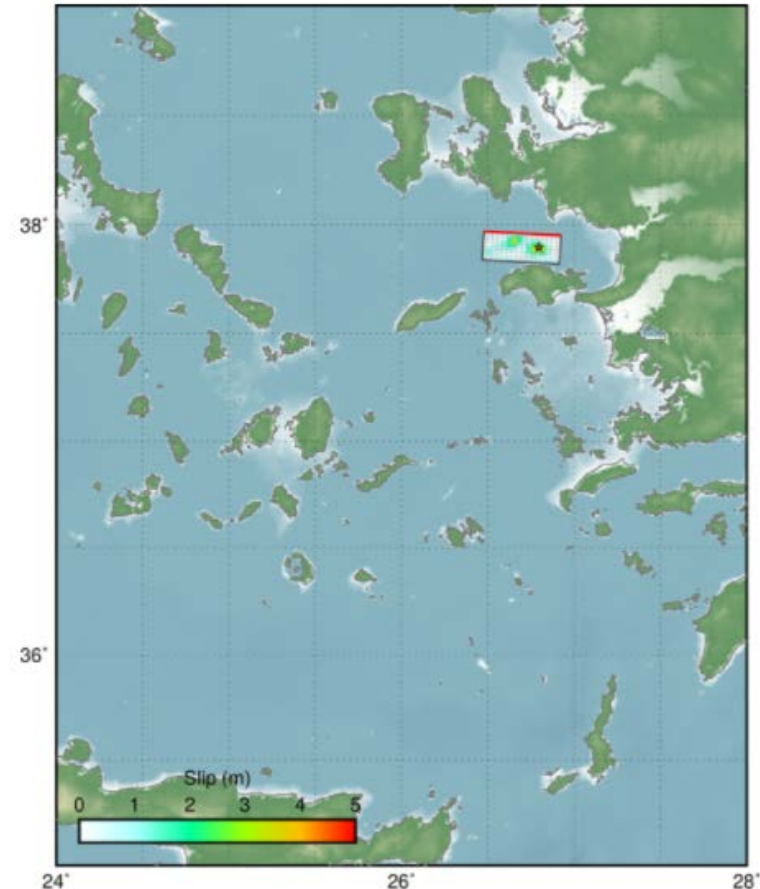
Surface projection of the slip distribution superimposed on GEBCO bathymetry.

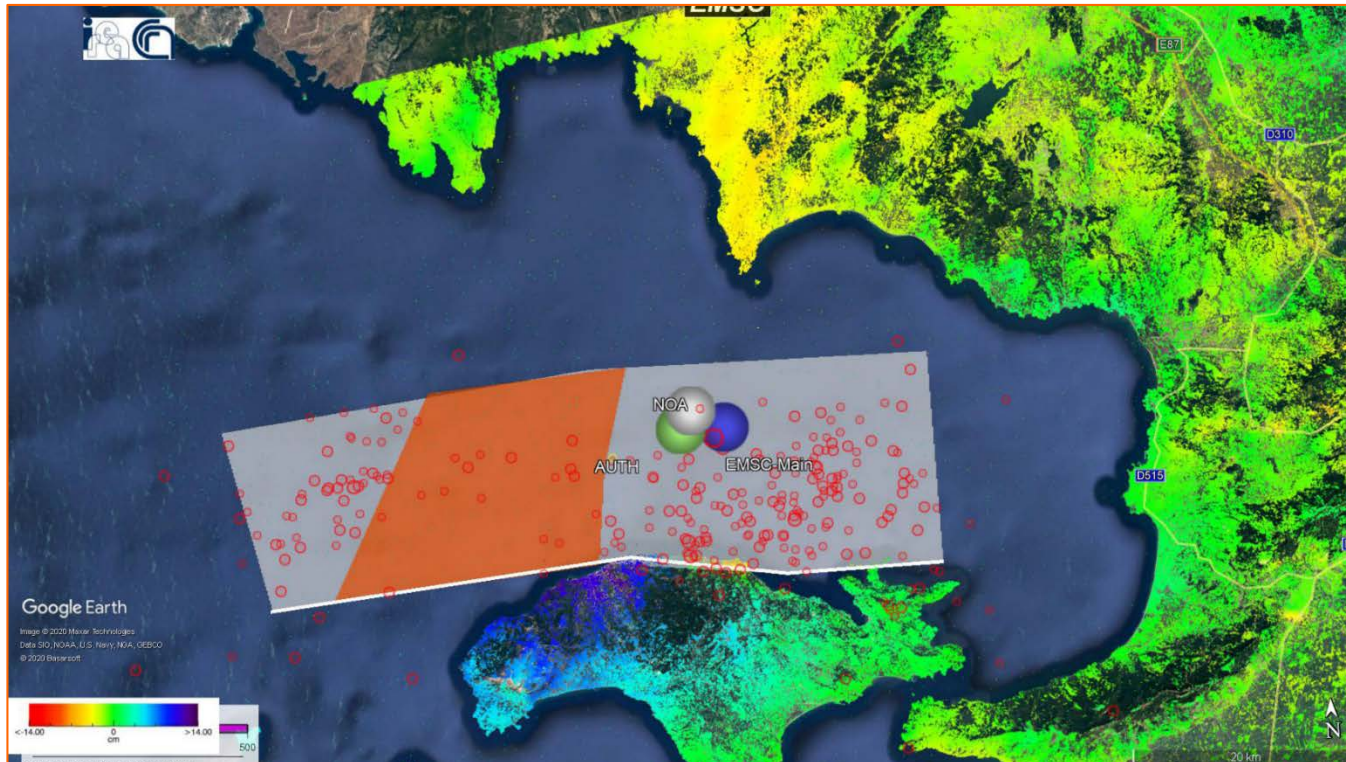
The rupture started from the hypocenter (relocated depth ~13 km), possibly expanded bilaterally in both directions (East and West), rupturing an area with a length of 55-60 kilometers and a width of 15 kilometers (the fault, white polygon). The large fault displacements possibly occurred along the western fault segment (orange area), where fault may have reached the surface, significantly shifting the sea bottom (though this can be done only by the static displacement) and generating the observed tsunami.

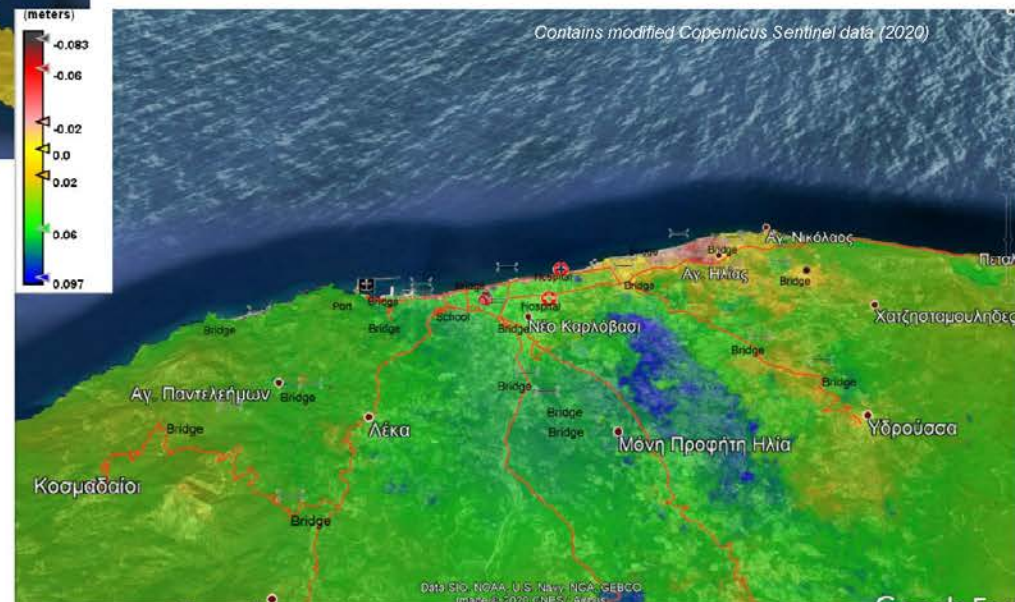
Displacement map produced by the descending Sentinel 1 SLC pair overlapped by local exposure (road network, hospitals, schools, cultural heritage sites and museums, bridges etc).

- ◀ The entire island of Samos
- ▼ The detailed of Karlovasi City

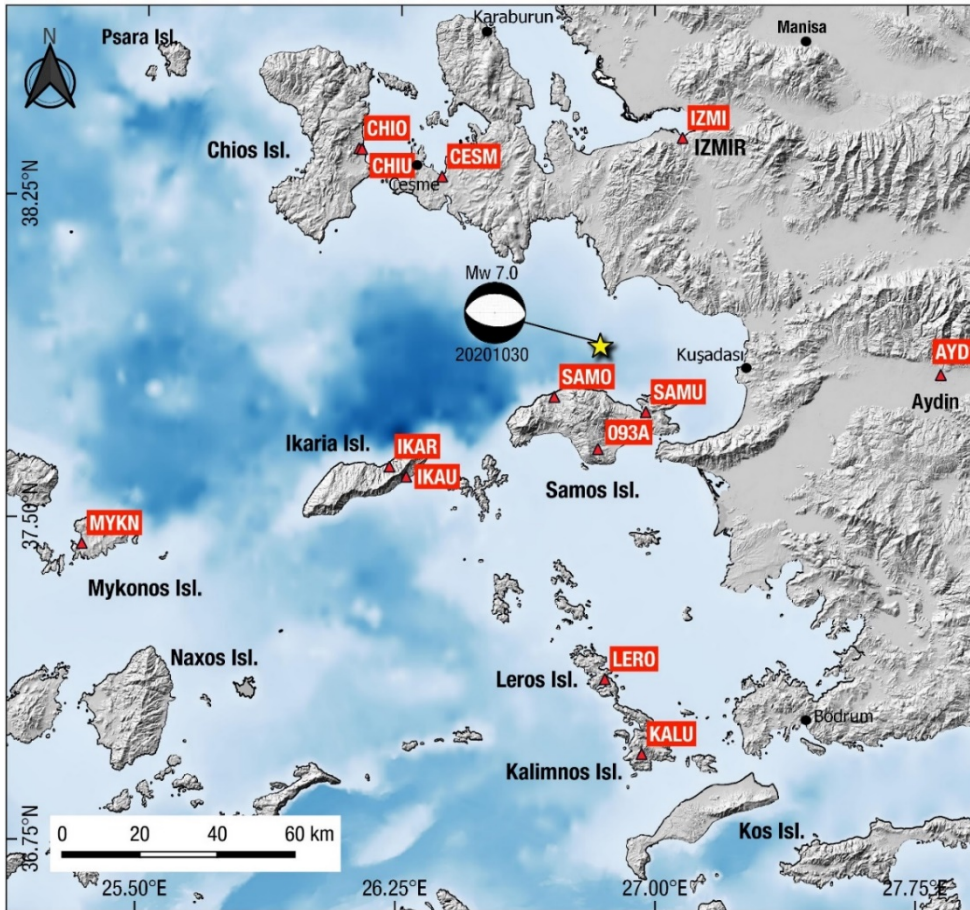
A first analysis of the geodetic data is presented by the NOA scientific team (Ganas, Tsironi, Karasante). They used a set of ascending SAR images acquired by the SENTINEL-1 satellites that are distributed routinely by the European Space Agency (ESA) free of charge. They also used GNSS data (at 30-s sampling interval) from permanent stations surrounding the epicenter that were provided by the Greek private GNSS networks (SmartNet and Uranus) and the Turkish CORS network. The NOA team preliminary inversion modeling indicates that the rupture occurred on a  $37 \pm 5$ -kilometer-long north-dipping tensional (“normal”) fault located off the northern shore of Samos (Ganas et al. 2020).

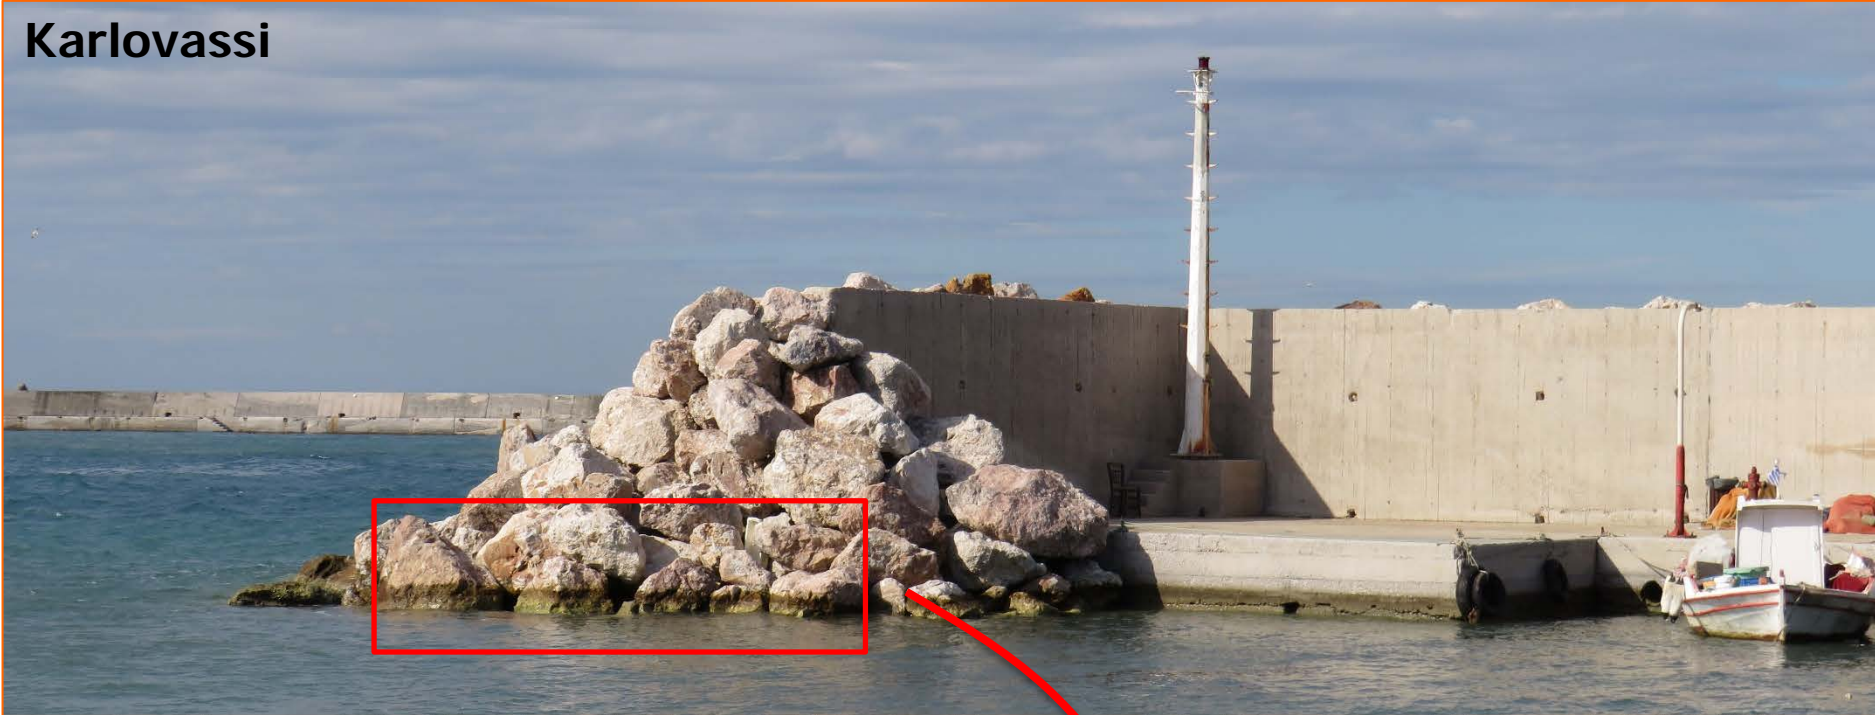
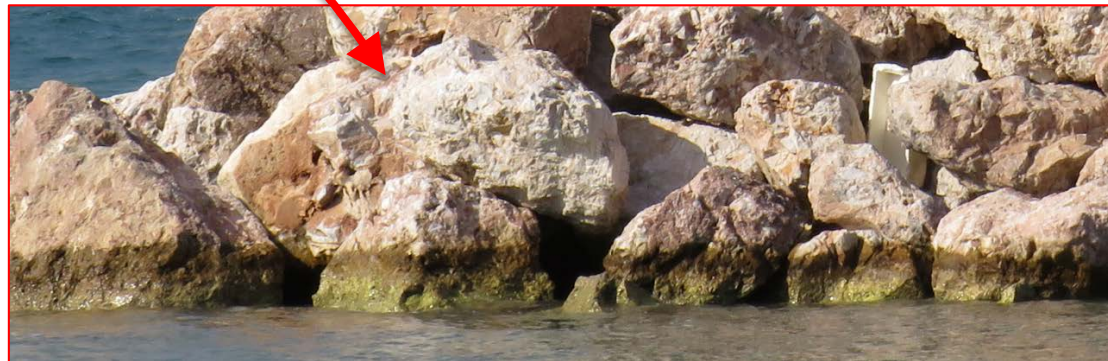
### Karlovassi

Permanent uplift in the Karlovassi coastal area. It has been observed in Karlovassi port. It has been imprinted not only on rocks for protection of the jetty, but also on the pier. Based on field measurements conducted by the scientific team of the NKUA, the uplift reached 24 cm.

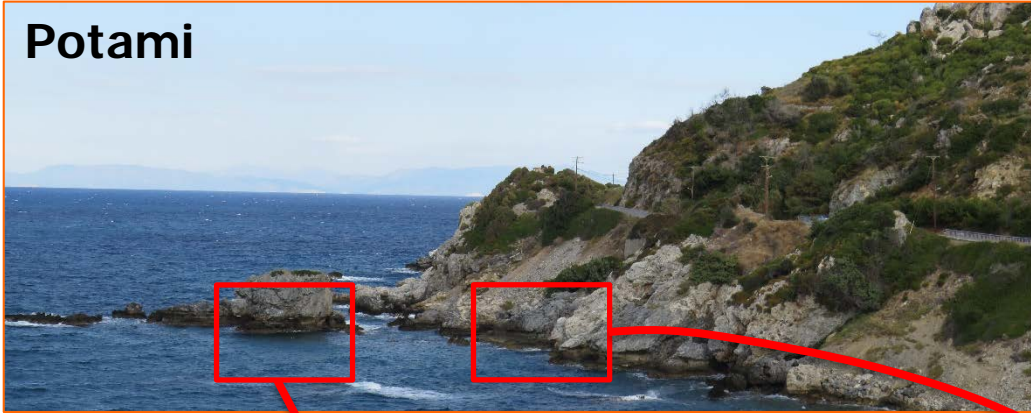
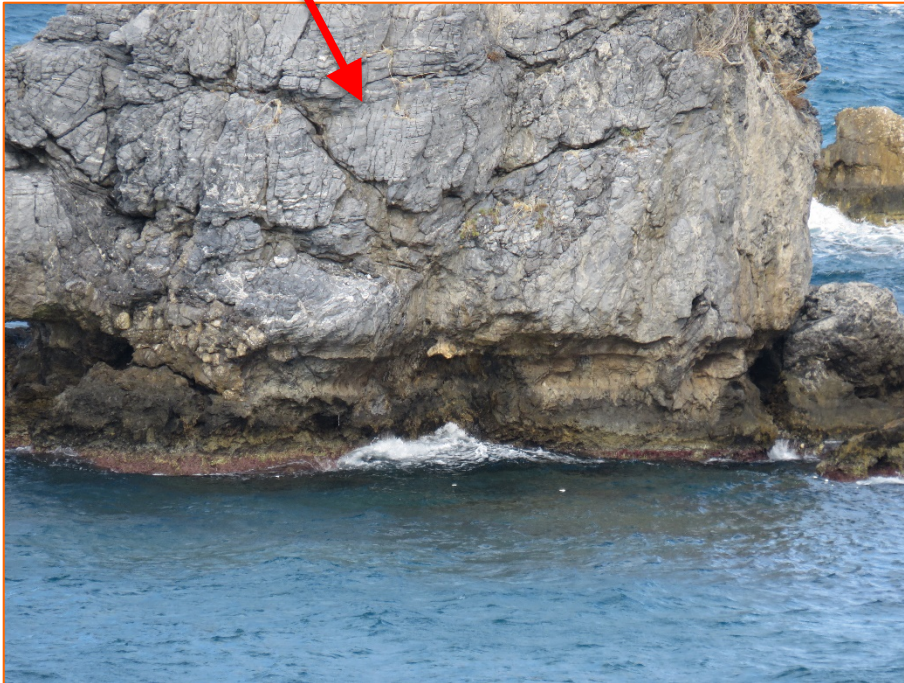
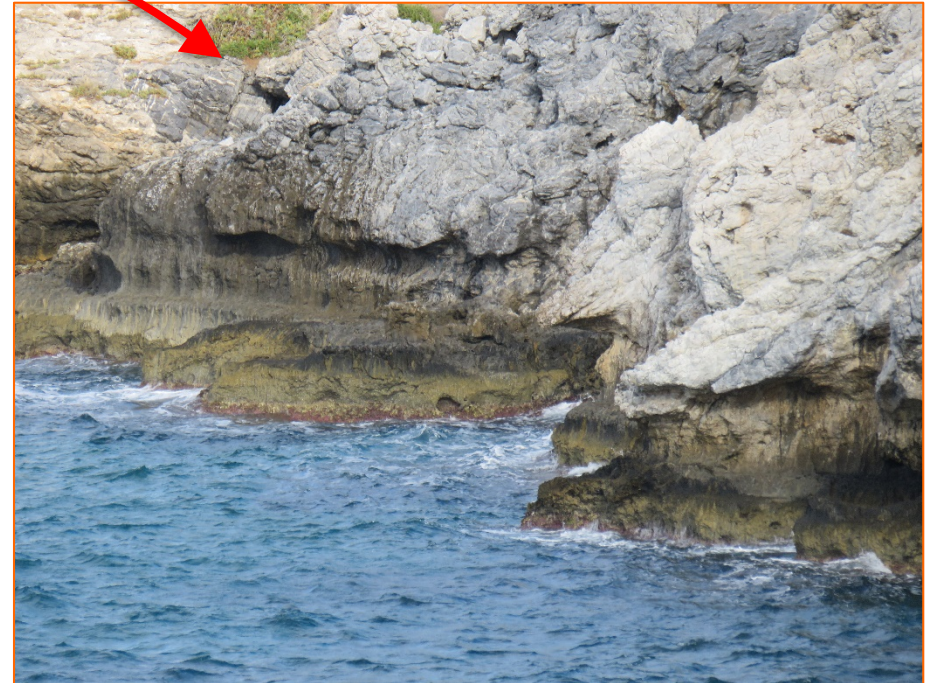
### Potami

Permanent coseismic uplift in the area west of the Karlovassi port has been detected by the scientific team of NKUA. It has been imprinted on marbles of the Kerketeas nappe along the rocky coast of Potami (east of Agios Nikolaos church).

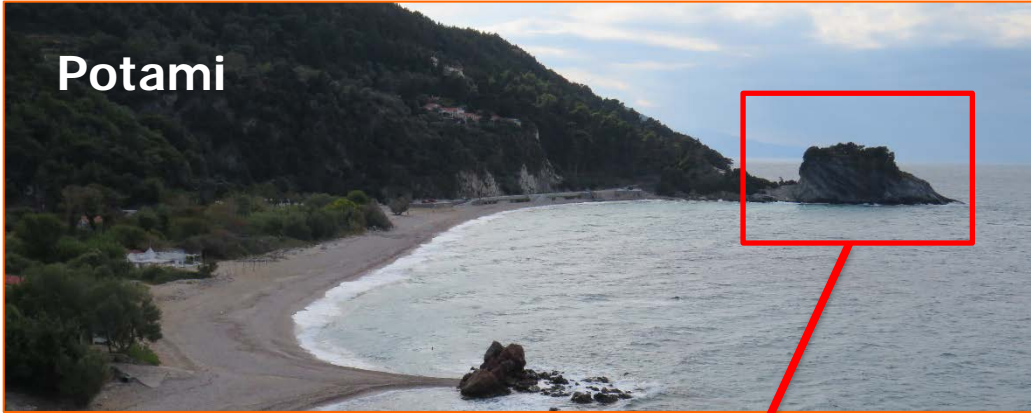
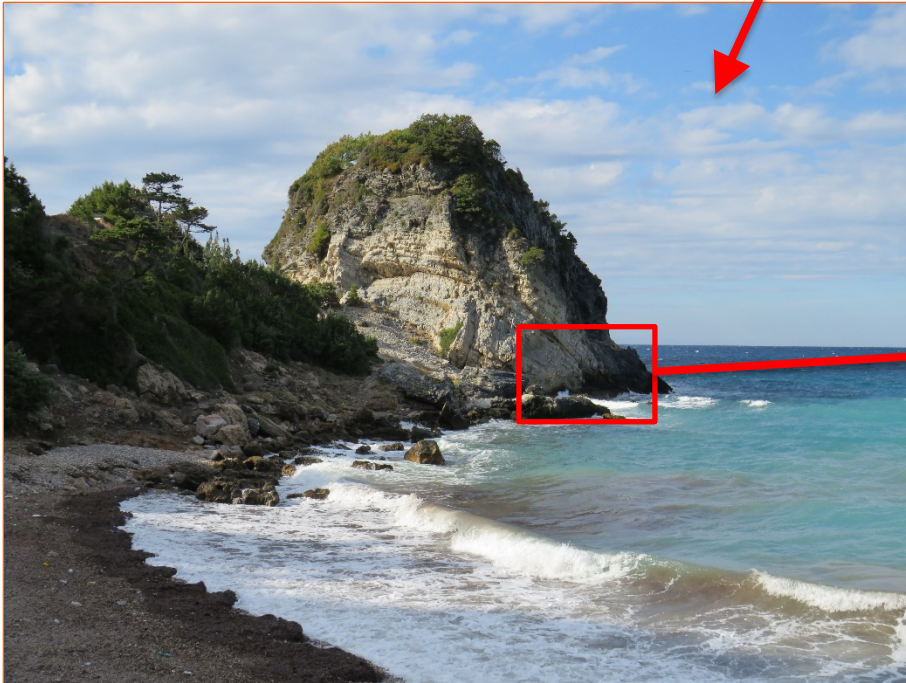
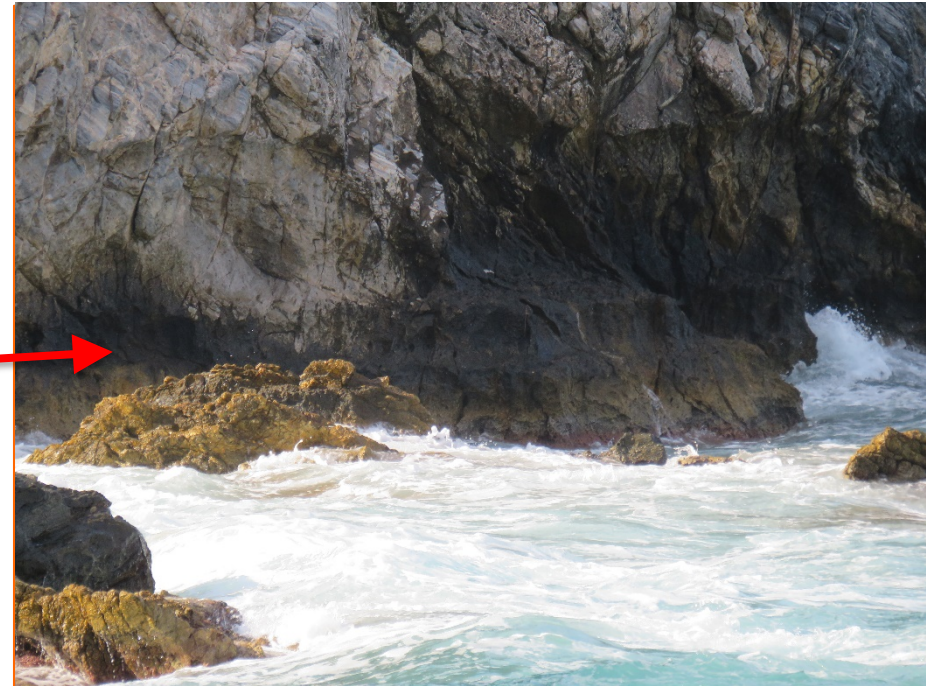
Potami

Permanent coseismic uplift in the area west of the Karlovassi port has been detected by the scientific team of NKUA. It has been imprinted on marbles of the Kerketeas nappe along Punta Promontory (west of Agios Nikolaos church).

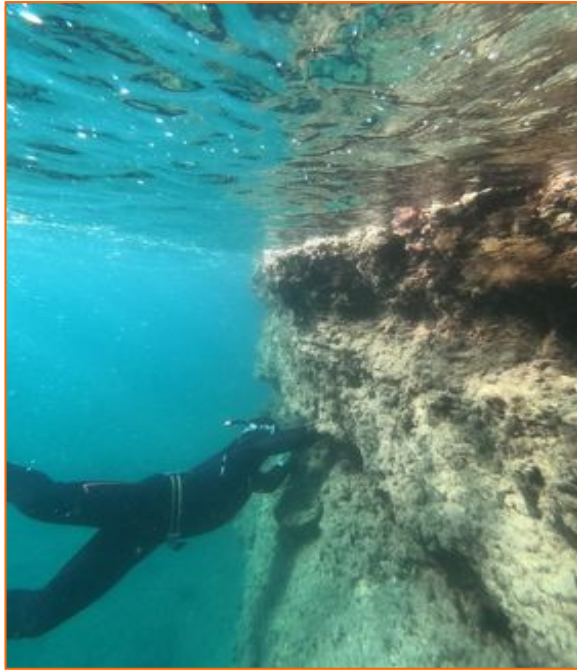
Underwater tidal notch observed NE of **Mourtia** beach, which was uplifted by 8 cm. Comparison of current measurements with values from field work conducted in 2015.

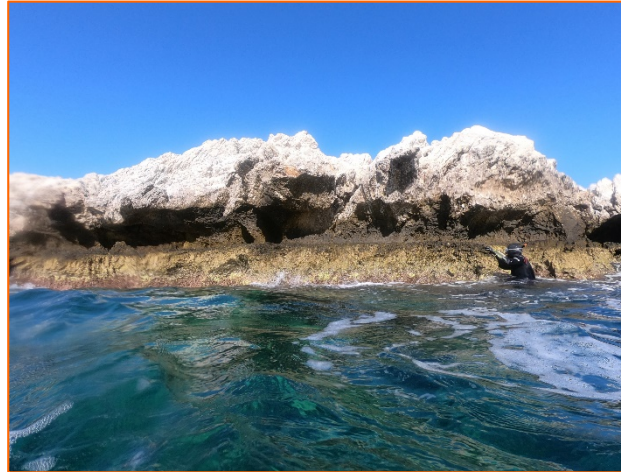
**Agios Isidoros**, uplift of 35 cm.  
Comparison of current measurements with values from field work conducted in 2015.

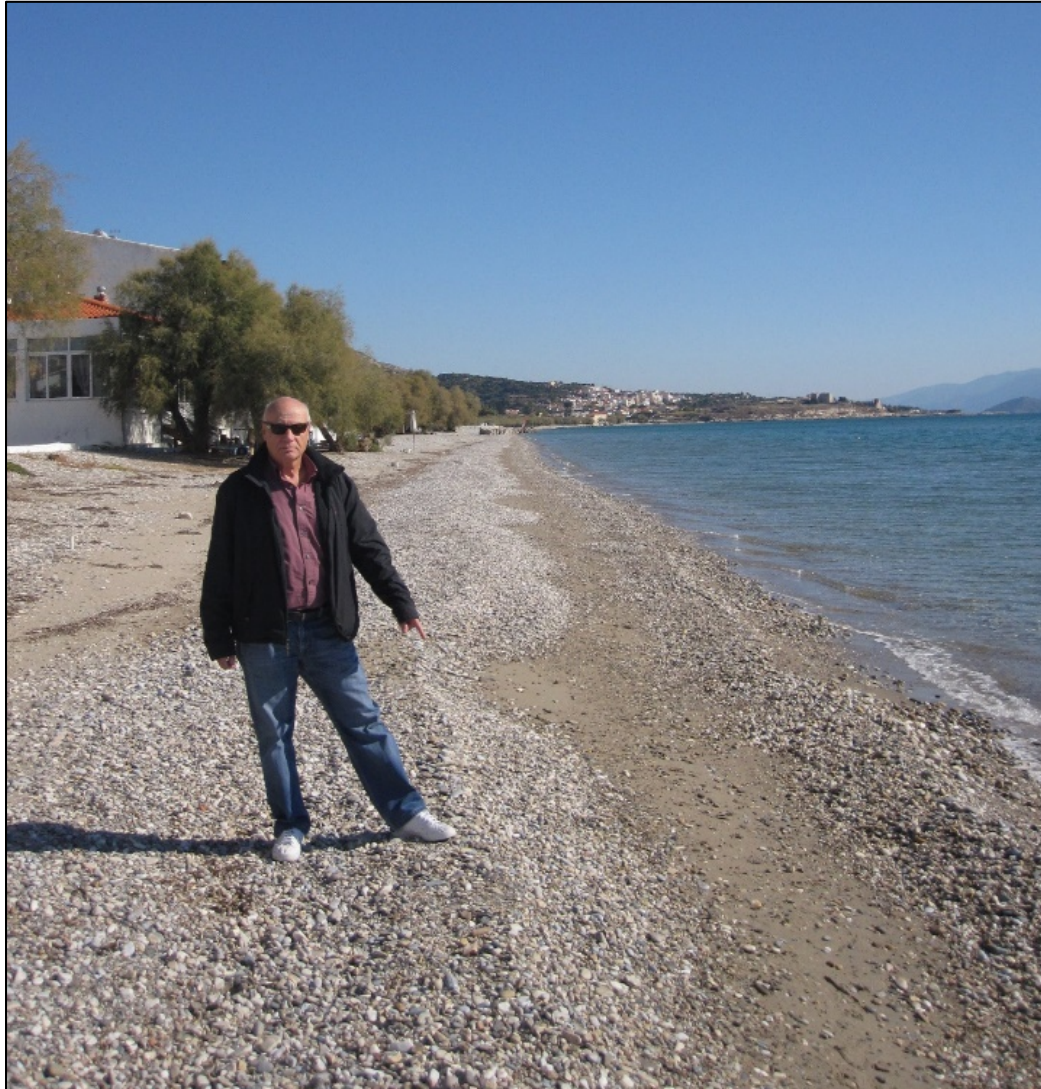
According to eyewitnesses in Potokaki area, the sea receded permanently by 3 meters from its original position immediately after the earthquake, which indicates earthquake-induced uplift.

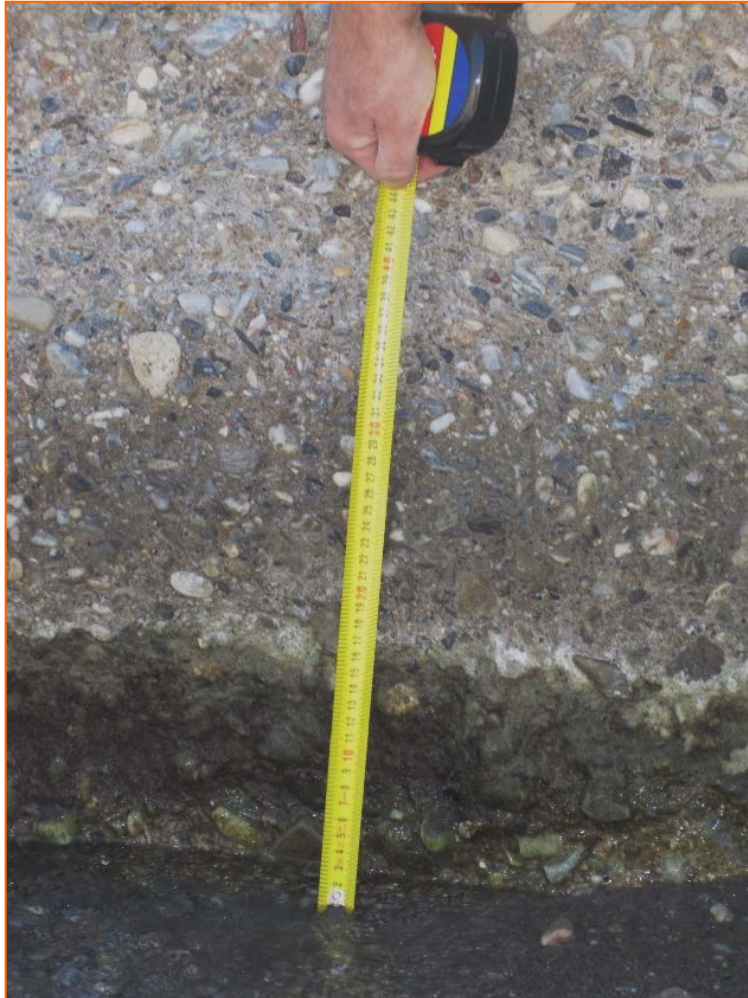
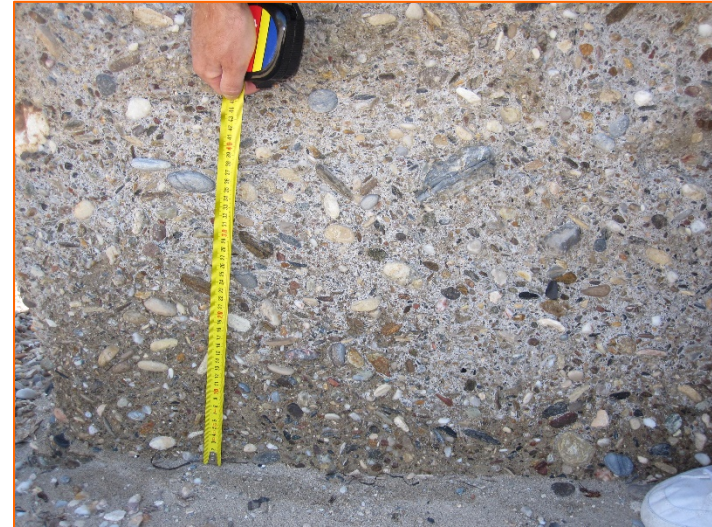
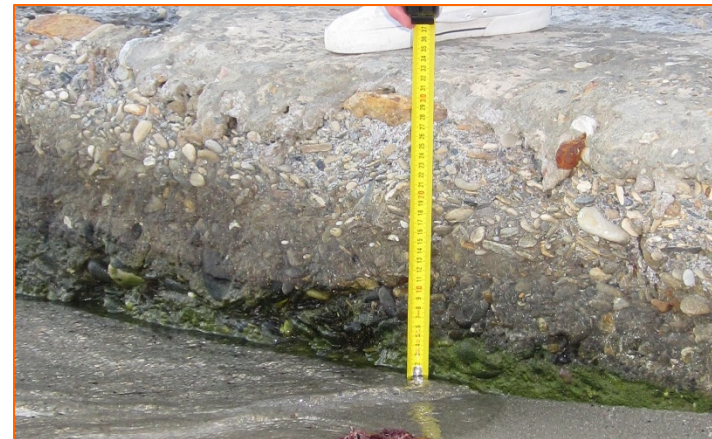
Coseismic uplift detected in abandoned breakwater construction in Potokaki area  
(From <https://twitter.com/GerasimosPapad2/status/1323949537954844672>)

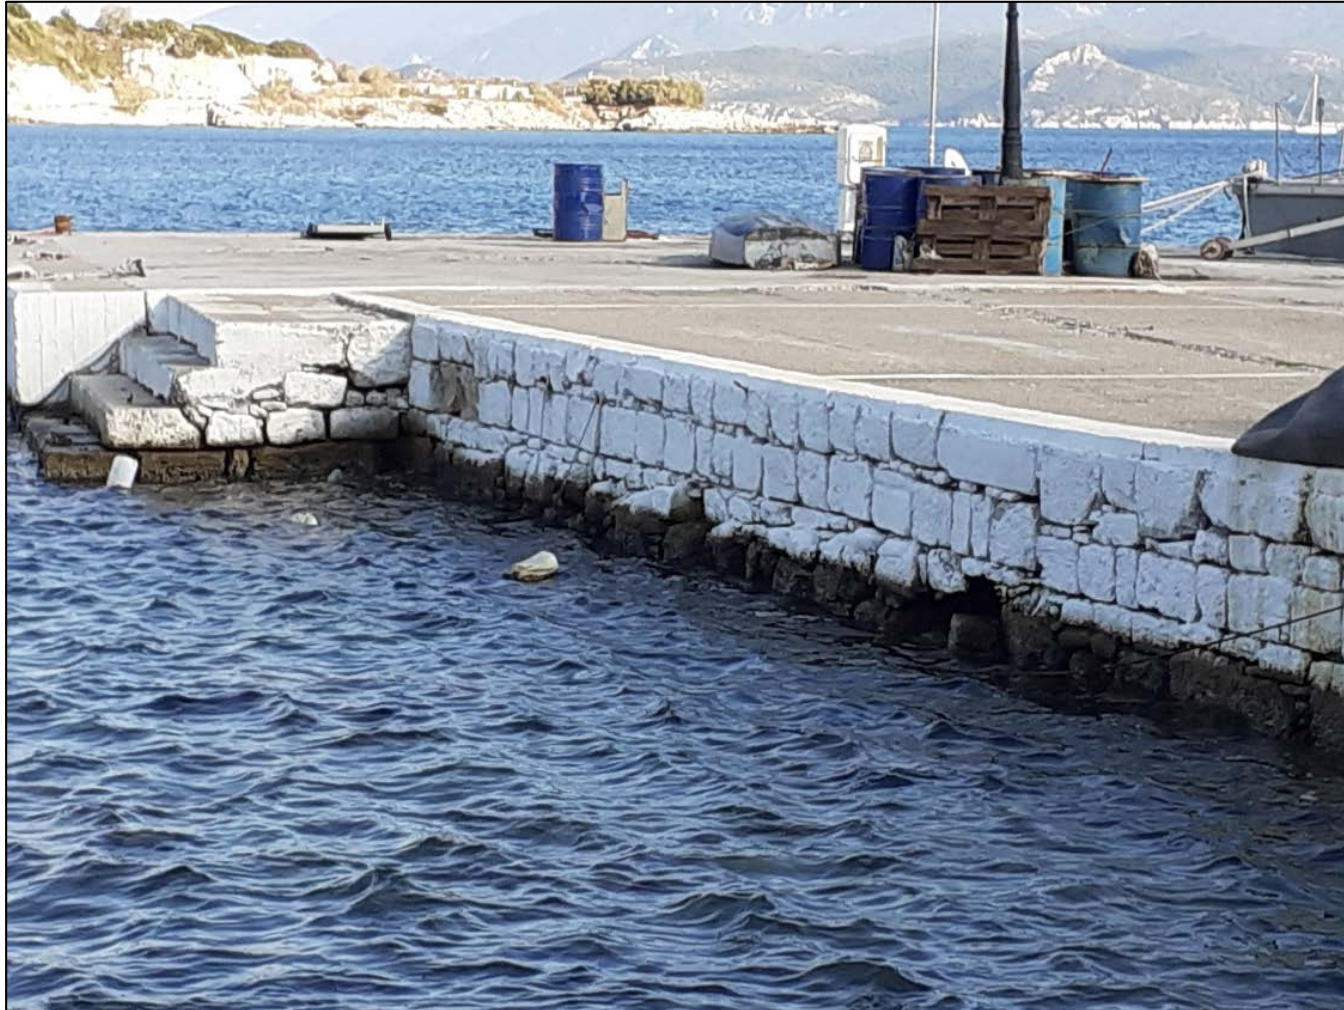
Coseismic uplift of about 20 cm detected in Pythagorio port

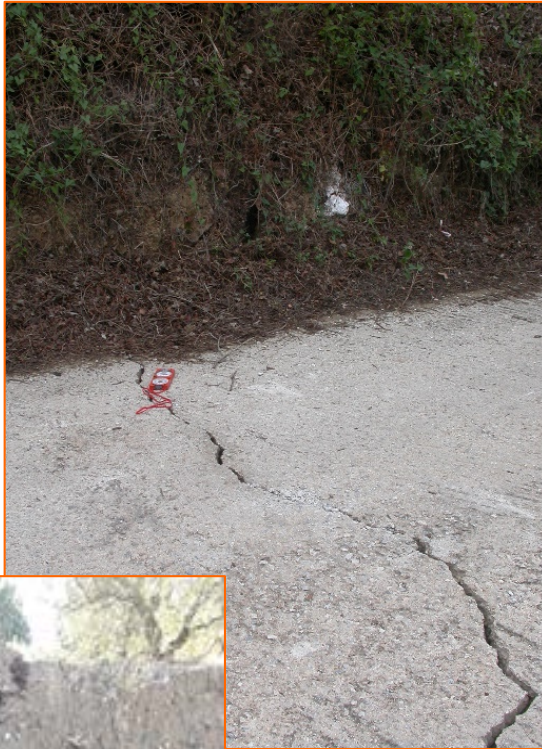
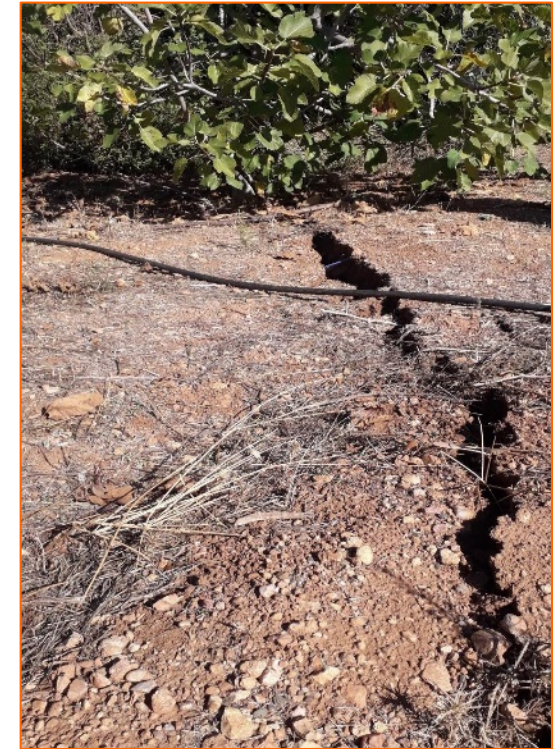
Coseismic surface ruptures were observed in Agios Nikolaos area, at a distance of about 5 km east of Karlovasi port.

The coseismic surface ruptures were observed not only in fields and roads but also in adjacent slopes resulting in clear offsets of several cm, both horizontal and vertical.

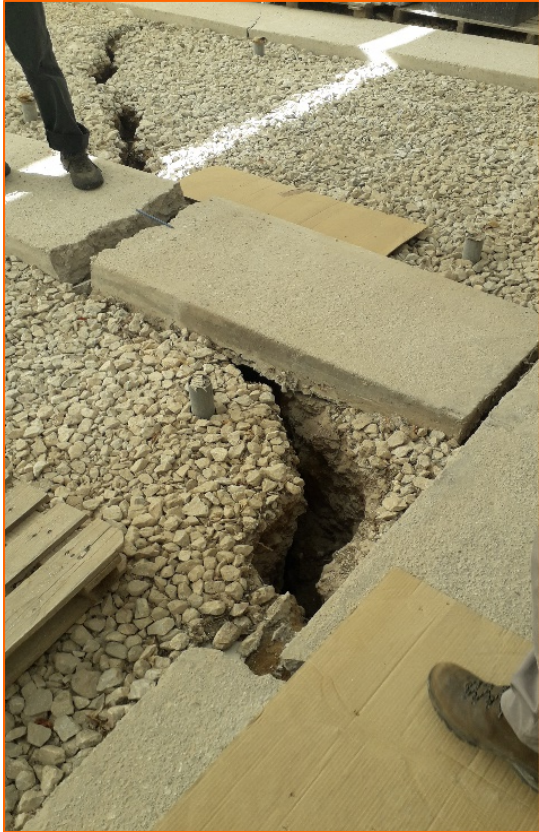
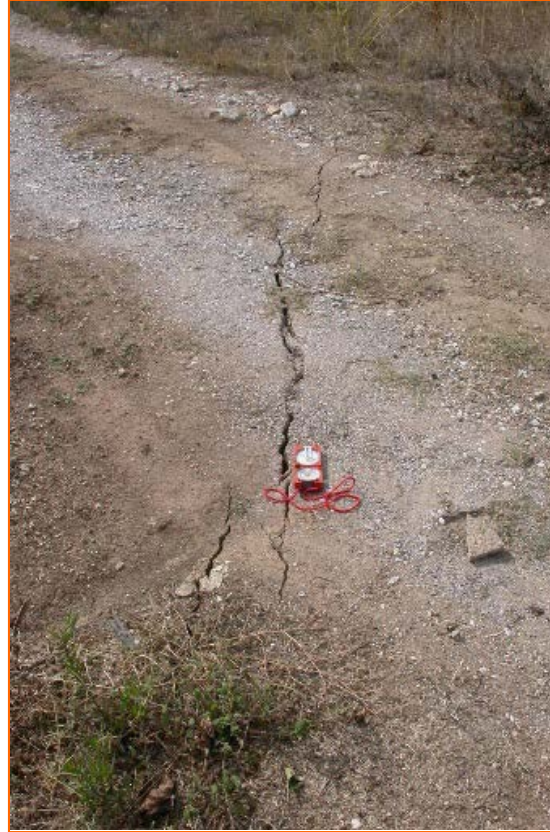
Coseismic surface ruptures and offsets south of Agios Nikolaos village (left) and in the coastal zone of Agios Nikolaos (middle).

Coseismic surface ruptures and offsets in olive fields located south of Agios Nikolaos.

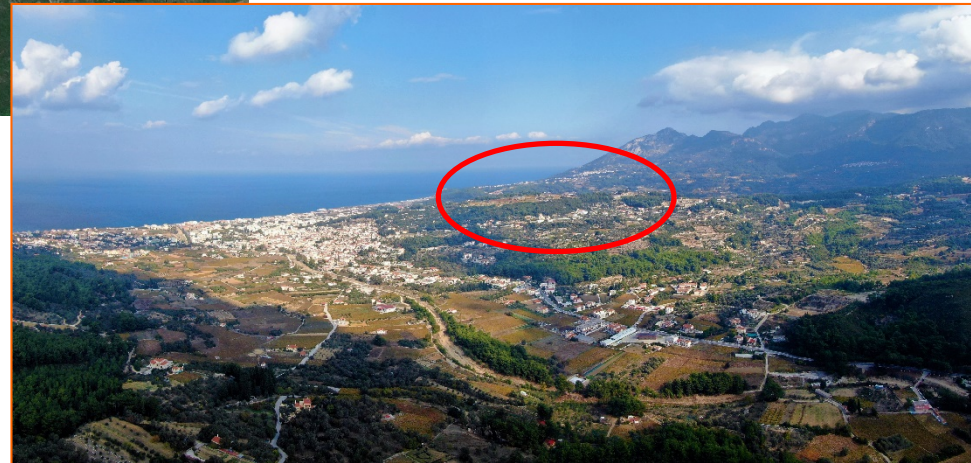
Primary environmental effects were detected in the area of Agios Nikolaos, located in the northwestern part of the earthquake-affected island of Samos. More specifically, they were surface ruptures observed in fields, roads and on the adjacent slopes. Their strike varied from N40 to N70 and their offset from 5 to 8 cm.

They caused deformation and damage to the asphalt pavement of the road leading from Vathy to Karlovassi. Based on the correlation of all aforementioned data, these coseismic surface ruptures can be considered as the western termination of the seismic fault that generated the October 30, 2020 Samos earthquake.

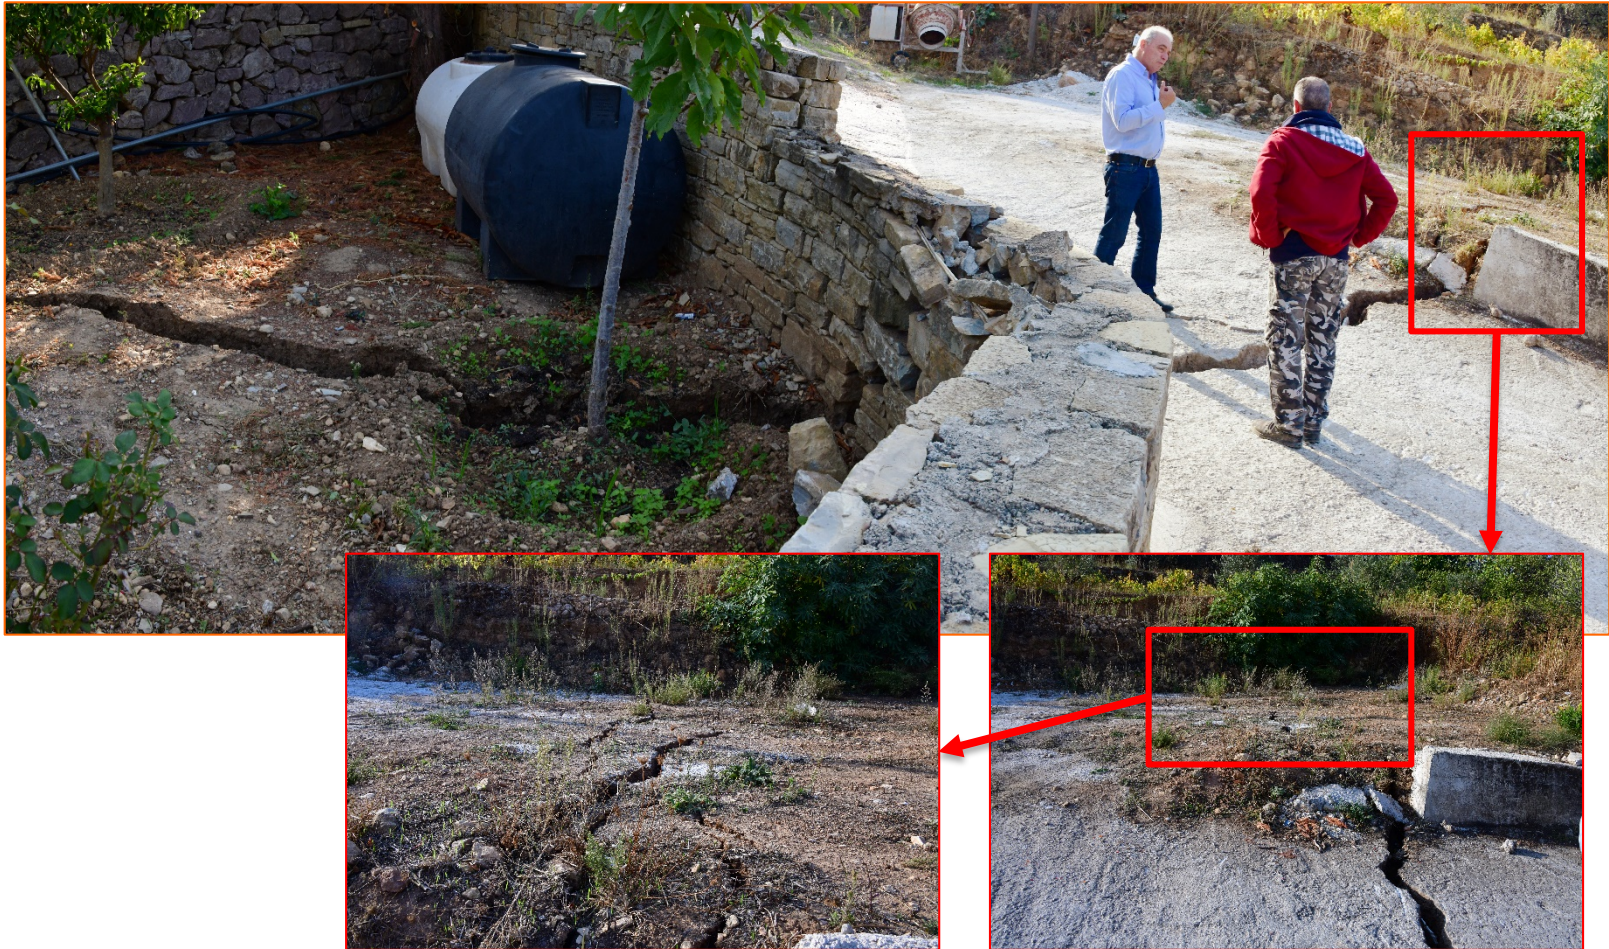
Coseismic surface ruptures were also observed in the area west of Kontakaeika village, located south of Agios Nikolaos area. They were observed continuously in the built environment of the village and they resulted damage to buildings, perimeter walls, pavements and roads.
