# Newsletter of **Environmental, Disaster, and Crises Management Strategies**

Issue No. 21 | November 2020

## **The October 30, 2020, Mw 6.9 Samos (Greece) earthquake**

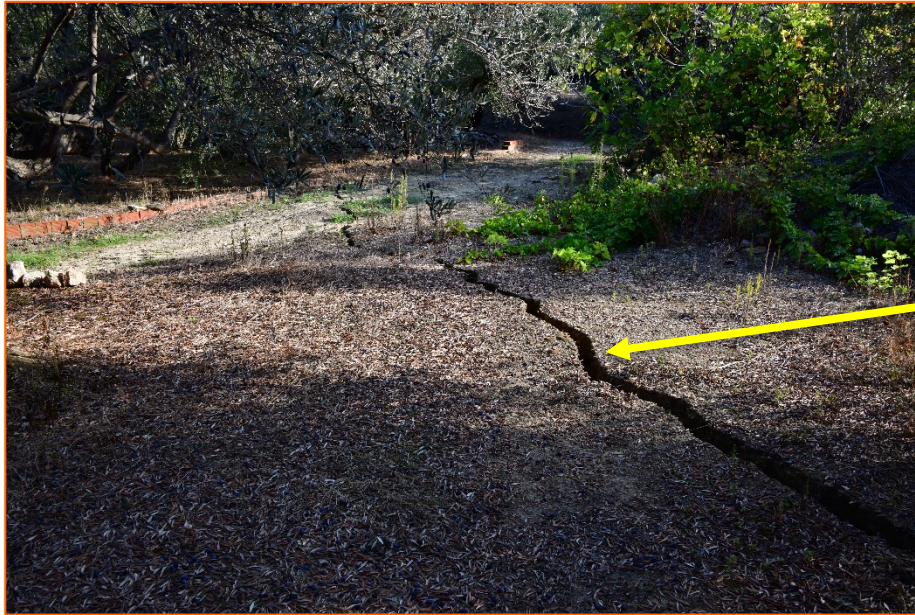
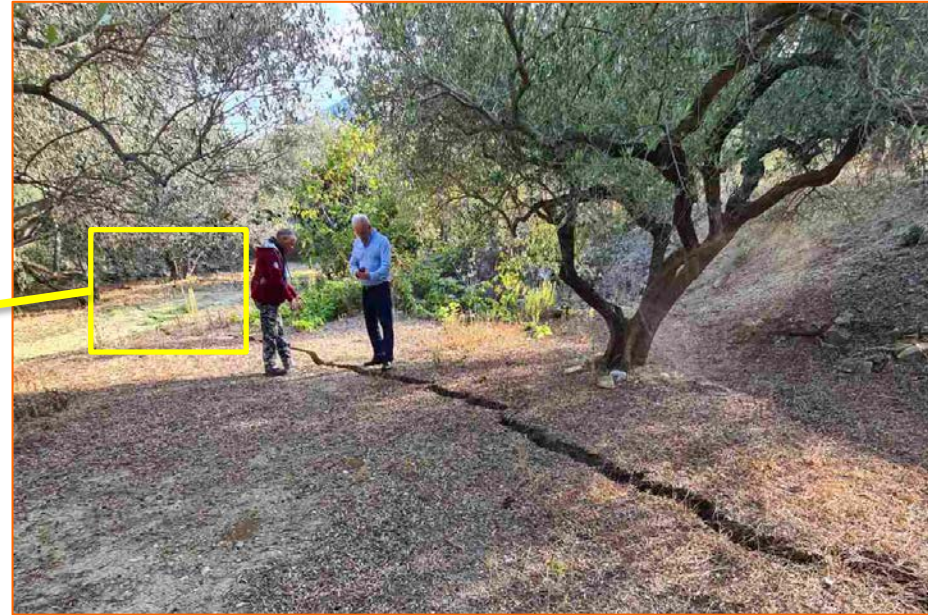
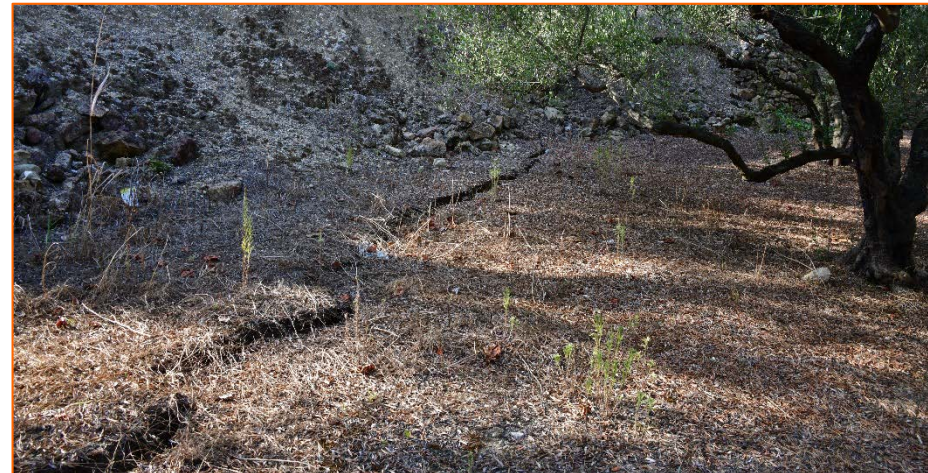
Coseismic surface ruptures were also observed in the area west and southwest of Kontakaeika village. They were observed continuously disrupting olive fields with vertical offset.

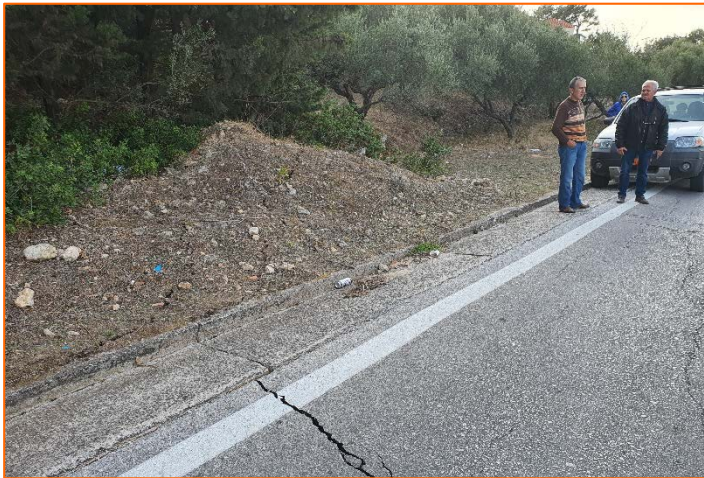
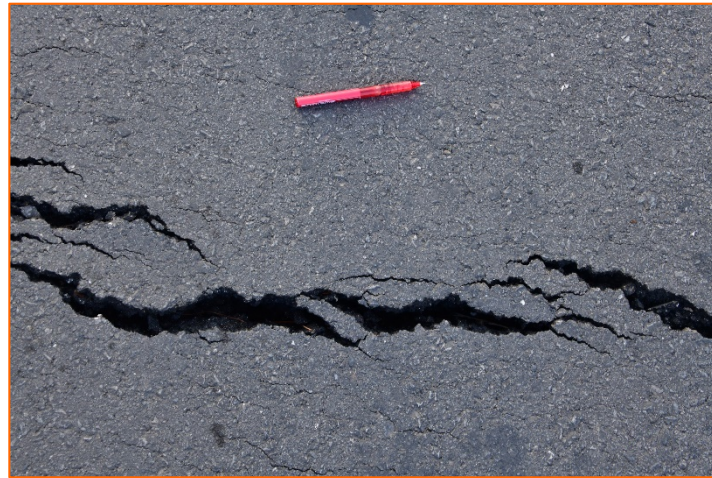
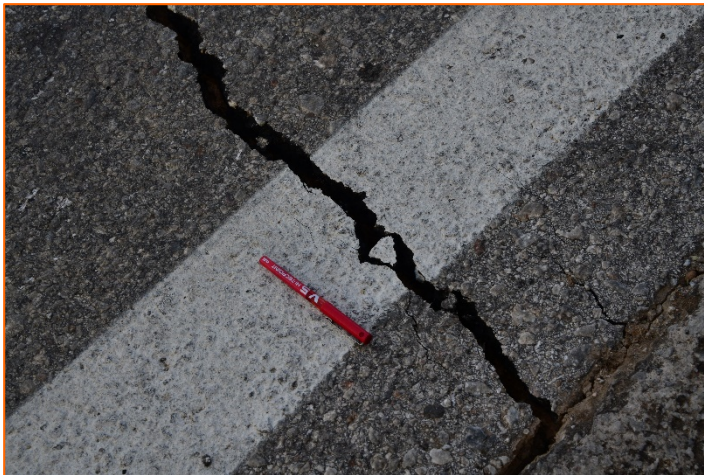
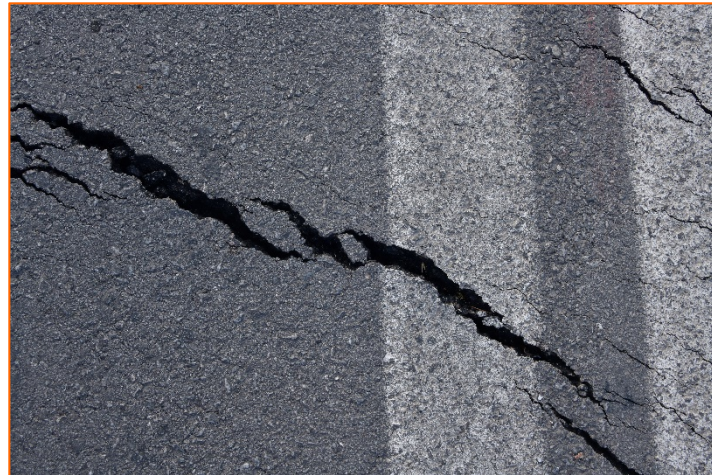
Coseismic surface ruptures observed in the area of Agios Nikolaos

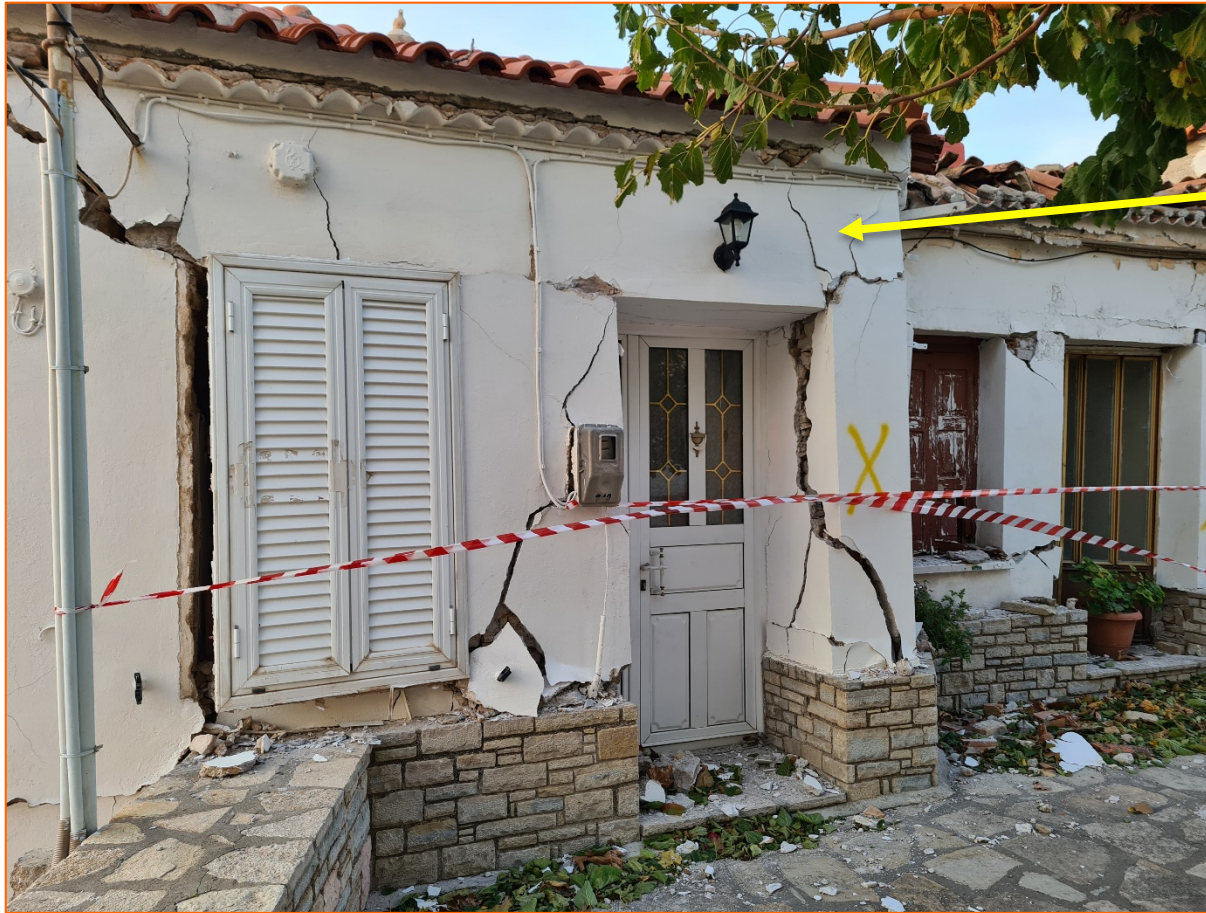
Kontakaeika village, located south of Agios Nikolaos, suffered damage to its buildings. The buildings are located close to the coseismic surface ruptures observed not only to the adjacent fields, slopes and roads but also within the village. The observed damage included not only non-structural damage comprising extensive cracking of walls but also heavy structural damage in their columns.

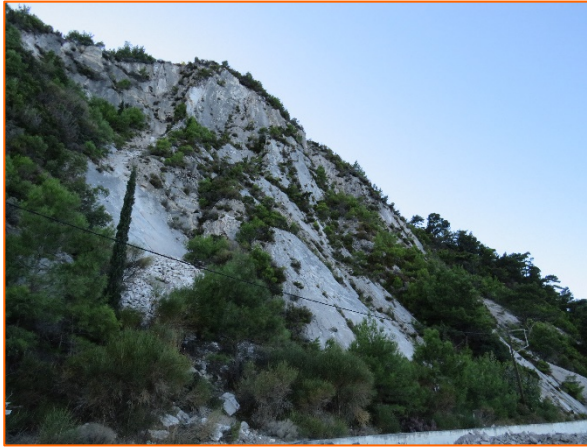
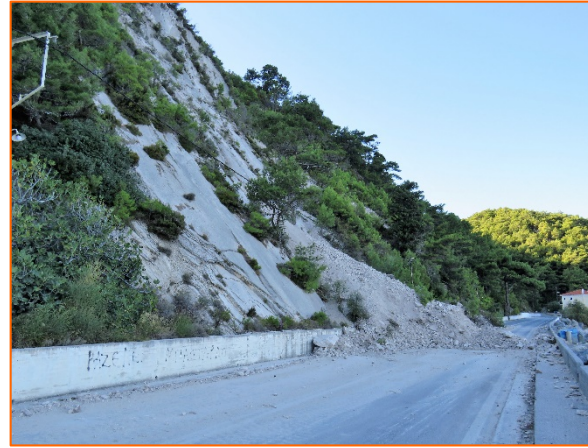
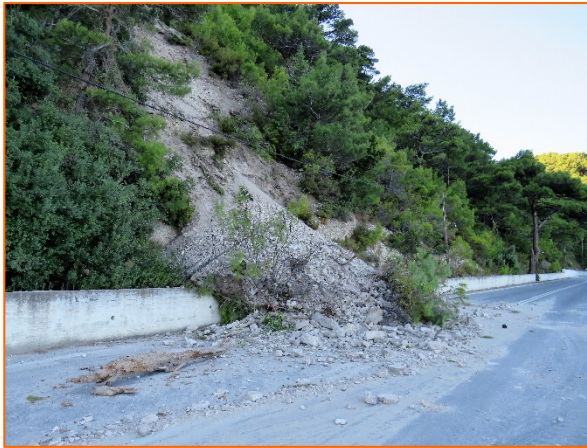
Slope failures were generated along coastal slopes in Avlakia area. The area has been strongly affected by NW-SE striking normal faults. Based on the neotectonic map of Samos Island, these normal faults have been considered as inactive. Taking into account the interferometric products of several scientific teams for assessing the surface deformation on Samos, they are observed in an area characterized by subsidence.

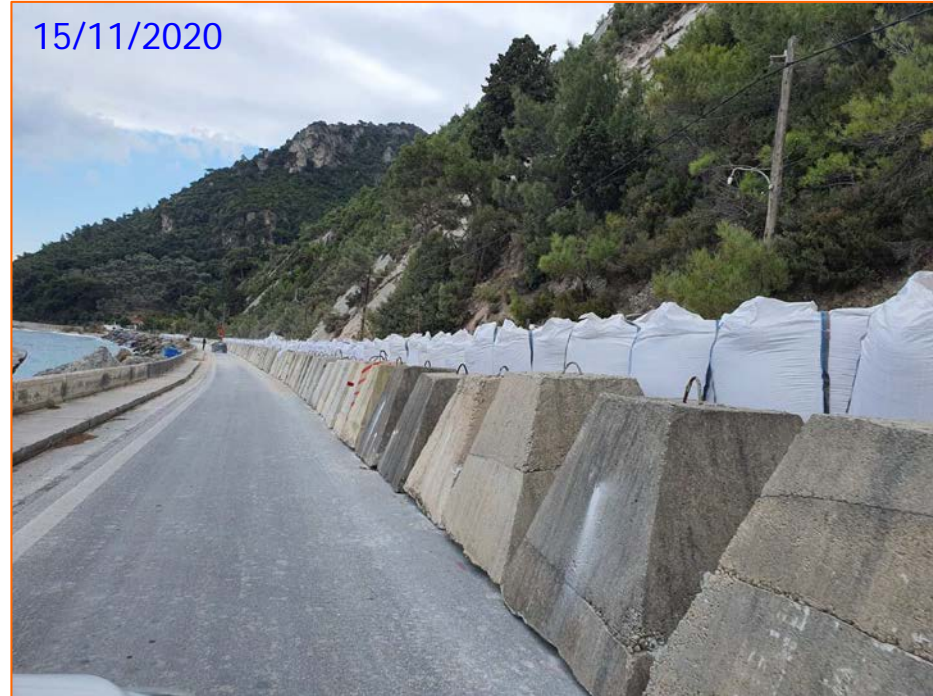
Slope failures along coastal slopes in Avlakia site were reactivated for many days after the generation of the mainshock, during the aftershock sequence. A concrete barrier made of large concrete block has been created along the base of the affected slope in order to protect the road from further slope failures and surface deformation during the aftershock sequence. They help block the rocks and debris from reaching the road. The unstable landslide material is now accumulated behind the barrier.

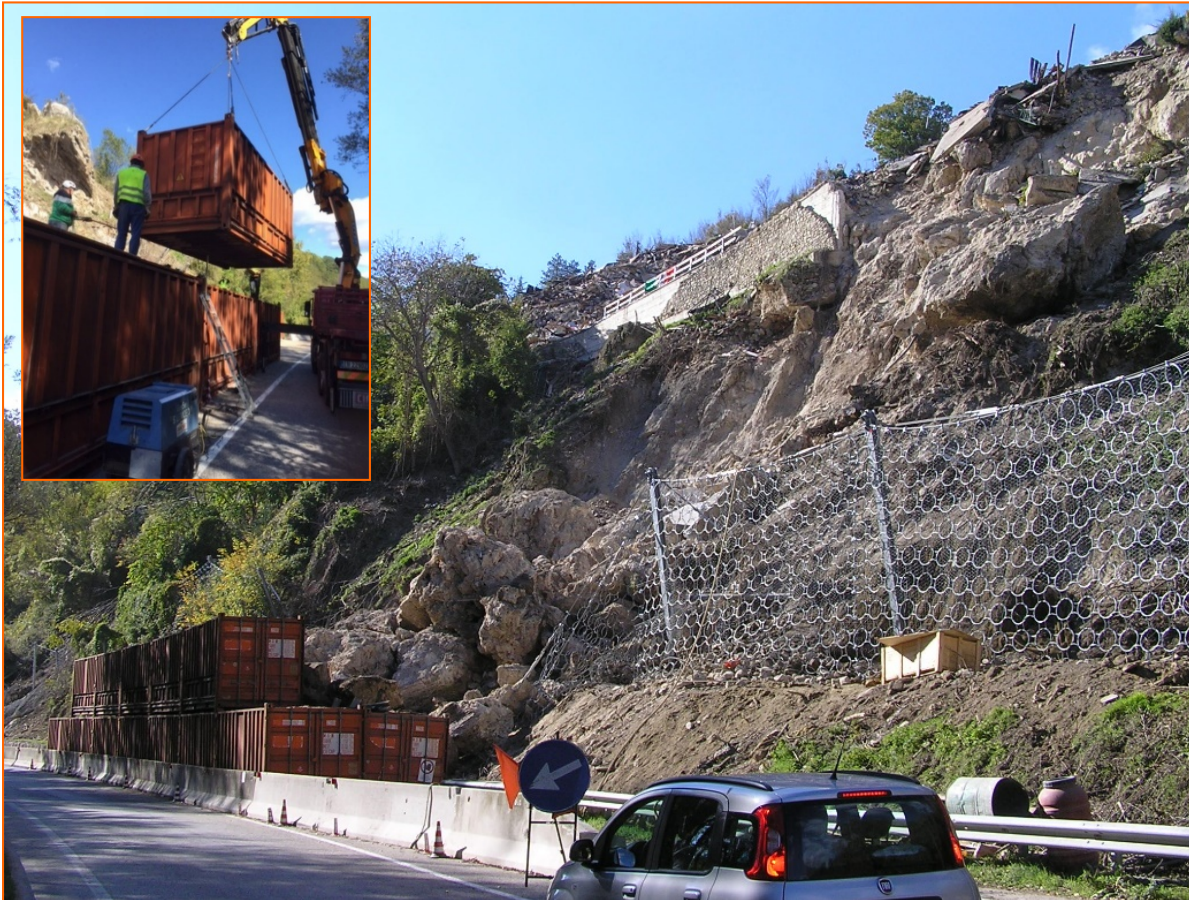
The use of large and heavy items along the base of a slope affected by an earthquake is usually adopted worldwide as a measure for the safety of passing cars and the protection of the road from further slope failures and surface deformation. These items are usually large concrete blocks or containers for helping block the rocks and debris from reaching the road. The unstable landslide material is accumulated behind the barrier.

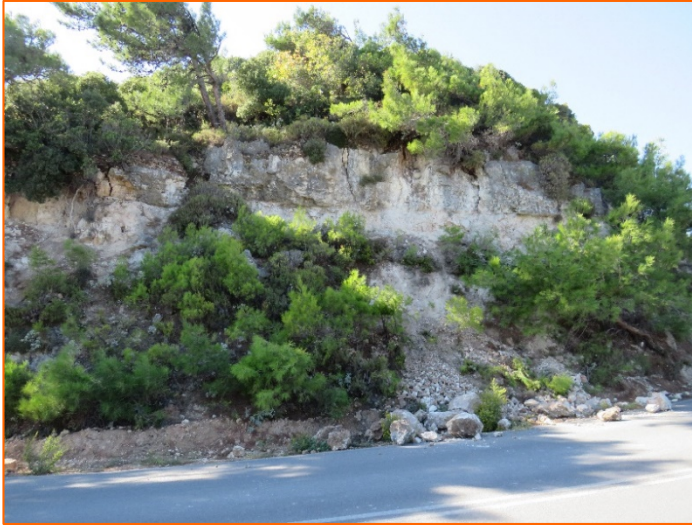
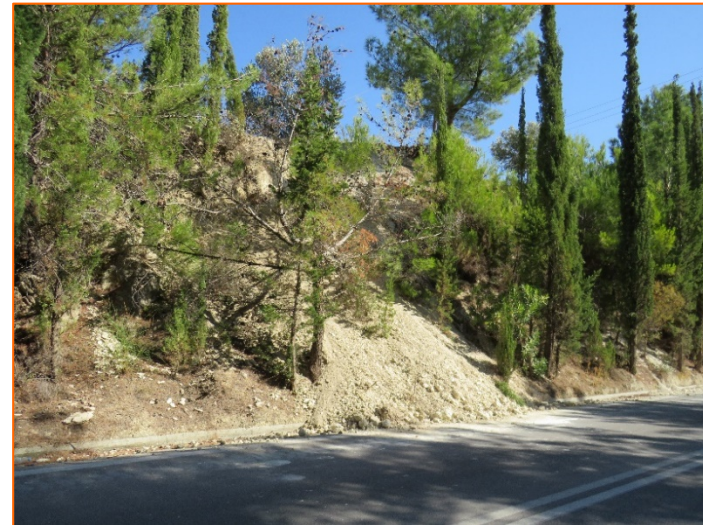
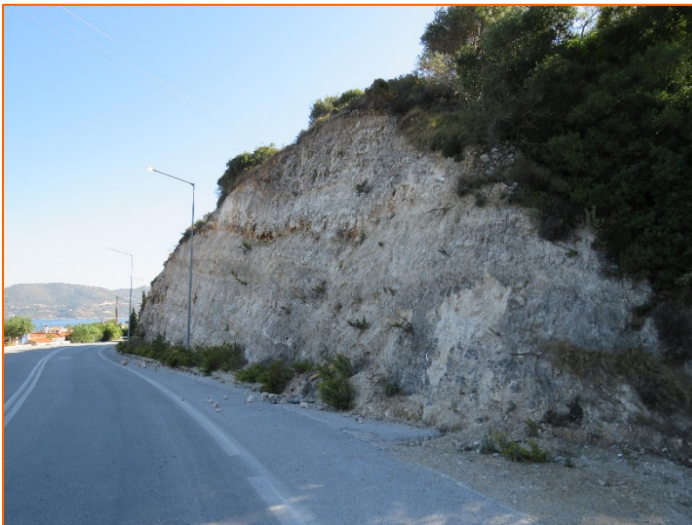
Rockfalls and landslides were triggered by the October 30, 2020, Mw 7.0, Samos earthquake in several sites along the road from Vathy to Karlovassi, in the northern part of the island. This part is composed of Neogene deposits and alpine formations of Vourliotes nappe.

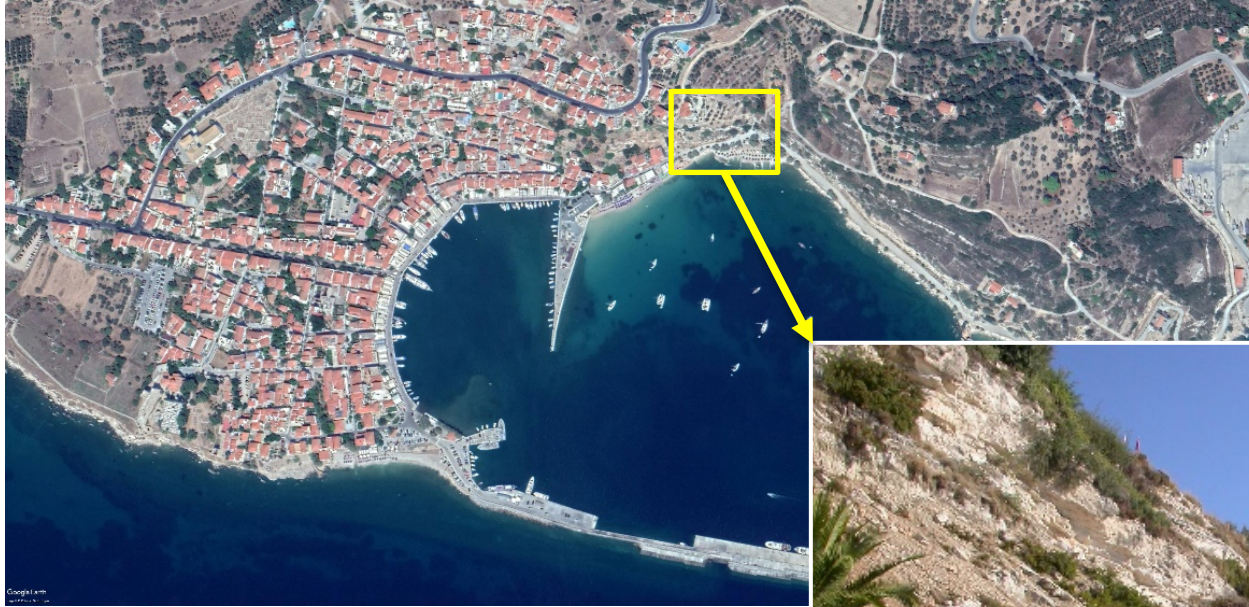
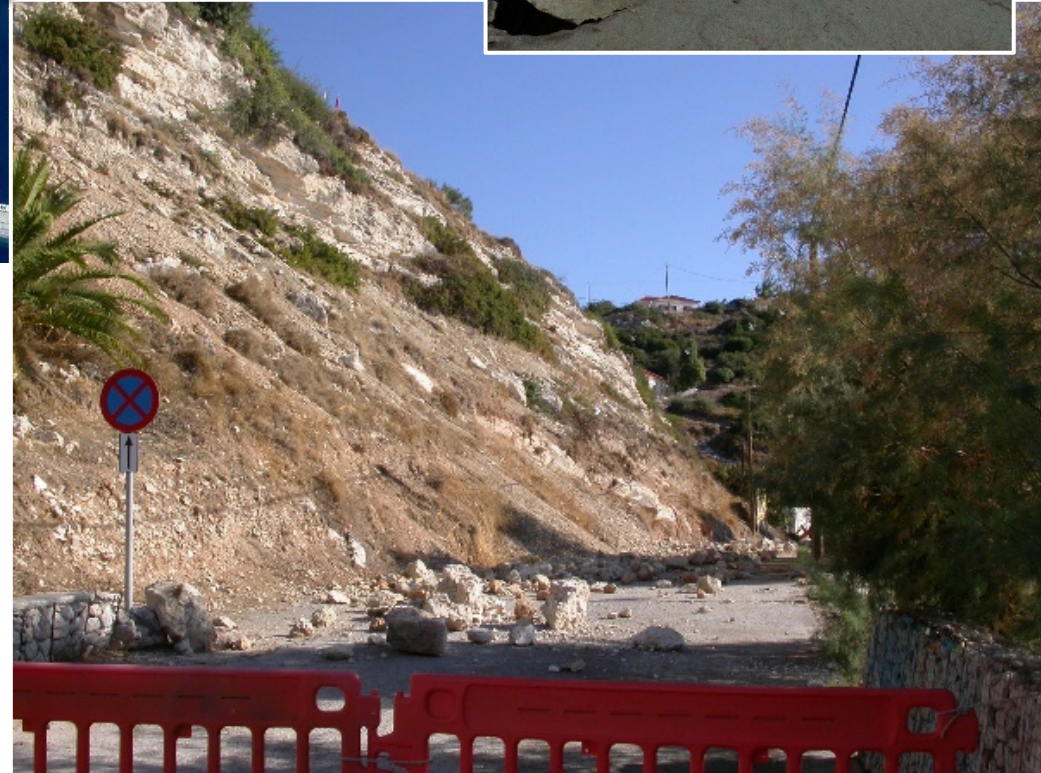
Remataki area is located at the western part of Pythagoreio. It is characterized by favorable conditions for the generation of slope movements including mainly rockfalls. This susceptibility is also certified by previous generation of such phenomena resulting in damage to vehicles. Nowadays, the road is blocked for implementation of technical works dealing with slope instabilities.

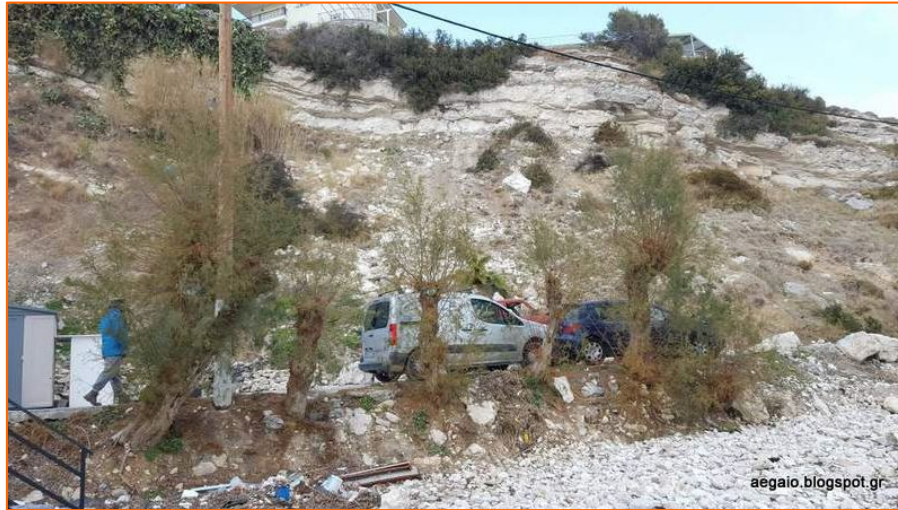
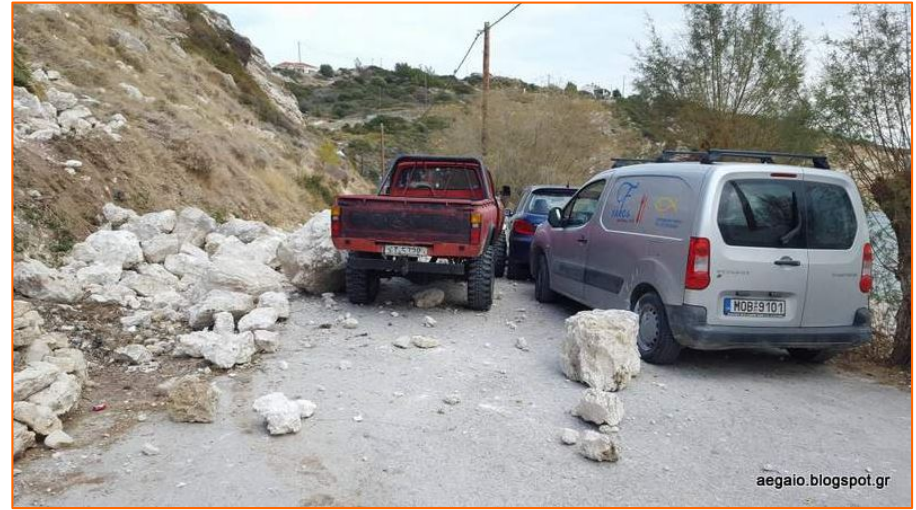
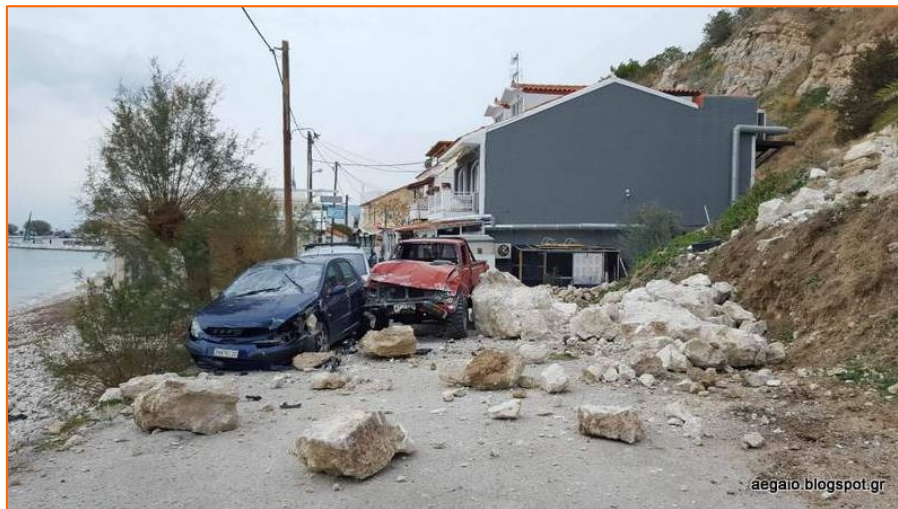
Slope failure in Remataki site was also generated in January 2017 resulting in crash damage to cars

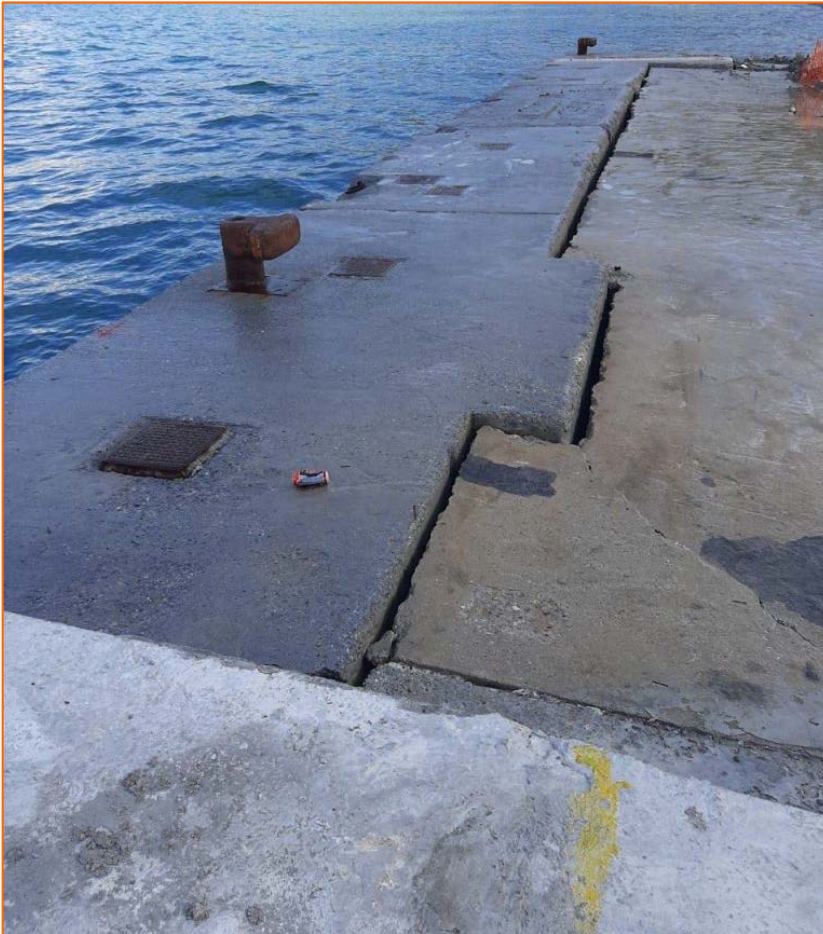
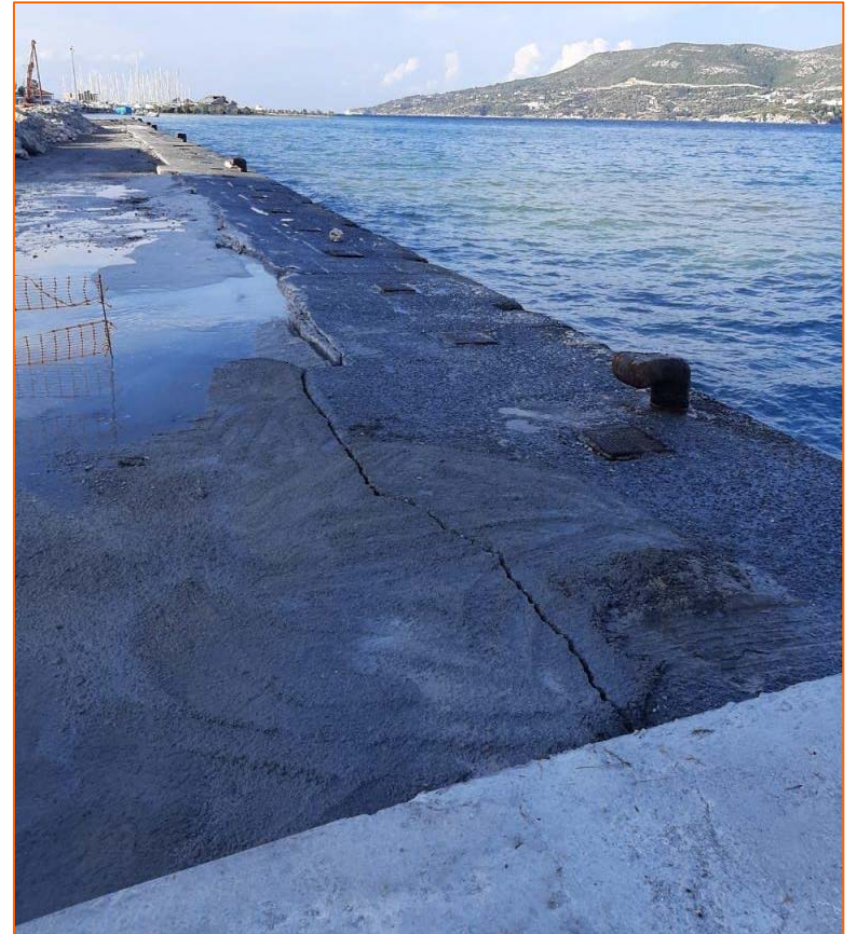
Interaction between concrete blocks that slightly settled and overturned and the dynamically compacted back - fill soil material. Ejection of liquefied sand material in the commercial port of Vathy (Malagari port). The observed liquefaction phenomena and the related damage were triggered by the main shock on October 30, 2020.

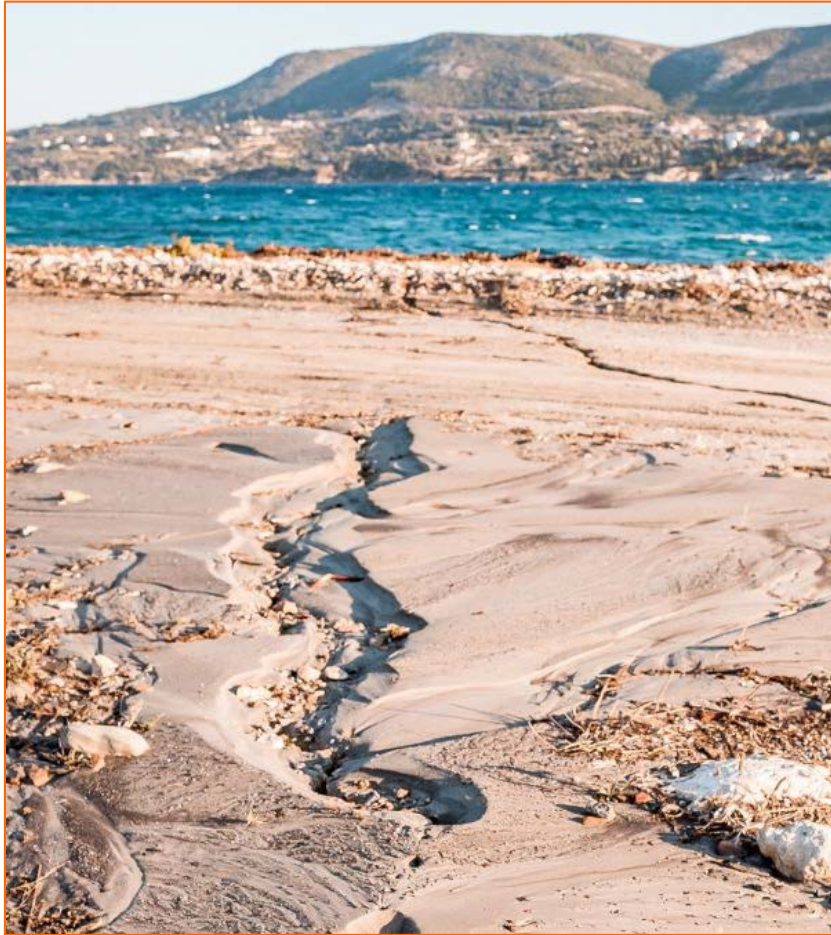
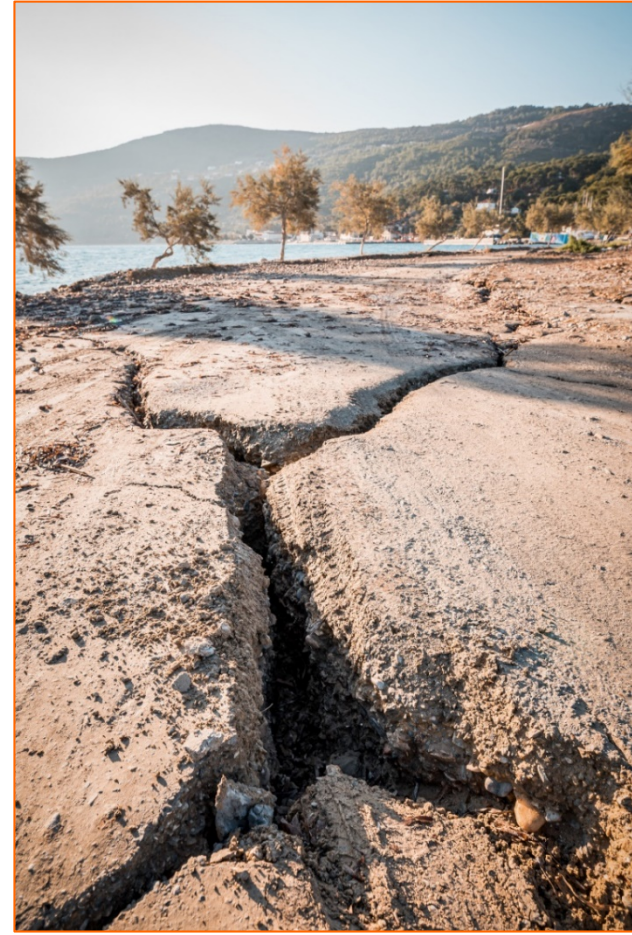
Extensive cracks and ejection of liquefied sand material from the cracks were observed to the coast adjacent to the commercial port of Vathy (Malagari port). The observed liquefaction phenomena were triggered by the main shock on October 30, 2020.

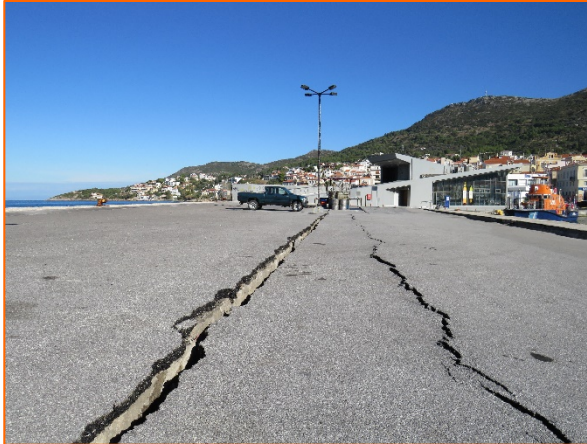
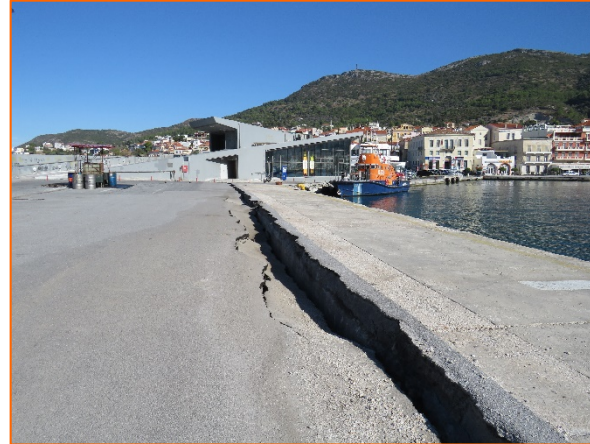
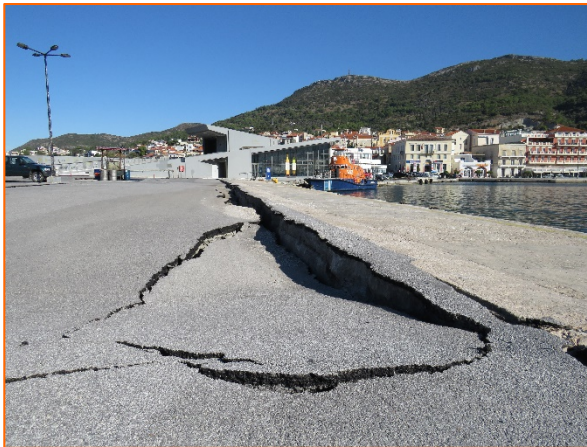
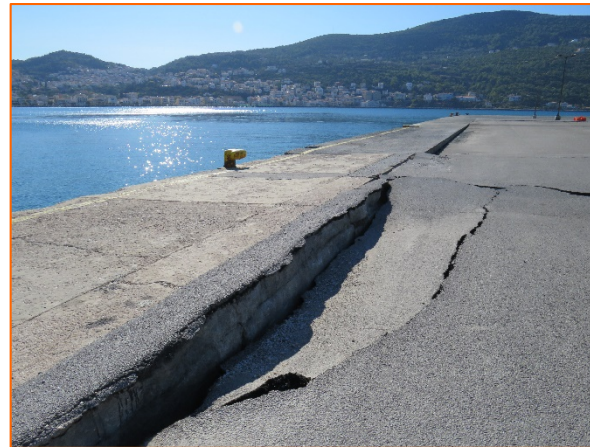
## SECONDARY EARTHQUAKE ENVIRONMENTAL EFFECTS DAMAGE INDICATING NEAR-SURFACE LIQUEFACTION

Deformation of Vathy port was attributed to a combination of the dynamic consolidation of the back-fill soil material and the near-surface liquefaction induced by the October 30, 2020, Samos earthquake.

Extensive cracking and subsidence resulted in tilting of the quay walls towards East.

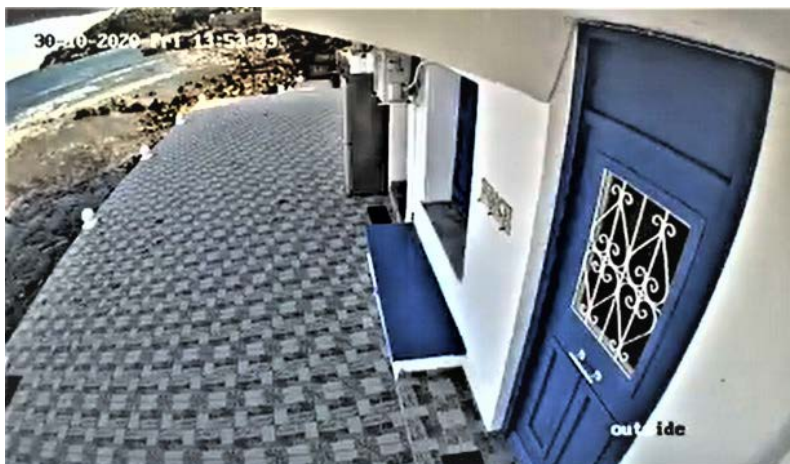
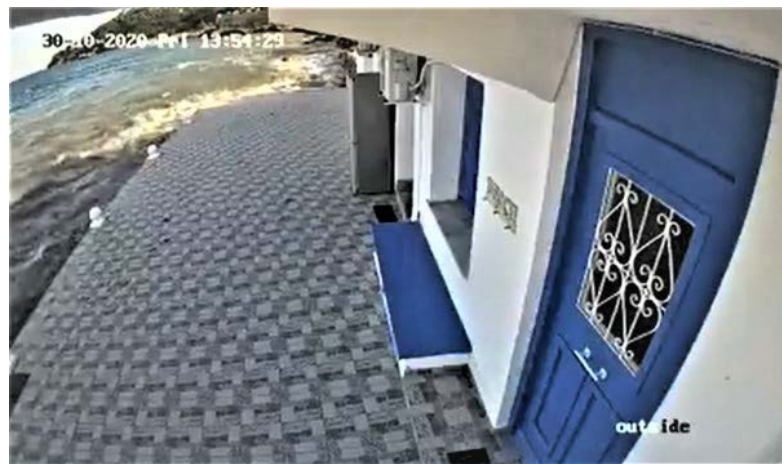
On 11:53:33 the maximum sea retreat of ~20 m occurs, while on 11:54:29 a small inundation happens.

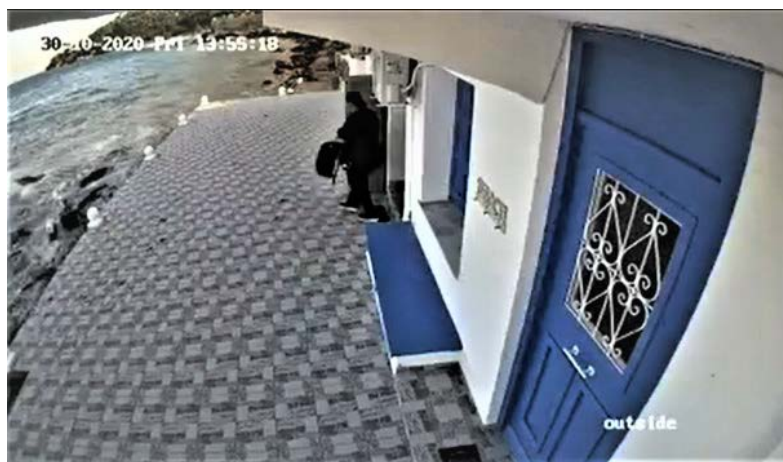
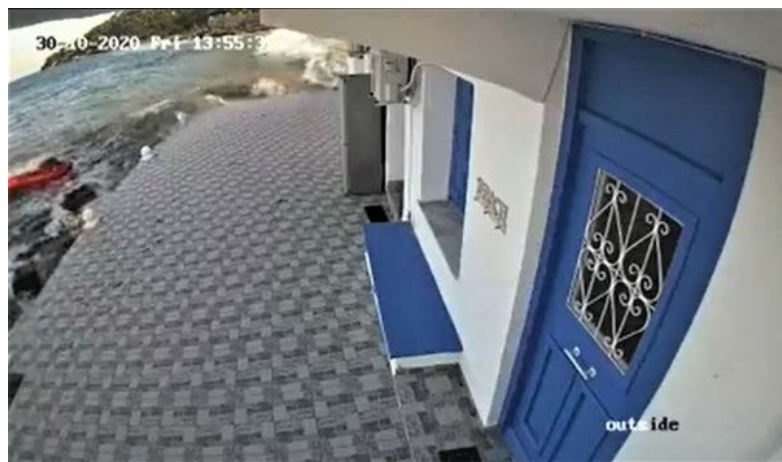
On 11:55:18 inundation restarts, the room residents leave. On 11:55:35 the tsunami strike starts.

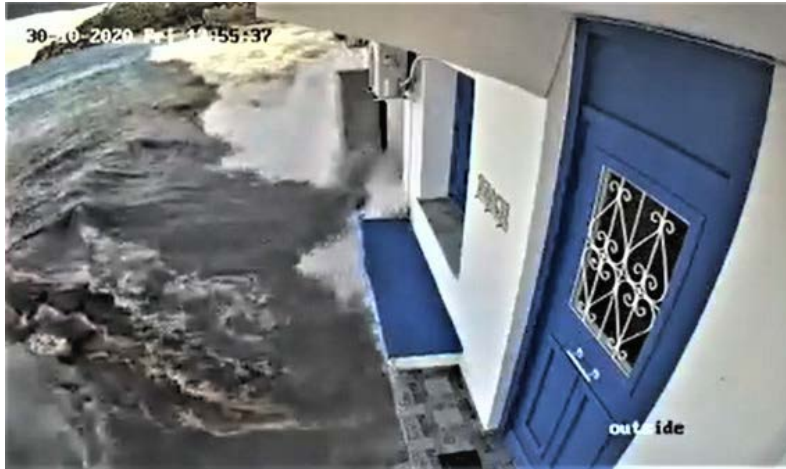
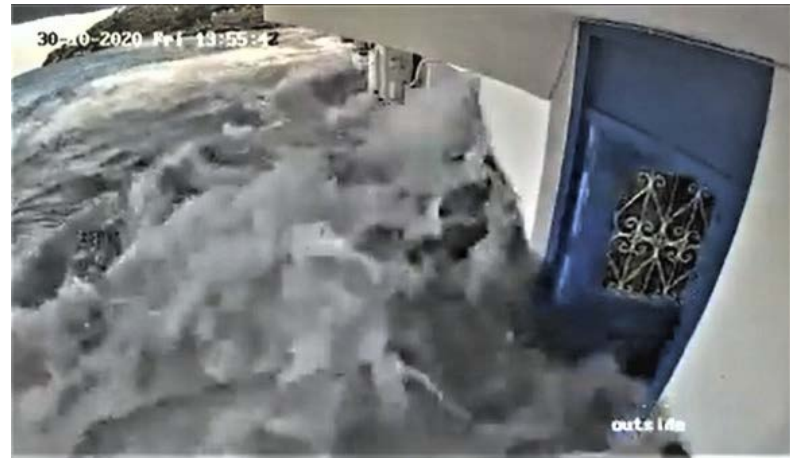
On 11:55:42 inundation at h~2 m asl happens.

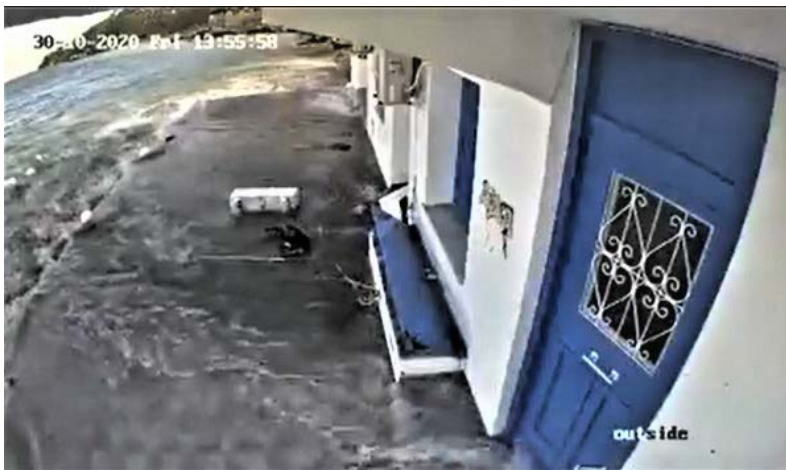
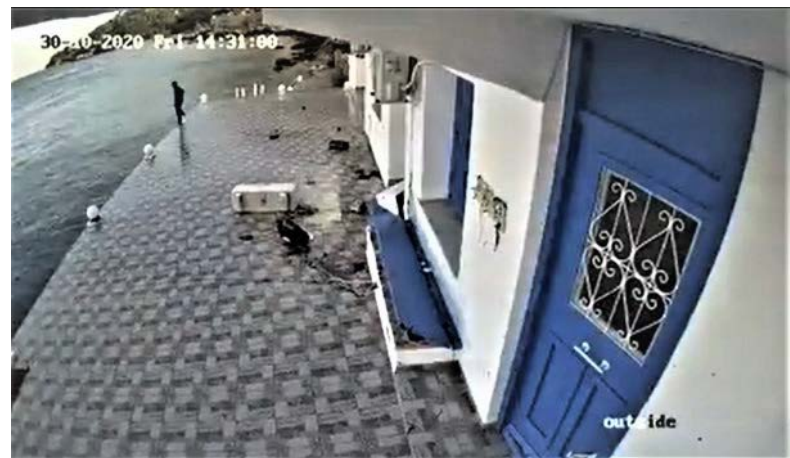
On 11:55:58 the wave retreat and on 14:31 the sea is completely calm.

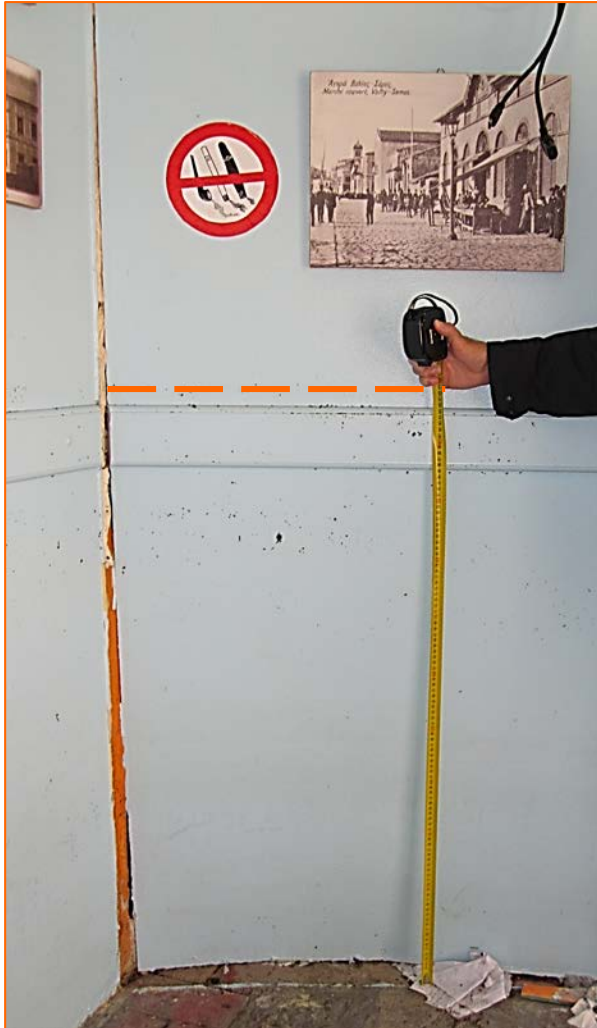
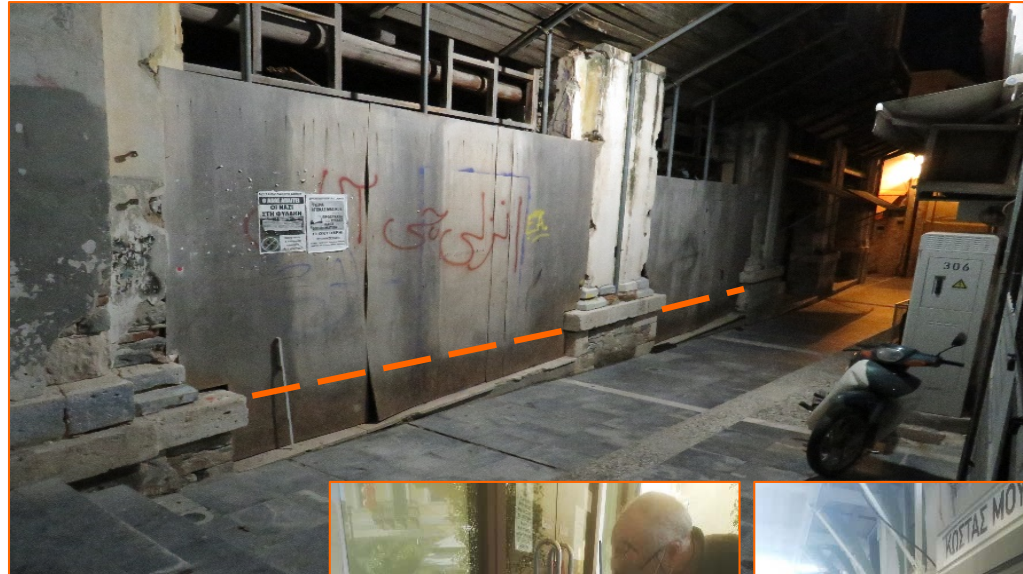
Maximum tsunami run up of 1.69 m was measured in the field. Watermarks were found in every street around the coastal road and the second main road parallel to the shore.

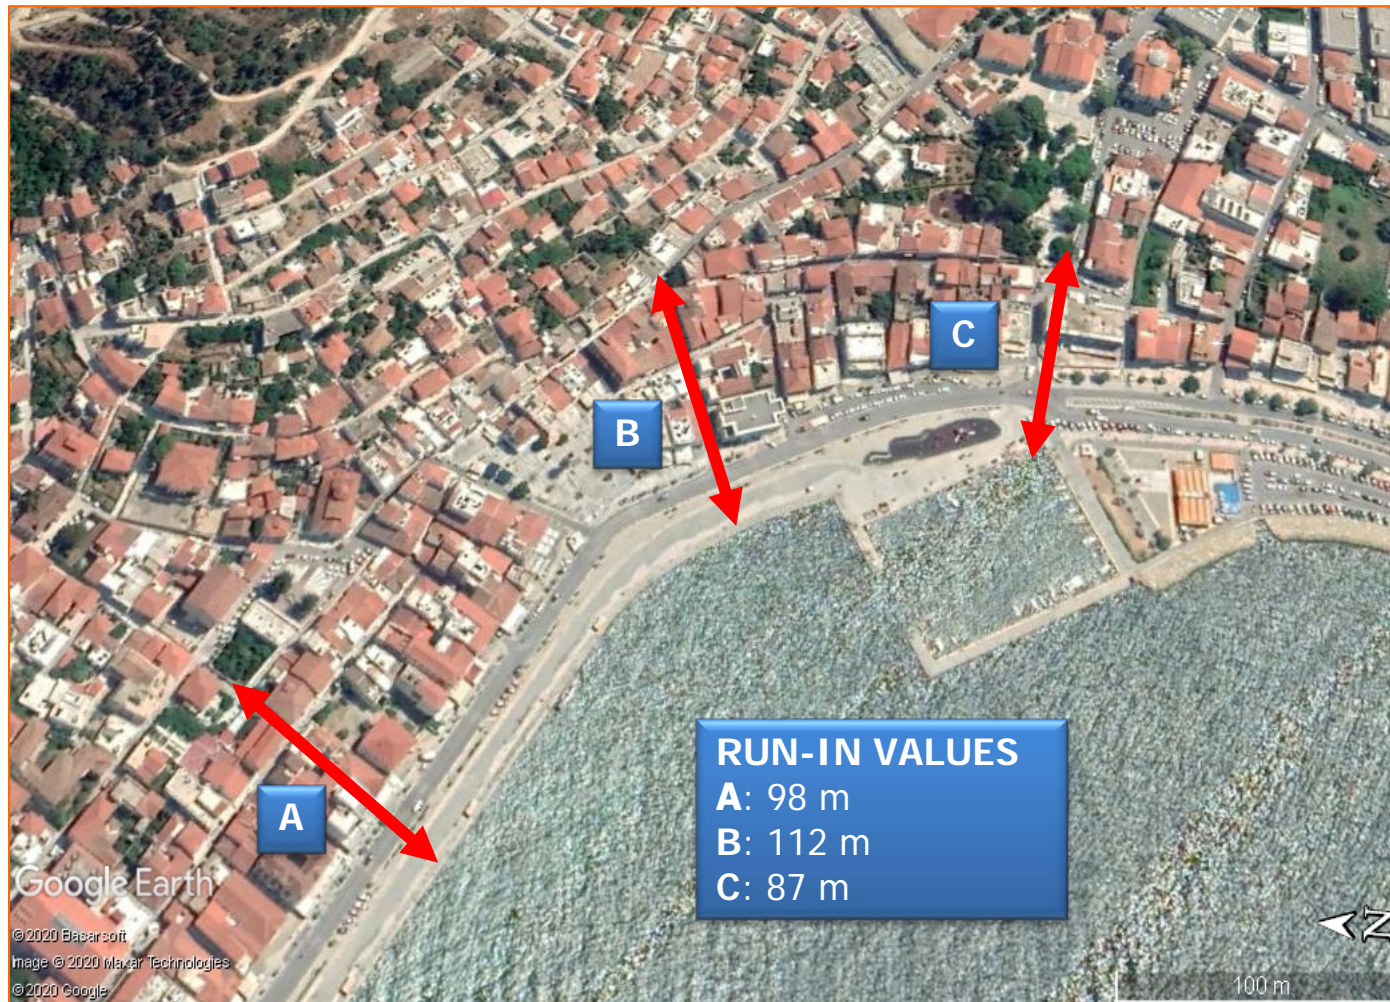
## SECONDARY EARTHQUAKE ENVIRONMENTAL EFFECTS TSUNAMI RUN-IN IN VATHY BAY

The run-in values derived from field survey shortly after the generation of tsunami and based on eyewitnesses in the eastern part of Vathy Bay

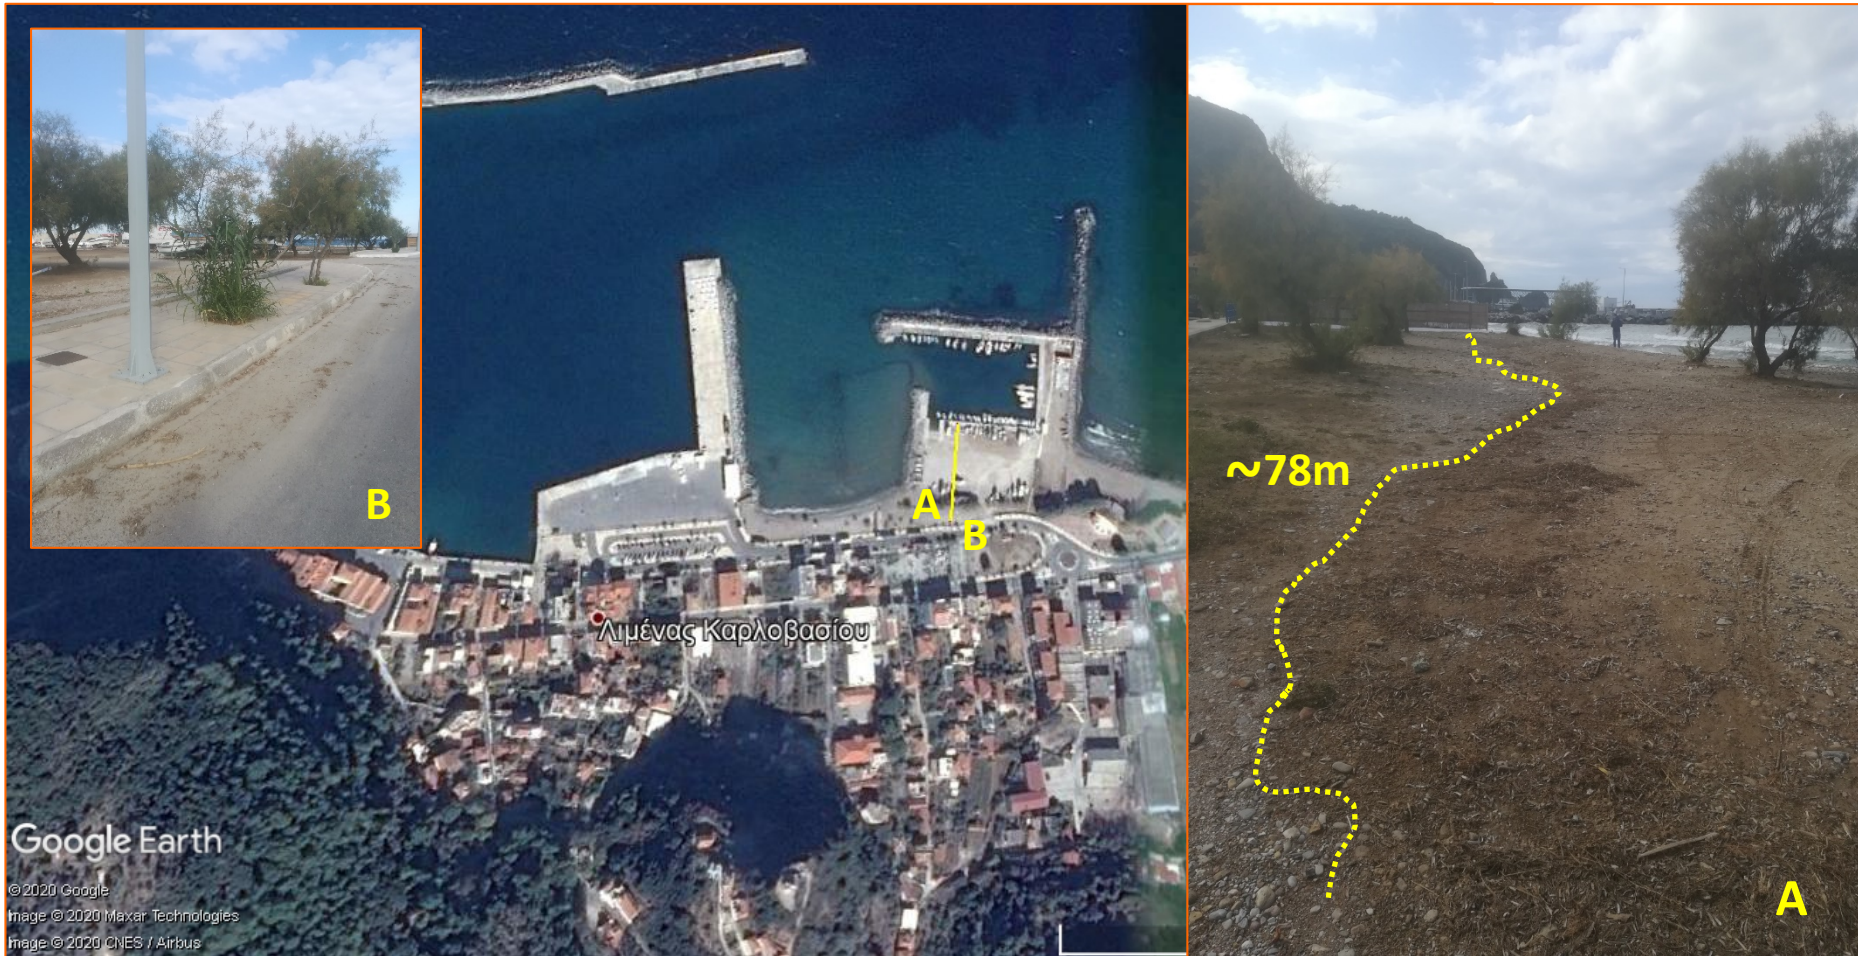
Based on the observed tsunami watermarks at the Karlovassi vessel shelter, at point [A] the inundation was 78m. At point [B], it reached 84 m.
