# Newsletter of **Environmental, Disaster, and Crises Management Strategies**

Issue No. 21 | November 2020

## **The October 30, 2020, Mw 6.9 Samos (Greece) earthquake**

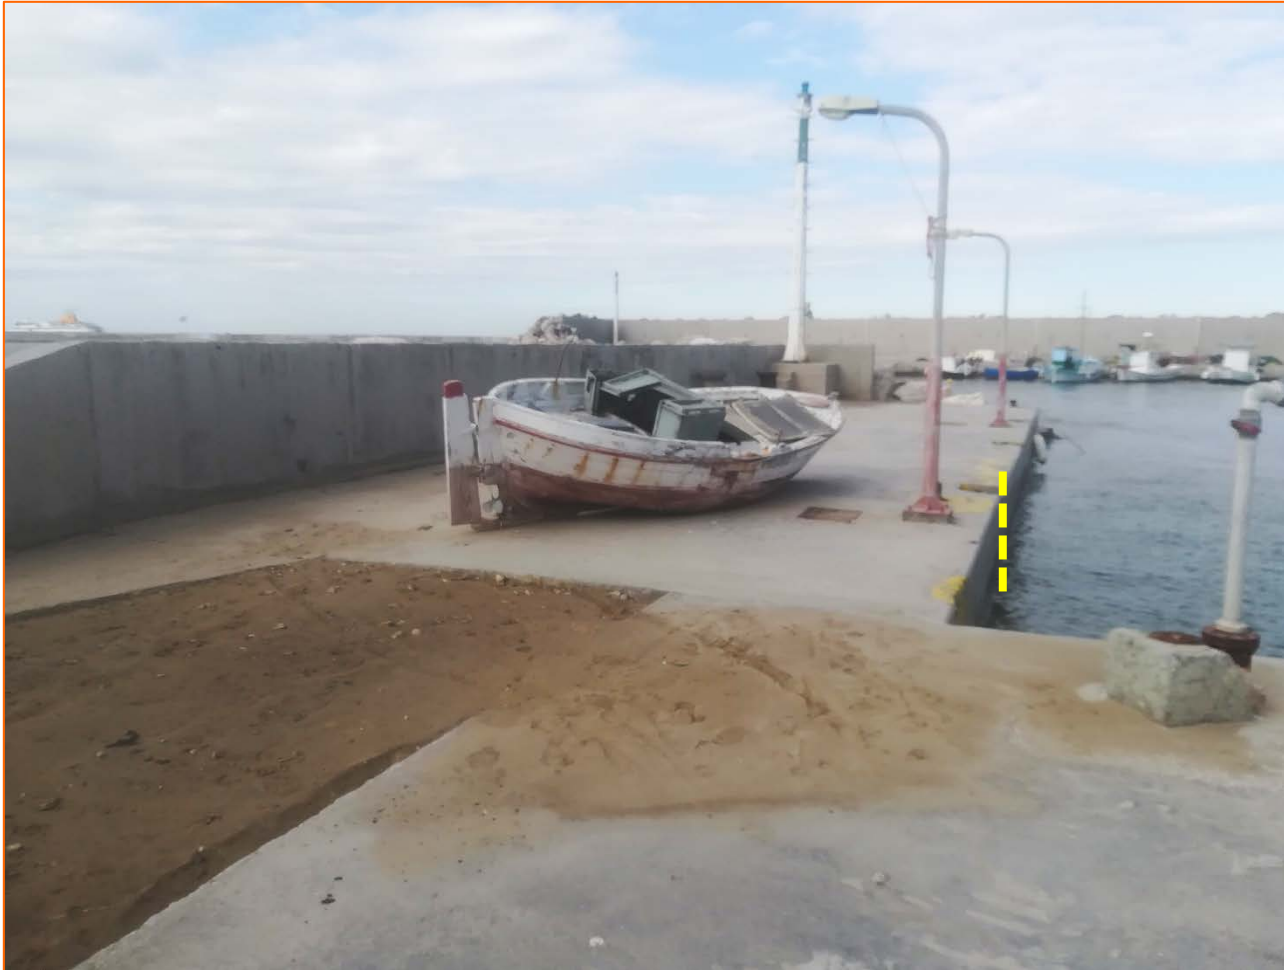
## SECONDARY EARTHQUAKE ENVIRONMENTAL EFFECTS TSUNAMI IN KARLOVASSI VESSEL SHELTER

Based on the observed tsunami watermarks at the Karlovassi vessel shelter, at point [A] the inundation was 78m. At point [B], it reached 84 m.

This wave overtopped the pier ( $h=0.7$  m) and penetrated inland.  
The small boat was washed ashore.

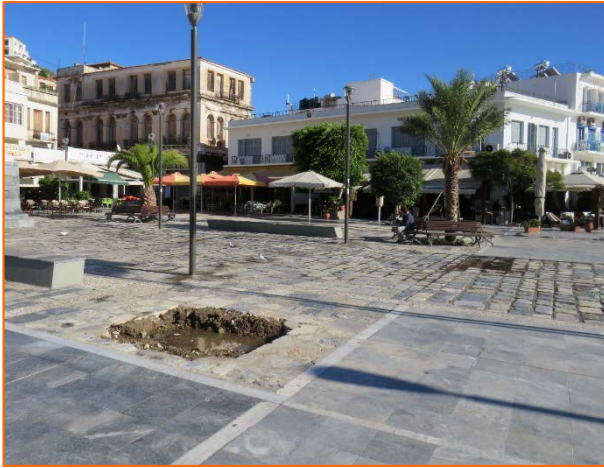
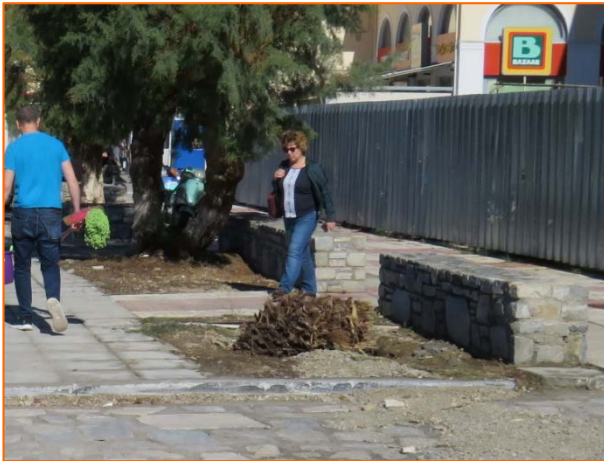
## SECONDARY EARTHQUAKE ENVIRONMENTAL EFFECTS TSUNAMI IMPACT ON THE ENVIRONMENT

Debris were observed at several sites along the coast as well as in the Pythagoras square. Deposition of sand and pebbles was also observed. Palm trees were uprooted and fishes were found onshore at large distance from the shoreline (about 100 m).

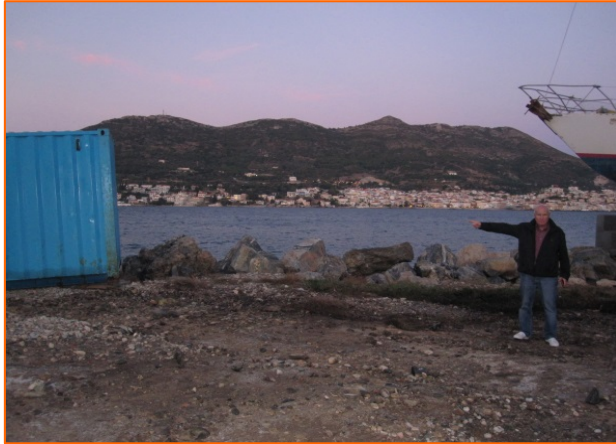
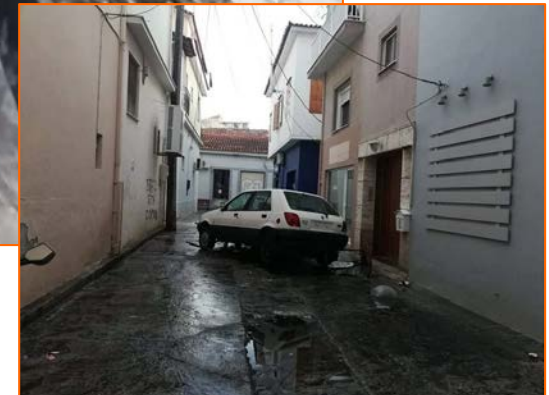
## SECONDARY EARTHQUAKE ENVIRONMENTAL EFFECTS TSUNAMI IMPACT ON MOBILE OBJECTS (VEHICLES)

A big container in Malagari port was drifted away. Many cars parked along the coastal road of Vathy town were carried by tsunami. Some of them were carried and found in the narrow streets of the town.

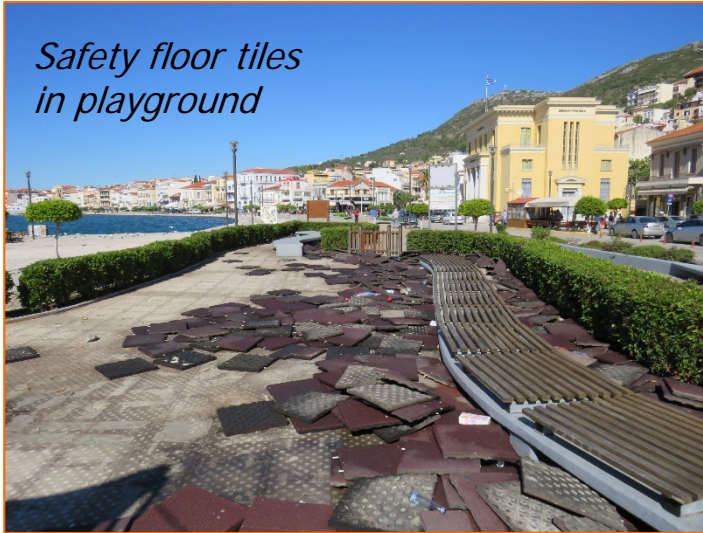
*Safety floor tiles  
in playground*

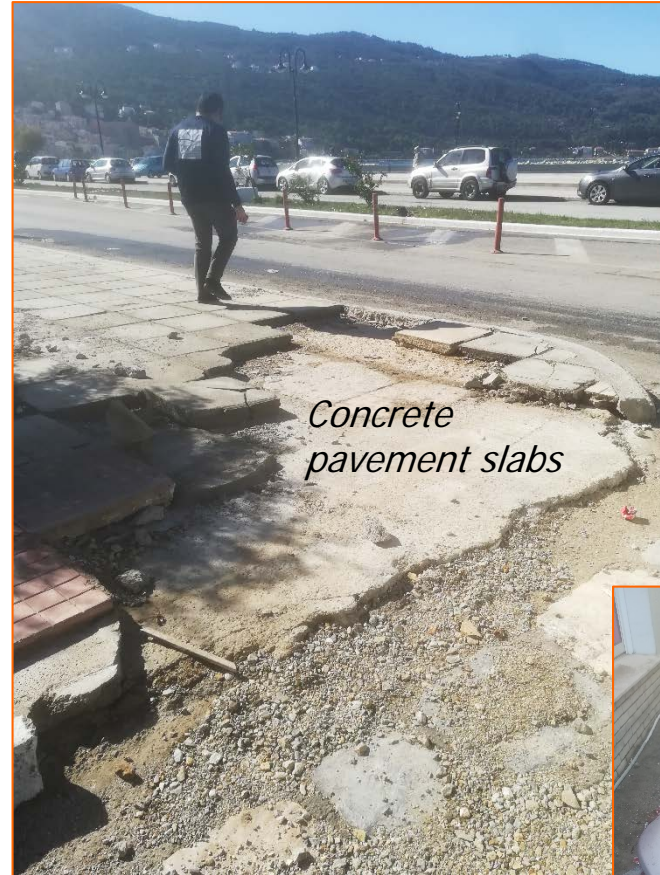
*Concrete  
pavement slabs*

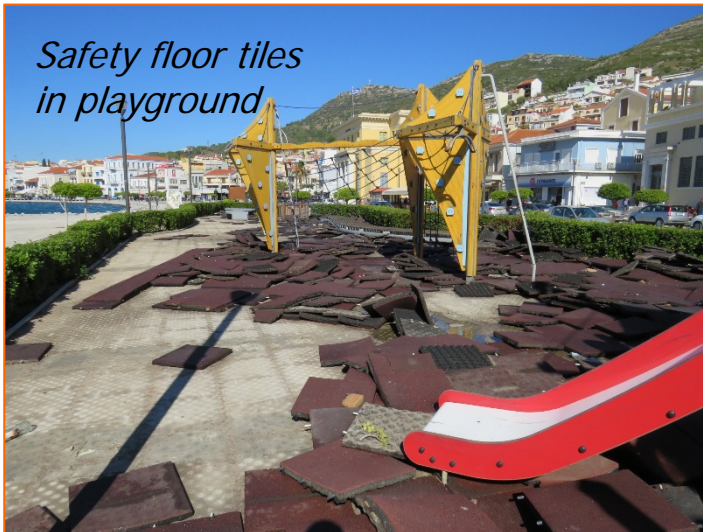
*Safety floor tiles  
in playground*

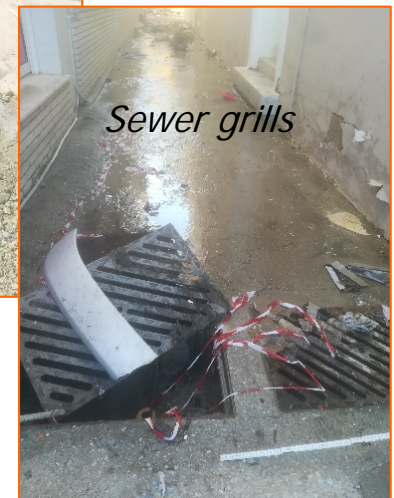
*Sewer grills*

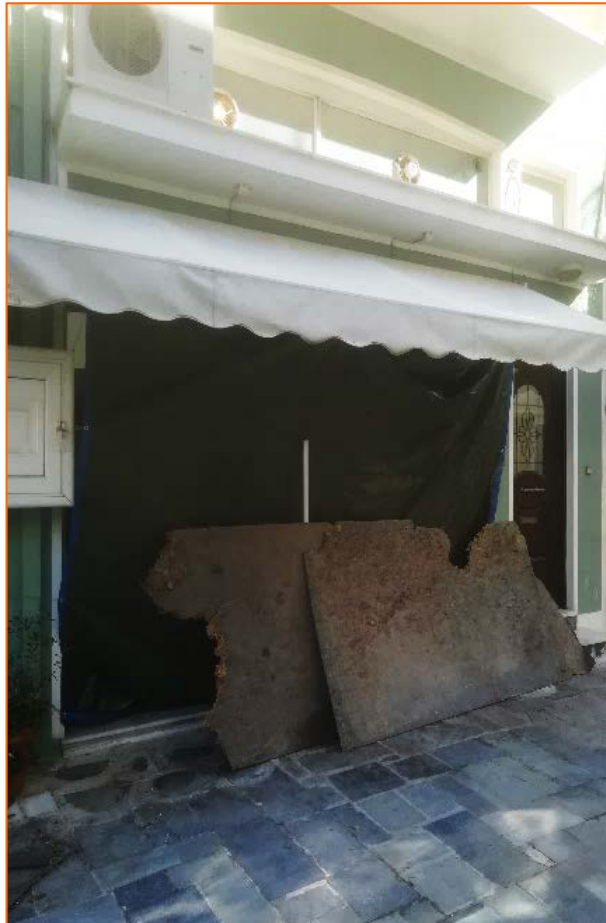
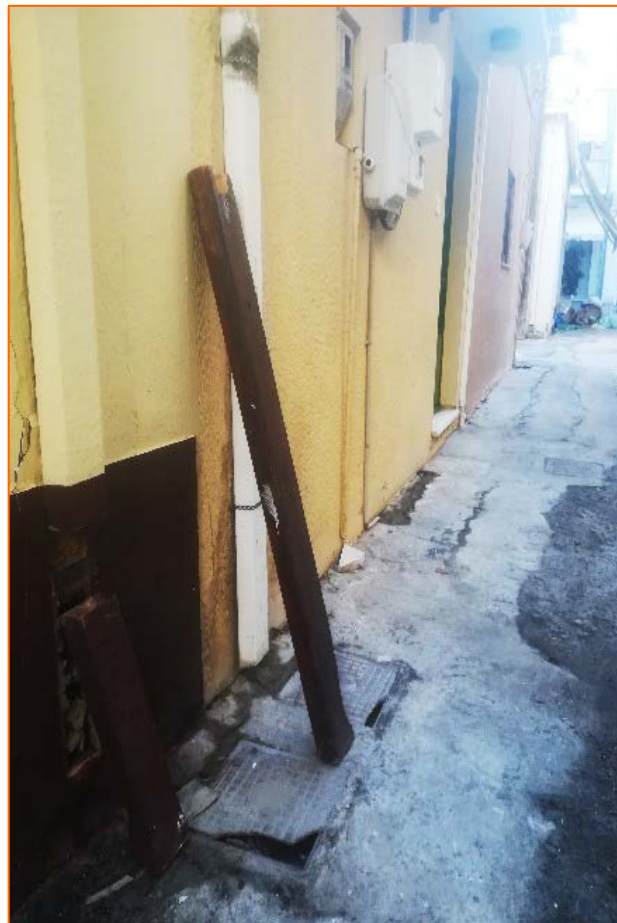
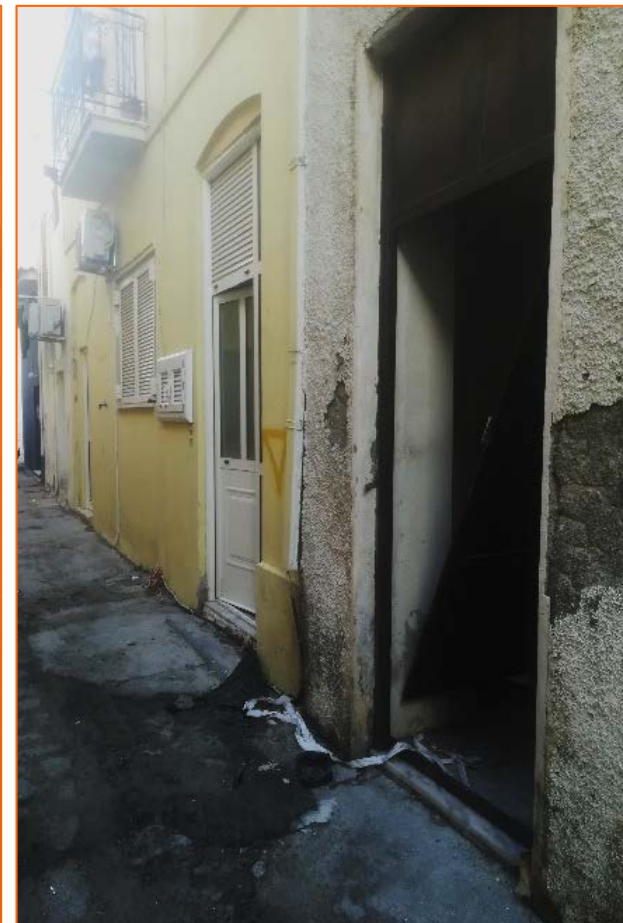
## SECONDARY EARTHQUAKE ENVIRONMENTAL EFFECTS TSUNAMI IMPACT ON BUILDINGS

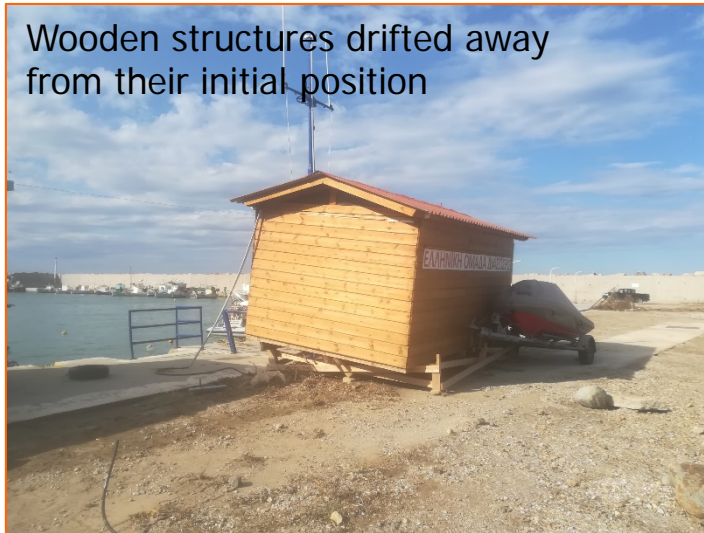
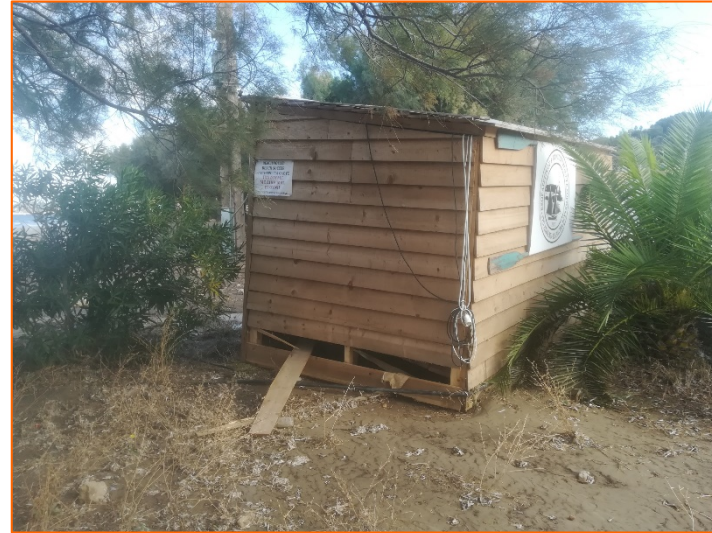
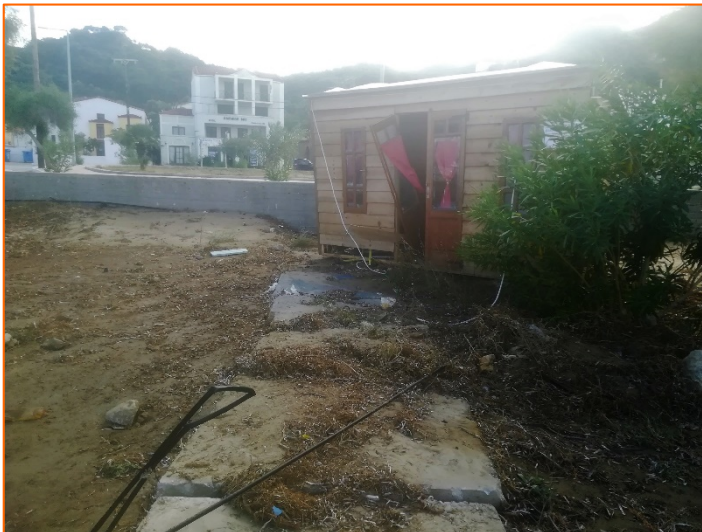
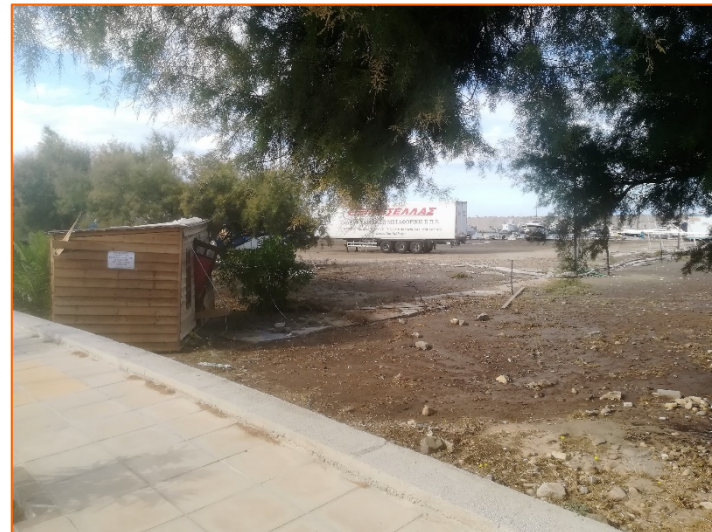
## SECONDARY EARTHQUAKE ENVIRONMENTAL EFFECTS TSUNAMI DAMAGE ON WOODEN STRUCTURES

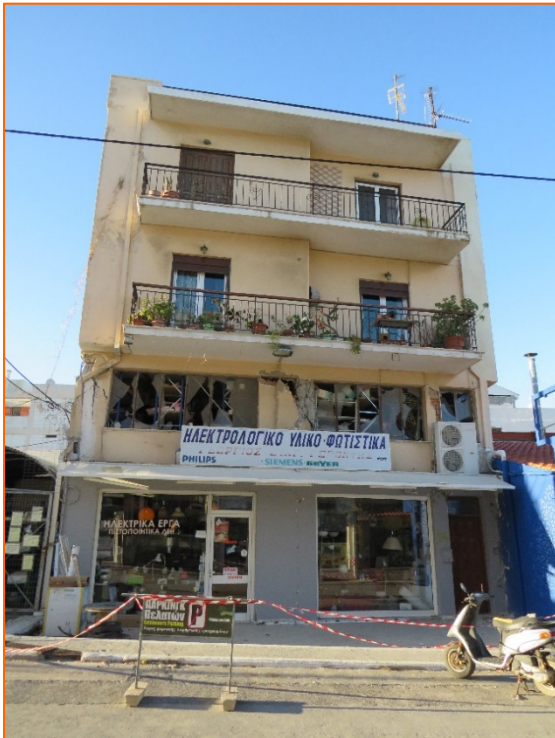
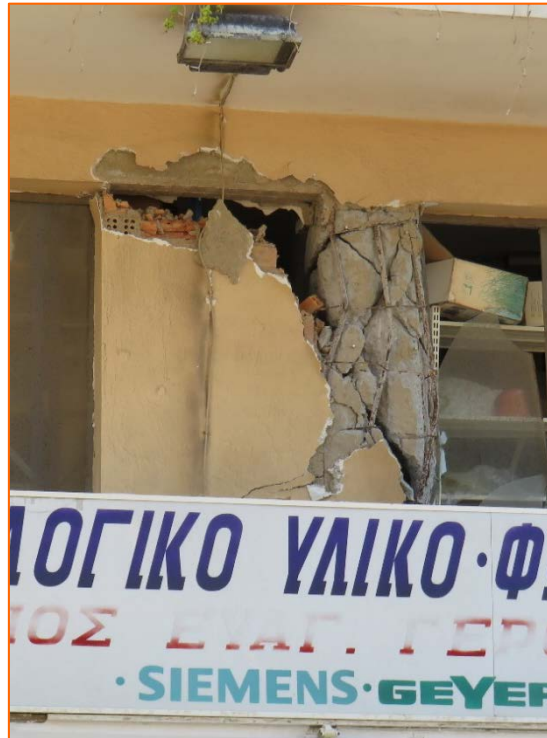
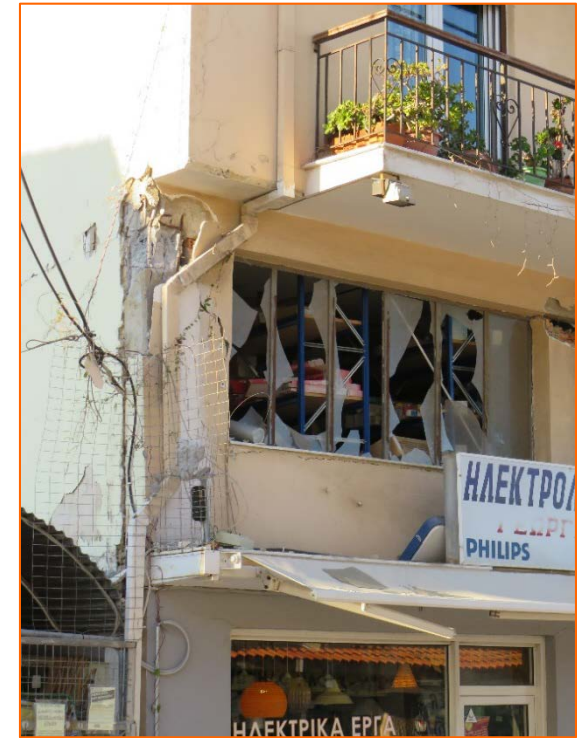
Structural damage to columns of a building with RC frame. The concrete in the columns suffered cracking and disorganization resulting in heavy damage to the frame. The floor over the ground floor suffered heaviest damage, while the rest of the building remained almost intact by the earthquake. The floor act as pilotis, over which floors comprise infill walls.

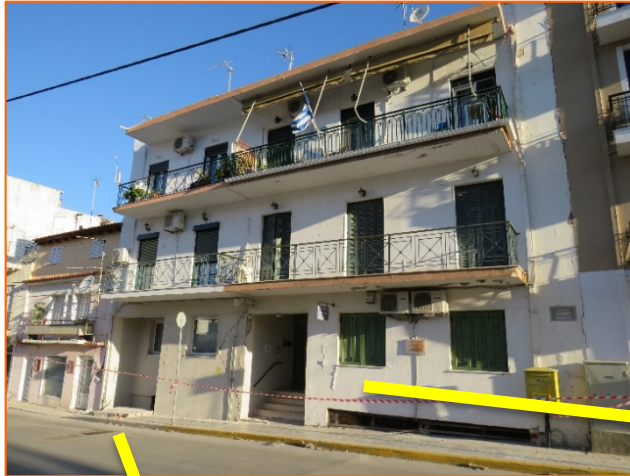
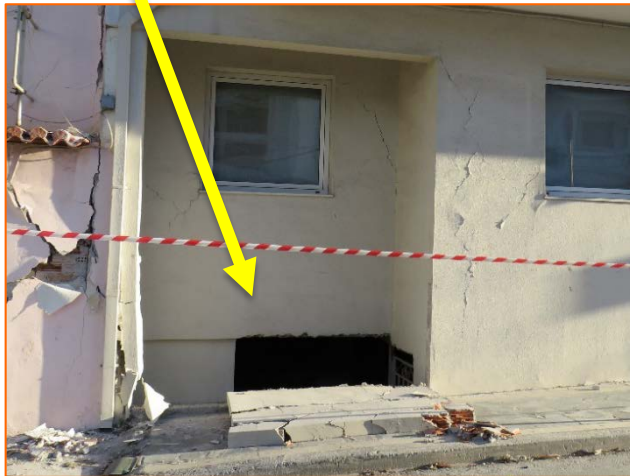
## NON-STRUCTURAL DAMAGE TO RC BUILDINGS IN VATHY TOWN

Non-structural damage to building with reinforced concrete frame and infill walls. It comprised detachment of plaster from the infill walls and extensive cracking and collapse of brick walls. It is significant to note that the rigidity of the building along its height is almost uniform mainly due to the presence of infill walls, which proves their beneficial contribution to the antiseismic behavior of the building, when they are not interrupted (for example in pilotis).

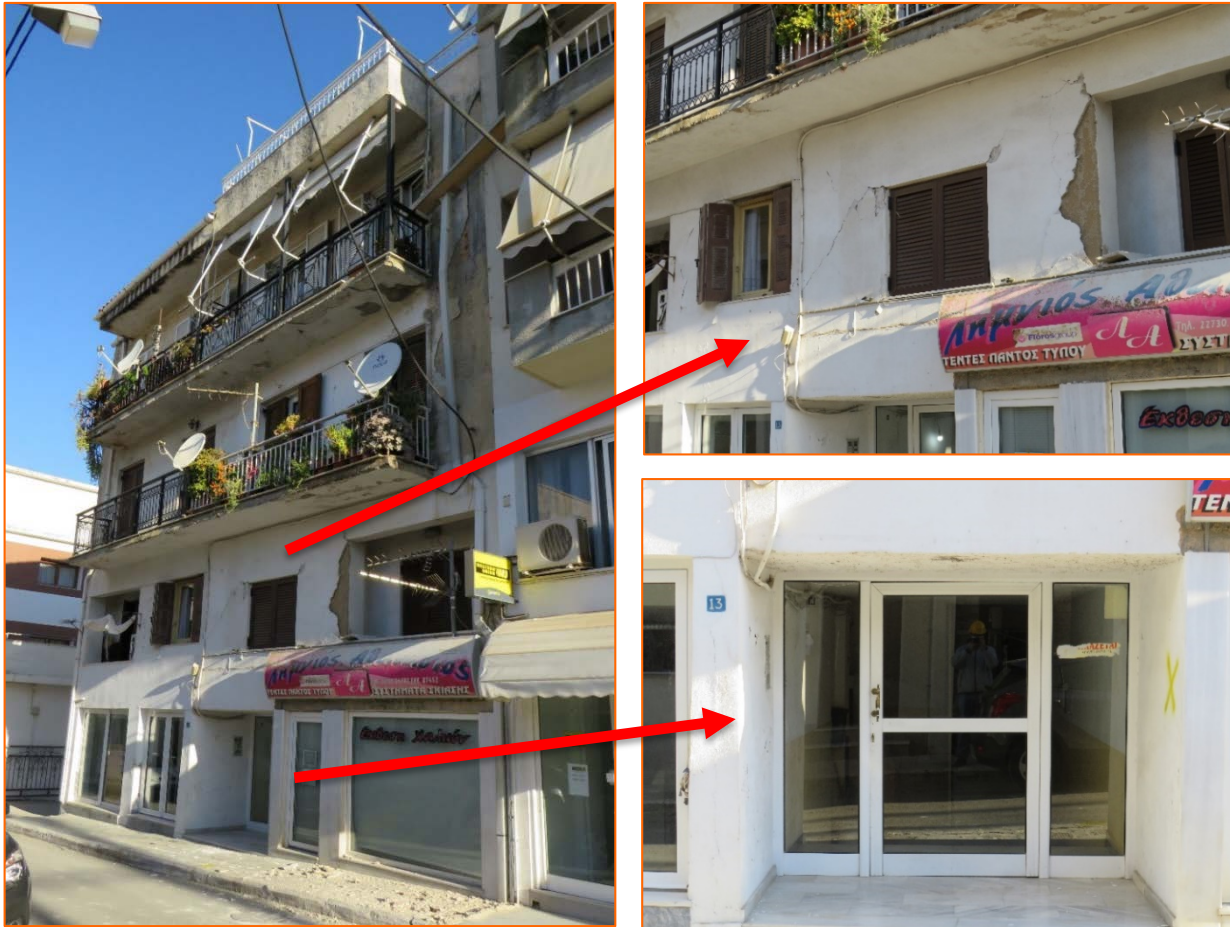
Non-structural damage to building with reinforced concrete frame and infill walls. It comprised detachment of plaster from the infill walls and extensive cracking of brick walls. The entrance door has been deformed. It constitutes one more example of the beneficial contribution of the infill walls in the ground floor to the antiseismic behavior of the building.

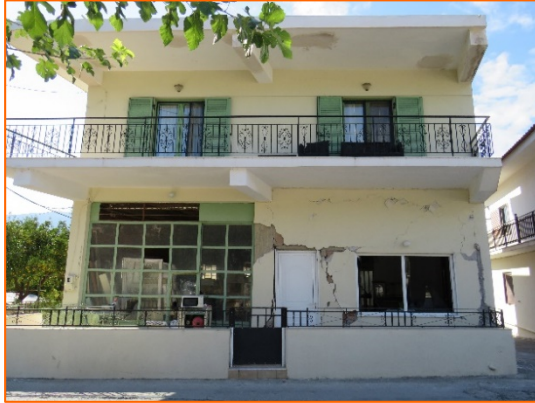
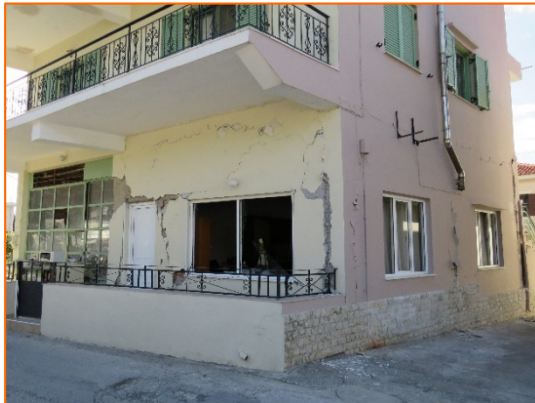
## **DAMAGE TO RC BUILDINGS IN KARLOVASSI TOWN**

The ground floor of this building has been heavily affected, while the upper floor remained almost intact by the earthquake. Structural and non-structural damage were observed. The first comprised heavy damage to columns of the ground floor, while the later included detachment of large pieces of plaster from the infill walls, extensive cracking of plaster and of brick walls, detachment of the walls from the surrounding RC frame and damage to the staircase.

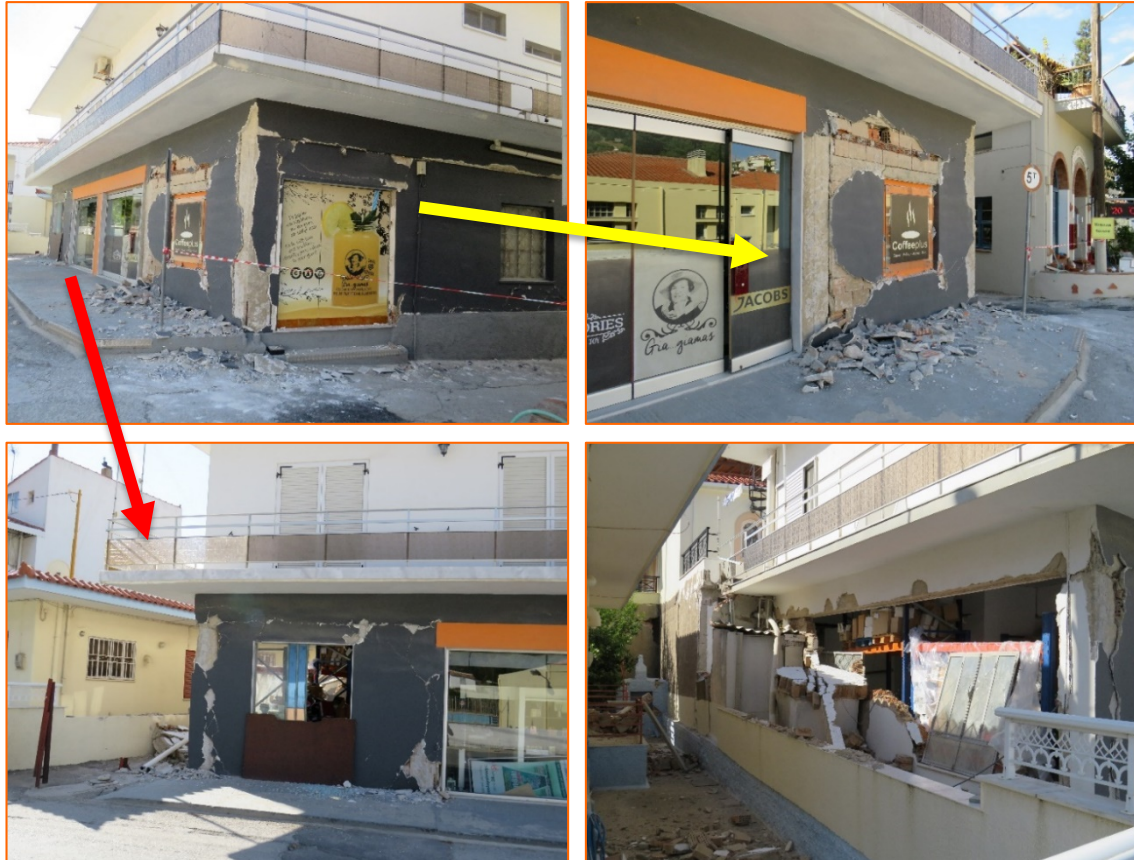
The ground floor of this building has been heavily affected, while the upper floor remained almost intact by the earthquake. Structural damage comprised heavy damage to the upper part of the columns of the ground floor, while non-structural damage included detachment of large pieces of plaster from the infill walls, extensive cracking of plaster and of brick walls, detachment of the walls from the surrounding RC frame and total collapse.

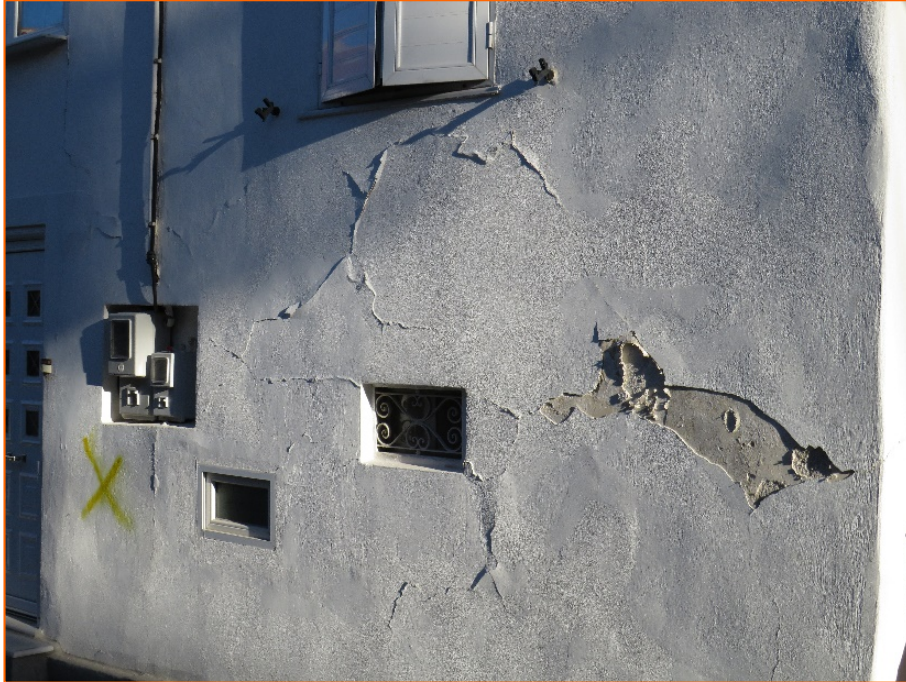
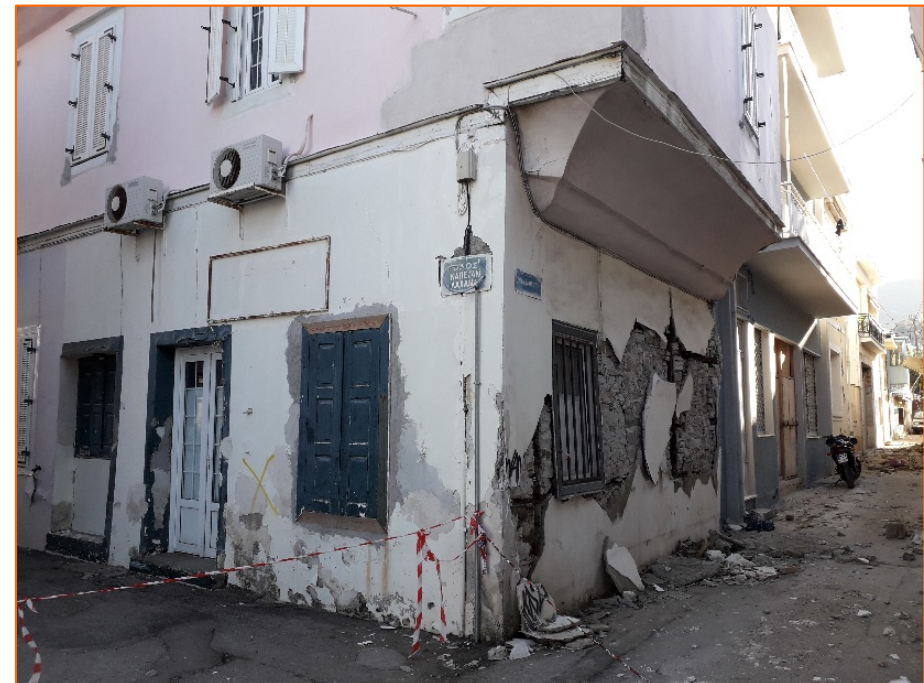
Vathy

Non-structural damage included cracking in plaster, detachment of large pieces of plaster from the walls, symmetrical cracks and displacement of collapse of the upper.

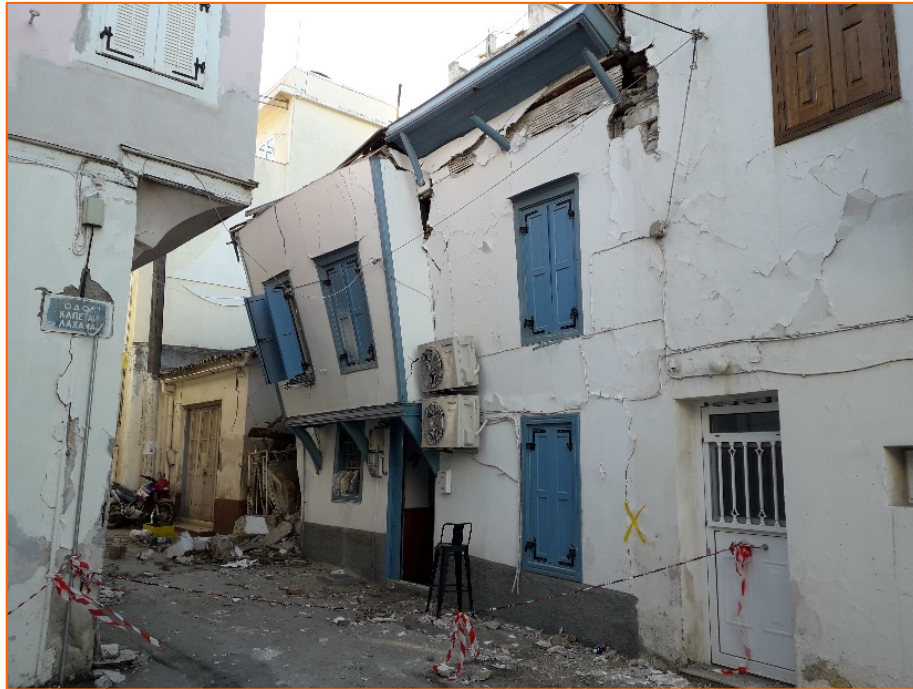
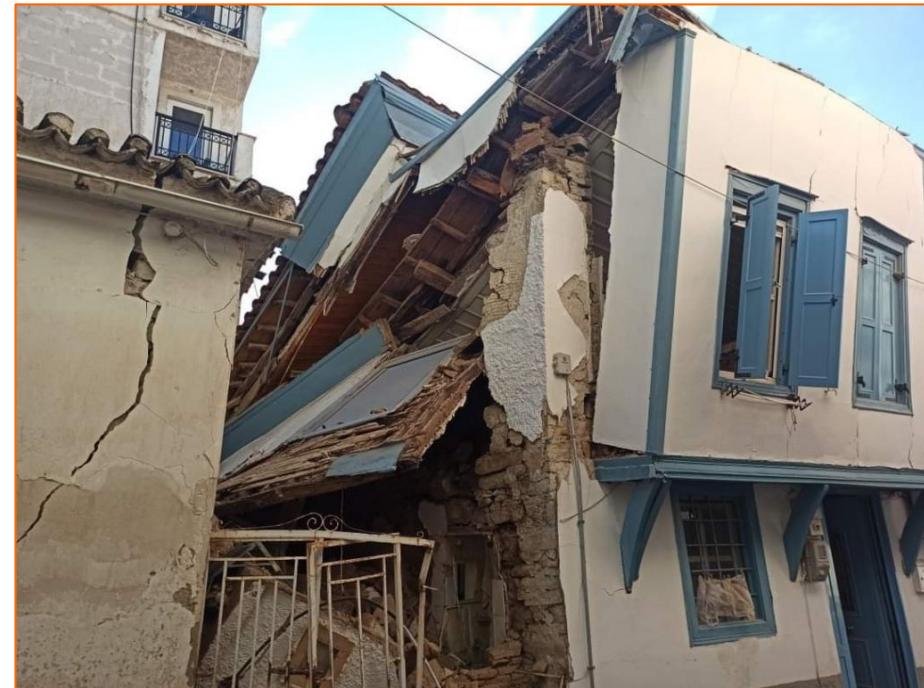
Heavy structural damage to building with load-bearing masonry walls. The building is on the verge of total collapse.

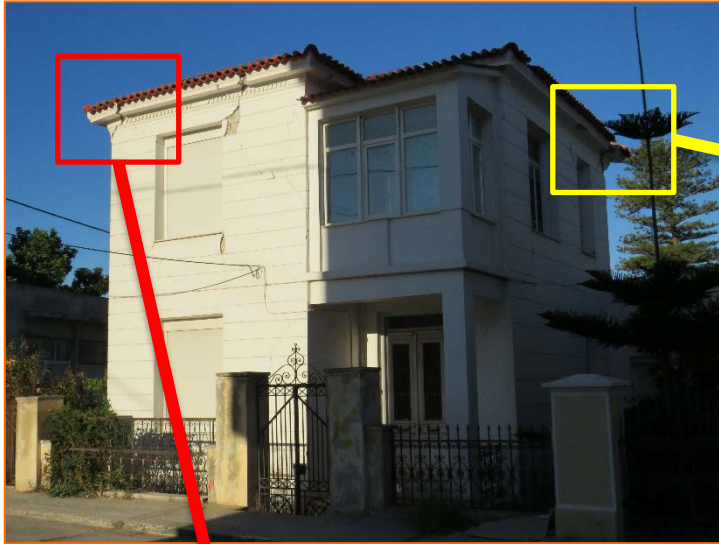
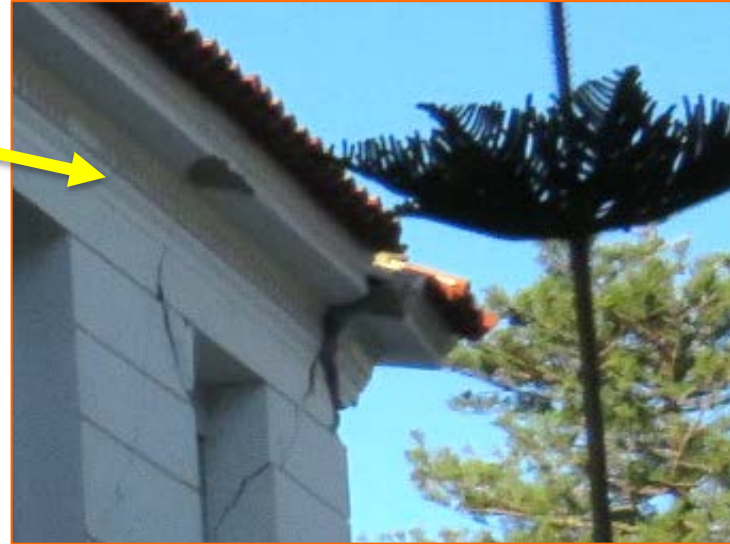
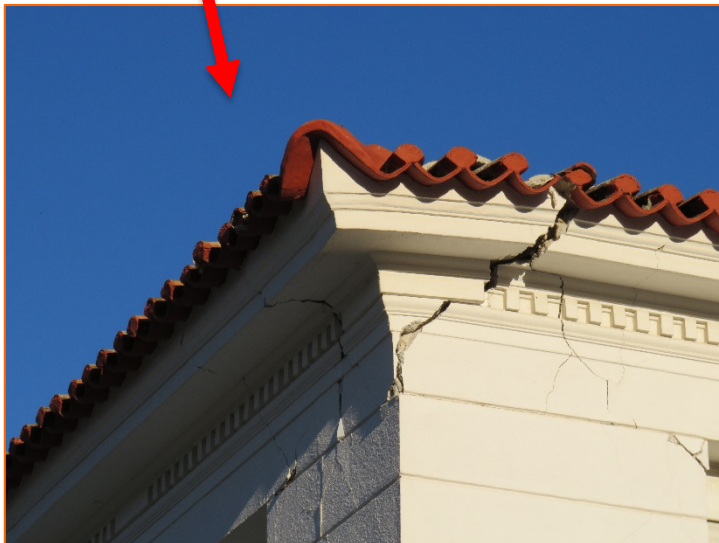
Symmetrical detachment of the corners edges of a building with masonry load-bearing walls is the trademark of the prevalence and the dominance of the vertical component of the earthquake ground motion over the horizontal. Collapse of the building cornices has been also observed.

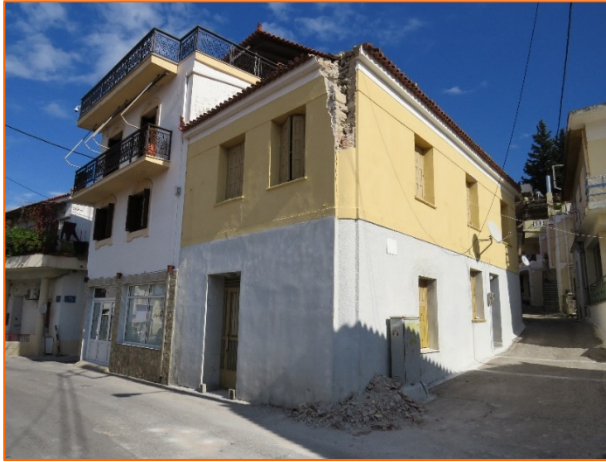
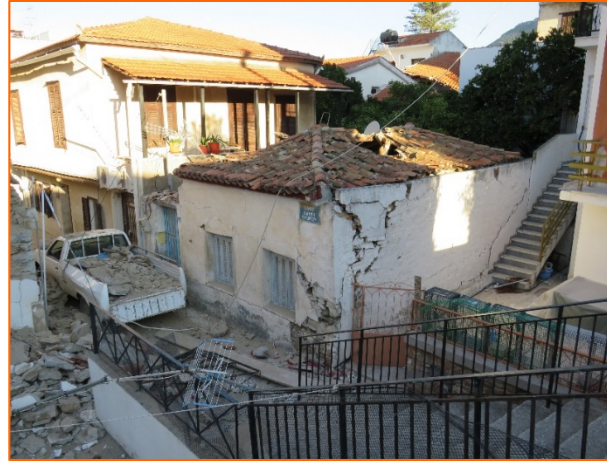
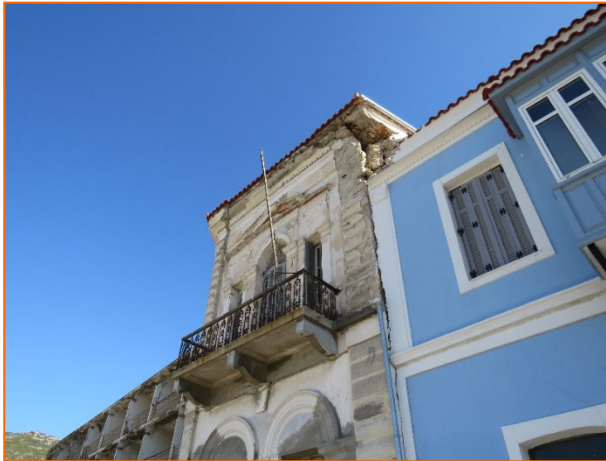
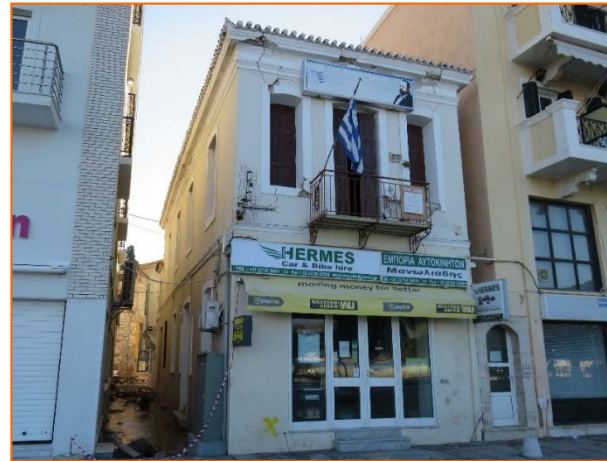
## **DAMAGE TO BUILDINGS WITH LOAD-BEARING MASONRY WALLS** **DAMAGE TO UPPER CORNERS**

Symmetrical detachment of the corners edges of a building with masonry load-bearing revealing the prevalence and the dominance of the vertical component of the earthquake ground motion over the horizontal. Collapse of the building cornices has been also observed. Impact between adjacent buildings is negligible.

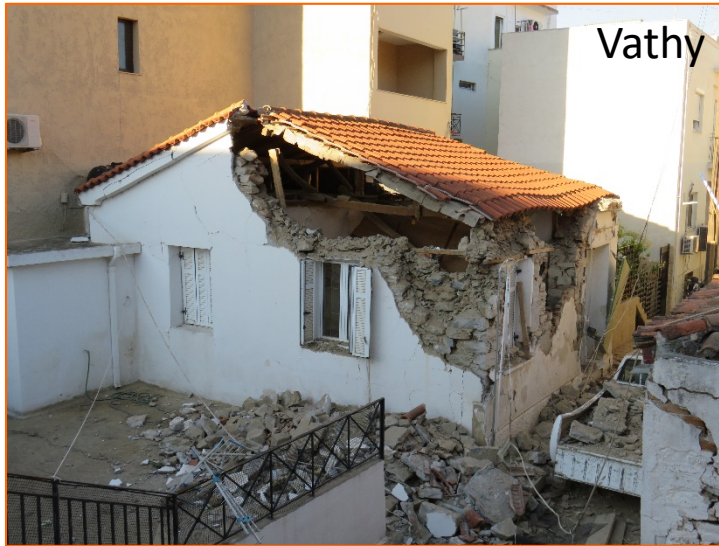
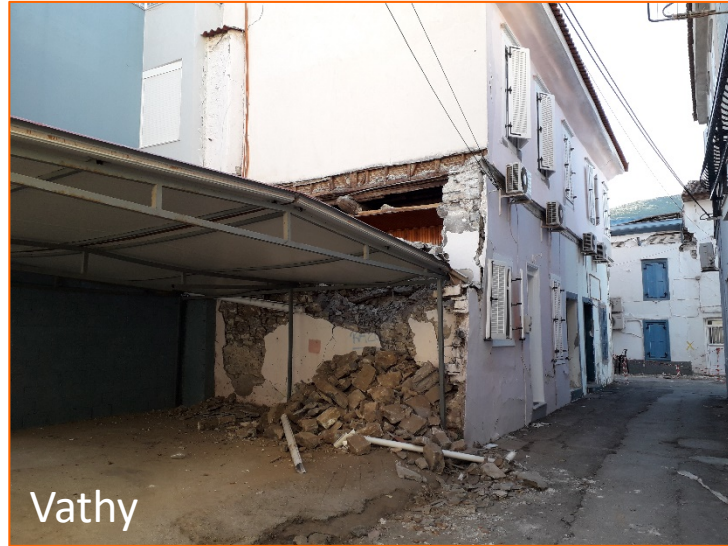
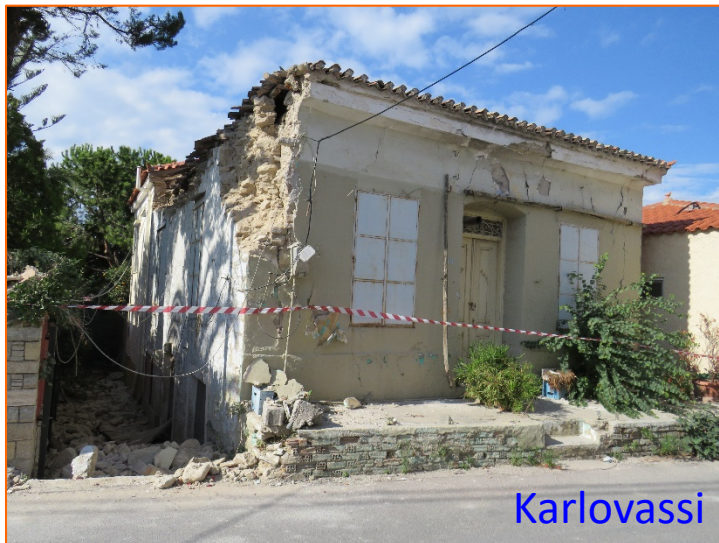
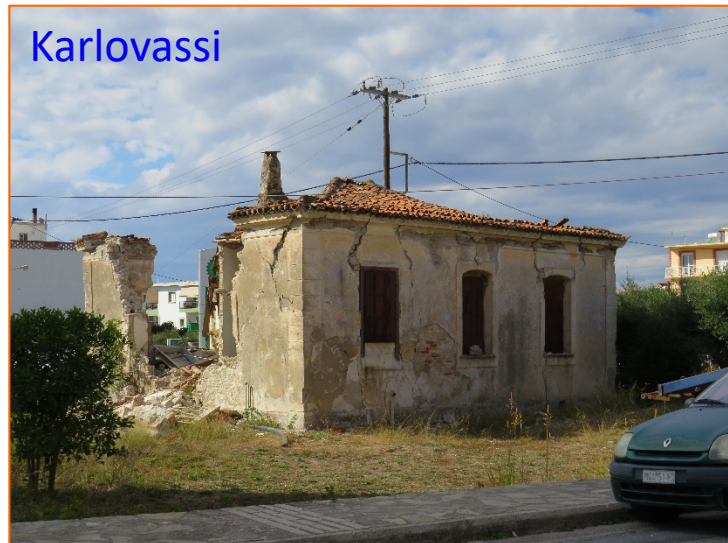
## **DAMAGE TO BUILDINGS WITH LOAD-BEARING WALLS** **PARTIAL COLLAPSE OF THE LOAD-BEARING MASONRY WALLS**

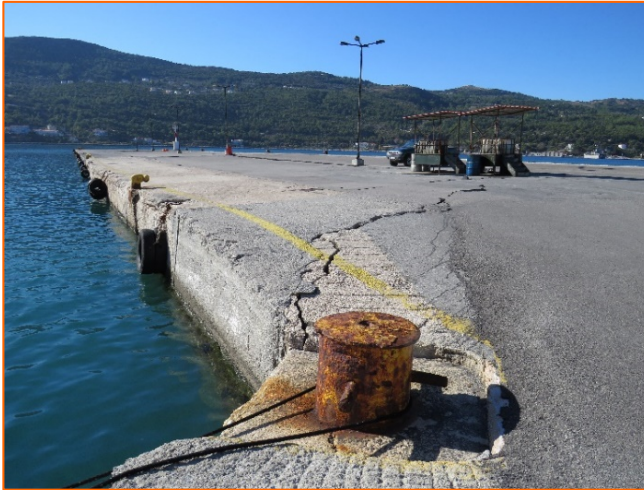
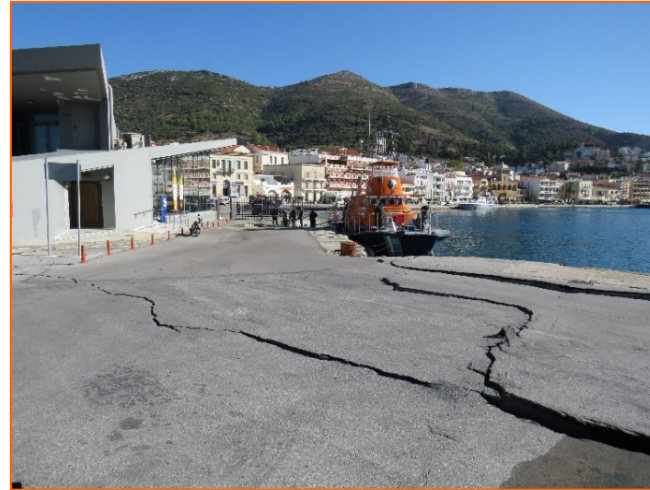
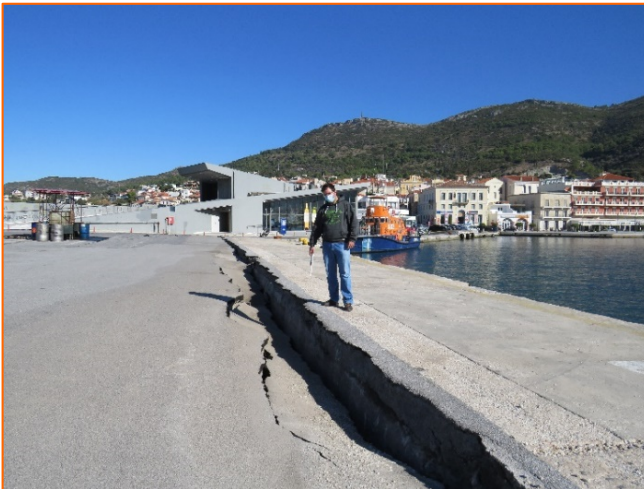
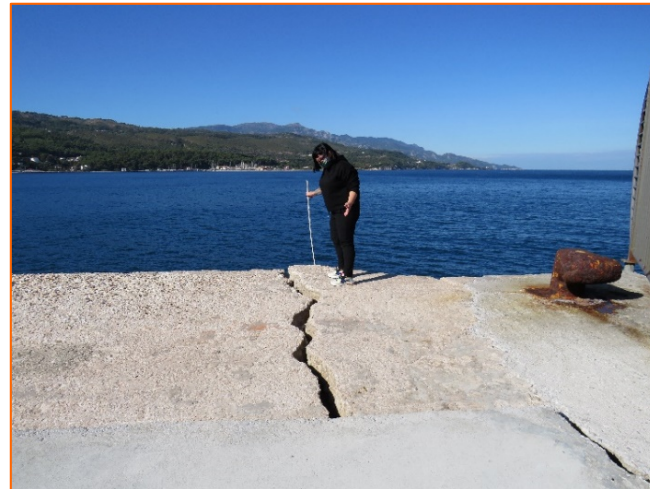
## **DAMAGE TO INFRASTRUCTURE VATHY PORT**

The jetty of the Vathy port has been affected by extensive longitudinal and transverse ground cracks resulting in subsidence and tilting due mainly to the dynamic compaction of the back-fill material.

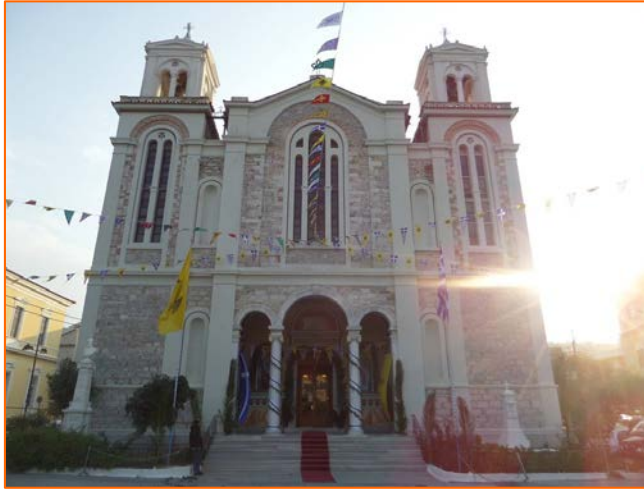
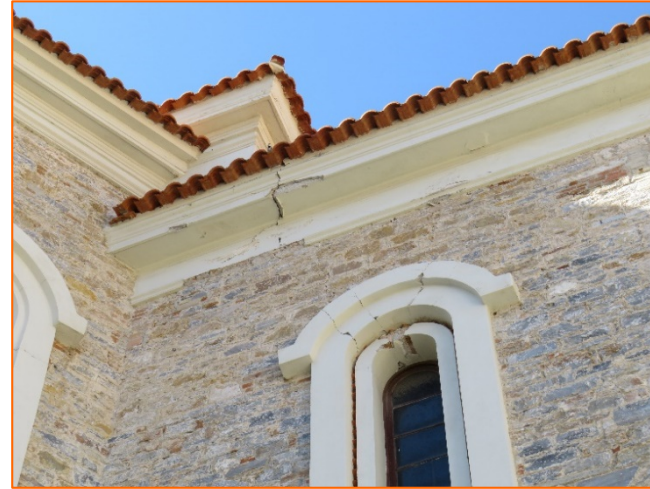
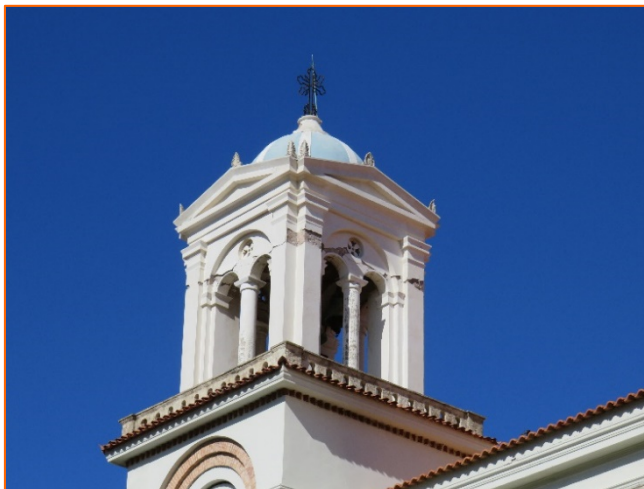
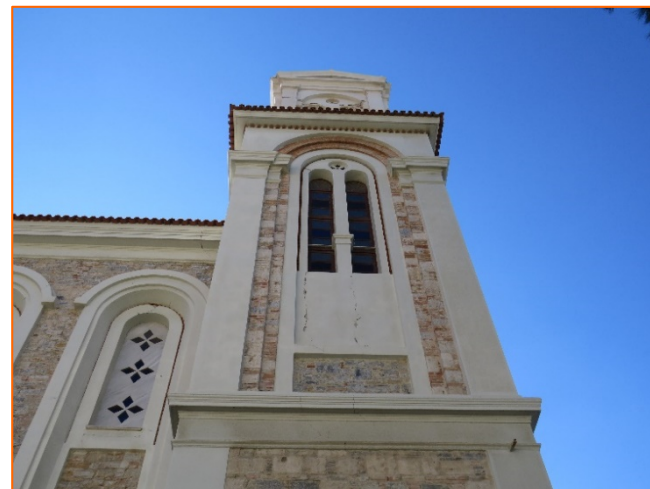
## **DAMAGE TO MONUMENTS AND SPECIAL STRUCTURES**

Churches in Samos suffered damage to the load-bearing masonry walls, arches, roofs, plasters and their bell tower. Characteristic damage in the Cathedral of Agios Spyridon in Vathy town.

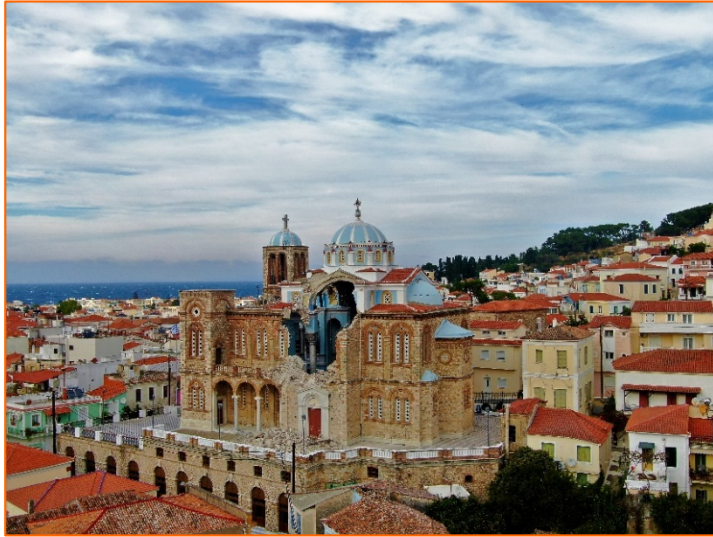
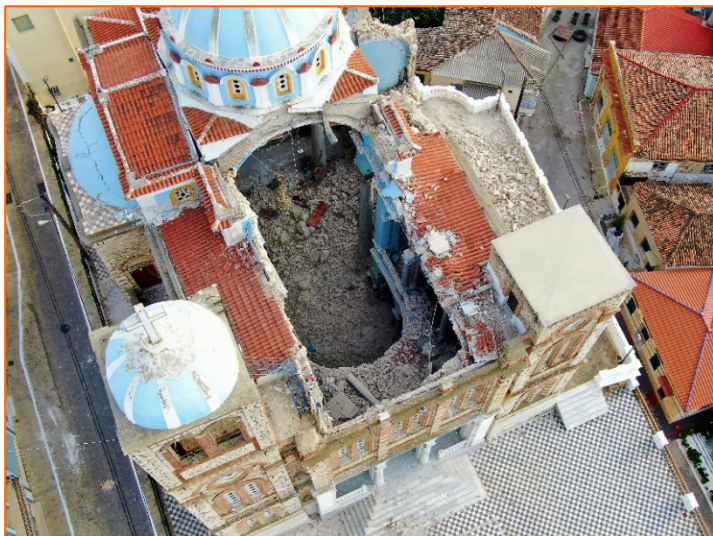
Characteristic example is Holy Church of the Assumption of the Virgin Mary in Karlovassi town, located at the northwestern part of Samos. It is the largest church in the Balkan peninsula. It suffered partial collapse of the roof and of their adjacent perimetric walls. The collapse occurred within the foundation plan of the building, while the remaining exterior walls were still standing indicating the prevalence of the vertical component of the earthquake ground motion.
