# Newsletter of **Environmental, Disaster, and Crises Management Strategies**

Issue No. 21 | November 2020

## **The October 30, 2020, Mw 6.9 Samos (Greece) earthquake**

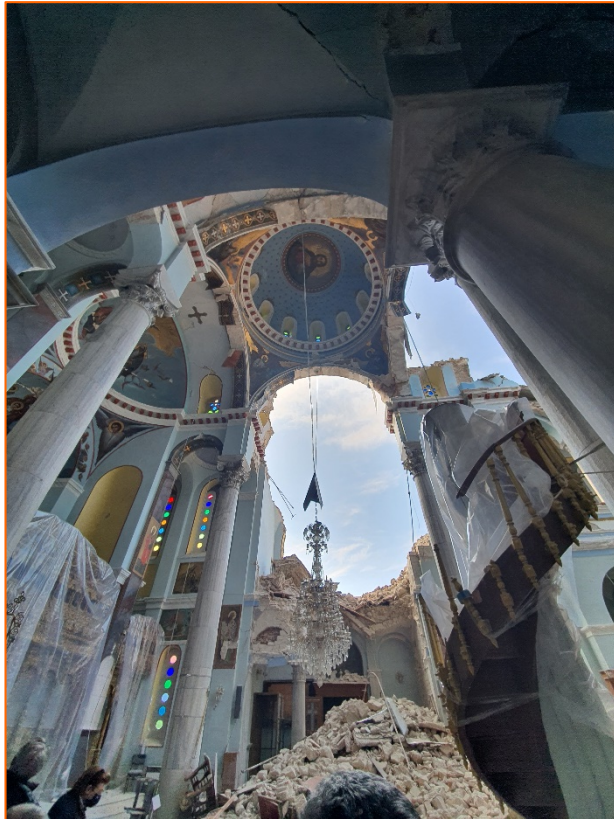
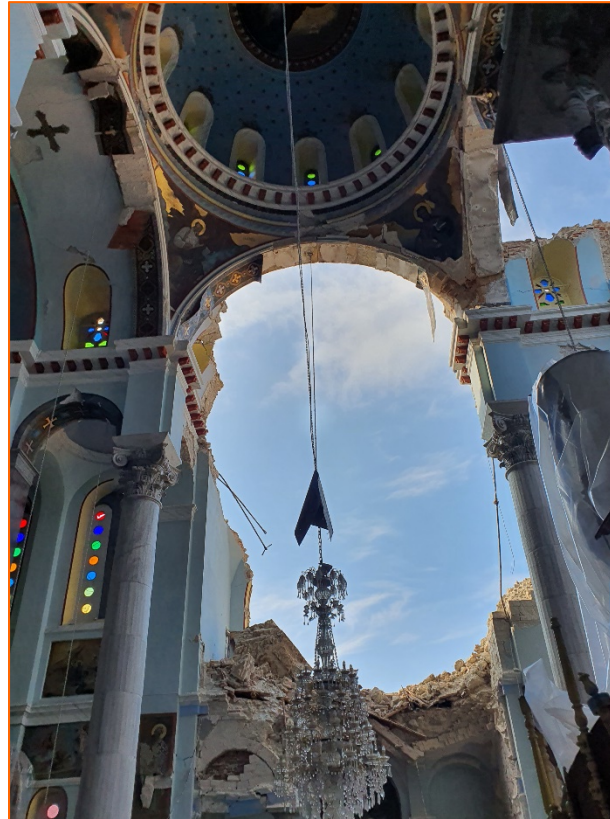
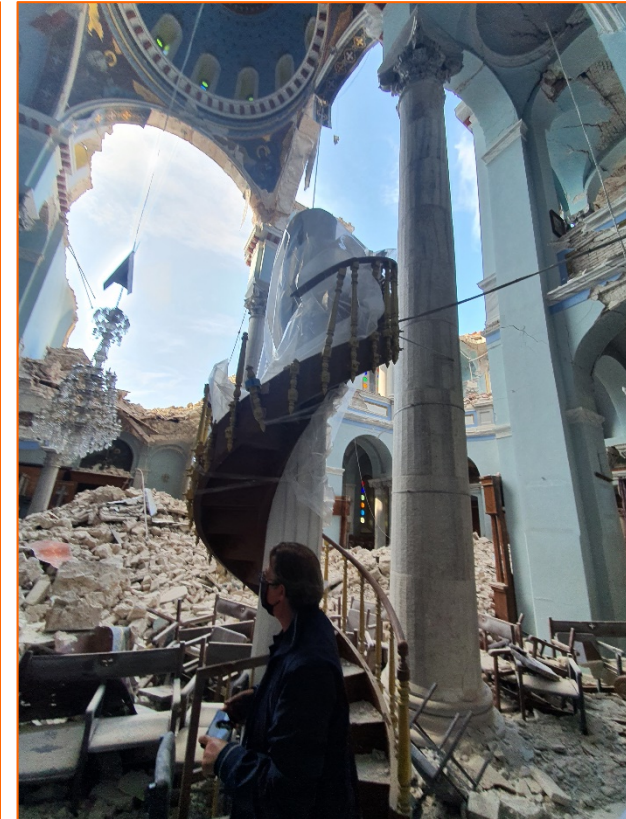
Characteristic views of the damage induced to the Holy Church of the Assumption of the Virgin Mary in Karlovassi town from the interior of the structure. It suffered partial collapse of the roof and of their adjacent perimetric walls. The collapse occurred within the foundation plan of the building.

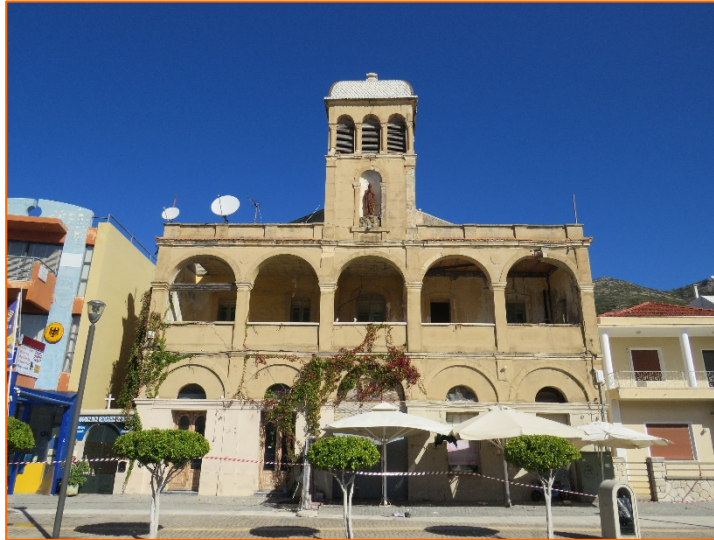
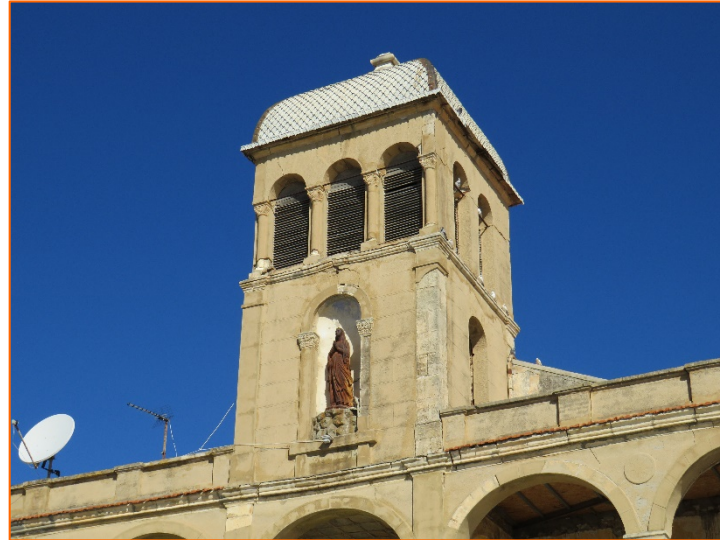
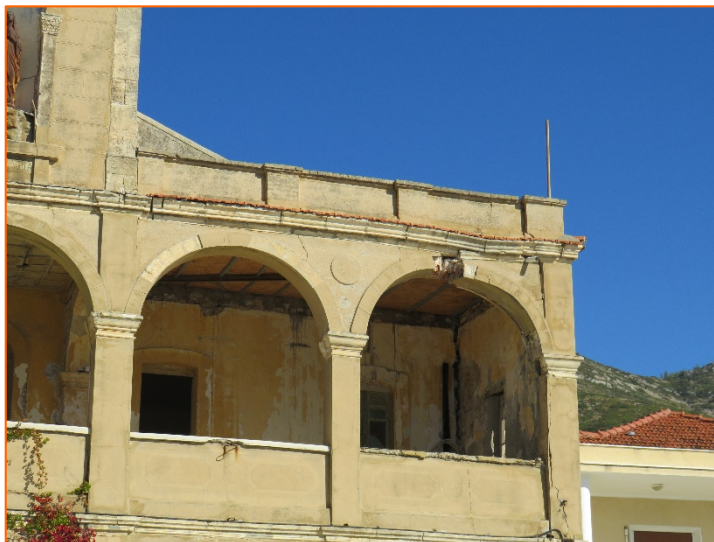
The Catholic Church located at the coastal area in Vathy town suffered damage to masonry walls, the bell tower and the arches. It was also affected by the subsequent tsunami and the coastal inundation.
