Newsletter of **Environmental, Disaster, and Crises Management Strategies**

Issue No. 30 | January 2024

The early September 2023 Daniel storm in Thessaly Region (Central Greece)

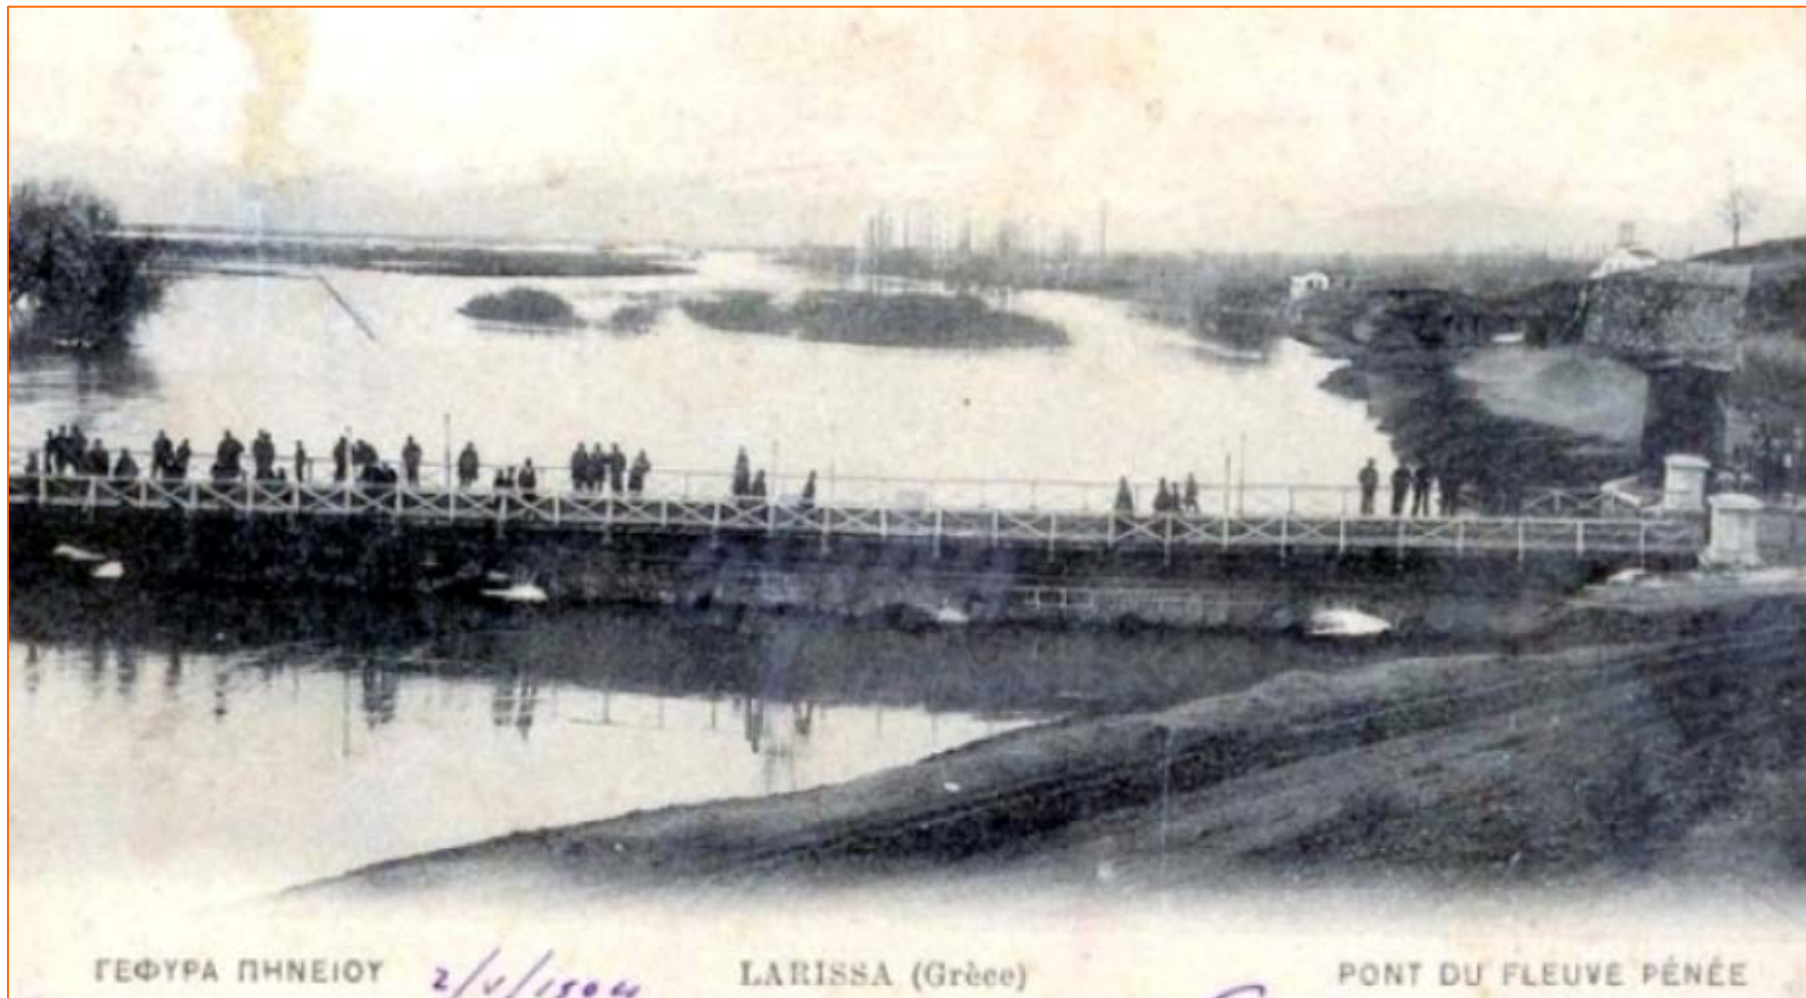
1903/1904 Flood in Larissa
Pineios bridge

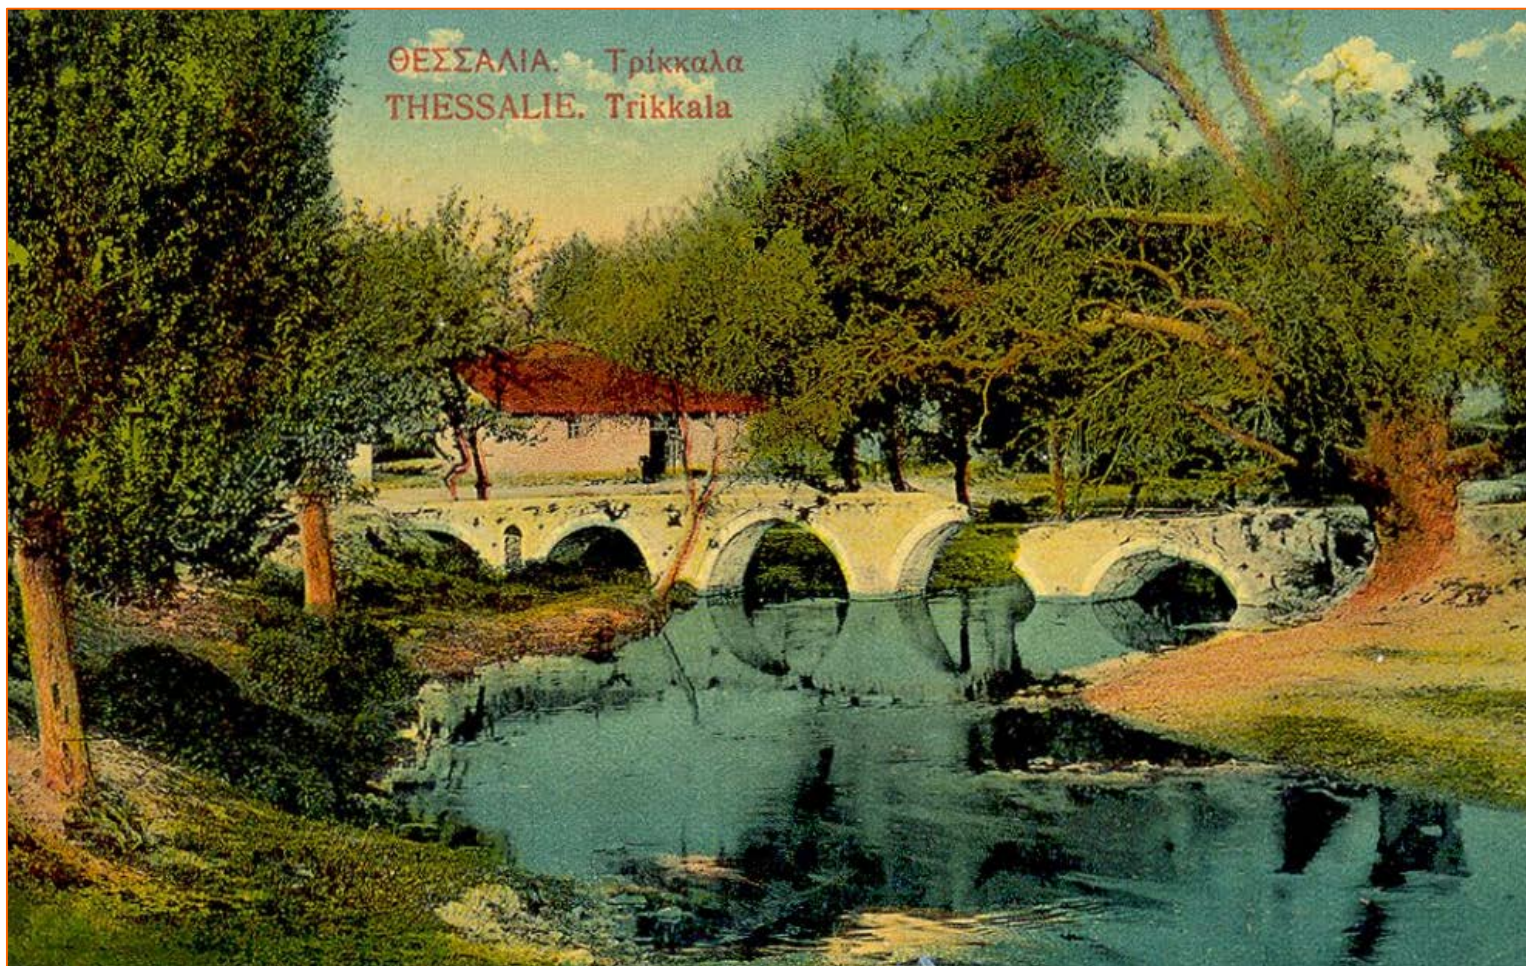
The Pichtou stone bridge destroyed after the 1907 flood in Trikala due to the overflow of Lithaios River, which is one of the most known tributaries of Pineios and affected the largest part of the Trikala town. Photo credit: Stefanos Stournaras

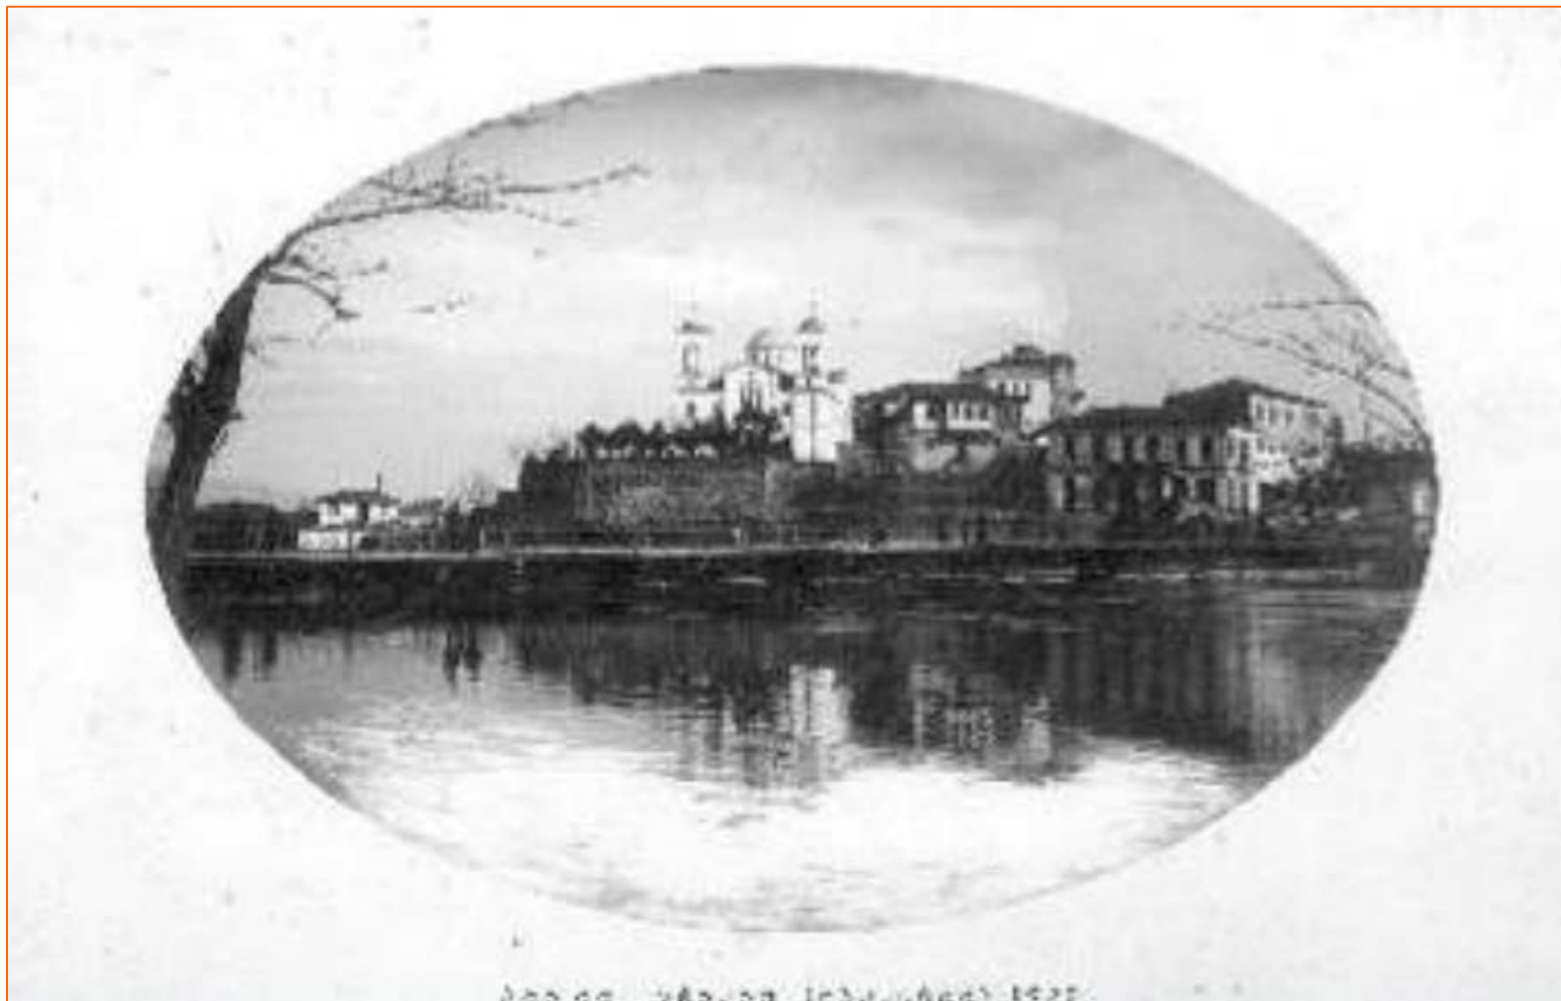
The 1920 Flood
The inundated Pineios River at Larissa (via Kypraiou 2011)

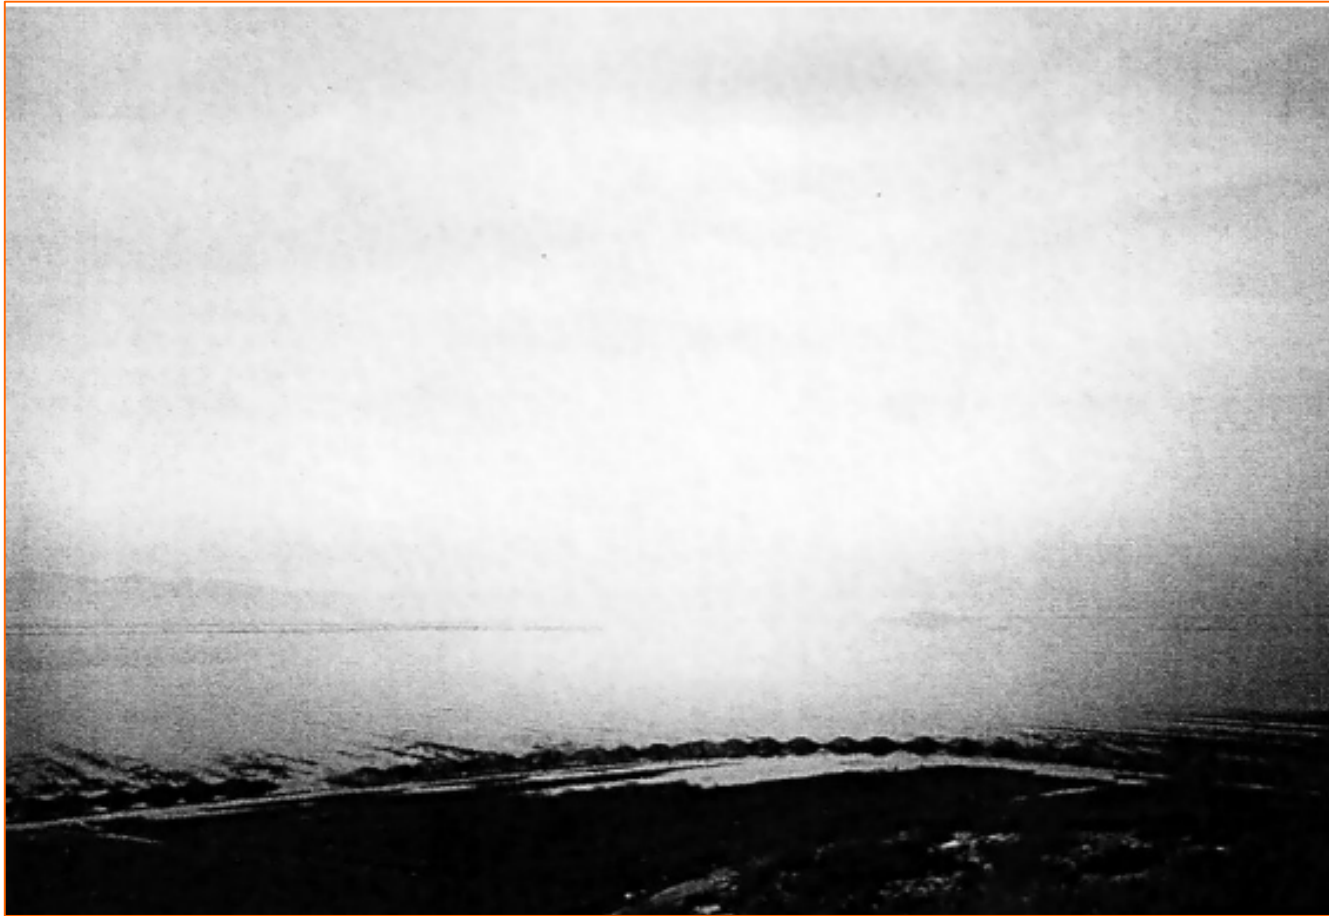
With the floods of March 1987 the landscape resembled a lake. Lake Karla appeared again, for only a few days. After the flood waters receded, it was found that the damage to farmland and existing crops was extensive.

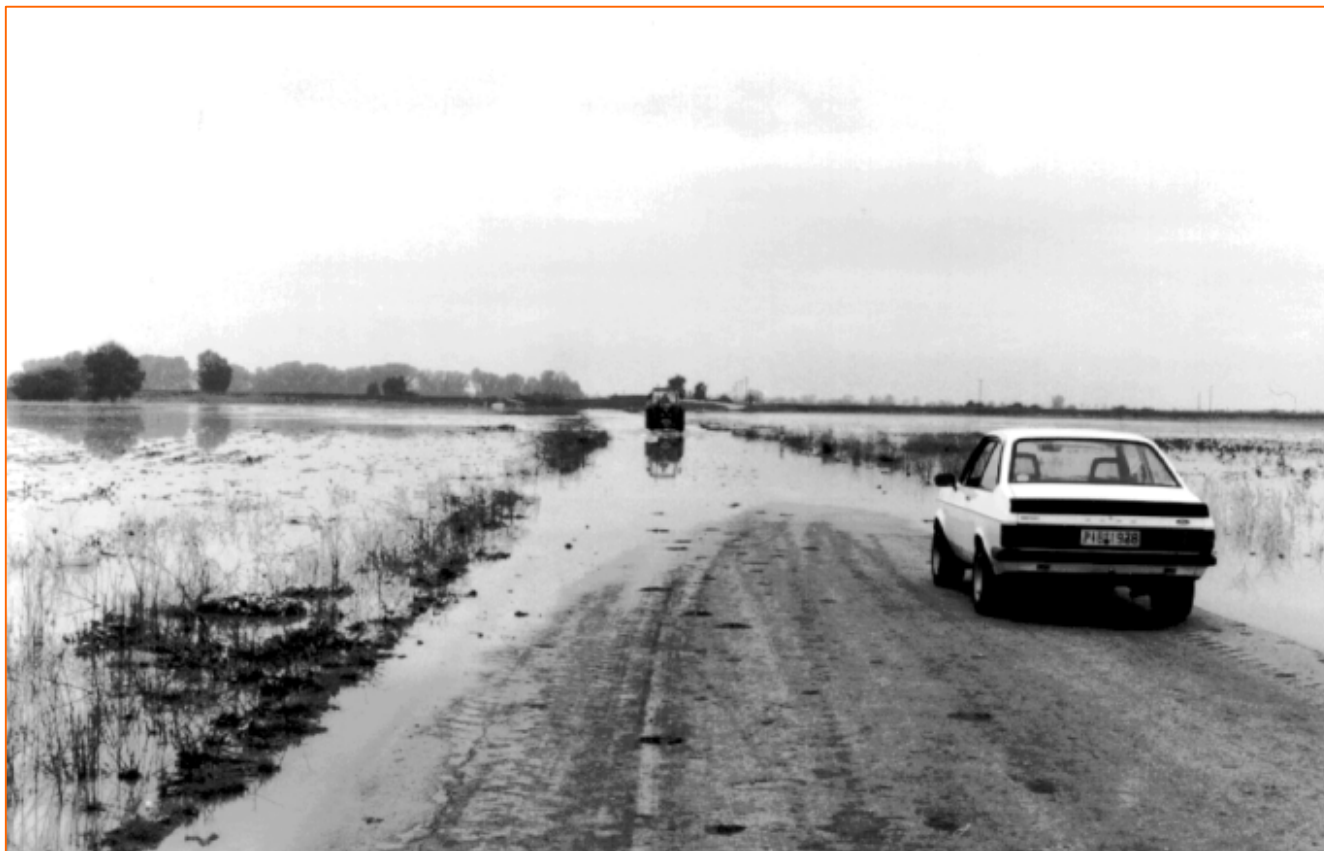
The 1994 Metamorphosi Flood

More than 70 houses in about 20 communities were totally destroyed by the flood, more than 200 suffered severe damage and other 90 minor damage, whereas 80 km² of agricultural land (cotton fields) were flooded. (Mimikou et al., 1995).

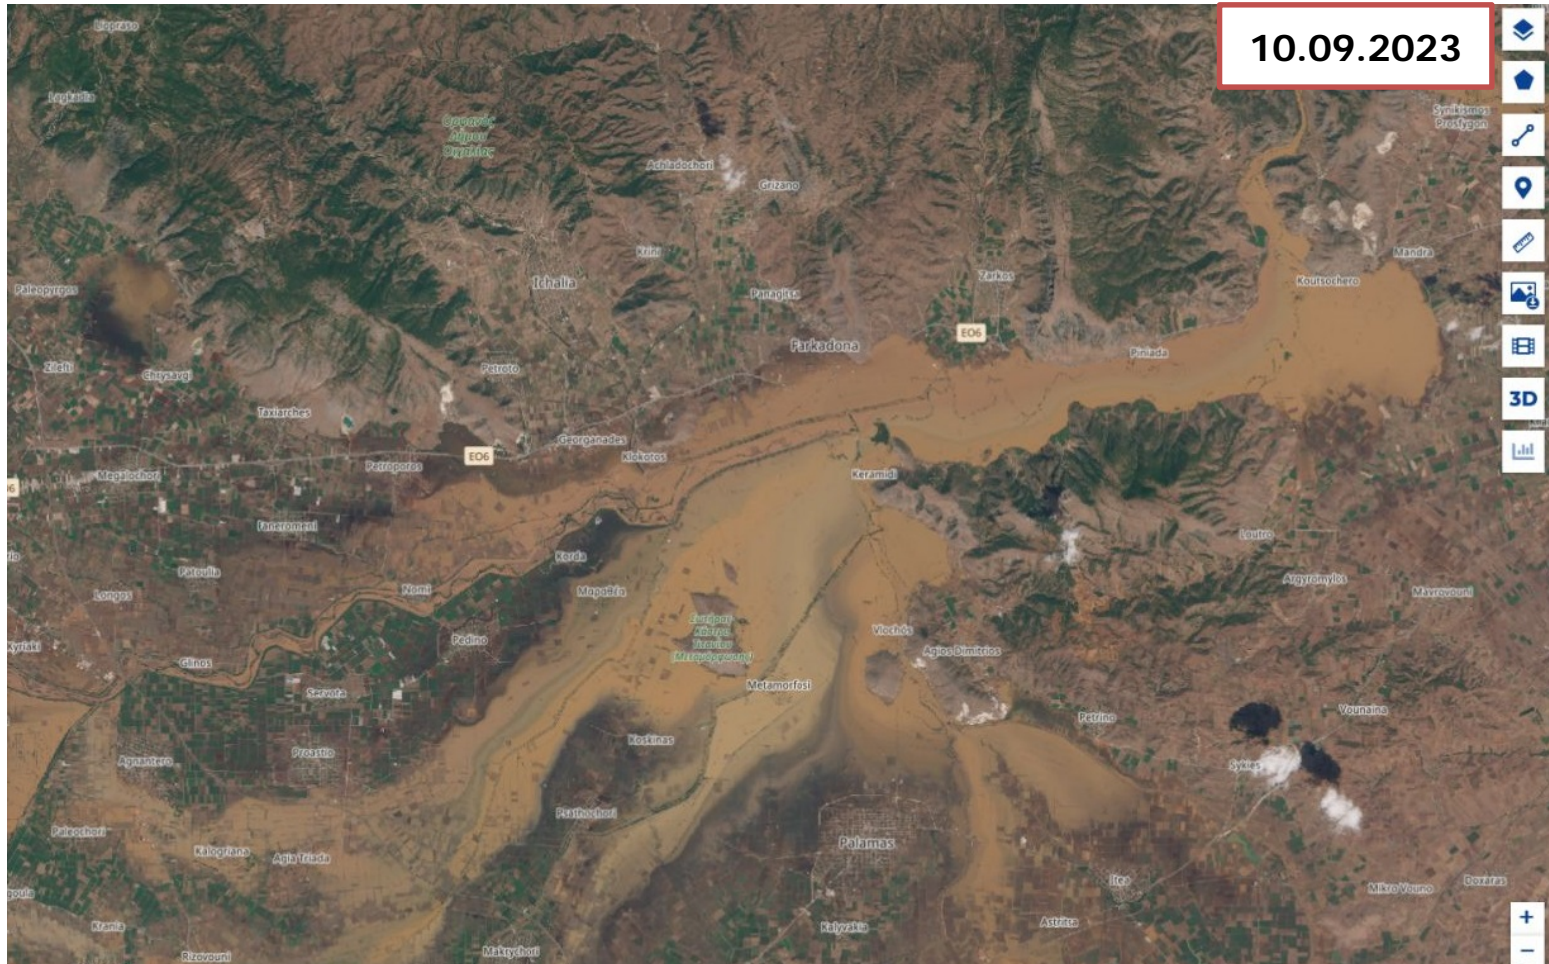
An image from optical satellite Sentinel 2 product L 1C true-color on 10 September 2023 showing the geographical extent of the flood event in the area west of Larissa.

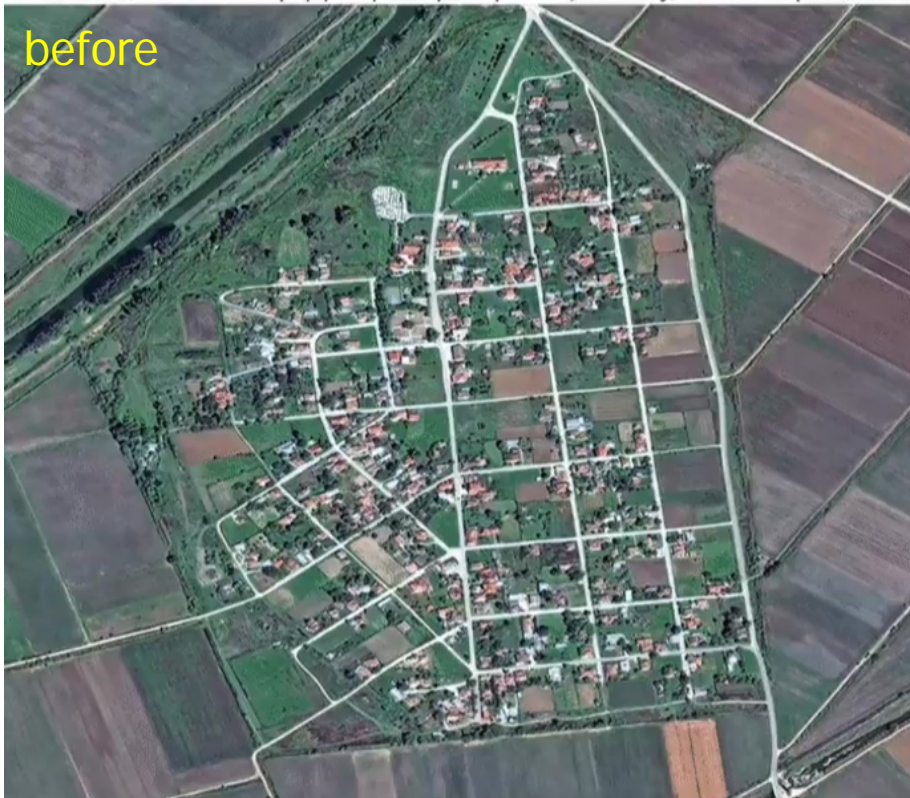
Loc. 39.506, 22.054 - Μεταμόρφωση Παλαμά Καρδίτσας, Thessaly, Greece - Sept 16, 2022

before

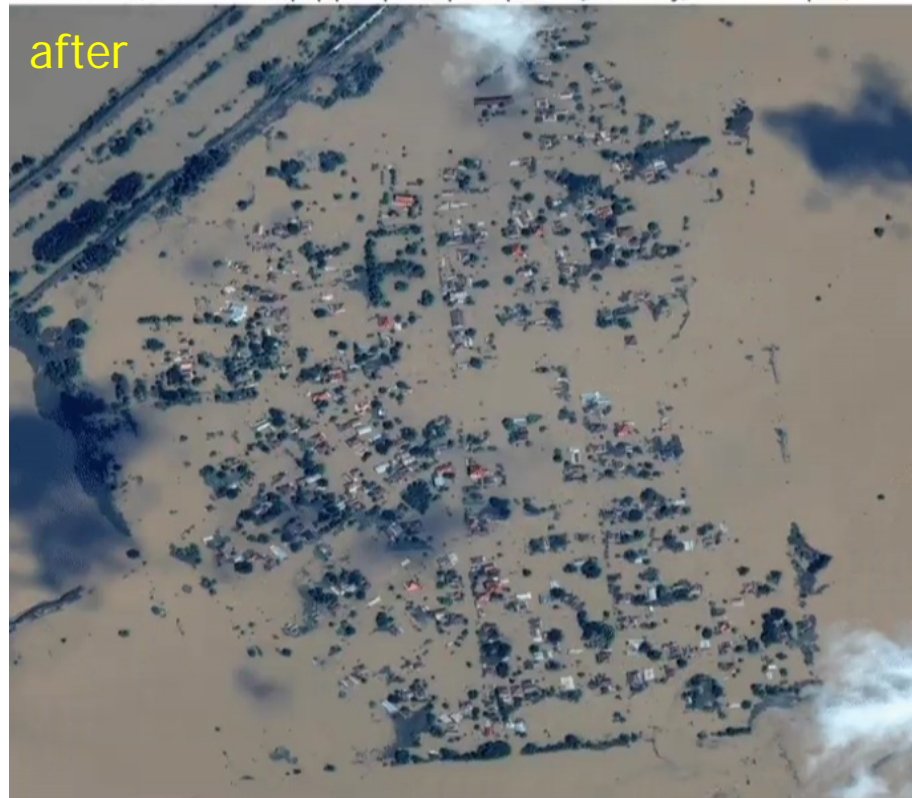
Loc. 39.506, 22.054 - Μεταμόρφωση Παλαμά Καρδίτσας, Thessaly, Greece - Sept 9, 2023

after

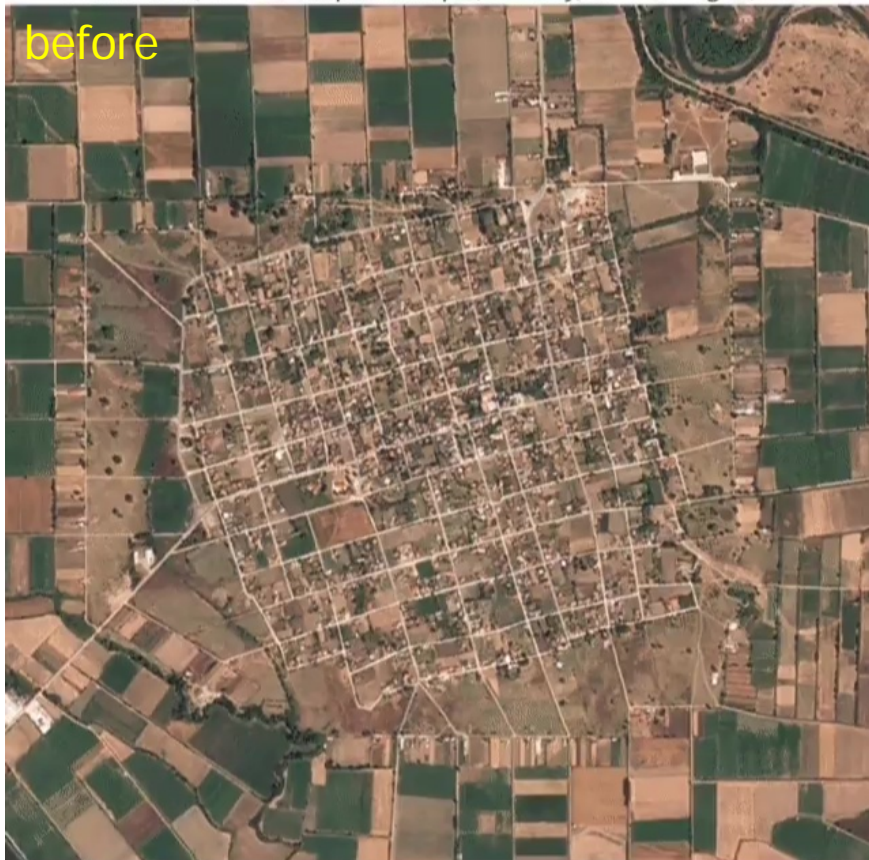
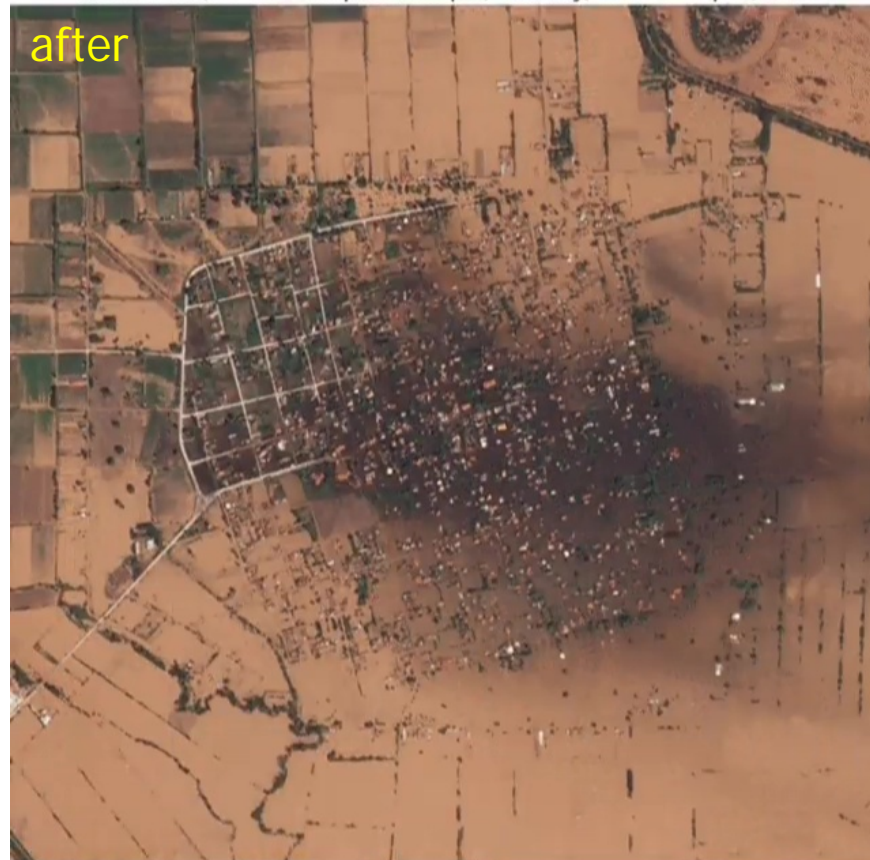
Loc. 39°30'N, 21°47'E - Μεγάλα Καλύβια, Thessaly, Greece - Aug 31, 2023

The Megala Kalyvia village in the Trikala Regional Unit before (acquisition on 31.08.2023) and after (acquisition on 08.09.2023) the flooding generated by the Daniel storm.
Source of satellite imagery: Maxar

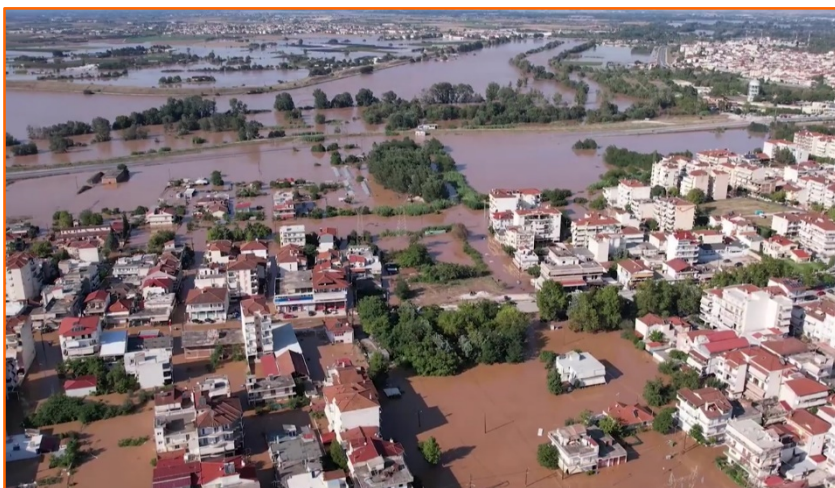
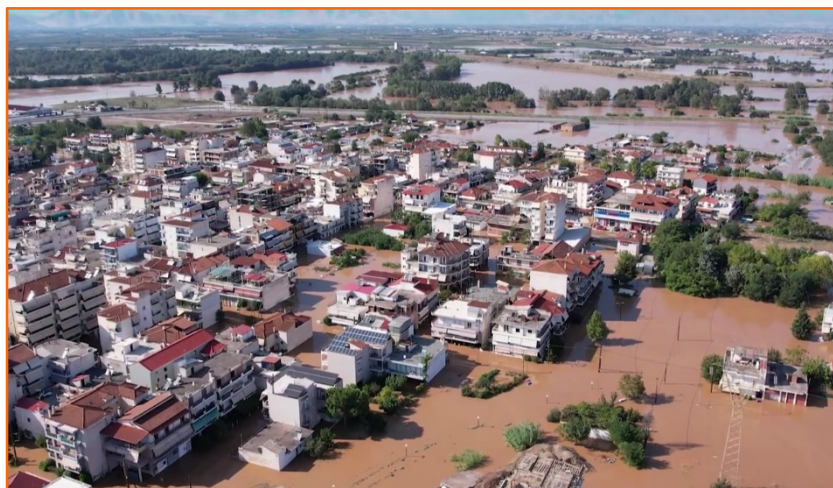
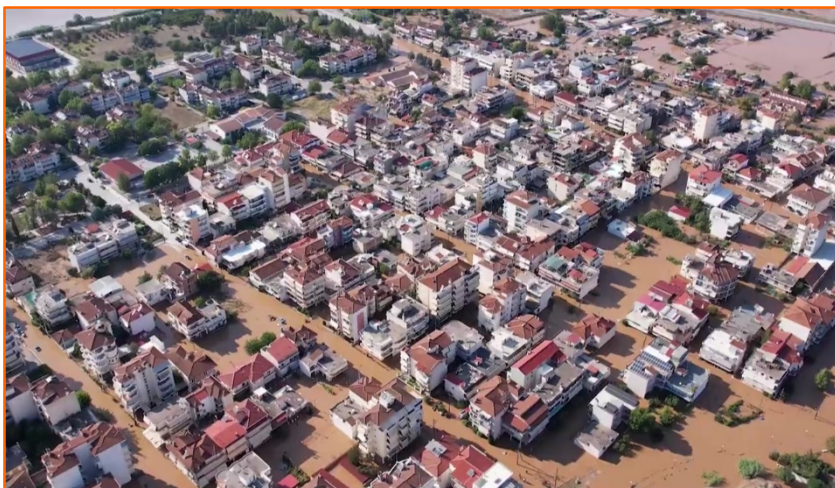
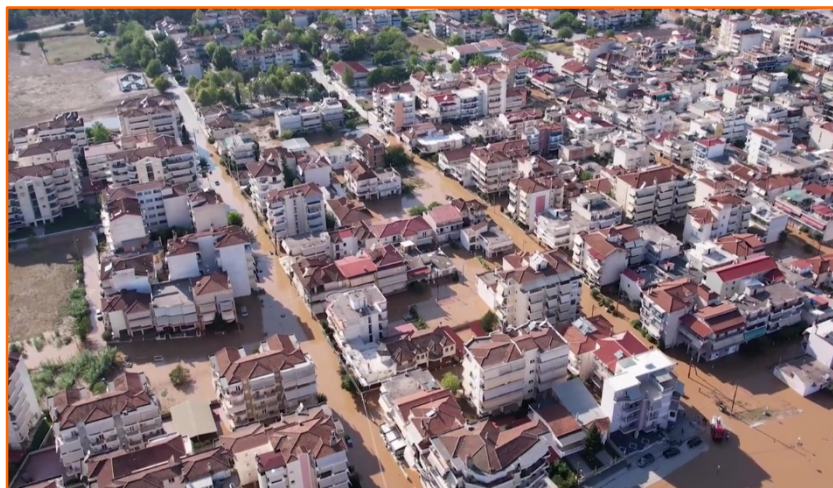
Larissa City, Ayios Thomas District
8 September 2023

Snapshots from a drone video presenting the flooded of Ayios Thomas district located very close to the overflowed Pineios River at the western part of Larissa City
(Video source: <https://www.youtube.com/watch?v=ogBH5L2H0I8>)

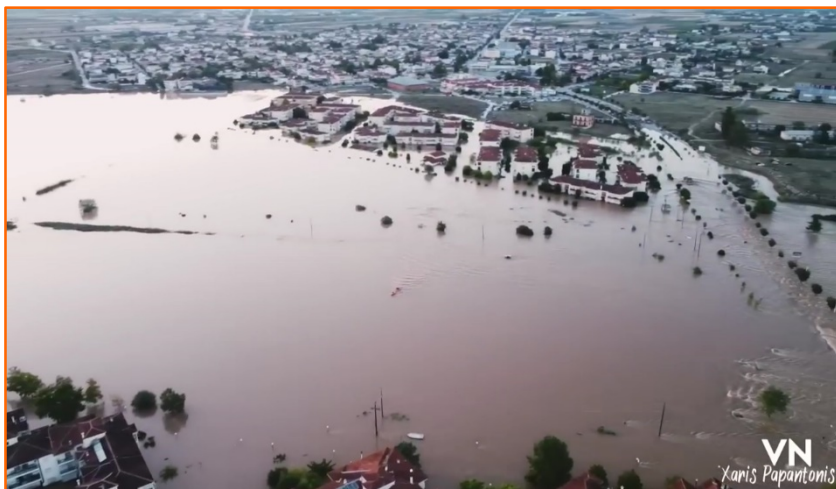
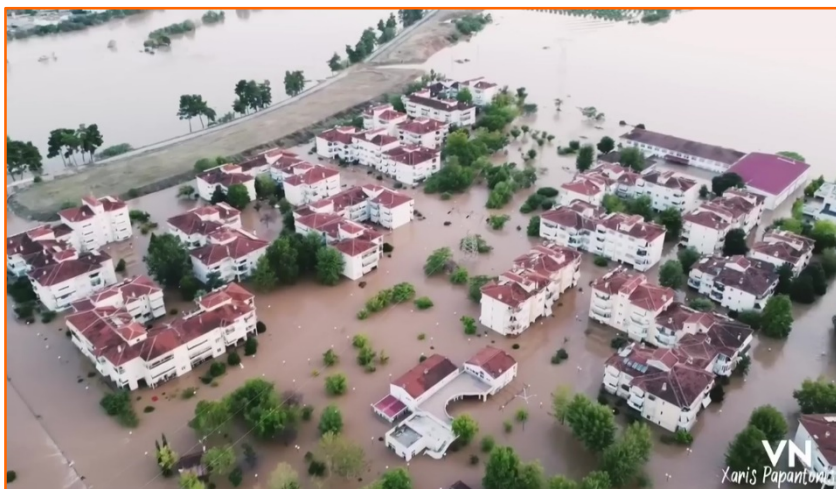
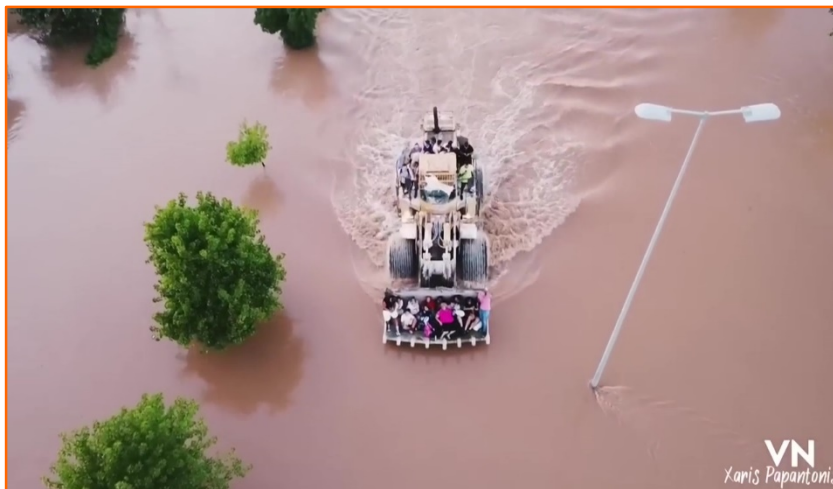
Larissa City, Giannouli District
9 September 2023

Snapshots from a drone video presenting the flooded Giannouli district located very close to overflowed tributaries of Pineios River at the southern part of Larissa City
(Video source: <https://www.youtube.com/watch?v=Ccyp7kNURgs>)

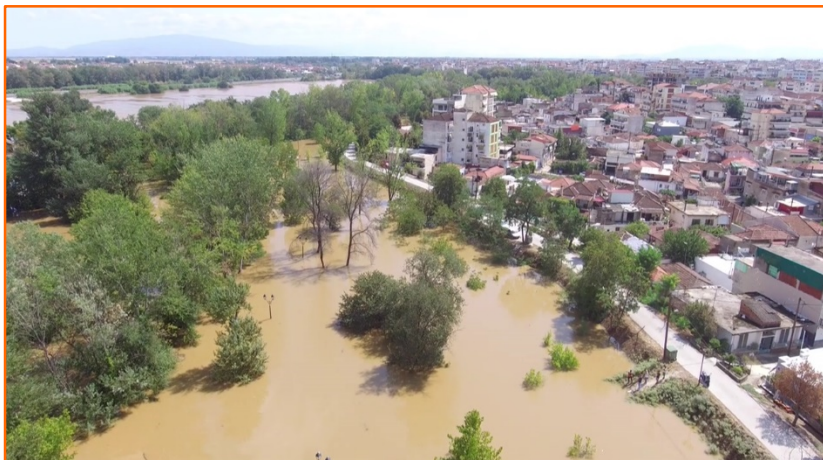
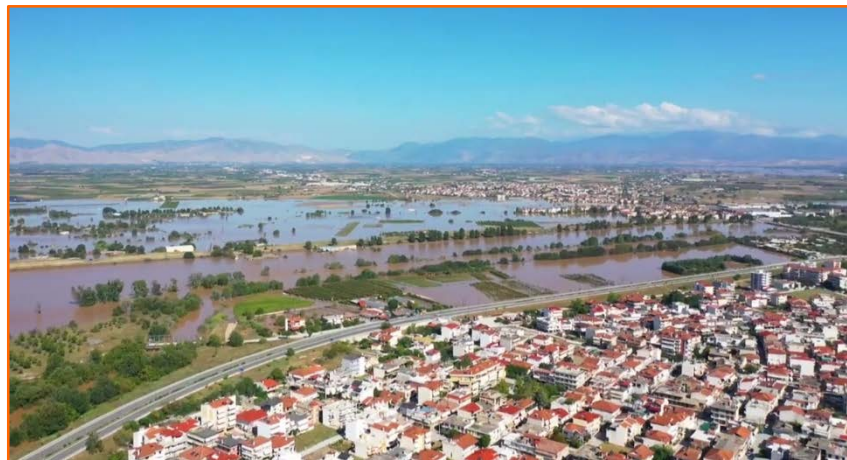
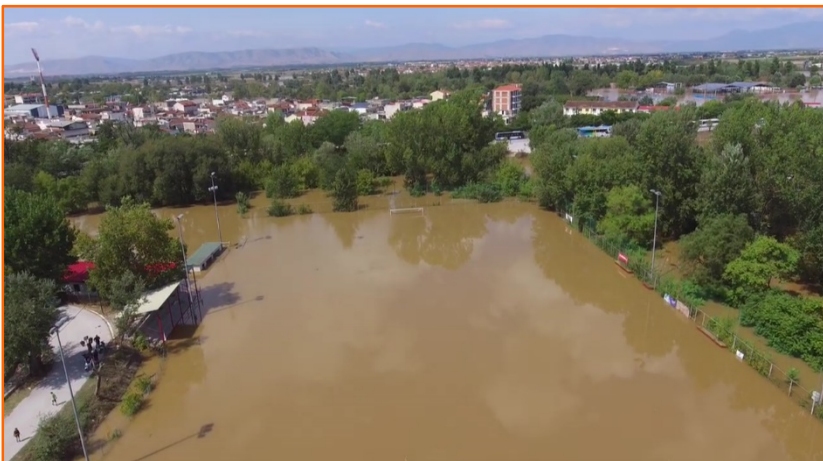
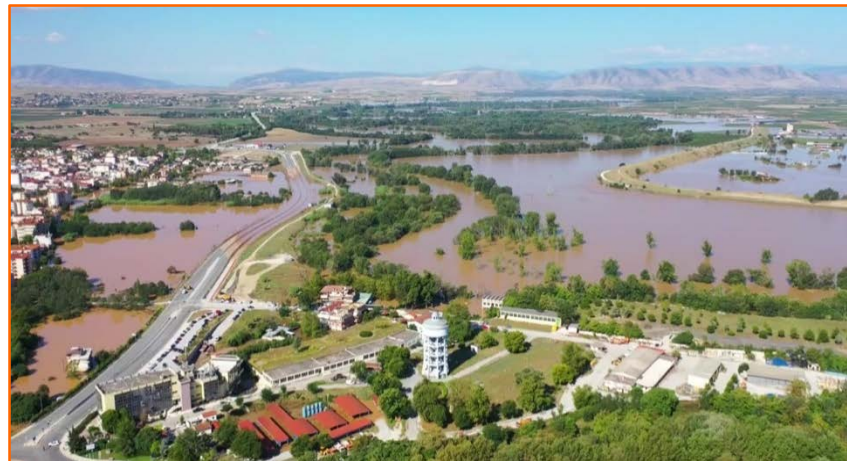
Larissa City, Tampakika and D.E.Y.A.L.
8 September 2023

Snapshots from drone videos presenting the flooded Tampakika and D.E.Y.A.L. districts located at the northern and western part of Larissa City respectively, both east of the overflowed Pineios River. (Video sources: <https://www.youtube.com/watch?v=3IE9JkKqbwQ> for Tampakika, <https://www.youtube.com/watch?v=z05Y84K41ts> for D.E.Y.A.L.)

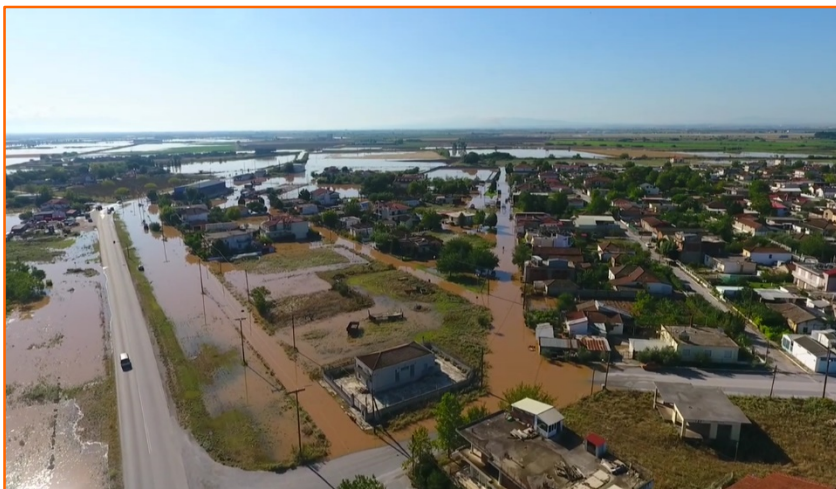
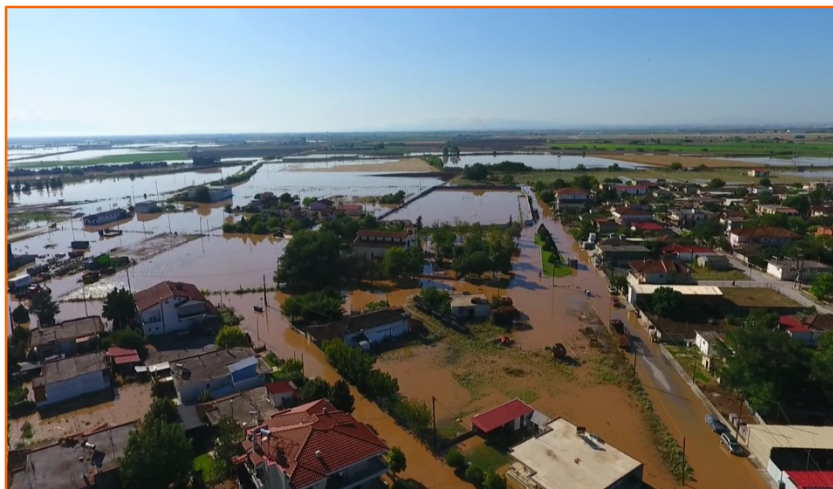
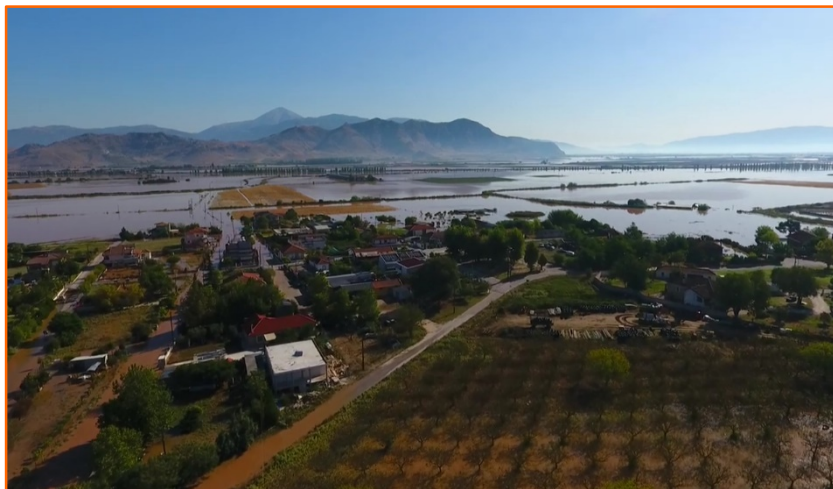
Larissa Regional Unit, Omorfochori
10 September 2023

Snapshots from a drone video presenting the flooded Omorfochori settlement located northeast of Larissa city and about 1 km east of the overflowed Pineios River.

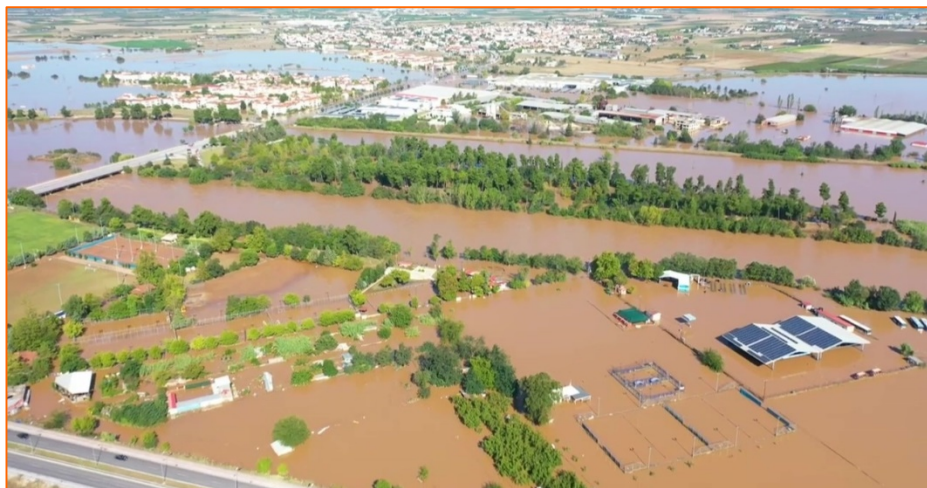
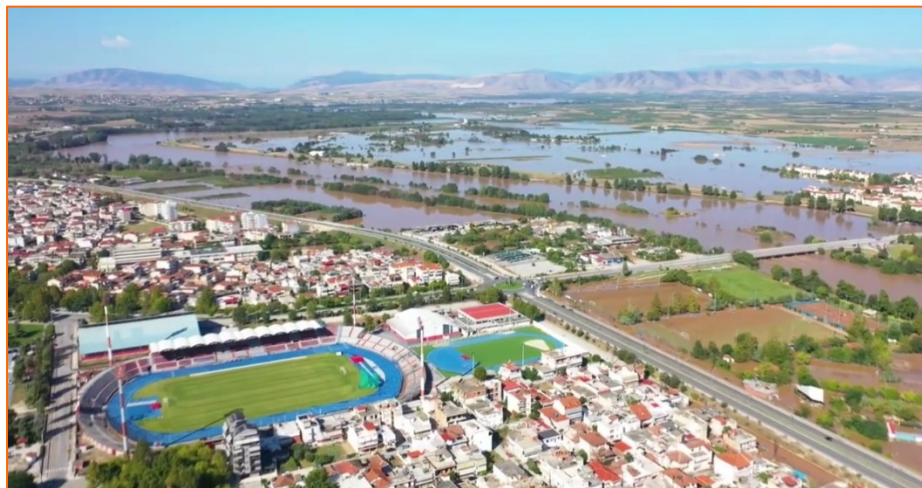
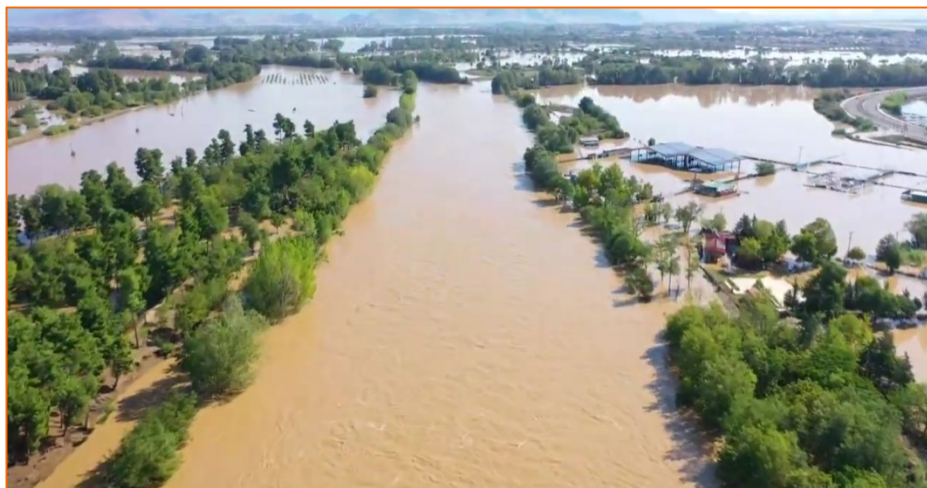
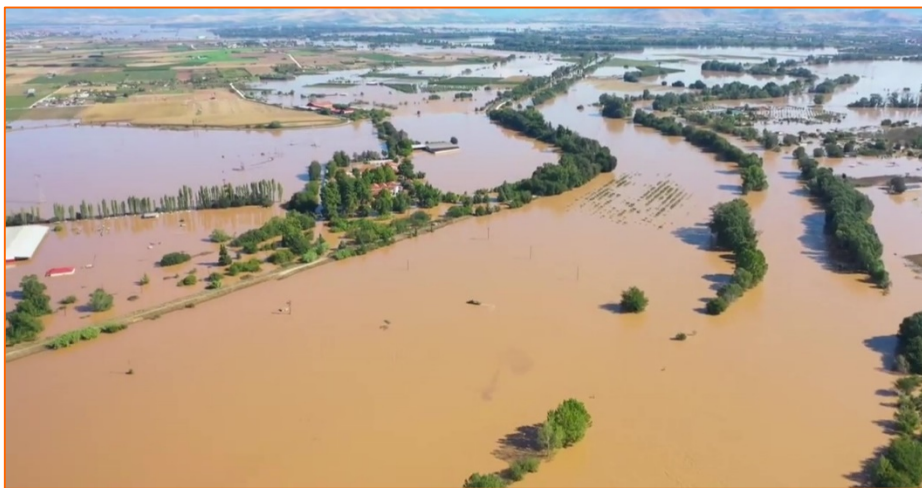
Larissa City, Giannouli District
11 September 2023

Snapshots from a drone video presenting the flooded Giannouli district located very close to overflowed tributaries of Pineios River at the southern part of Larissa City.
(Video source: <https://www.youtube.com/watch?v=z05Y84K41ts>)

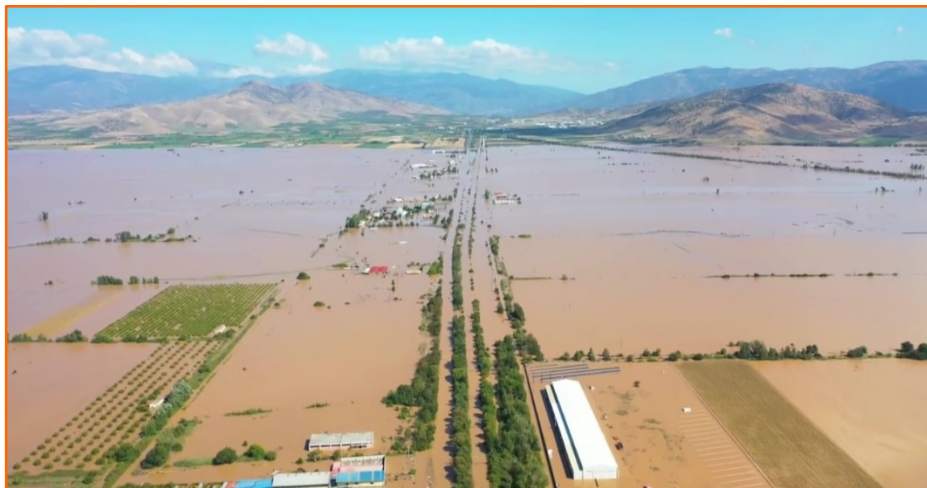
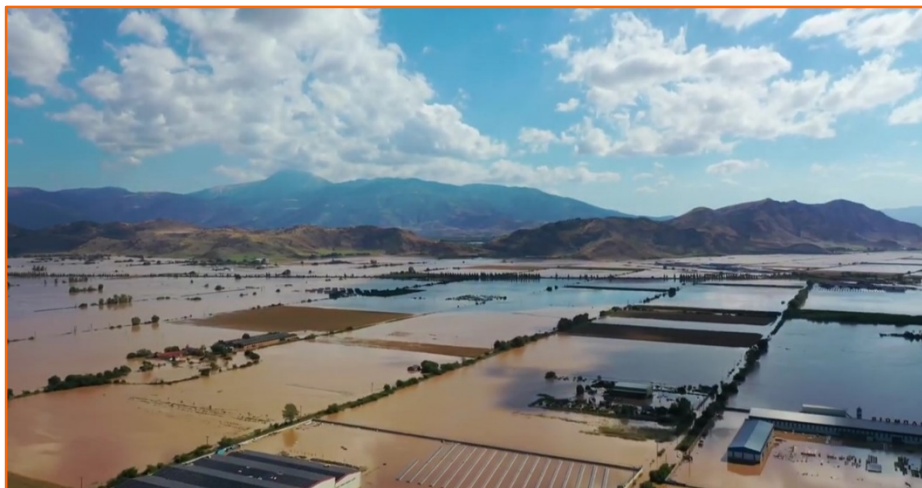
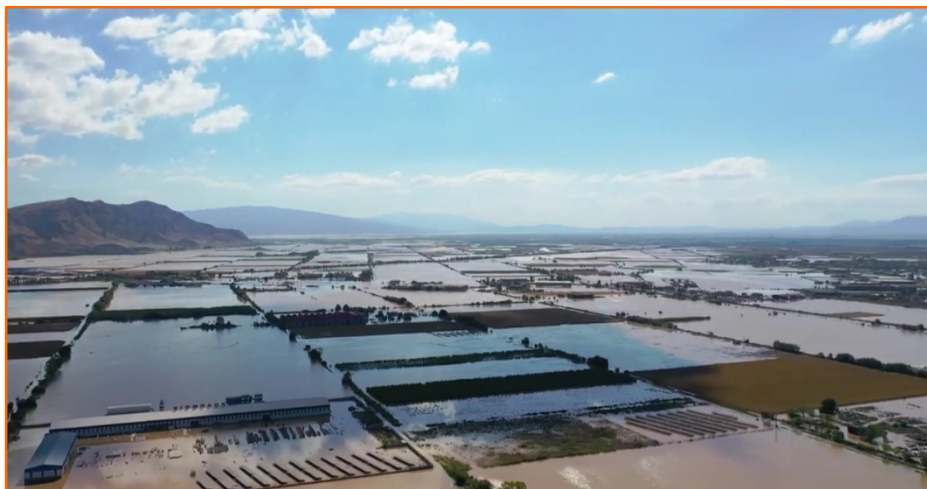
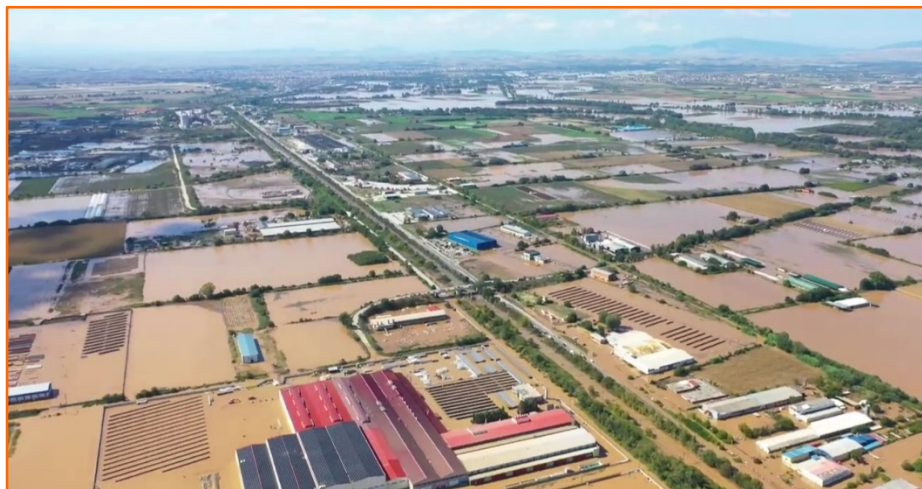
Larissa Regional Unit, Koulouri and Gyrtioni
11 September 2023

Snapshots from a drone video presenting the flooded Koulouri and Gyrtioni areas located north of Larissa City and very close to the overflowed Pineios River.
(Video source: <https://www.youtube.com/watch?v=z05Y84K41ts>)

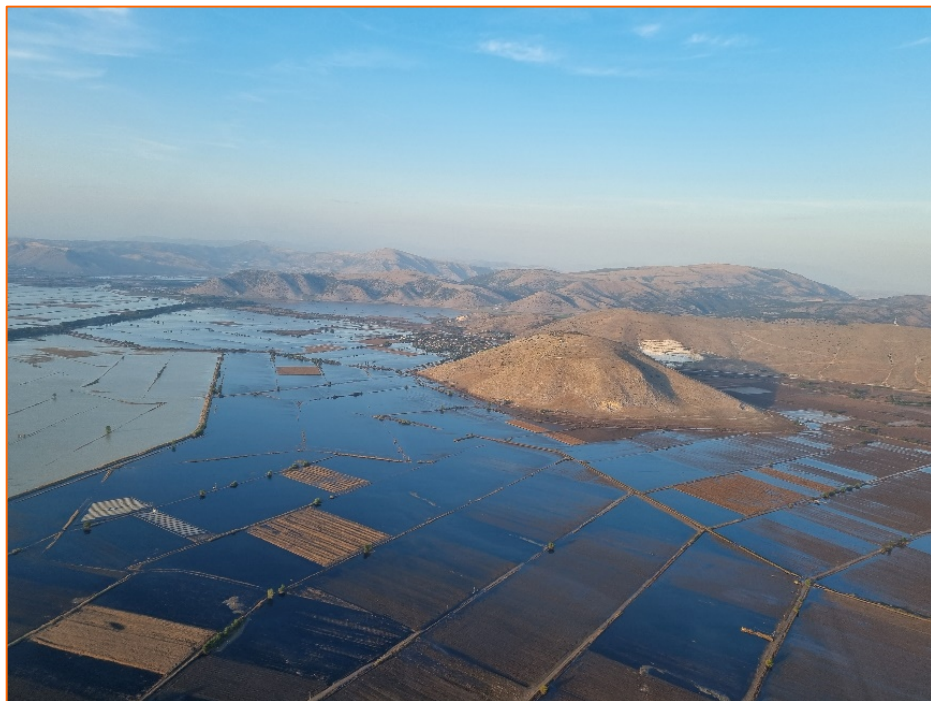
Thessalian Plain
1 October 2023

Flooded area between Marathea and Vlohos

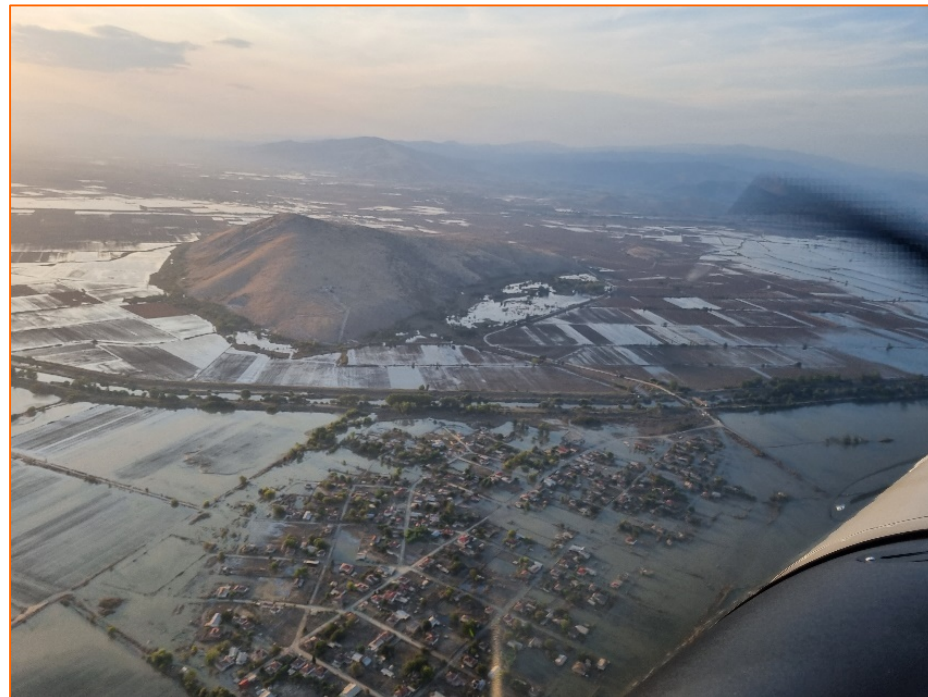
Flooded area in Metamorphosi
