Newsletter of **Environmental, Disaster, and Crises Management Strategies**

Issue No. 30 | January 2024

The early September 2023 Daniel storm in Thessaly Region (Central Greece)

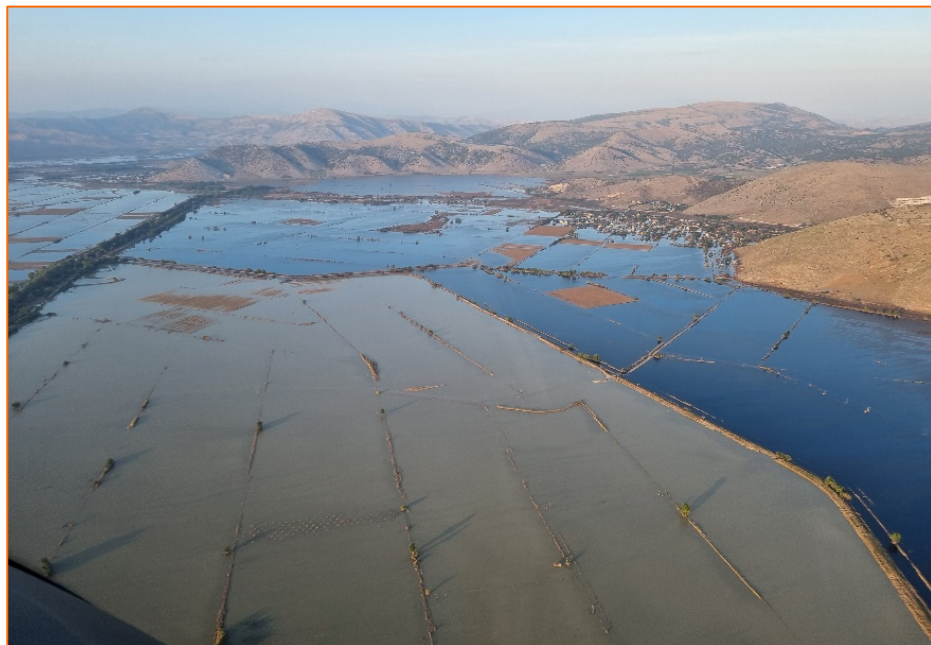
Thessalian Plain
1 October 2023

Flooded area between Marathea and Vlohos
(looking at Vlohos)

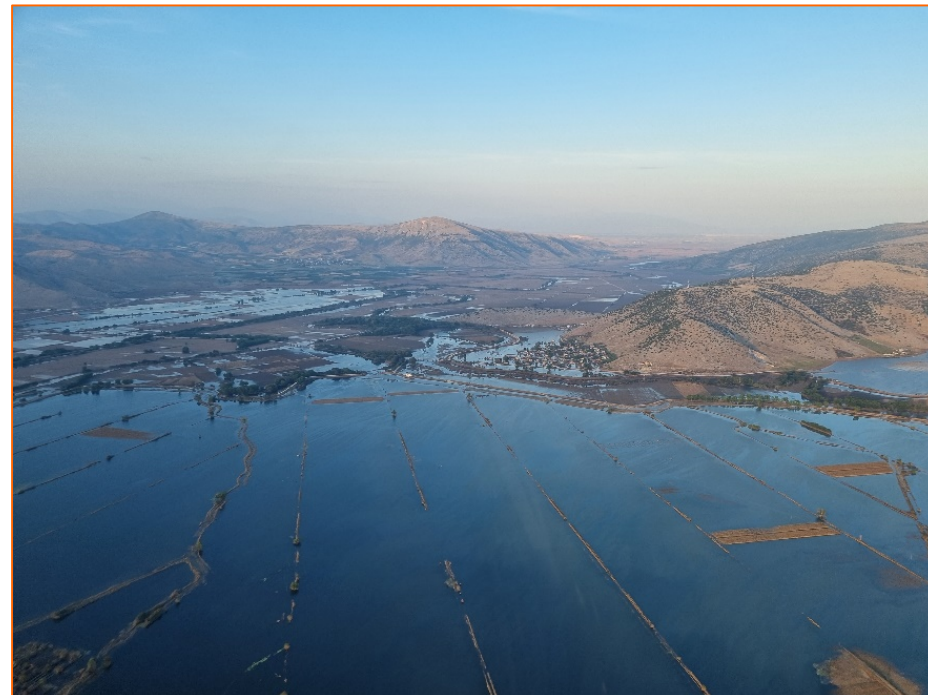
Flooded area in Keramidi village

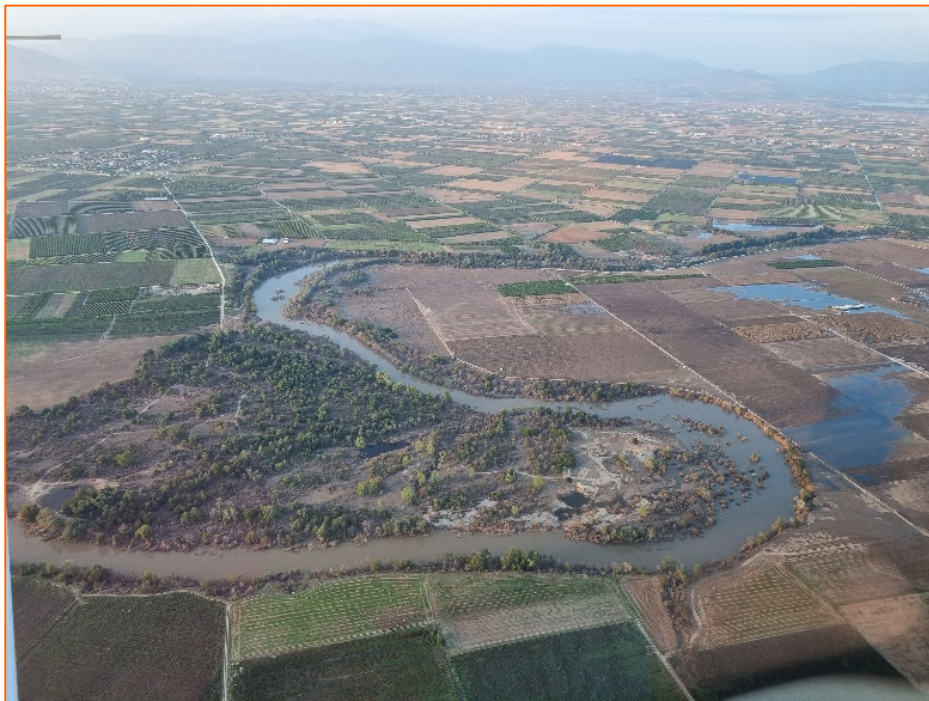
Thessalian Plain
1 October 2023

Inundation around Pineios River after recession
of the largest part of floodwaters

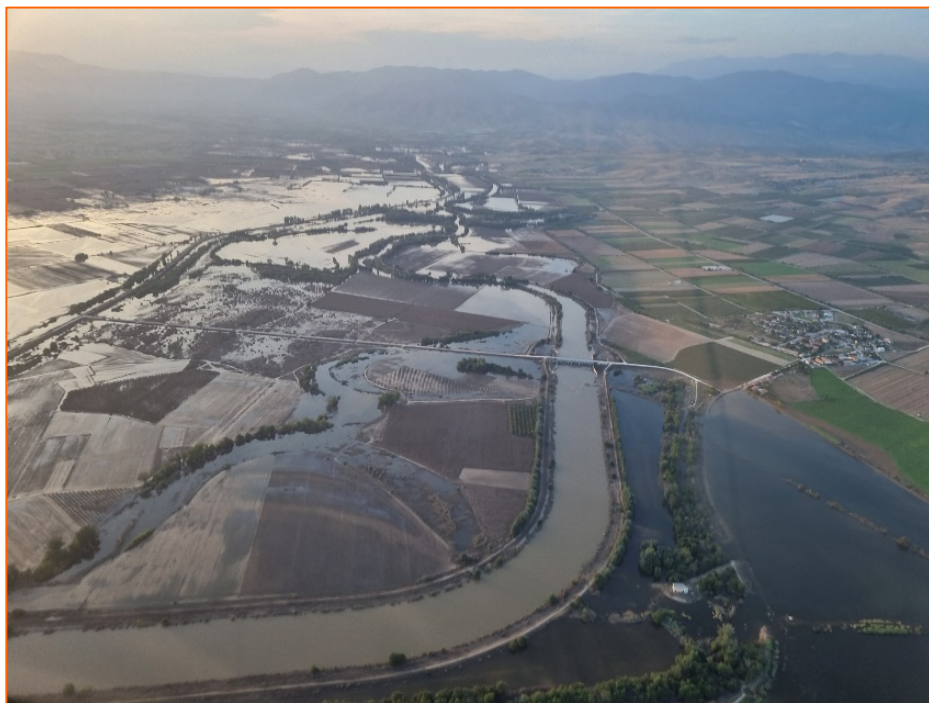
Thessalian Plain
1 October 2023

Inundation around Pineios River

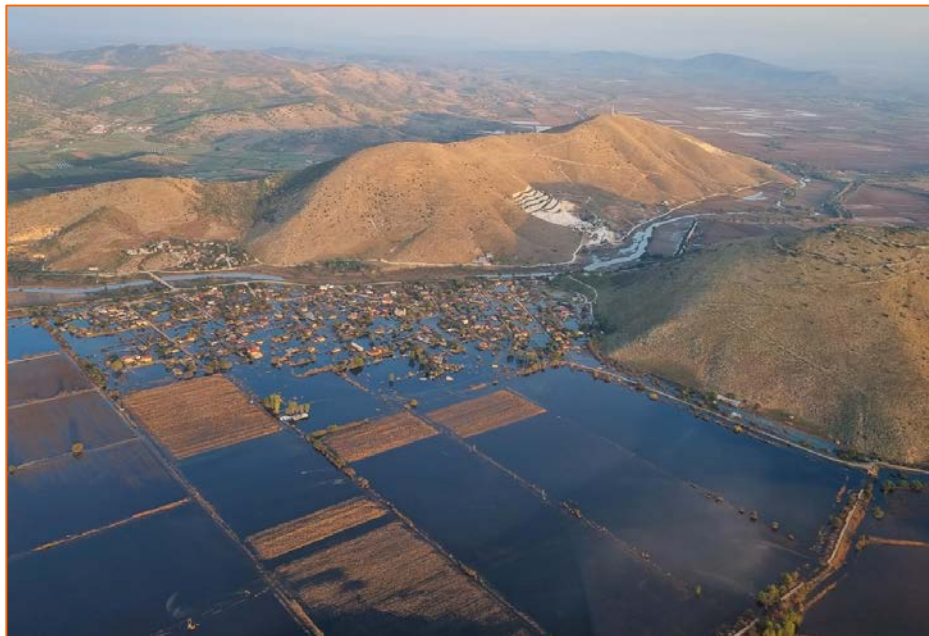
Thessalian Plain
1 October 2023

Flooded area of Enipeas in Vlohos

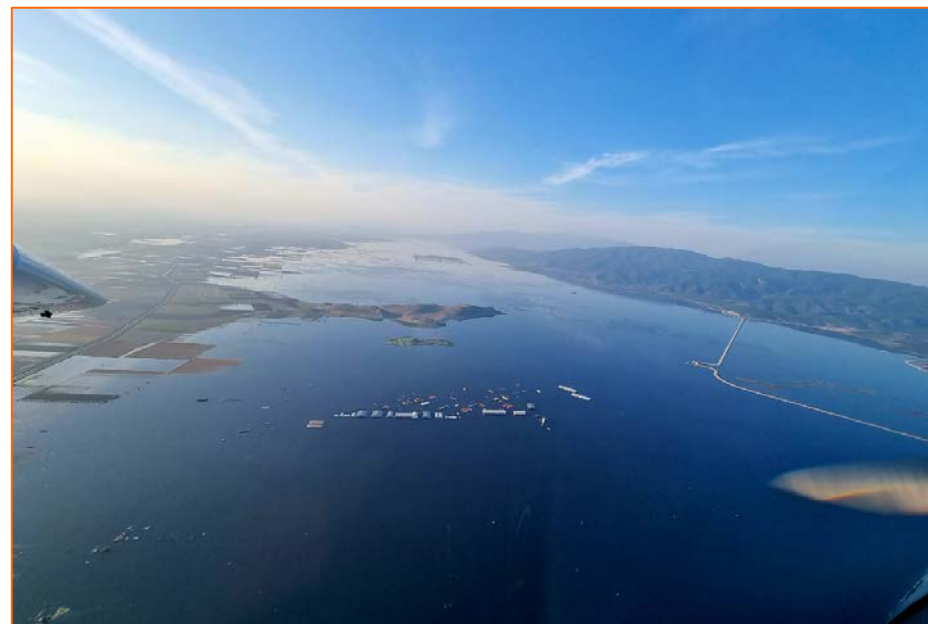
Flooded area of Karla Lake (looking North)

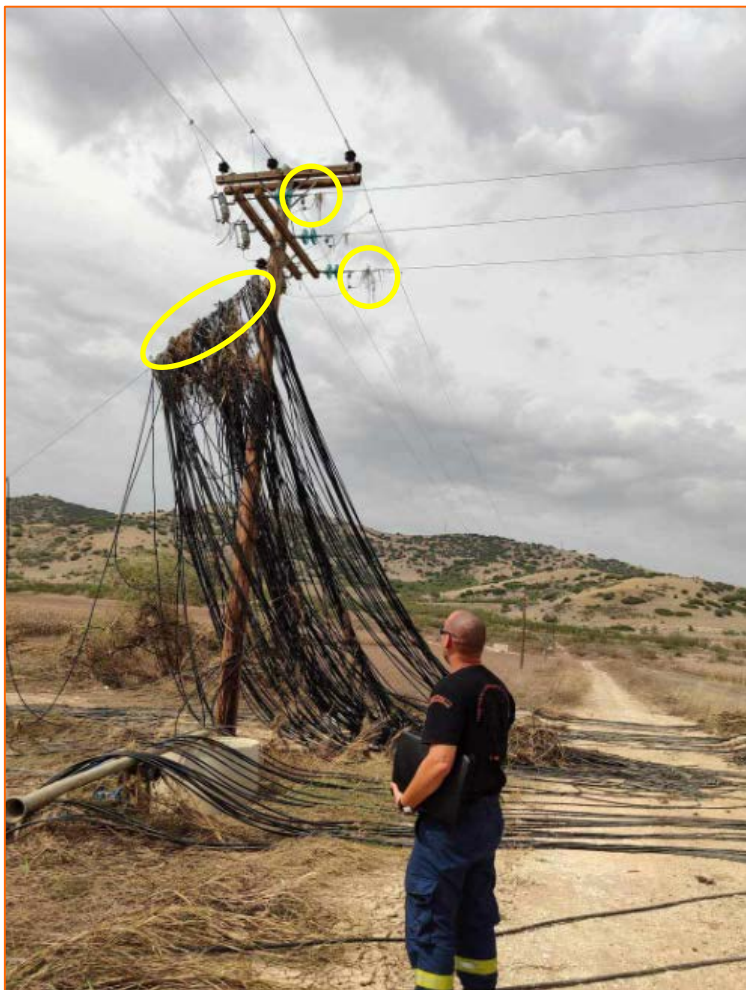
Flood water stage at about 9 m was determined in Pineiada area.
Photo credit: Stephanos Gogos (2023)

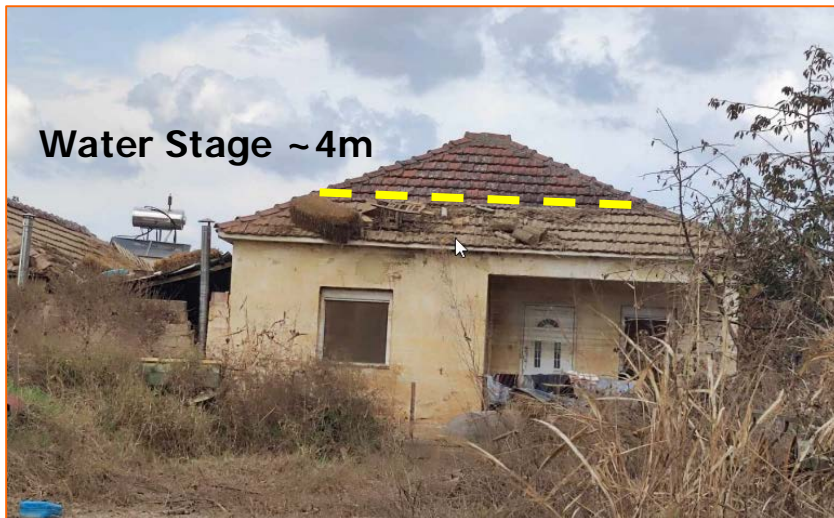
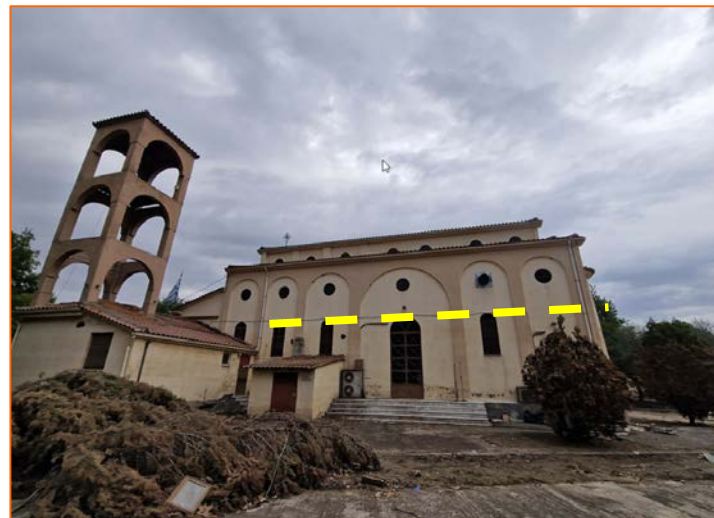
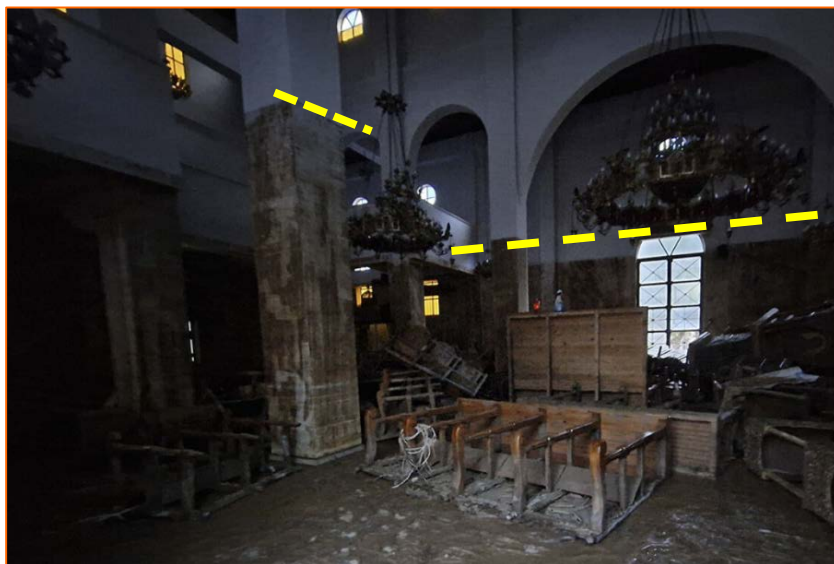
Flood water stage (yellow dashed line) at about 4 m was determined in Keramidi area.

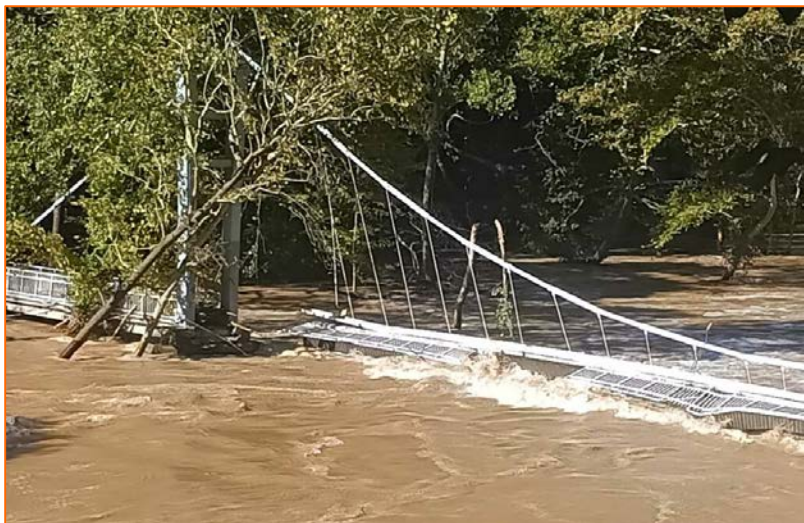
Floodwaters of Pineios River demolished the bridge in Tempi valley during the 2023 flood discharge reaching approximately a flood water depth of about 19-20m.

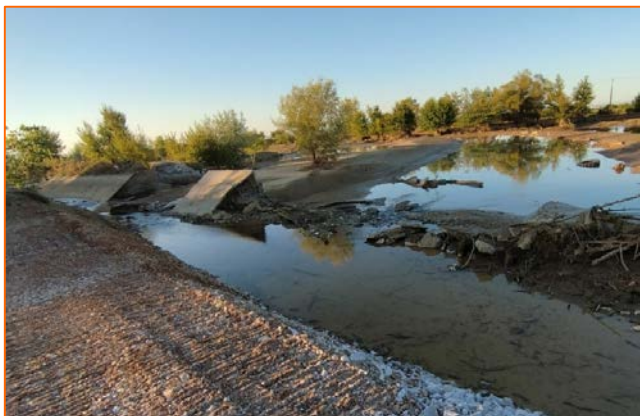
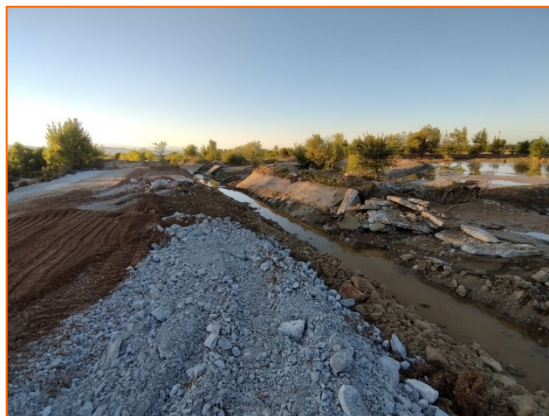
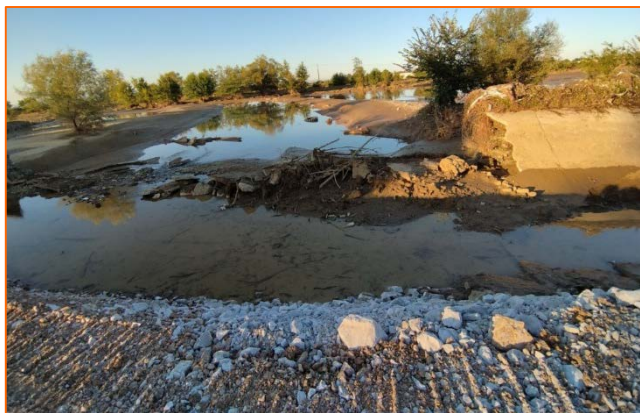
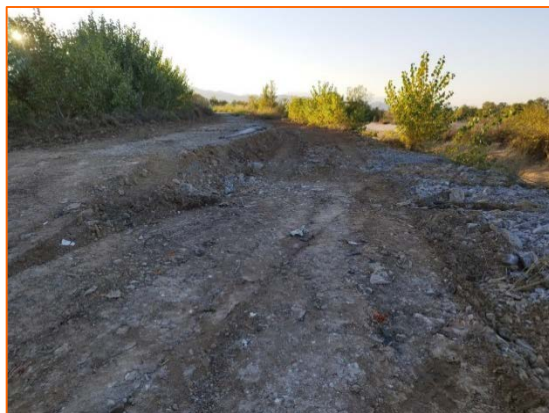
The dam / embankment about 80 meters long in Gavria stream, at Tsapocha, near the hospital of Karditsa, after the Chilia Dendra area, on the road to Metropolis, was shattered during flooding.

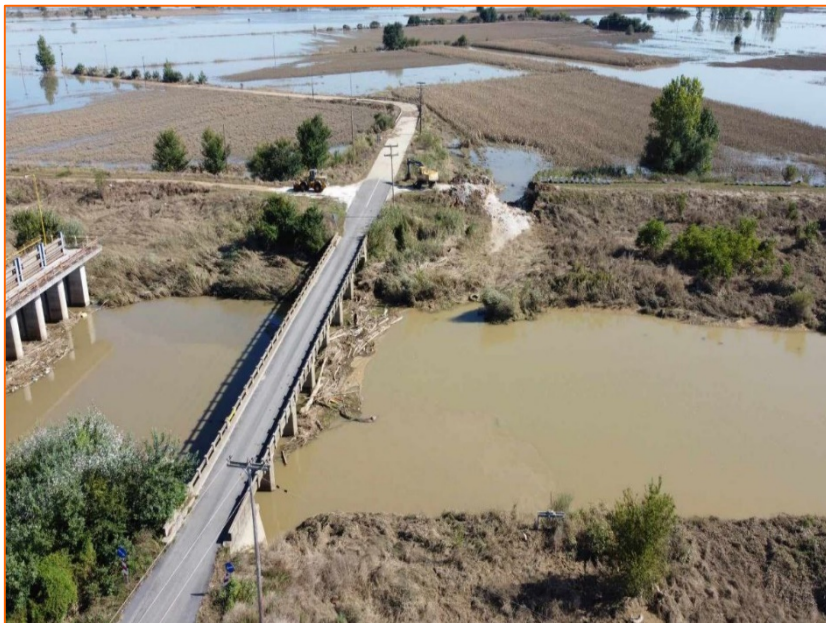
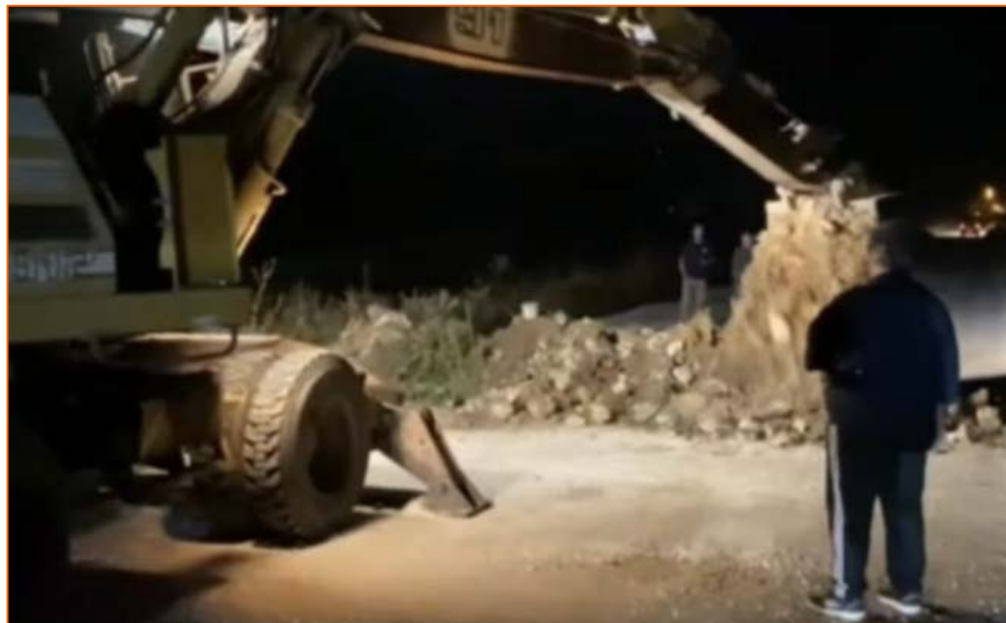
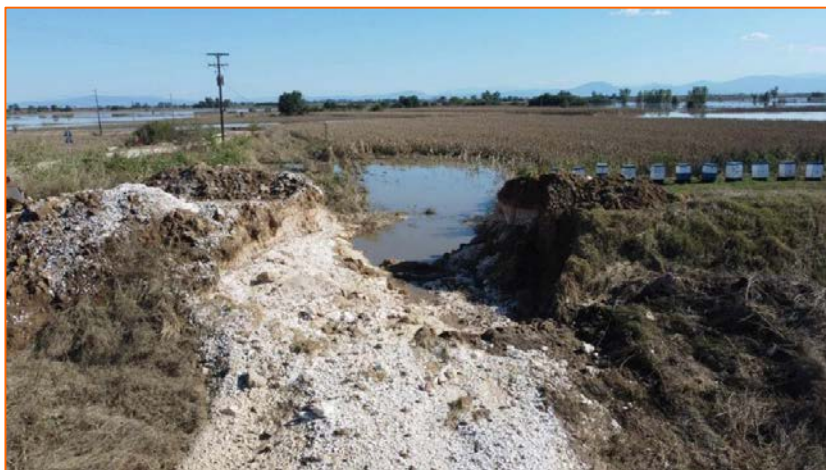
Excavators opened embankments on purpose in some instances to direct floodwaters to parts of the floodplain in order to lower water level in the main river (in last effort to avoid flooding in urban areas).

Characteristic views of structural failures of embankment close to Larissa city due to the intense flooding (left) and near Giannouli area (Larissa regional unit; right).

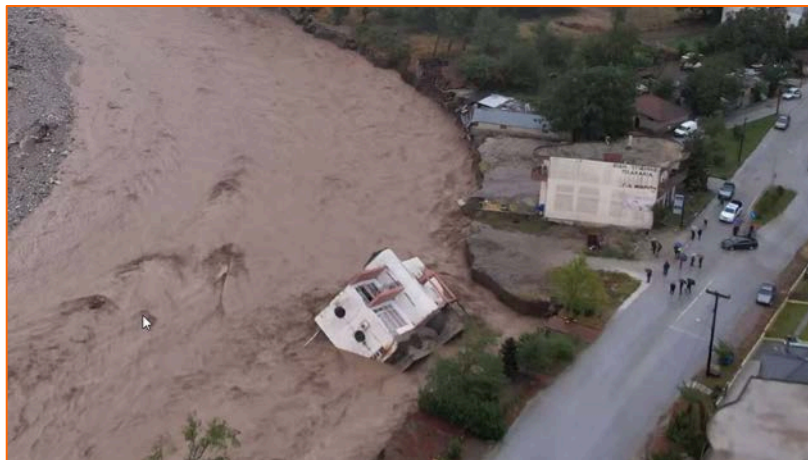
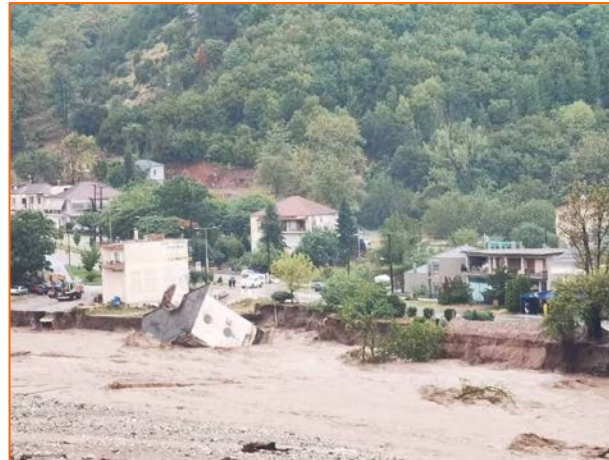
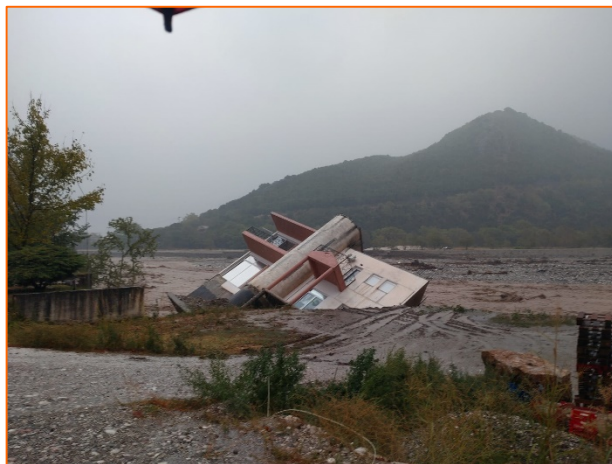
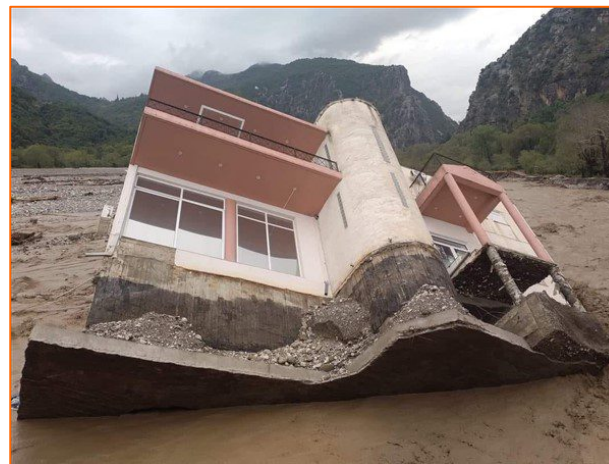
A reinforced concrete engineered building in Mouzaki built on the bank of Pamisos River was initially tilted and then overturned within the riverbed due to erosion and undercutting phenomena caused by the rushing river

A typical example of a heavily affected reinforced concrete building is the two-storey structure in Mouzaki (Karditsa Regional Unit). The Pamisos River caused severe erosion and undercutting on its

banks, causing the ground on which the building was founded to be washed away by the rushing water and the building to initially tilt and subsequently overturn within the riverbed.

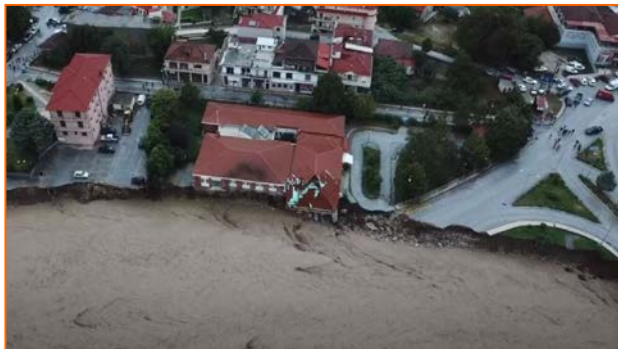
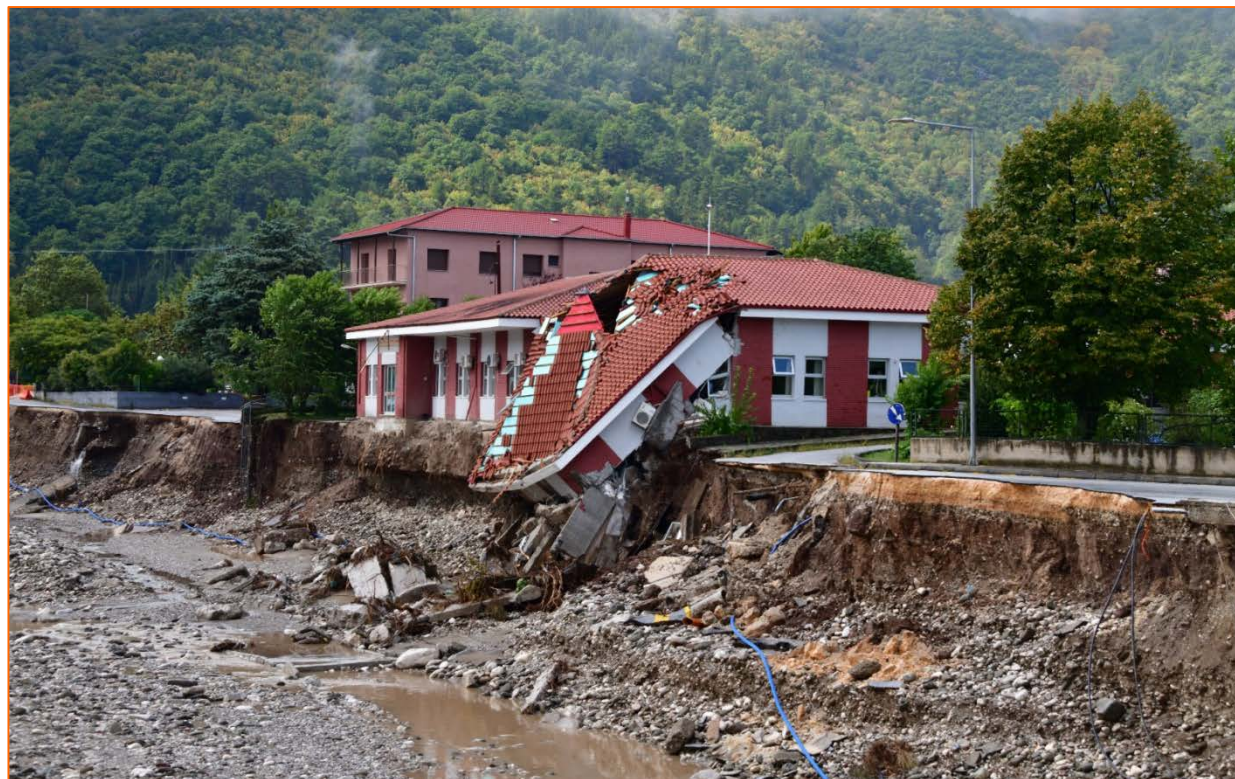
Ianos Medicane September 2020

Mouzaki was also affected

Similar effects were observed in the same settlement during the Ianos medicane in mid-September 2020. The Mouzaki health centre was located at a distance of 30 m from the river bank. Due to river erosion and subsidence phenomena along the banks, the Mouzaki Health Centre suffered a partial collapse, while the rest of the structure was on the verge of devastation.

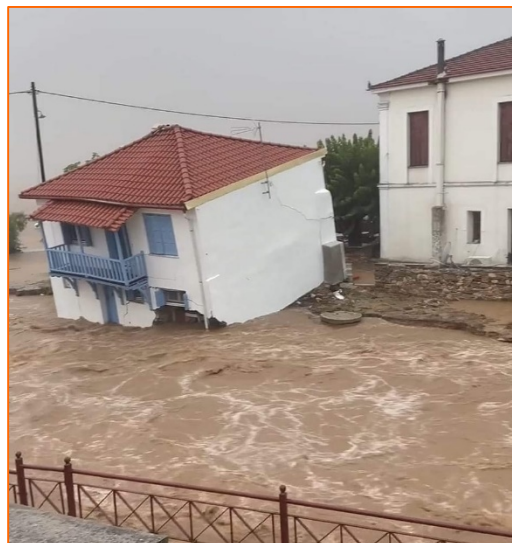
Similar impact on buildings was detected in the area of the settlement of Horto in Pelion, where a building constructed on the bank of a stream that crosses the settlement suffered severe erosion and undercutting of its foundations, causing it to tilt and be on the verge of total collapse.
Photos credit: Weather News Greece

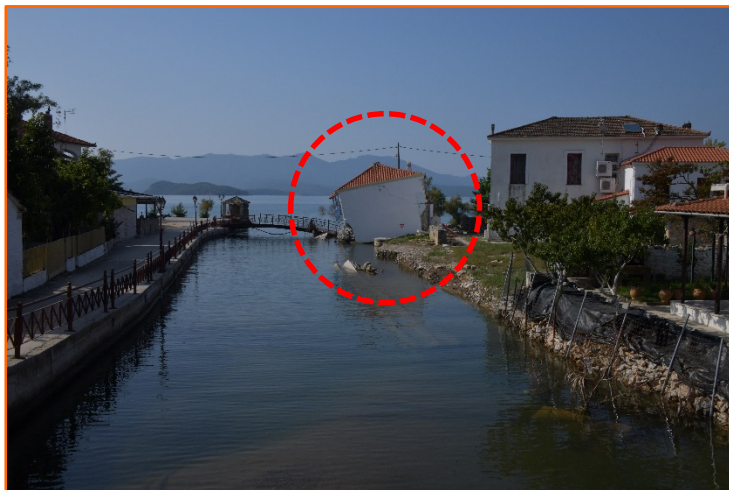
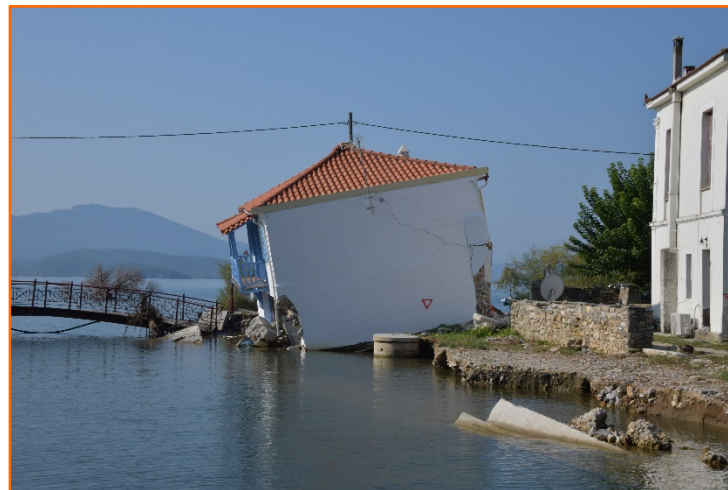
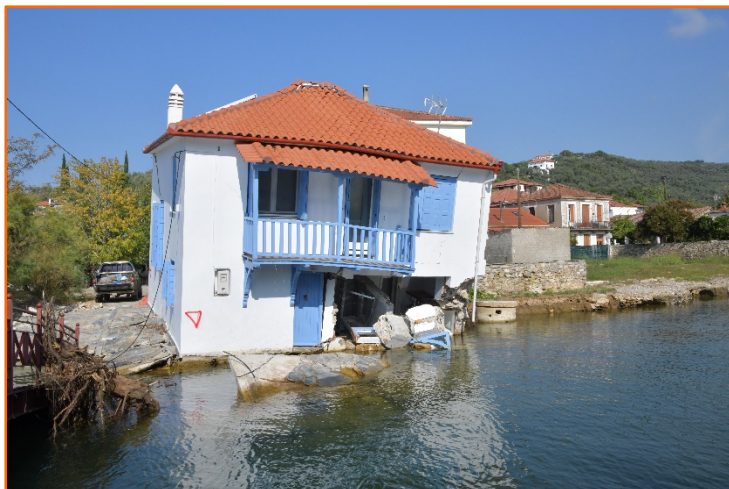
The building in the red dashed frame was marked red after flooding, which means to be demolished. Photos credit: Prof. Efthymis Lekkas

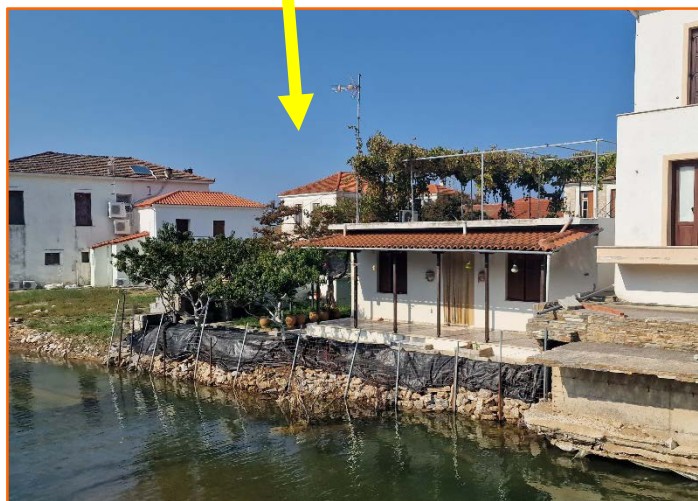
Similar impact on buildings was detected in the same area of Horto settlement on a building located upstream of the previous heavily affected one. In this case, the rushing stream caused erosion of the bank under the buildings constructed right next to the stream bed.

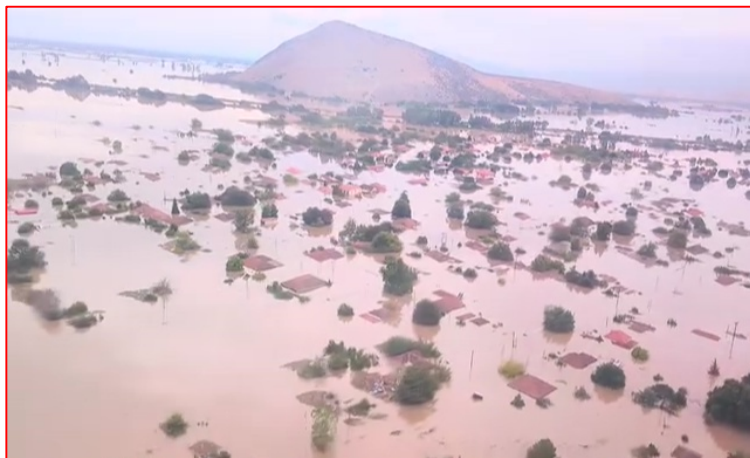
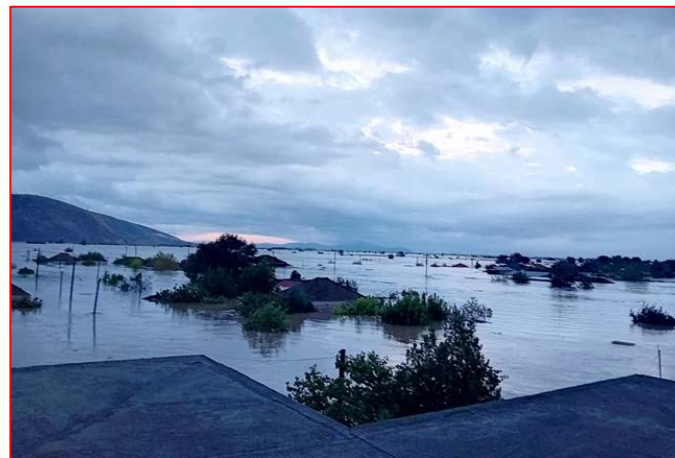
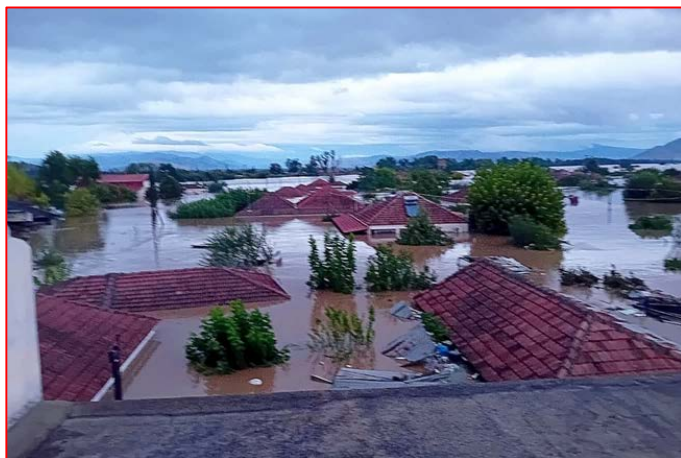
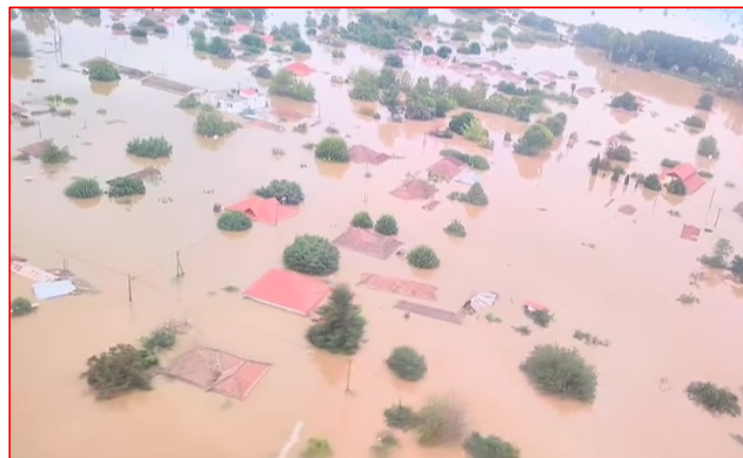
Many villages of the Thessalian plain stayed for several days under water. This fact greatly affected the performance of buildings with load-bearing masonry walls and particularly the adobe ones, which suffered heavy and very heavy structural damage including partial or total collapse.

During the flood phenomena, many of the buildings with load-bearing masonry walls (natural stones, baked bricks or adobes) that form part of the residential fabric of the mainly rural areas were inundated for several days by the flood waters. The water level reached in many cases either up to the roof of ground floor residential buildings or up to the first floor of multistory structures. The inundation of these residencies resulted in serious structural damage in many cases, leading to their partial or total collapse. The last case mainly refers to adobe buildings. These damage is attributed to the presence of clay in their structural elements and to the lithology of the deposits in the foundations and the surroundings of the houses. Clay is an important structural element in the older buildings at the region and a cementing agent that can provide protection even during a strong earthquake. However, when it erodes, it goes from being a good binder with strength to becoming slippery, losing its strength and creating stability problems, which are attributed either to its destruction as a binder or to deformation in the foundation of the buildings and the surrounding area.

When it gets wet, it loses its strength and creates stability problems in the building that are attributed either to its destruction as a cementing agent or to deformation phenomena in the foundation of the buildings and the surrounding area. This deformation including bulge, subsidence, etc. has a high potential to cause significant structural damage to buildings and infrastructure including partial or total collapse.

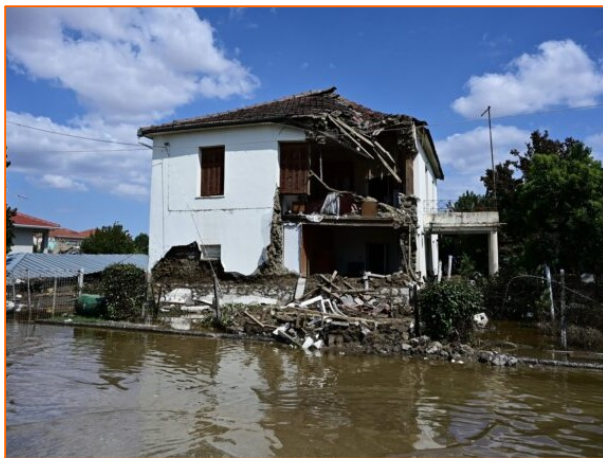
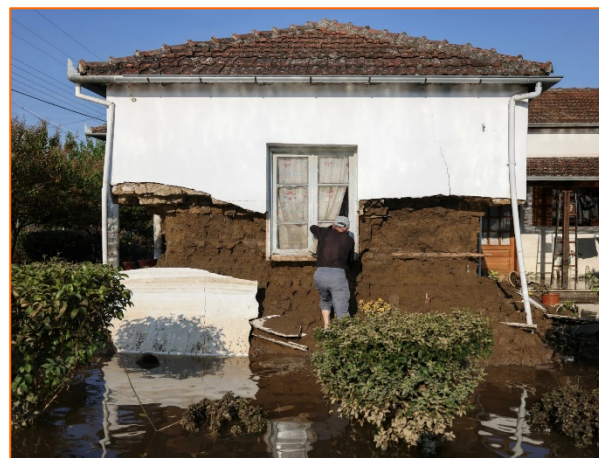
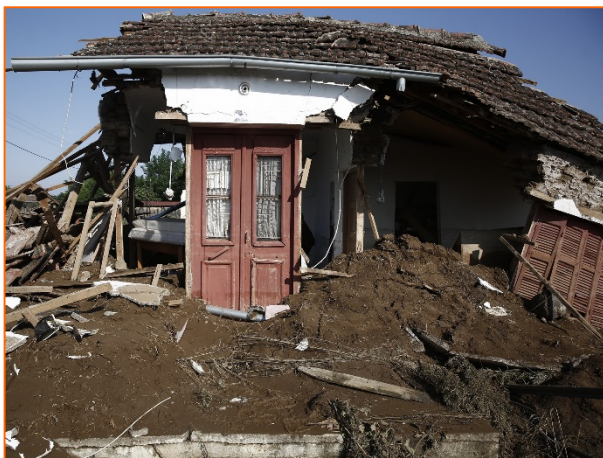
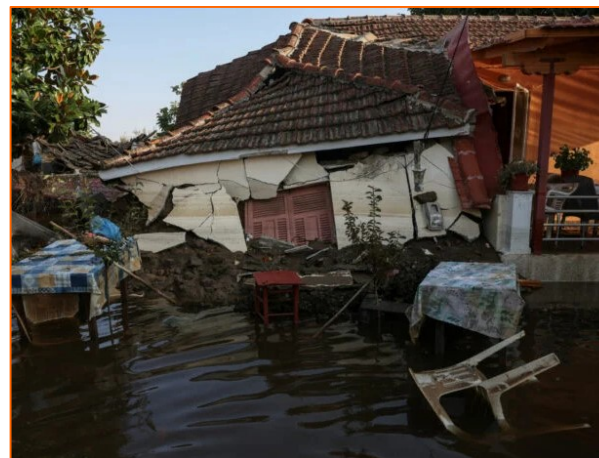
Characteristic views of the flood-induced damage caused in several villages of Thessaly. The observed damage is mainly attributed to inundation and the high water stage of the area that adversely affected not only the buildings but also their foundation area. The majority of those buildings are non-engineered.

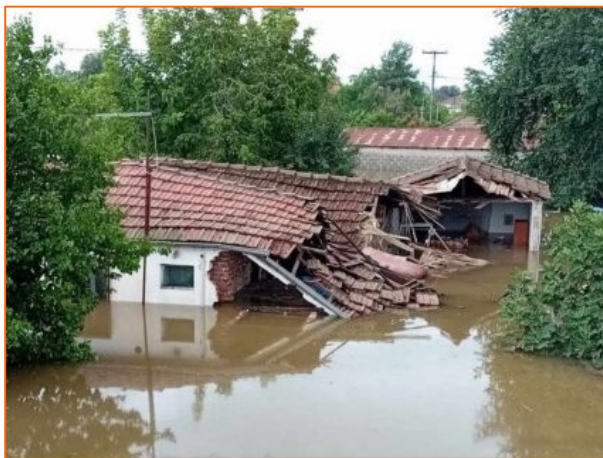
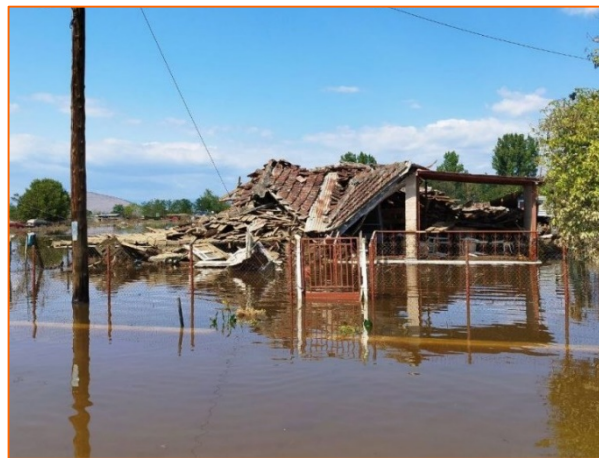
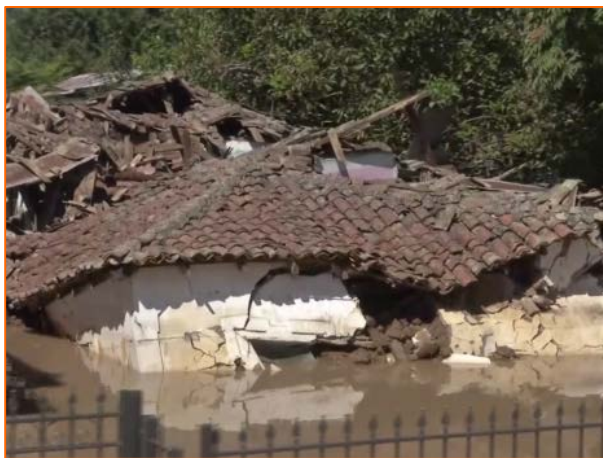
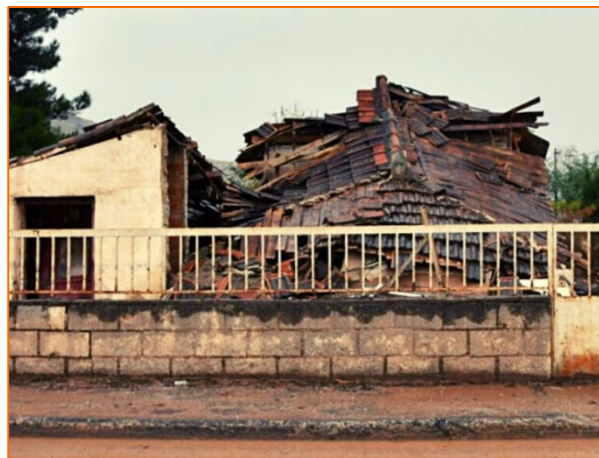
IMPACT OF FLOODS ON THE BUILT ENVIRONMENT DAMAGE TO BUILDINGS

Characteristic views of the flood-induced damage caused in several villages of Thessaly. The observed damage is mainly attributed to inundation and the high water stage of the area that adversely affected not only the buildings but also their foundation area. The majority of those buildings are non-engineered.

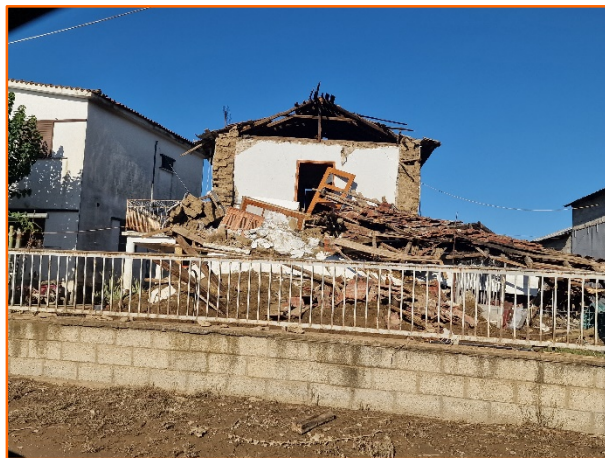
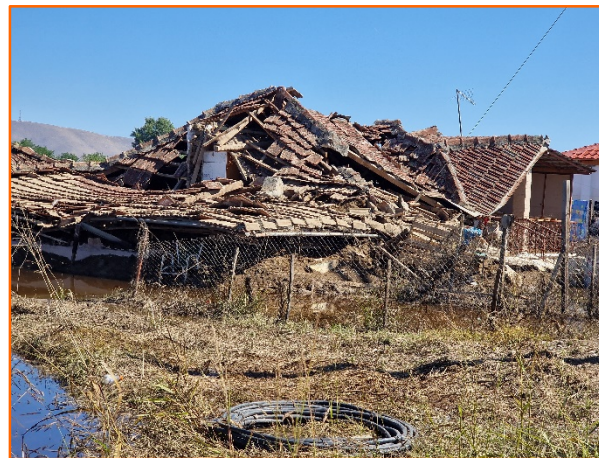
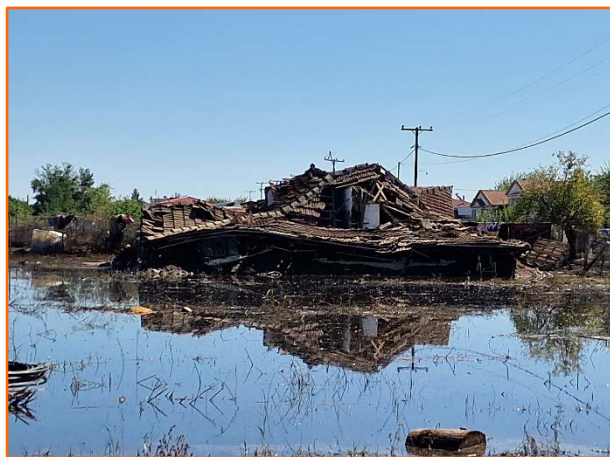
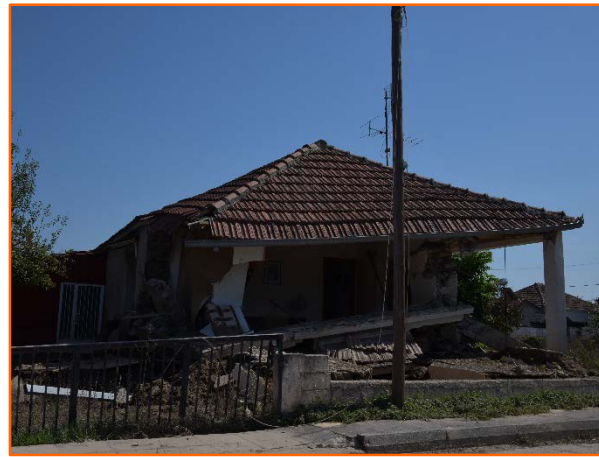
IMPACT OF FLOODS ON THE BUILT ENVIRONMENT DAMAGE TO BUILDINGS

Characteristic views of the flood-induced damage caused in several villages of Thessaly. The observed damage is mainly attributed to inundation and the high water stage of the area that adversely affected not only the buildings but also their foundation area. The majority of those buildings are non-engineered.

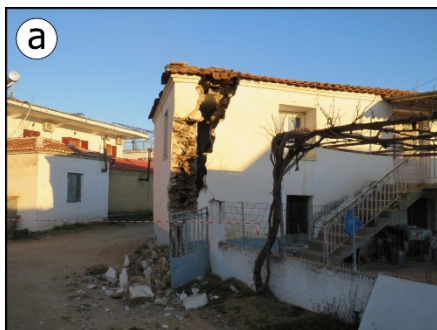
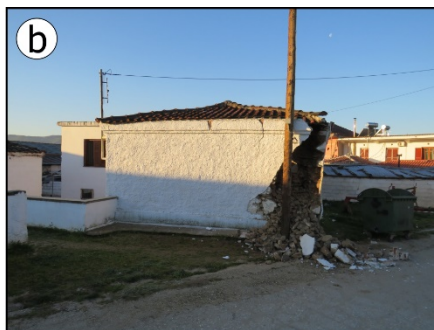
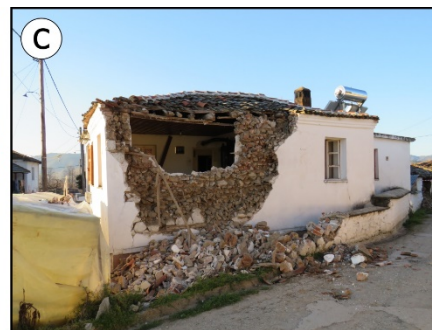
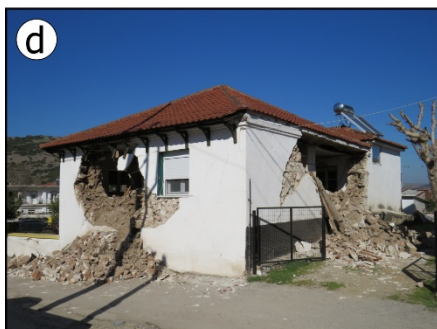
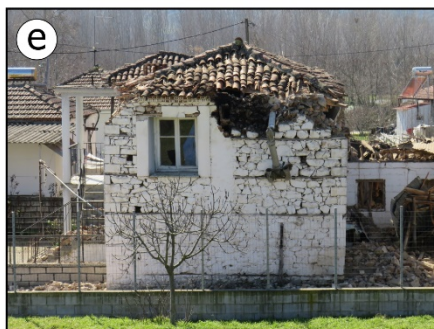
(a, b) Mesochori village

(c, d) Mesochori (c) and
Damassi (d) villages

(a, b) Vertical cracks and gaps were frequently formed and propagated along the height of the bearing wall intersections. (c, d) Failures of the upper part of the walls were also attributed to the interaction of roof structure and perimeter walls. (e, f) Damage were also attributed to poor mortar and poor workmanship resulting in partial or total collapse. (Mavroulis et al., 2021)

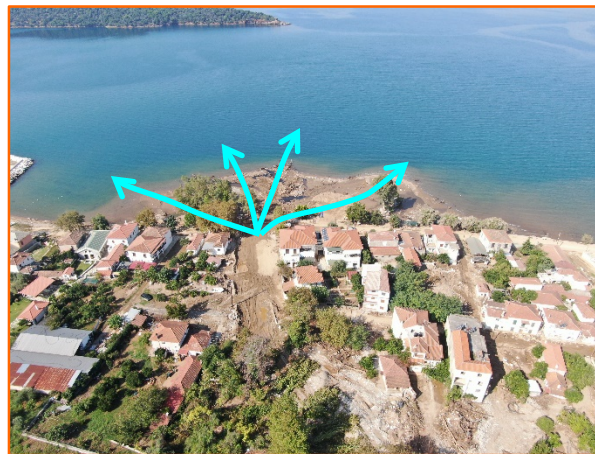
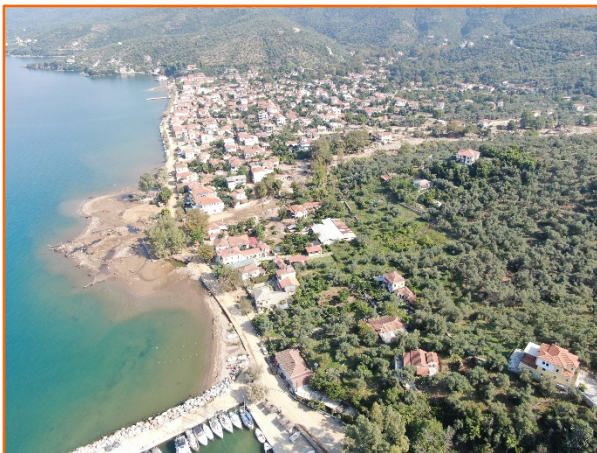
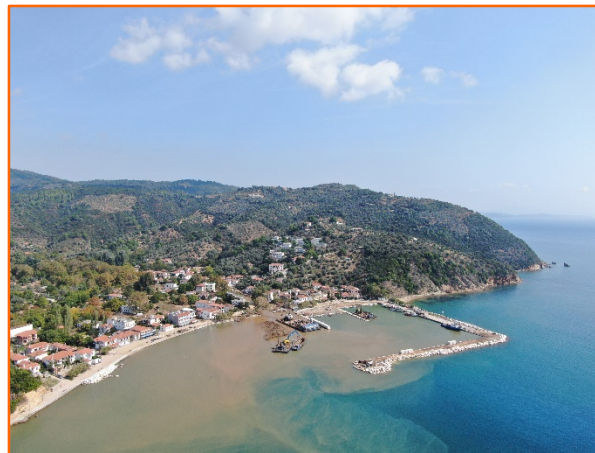
IMPACT ON THE COASTAL ENVIRONMENT INCREASE OF SUSPENDED MATTER AND FLOOD DEPOSITS IN DELTAS

A typical case of the impact of flooding along the coastline in Milina area of Magnesia Regional Unit. Flood debris and deposits were concentrated in the stream estuary located in the southern part of the settlement and altered the port bathymetry. Photos credit: Prof. Efthymis Lekkas.

Flood debris and deposits were concentrated in the stream estuary located in the southern part of Milina settlement and altered the port bathymetry. Special crews removed the deposits in order to reopen the port and ensure the safety of maritime transport. Photos credit: Prof. Efthymis Lekkas.

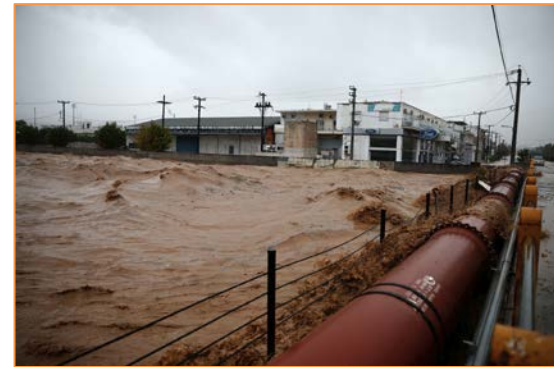
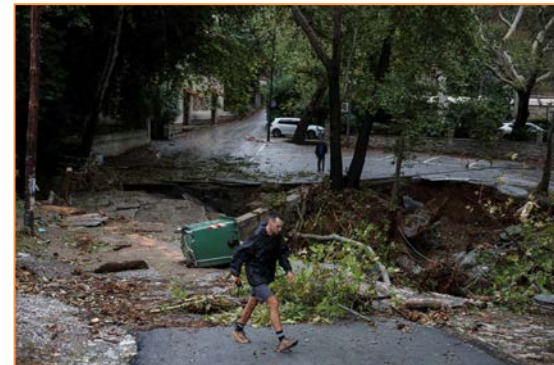
Impact on bridge in Volos and on road in Ano Meria.
Source: <https://www.ertnews.gr/eidiseis/ellada/poia-einai-i-katastasi-sto-odiko-diktyo-tis-thessalias/>

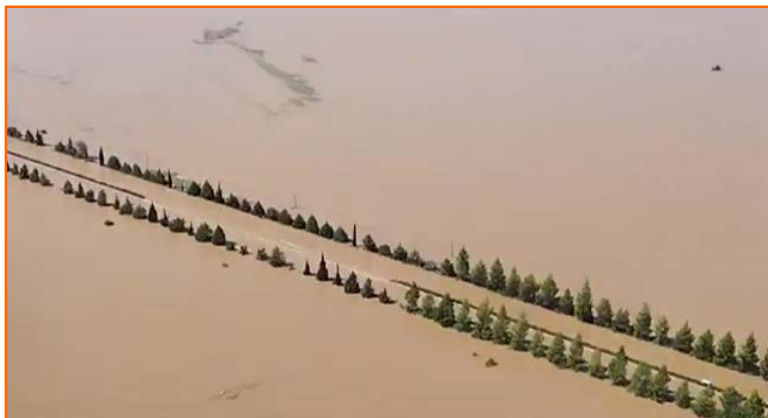
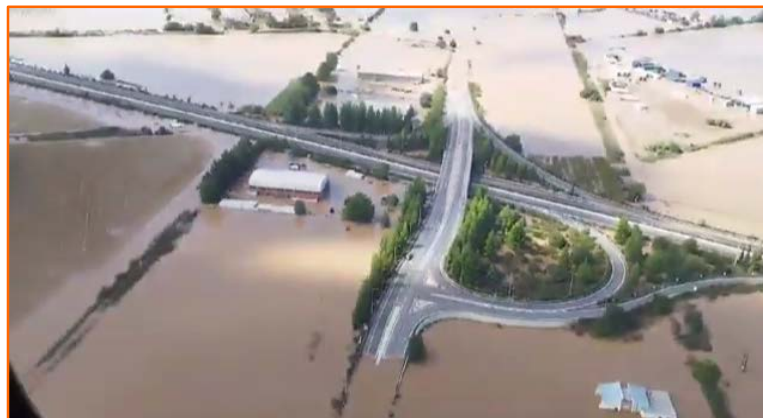
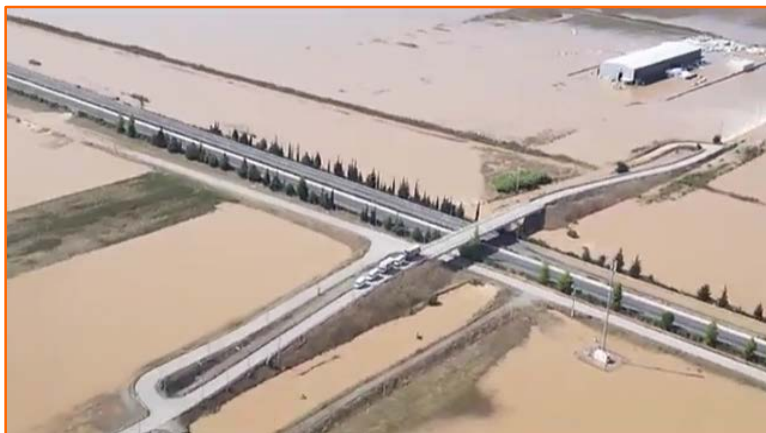
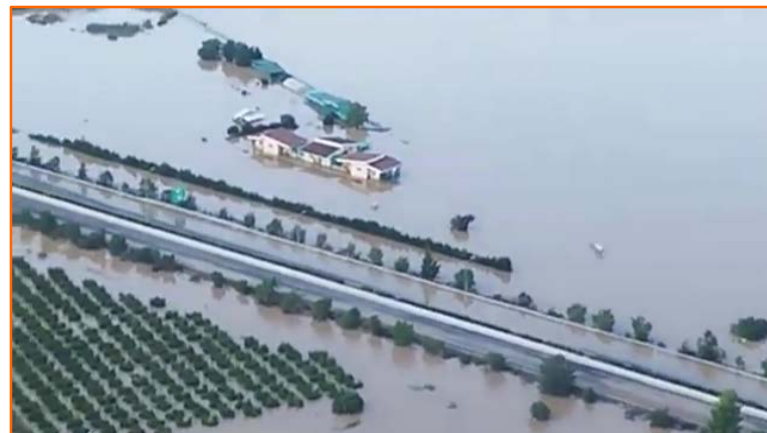
IMPACT OF FLOODS ON THE ROAD NETWORK THE THESSALONIKI – LARISSA HIGHWAY AFTER THE TEMPI GORGE

The National Road Thessaloniki-Larissa after the Tempi gorge, as mapped by the "Aegean Motorway" company, which manages this section. The road surface and the adjacent agricultural land have been inundated by flood waters. What testifies to the existence of a road are the rows of trees on the margins of the road as well as the vegetation on the dividing line between the different directions. Photos credit: Aegean Motorway. Source: <https://www.youtube.com/watch?v=ZetW7PP7Nts>
