Newsletter of **Environmental, Disaster, and Crises Management Strategies**

Issue No. 30 | January 2024

The early September 2023 Daniel storm in Thessaly Region (Central Greece)

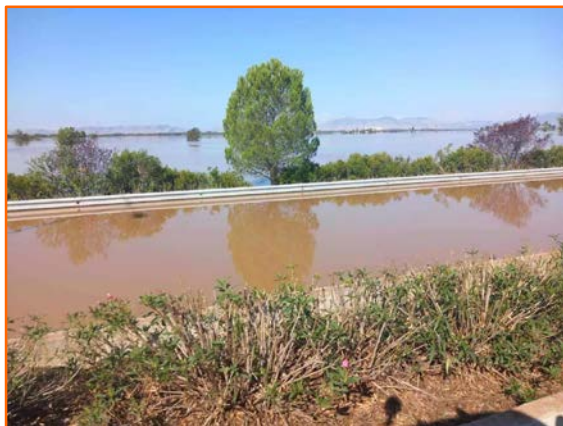
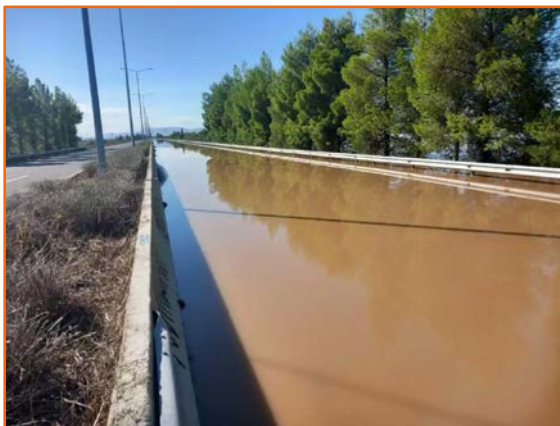
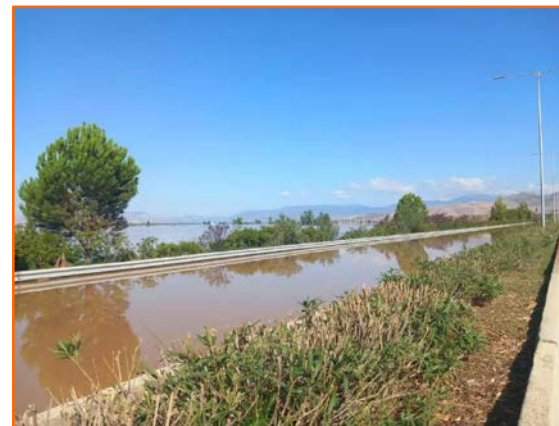
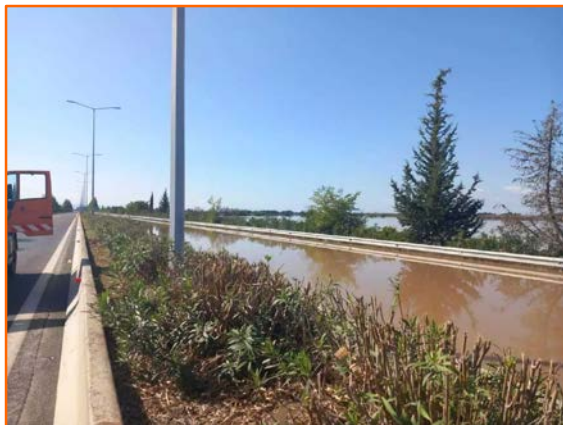
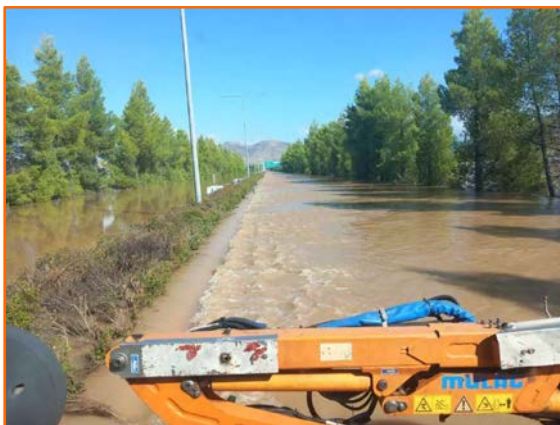
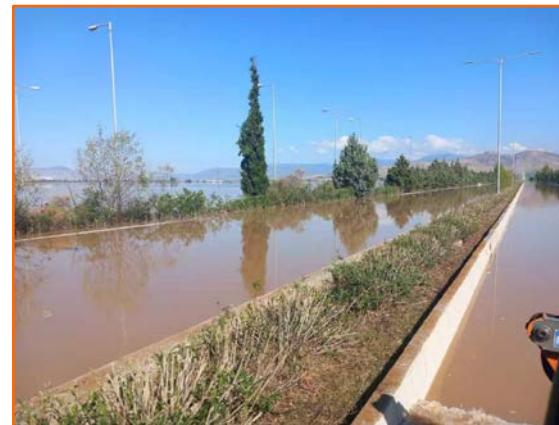
IMPACT OF FLOODS ON THE ROAD NETWORK **THE THESSALONIKI – LARISSA HIGHWAY AFTER THE TEMPI GORGE**

The Thessaloniki-Larissa National Road after the Tempi gorge. The road surface and the adjacent agricultural land have been inundated by flood waters. What testifies to the existence of a road are the rows of trees on the margins of the road as well as the vegetation on the dividing line between the different directions. Source: <https://www.iefimerida.gr/ellada/ethniki-odos-larisas-thessalonikis-adiabati-tempi>

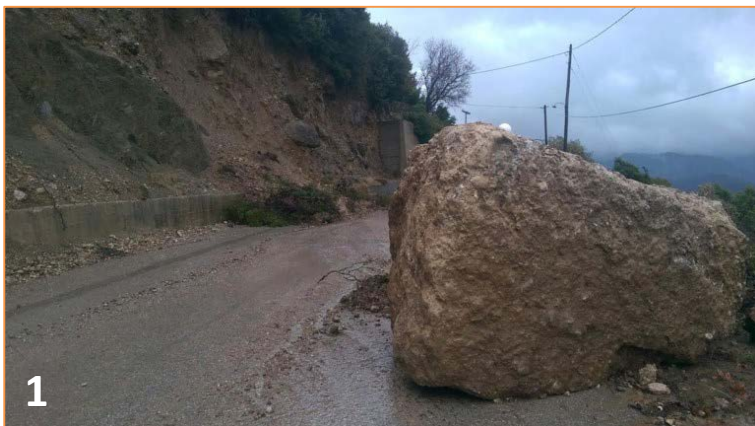
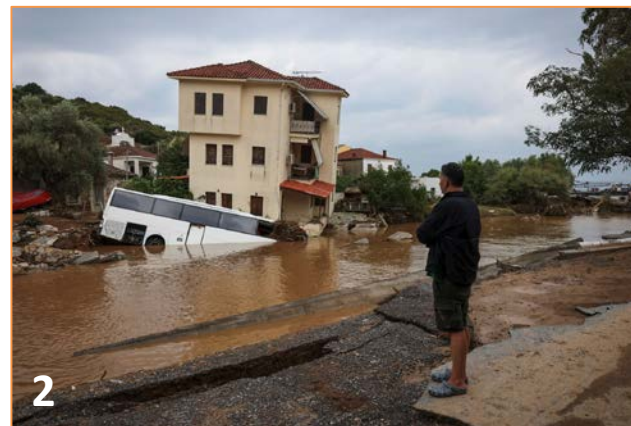
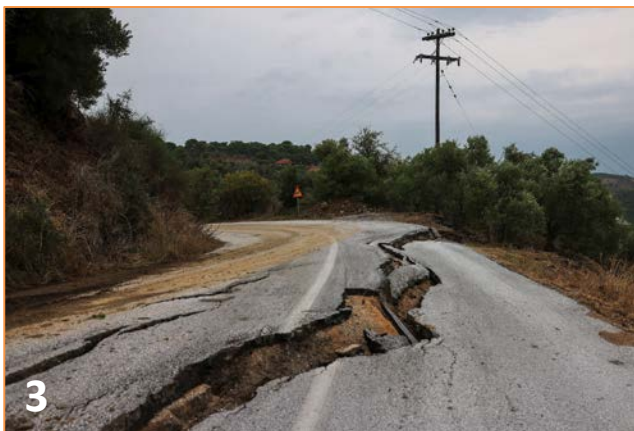
IMPACT ON INFRASTRUCTURE DAMAGE ON ROAD NETWORK – COUNTRY ROADS

- (1) Landslide in 5th km of Volos-Agria road (Photo credit: THETOC TEAM)
- (2) Destruction of a road by flooding (Alexandros Avaramidis, REUTERS)
- (3) Destruction of the road surface in Makrynitsa (Pelion) (Human Stories)
- (4) Damage to road attributed to intense erosion and along the road in Platanias village (Alexandros Avaramidis, REUTERS)

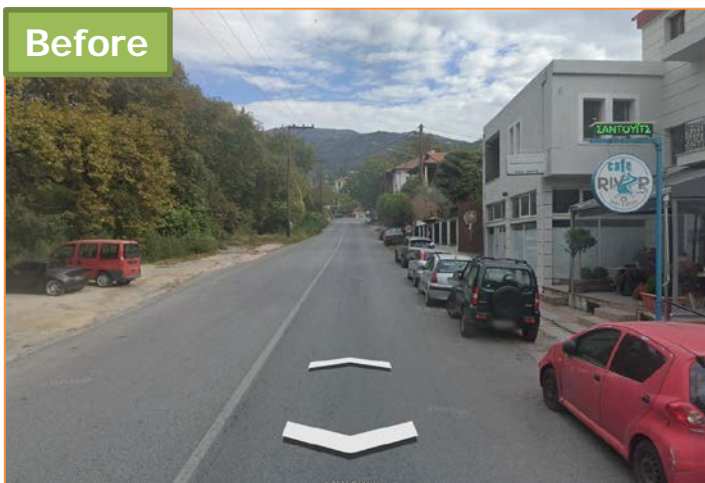
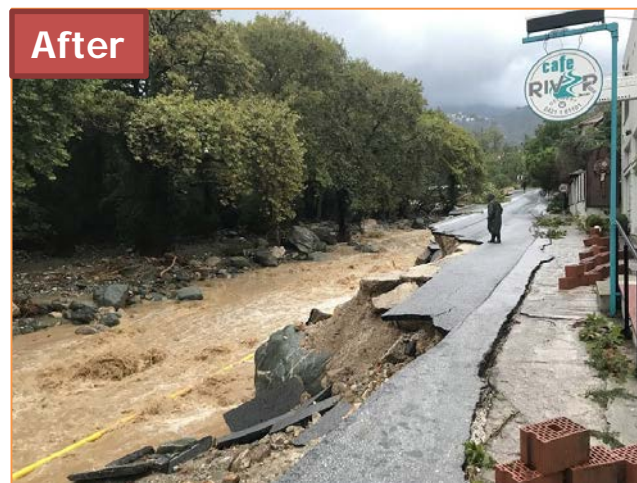
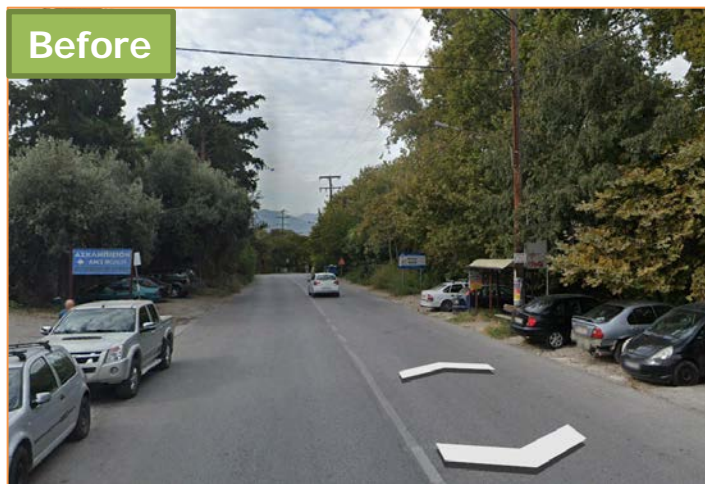
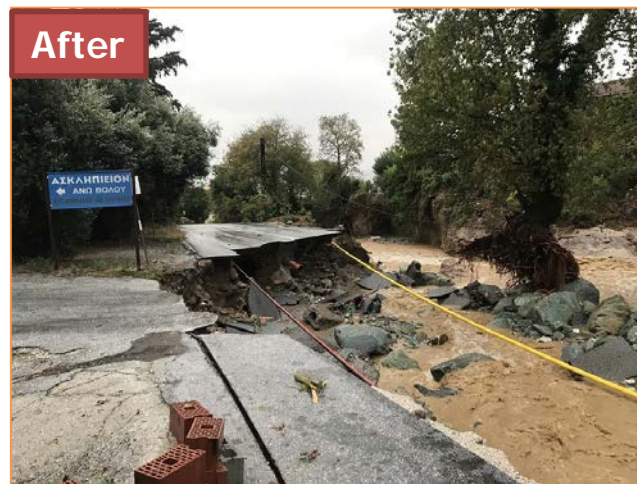
IMPACT ON INFRASTRUCTURE DAMAGE ON ROAD NETWORK – COUNTRY ROADS

The Iolkos Str. in Volos City before (left column) and after (right column) the Daniel storm in early September.

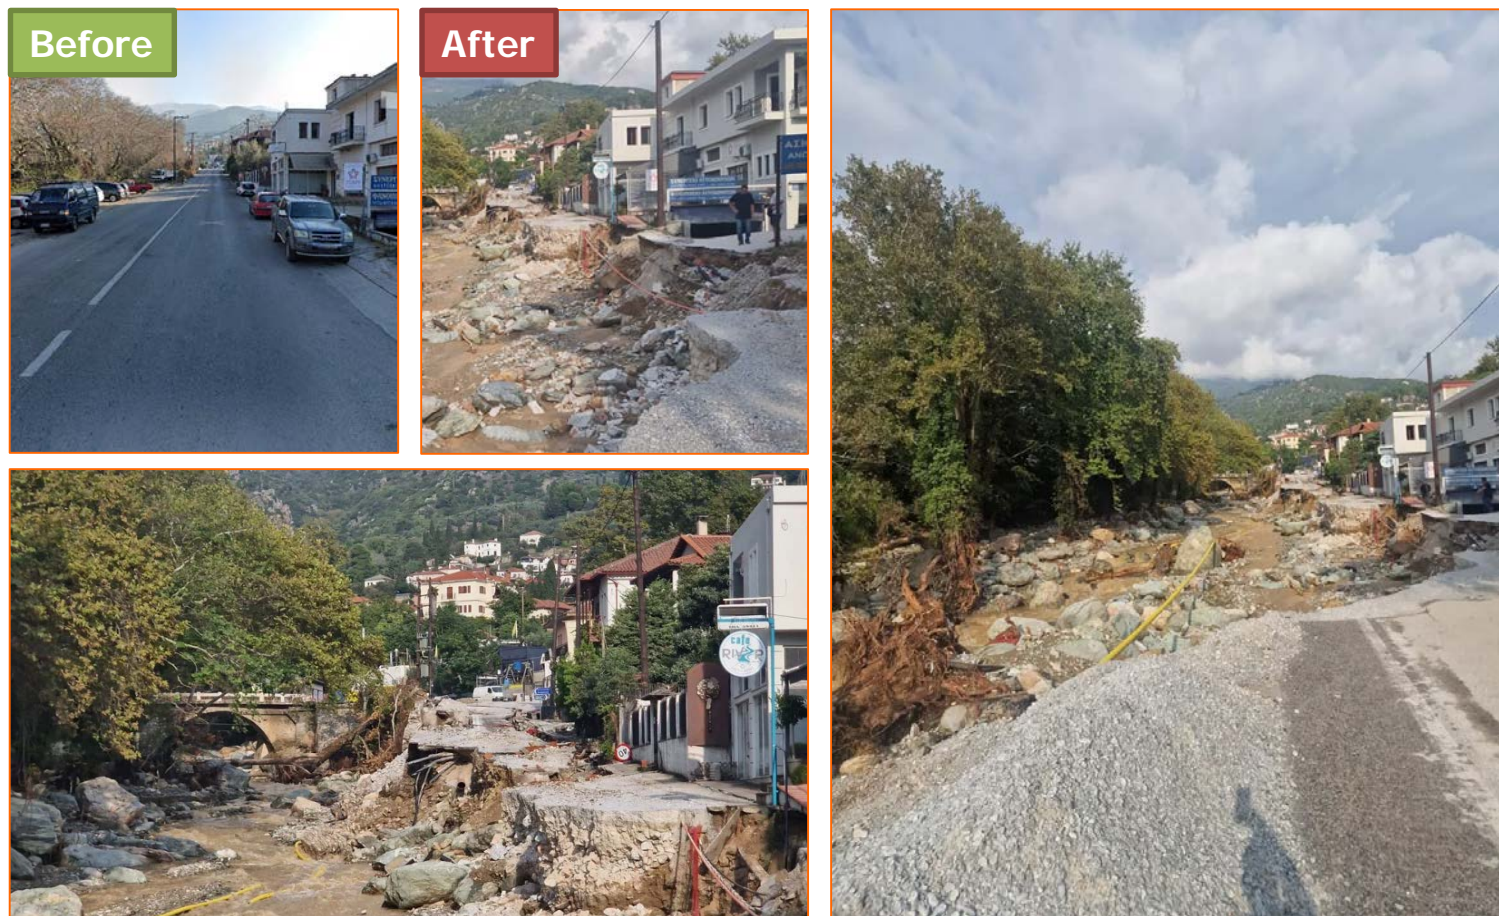
IMPACT ON INFRASTRUCTURE DAMAGE ON ROAD NETWORK – COUNTRY ROADS

The Iolkos Str. in Volos City before (left column) and after (right column) the Elias storm in late September.

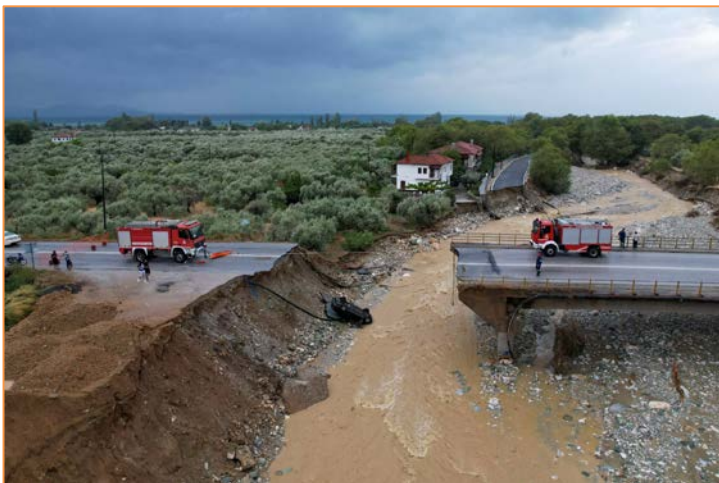
Kala Nera, Pelion (Photo credit: Stamos Prousalis, Reuters)

IMPACT ON INFRASTRUCTURE DAMAGE ON ROAD NETWORK – BRIDGES

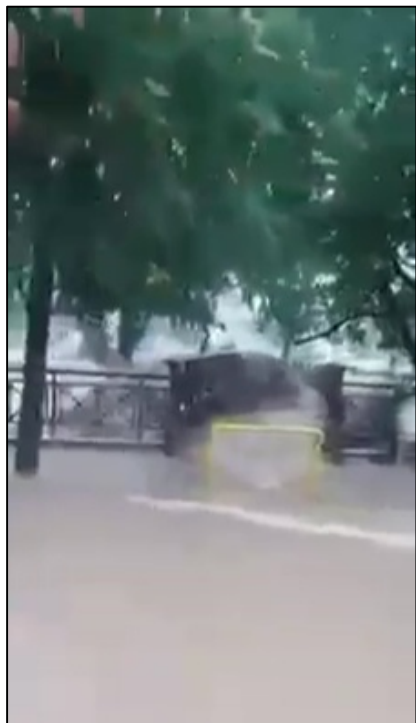
Rushing water reached the level of the bridge

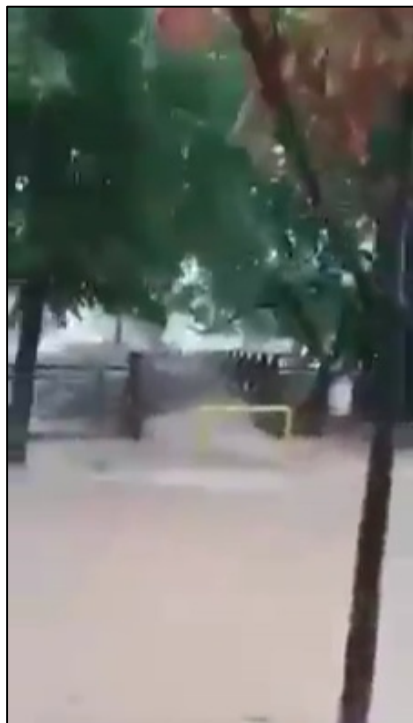
The bridge was heavily damaged by the rushing water

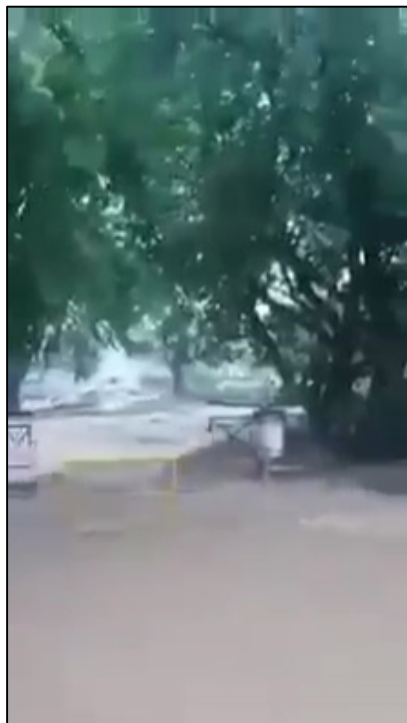
The bridge was totally destroyed and swept way by flooding.

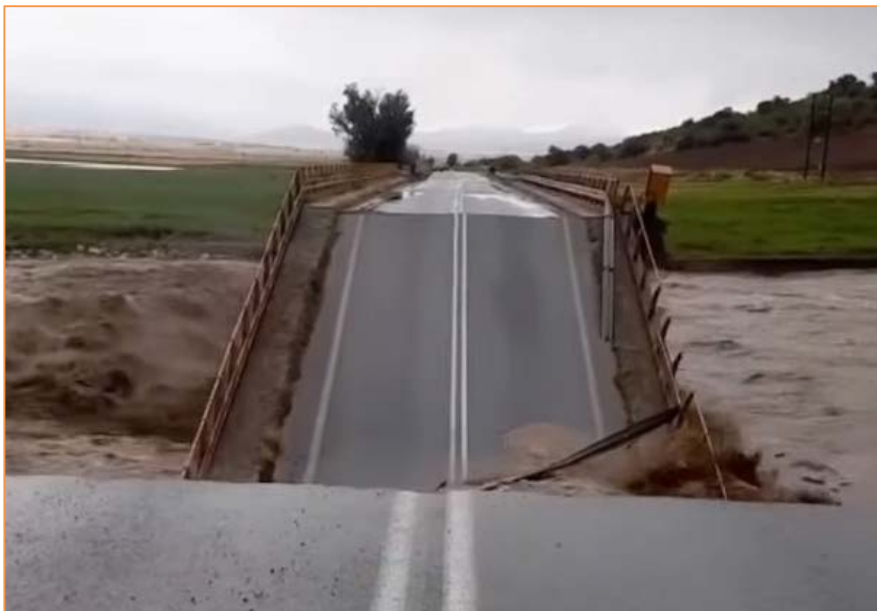
Total destruction of the bridge in Ampelia site located in Farsala area was attributed to the flooding waters of Enipeas River.

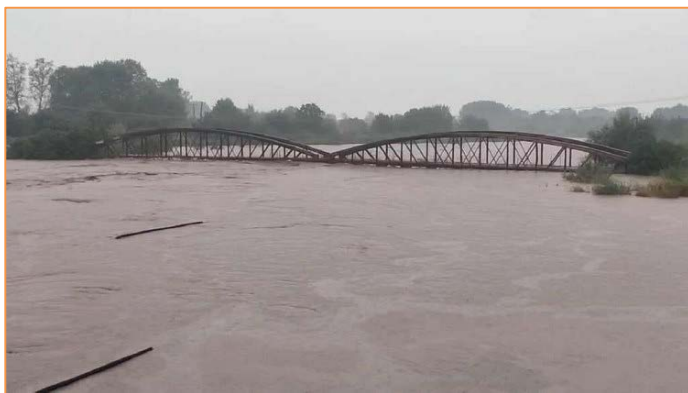
Karavoporos, Trikala

IMPACT ON INFRASTRUCTURE DAMAGE ON ROAD NETWORK – BRIDGES

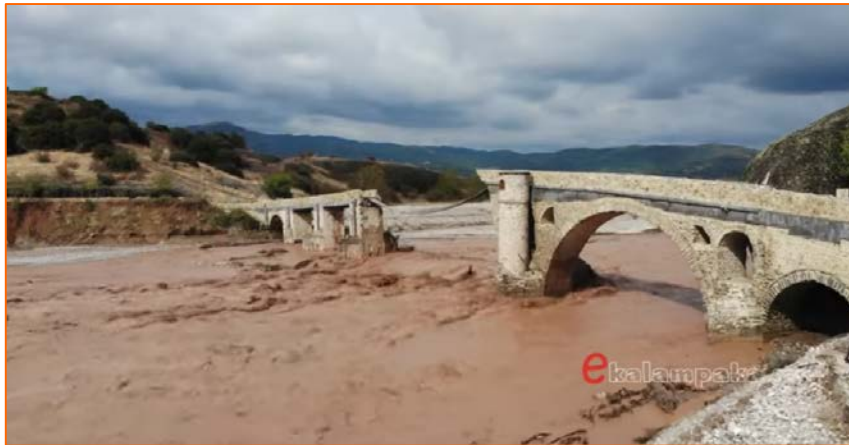
Sarakina Bridge, Kalampaka (Source: https://www.youtube.com/watch?v=CW_OYzintu0)

IMPACT ON INFRASTRUCTURE DAMAGE ON ROAD NETWORK – BRIDGES

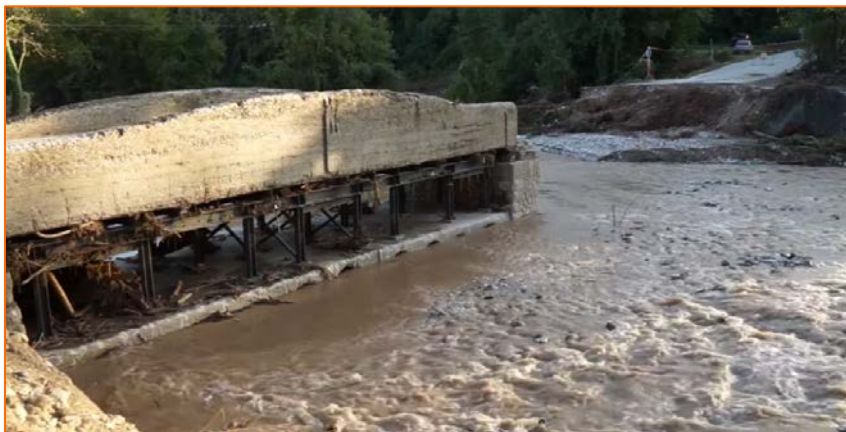
Argyri Bridge, Karditsa (Source: <https://www.youtube.com/watch?v=0GrzXNIUdw>)

IMPACT ON INFRASTRUCTURE DAMAGE ON ROAD NETWORK – BRIDGES

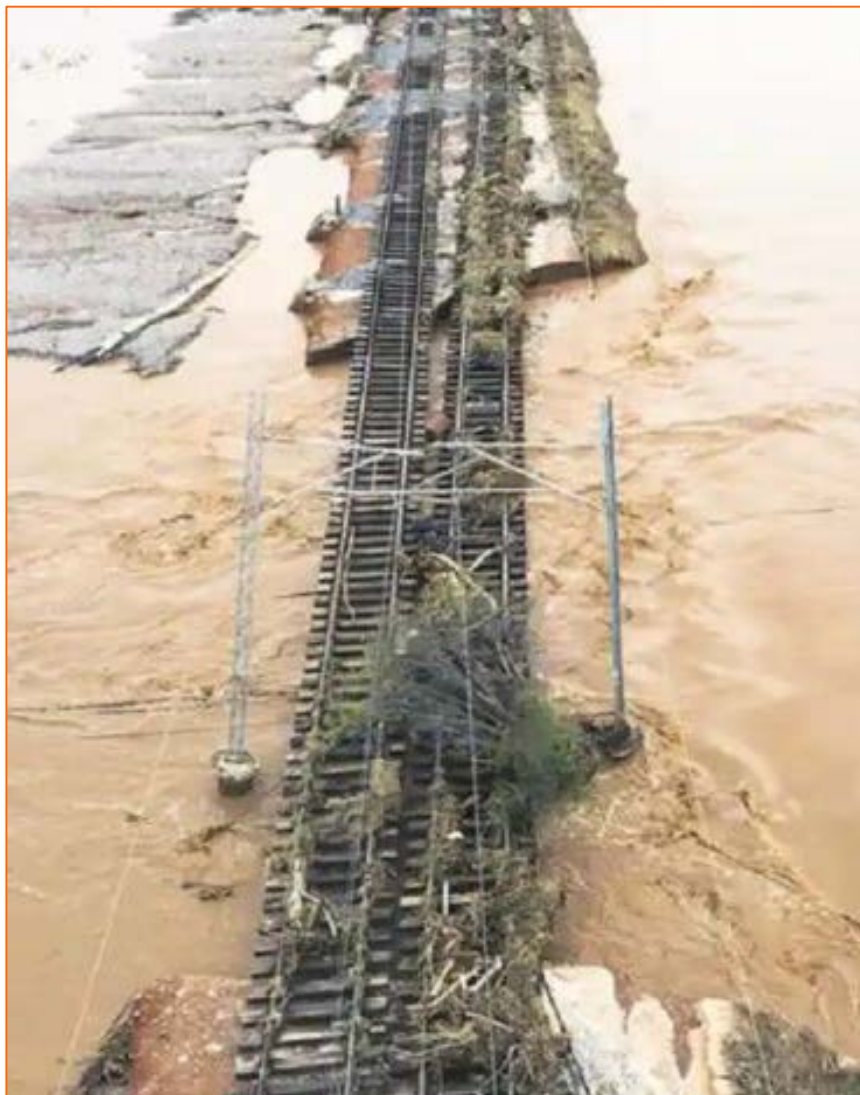
According to the statements of the Hellenic Railways Organization (OSE in Greek) managing director at ITC 2023 - 6th Infrastructure and Transport Conference, a total of 180 km of network have been destroyed including:

- 50 km of double line on the Athens-Thessaloniki axis;
- 80 km on the Palaiofarsalos-Kalambaka section;
- 50 km on the Larissa-Volos section.

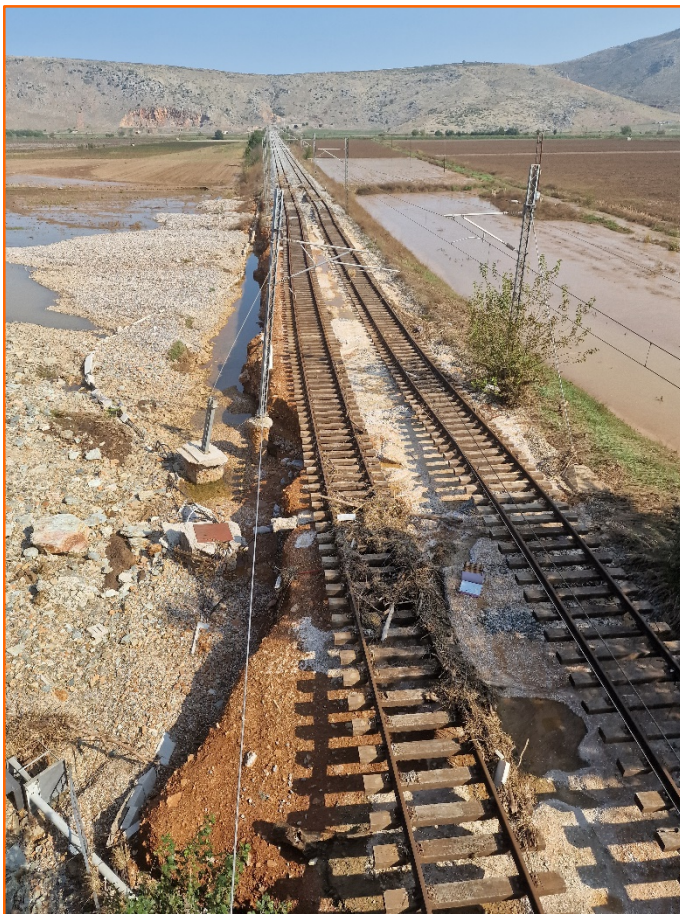
The flooding caused damage to the railroad network. It affected several components of the railroad infrastructure including rail tracks, rail ties, track beds and catenary masts among others important elements.

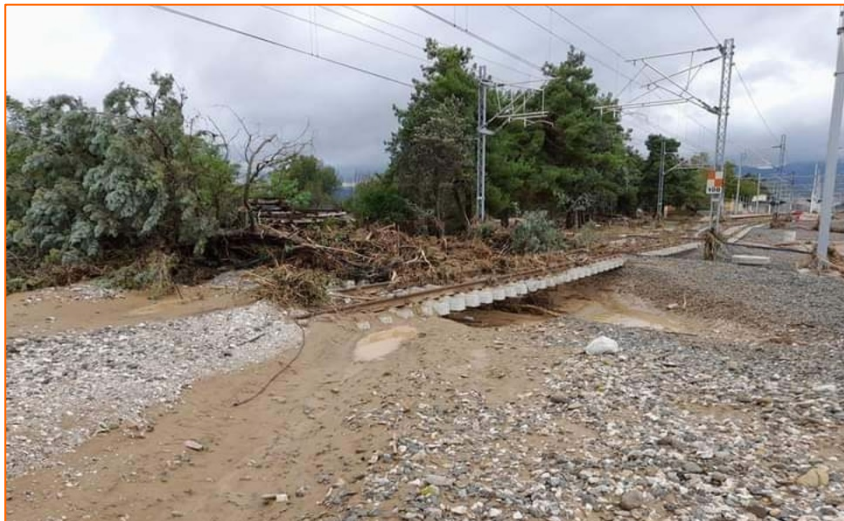
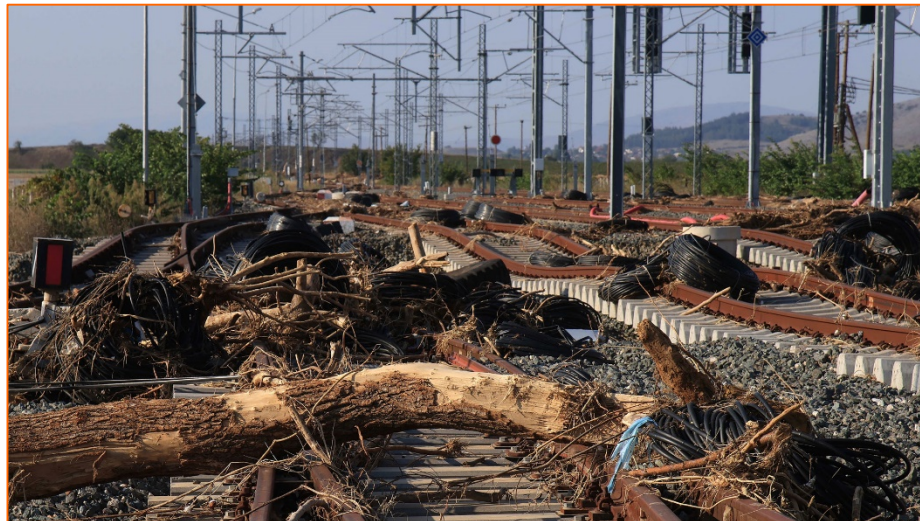
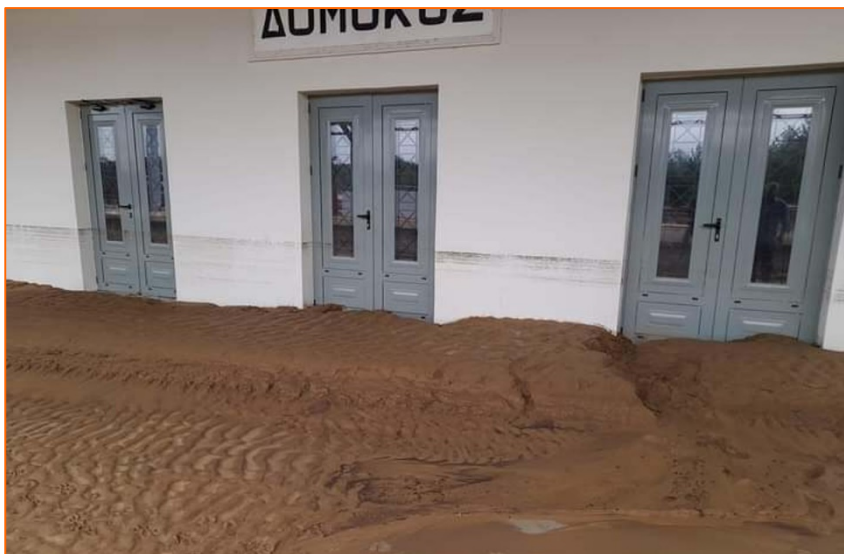
The part of the railway network in Domokos area suffered the most by the generated flood due to Daniel. Several elements of the network including tracks, the electromechanical systems comprising signalling systems were severely damaged. Furthermore, several stations were also affected with Domokos station being devastated.

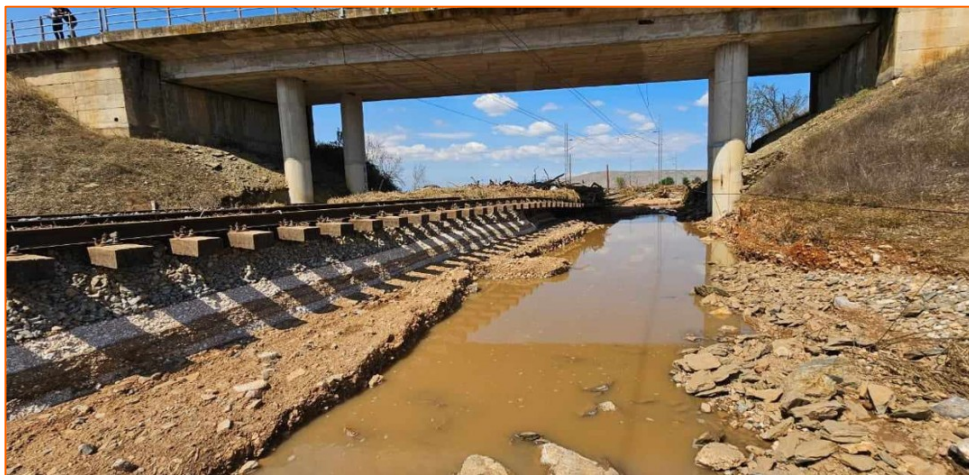
The most common damage to the railway network is the deposition of debris on the rails, the erosion of the material under the rails and the subsequent deformation of the rails, the drifting of various network elements such as rails, signalling, traffic lights, cabling, etc., the deposition of mud and the covering of railways. These failures resulted railway disruptions for a long period of time.

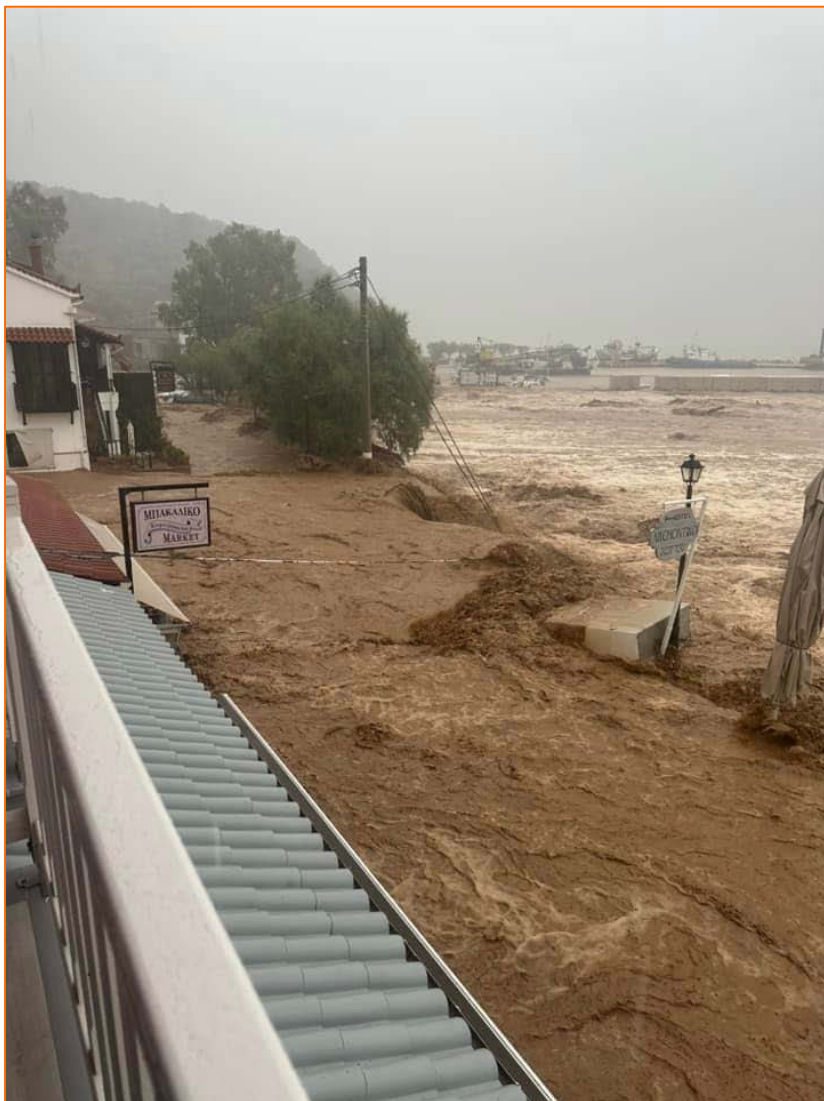
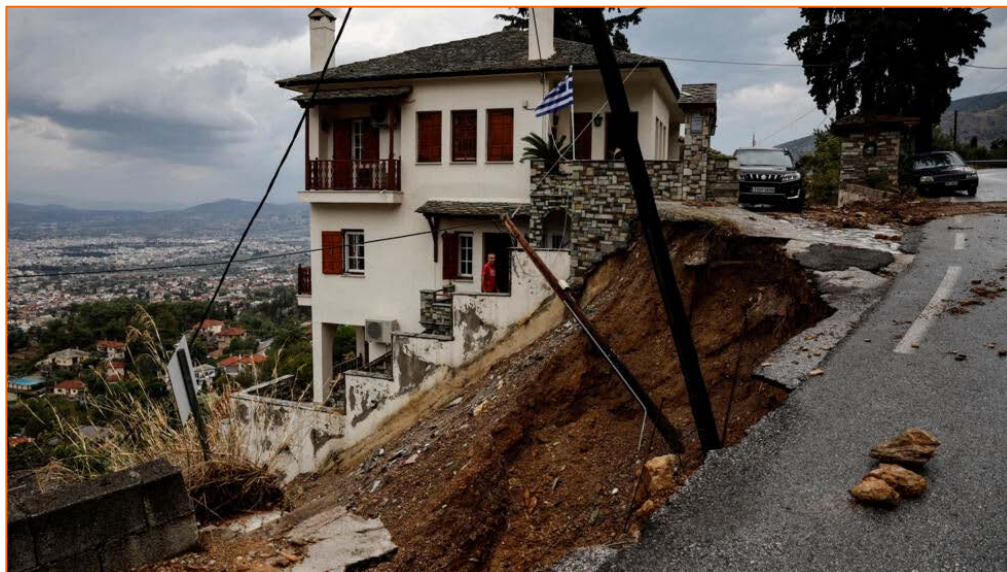
▲ Ano Meria, Pelion

Electricity distribution network damages in area of the mountainous and coastal Pelion.

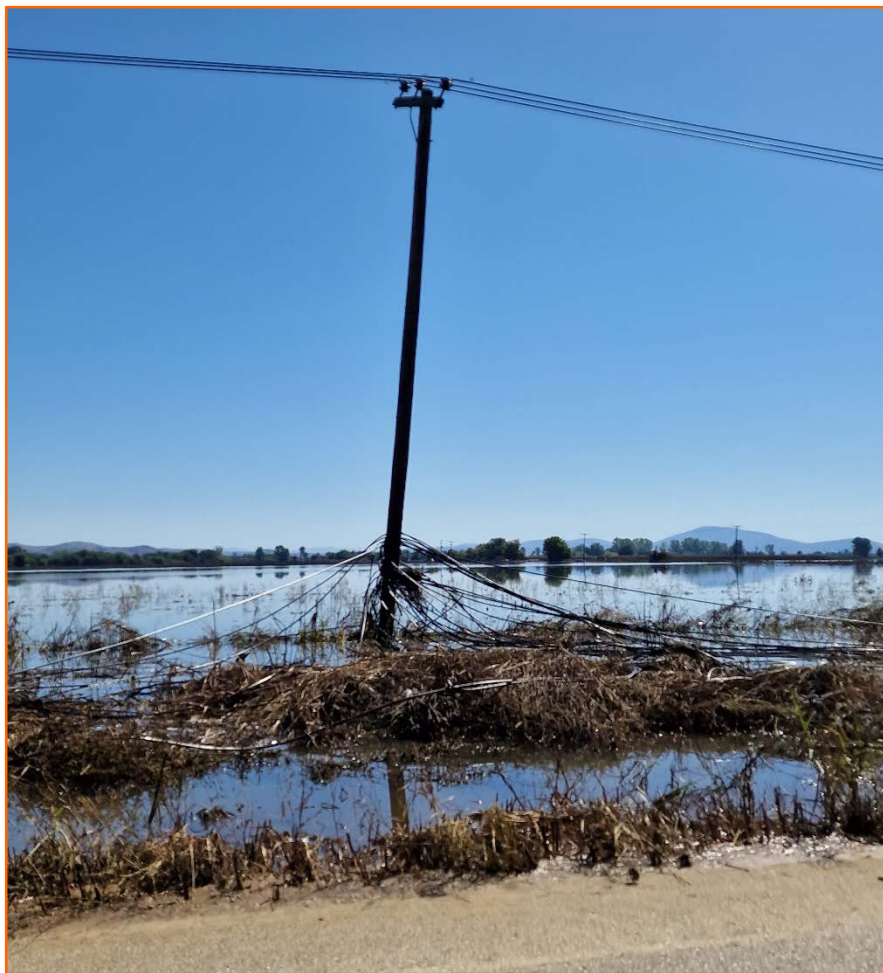
Electricity distribution network damages in the Thessalian Plain attributed to flooding after the Daniel storm.

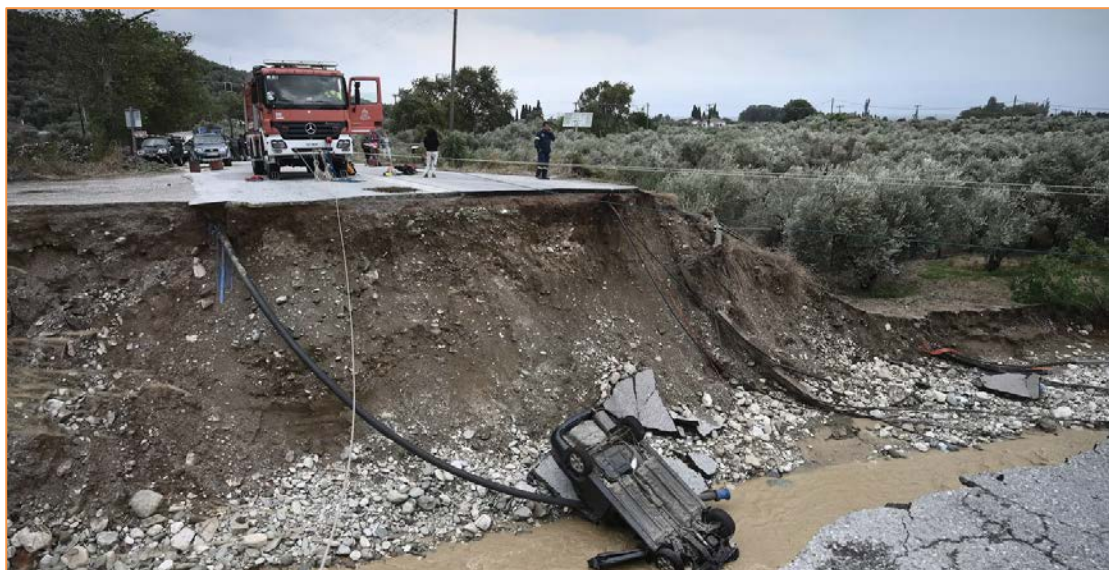
The most common impacts on landlines relate to damage to individual sections of the road network, damaged by flooding and the rushing waters of rivers and torrents.

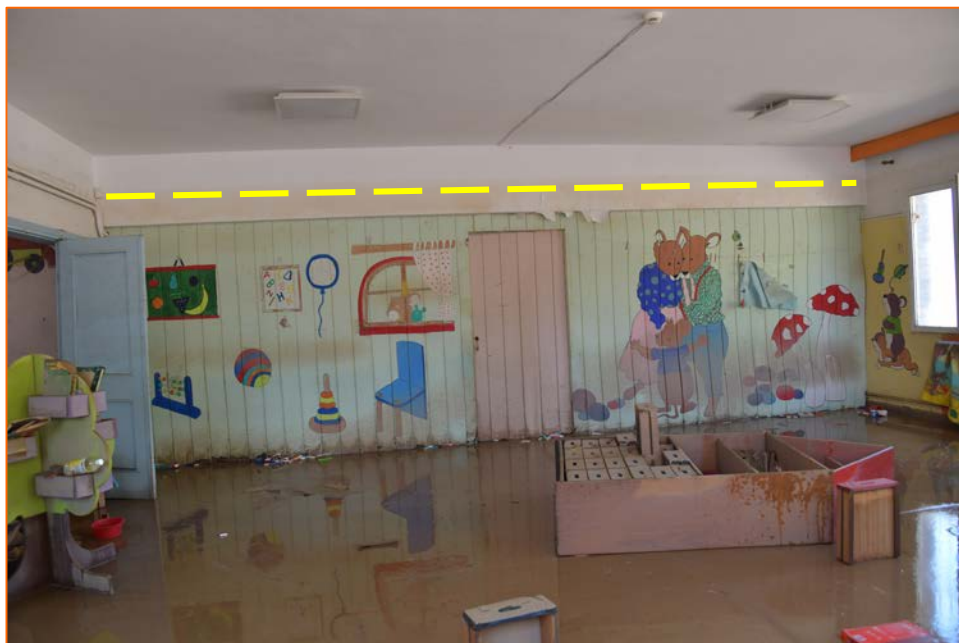
Flood-related disaster in the kindergarten of Farkadona village.

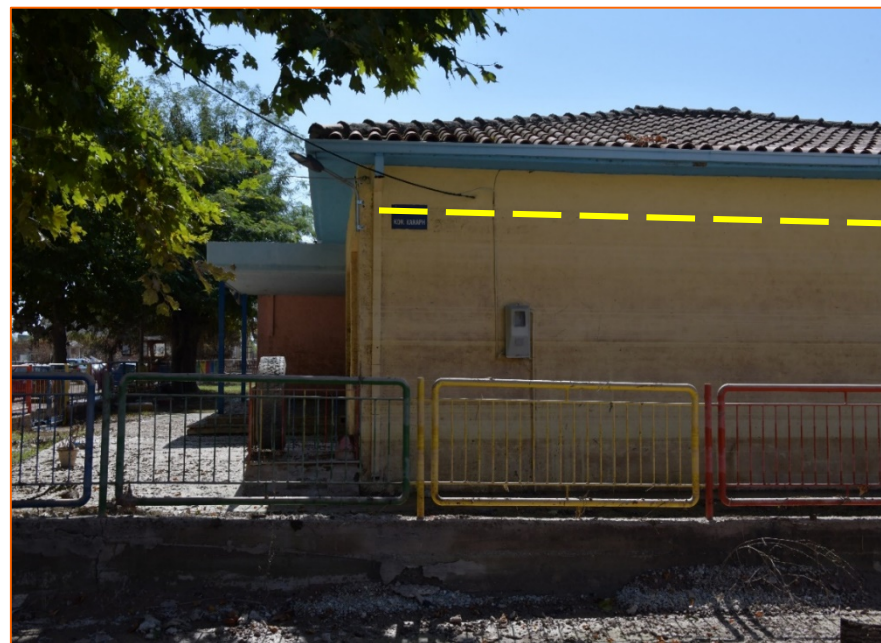
The water level (yellow mark) from the flooding has been imprinted on both the exterior and interior walls of the school.

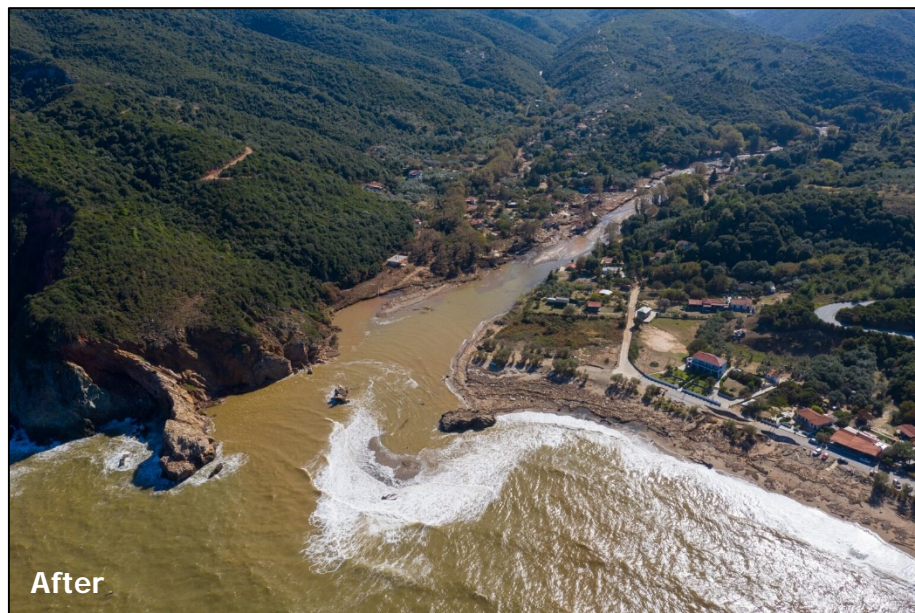
Coastal morphology changes at Paltsi (Pelion)

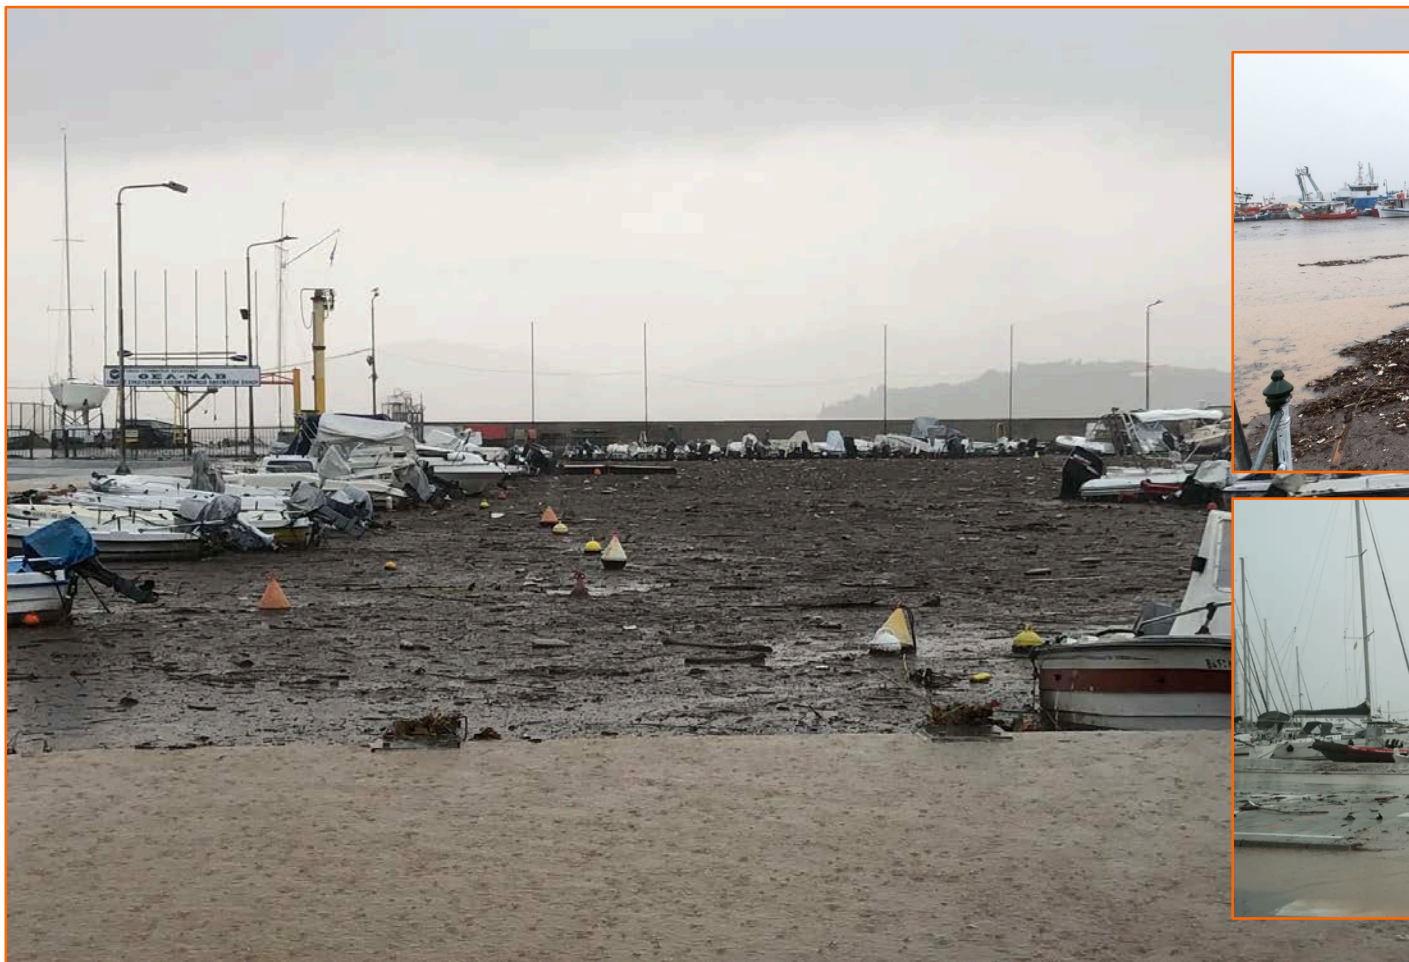
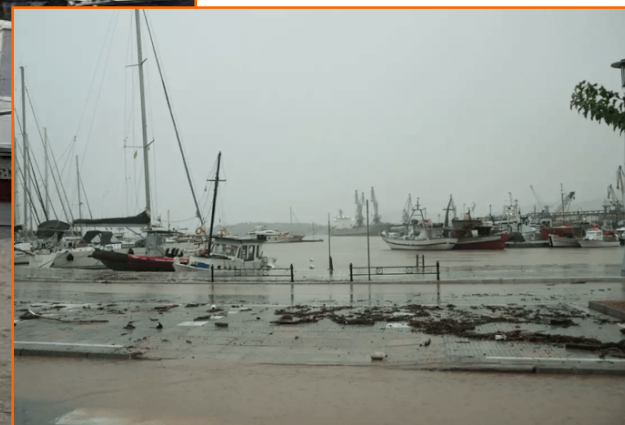
Bathymetry variations were detected in Volos port and attributed to the extreme weather events and the subsequent flooding.

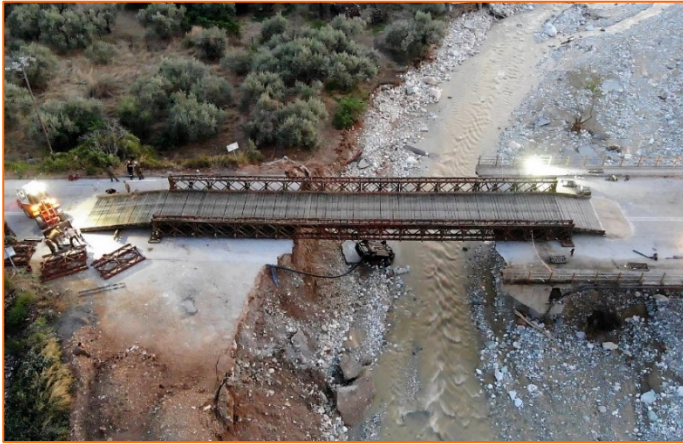
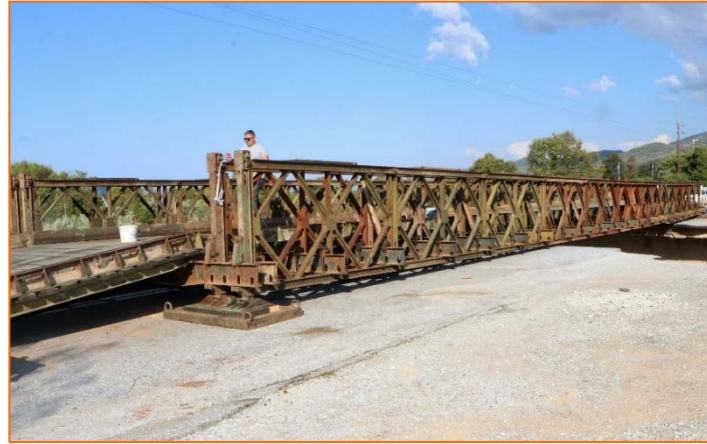
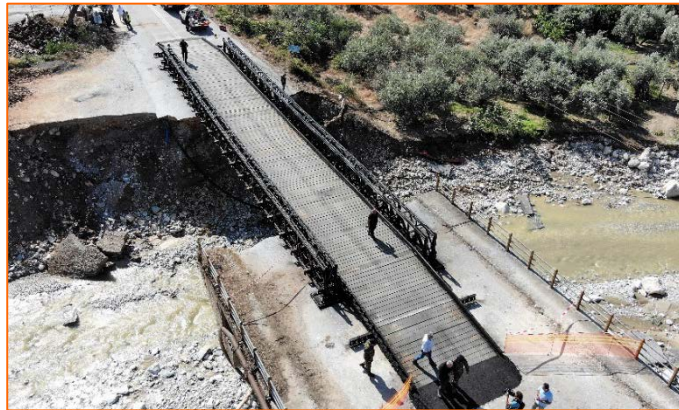
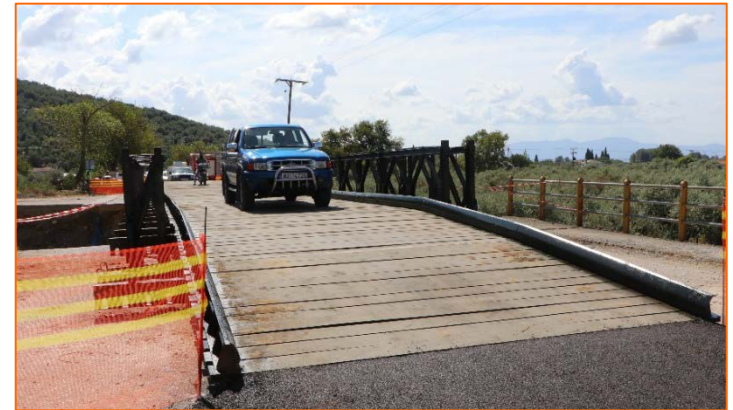
A metal bridge with a length of 30m and carrying capacity of 16t was constructed in Kala Nera area within 30 hours by a team of the Design - Construction Unit of the Hellenic National Defense General Staff. The bridge was constructed for restoring the road from Volos to South Pelion area after collapse of the previous bridge due to intense river erosion.

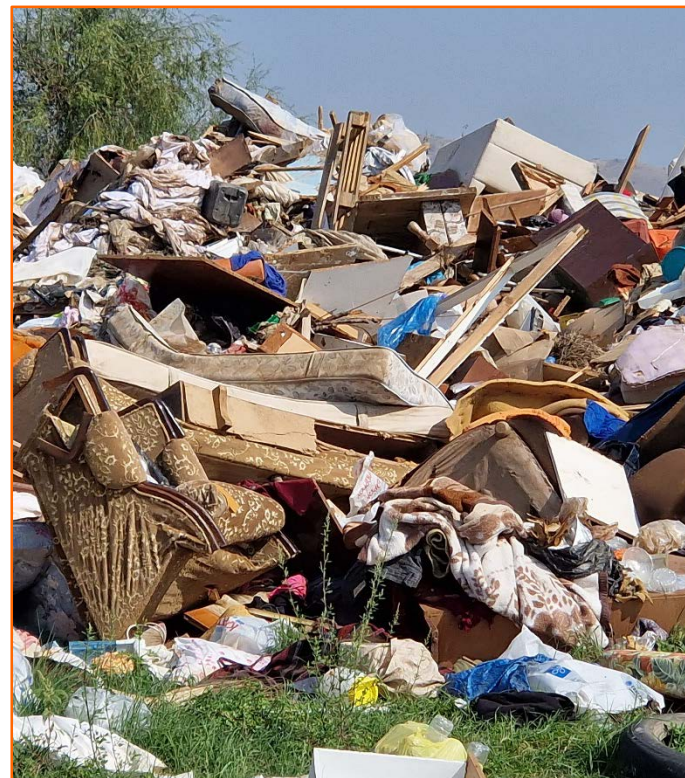
- **Green waste:** Vegetation such as fallen trees, soil, agriculture products, farms, and timbers.
- **Building rubble:**
 - Timber, wood chips, waste wood (such as column, beam wall-material), bulky items, cables
 - Concrete/bricks
 - Steel, rebar, aluminium material, etc.
- **Household material:** Food wastes, wastes mixed with fibres, paper, wood chips, packaging

materials, household furnishing and belongings, other wastes (such as plastics, cardboard, paper).

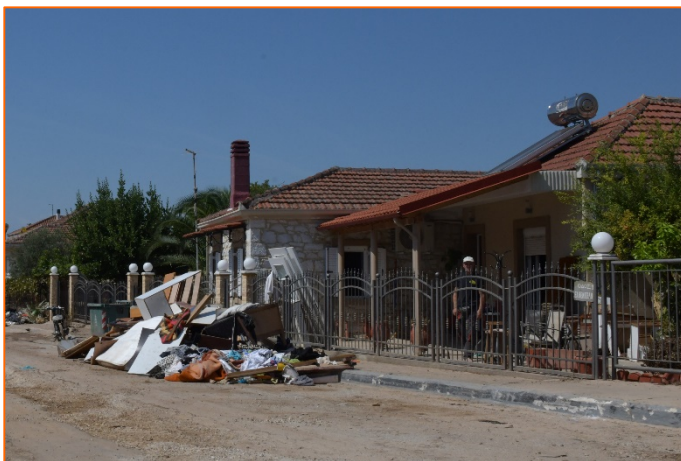
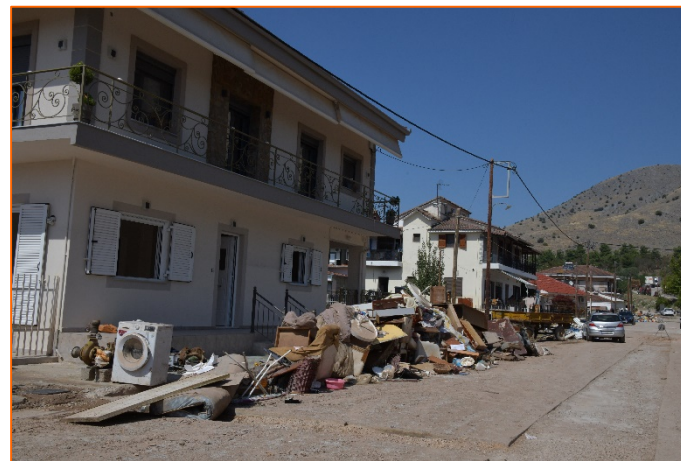
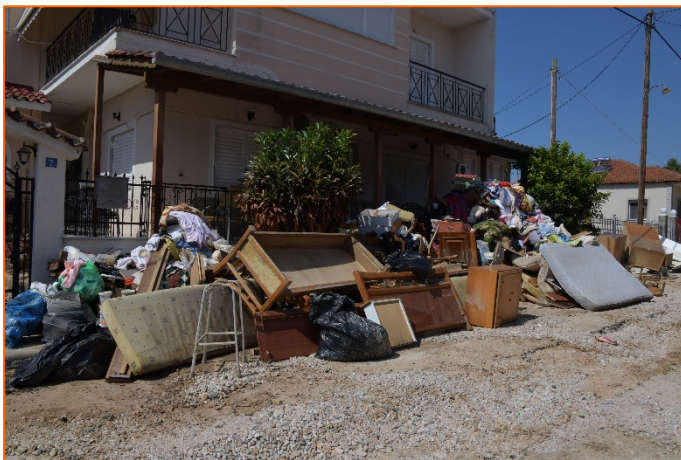
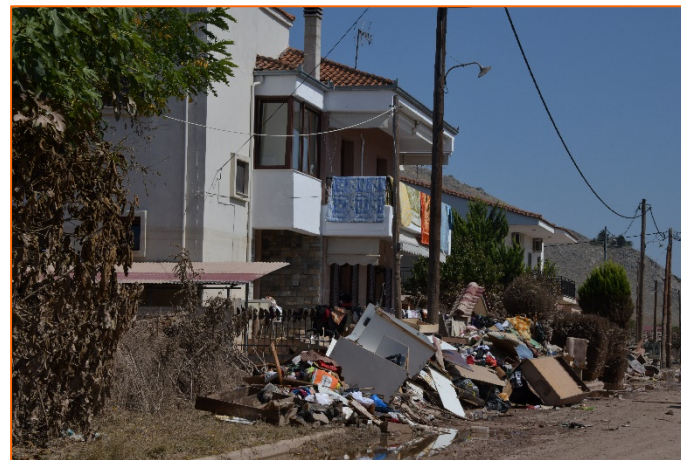
Typical views of the waste resulted after flooding in the Thessalian Plain. The disaster waste resulted from residential buildings can be classified into household material, mixed and hazardous waste. Photos credit: Prof. Efthymis Lekkas
