Newsletter of **Environmental, Disaster, and Crises Management Strategies**

Issue No. 30 | January 2024

The early September 2023 Daniel storm in Thessaly Region (Central Greece)

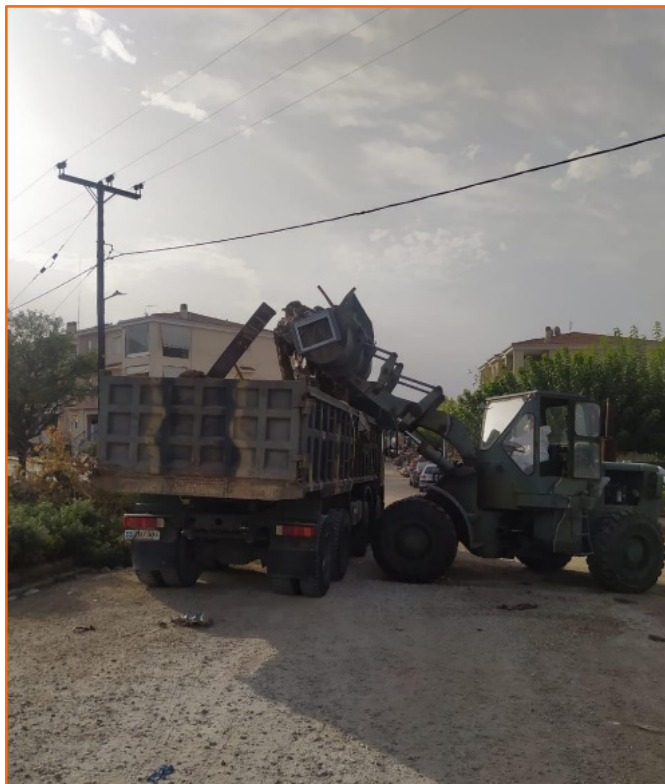
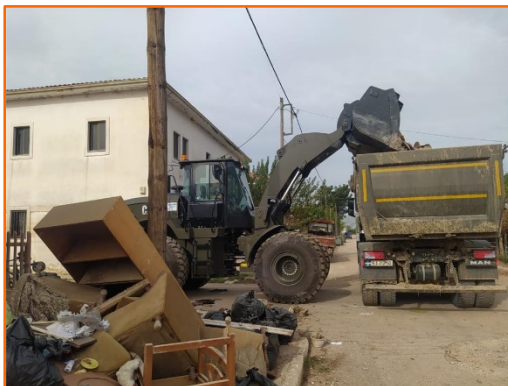
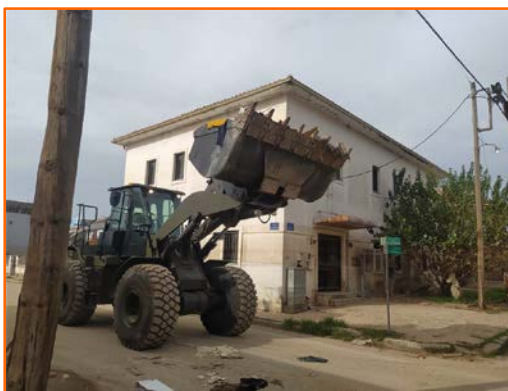
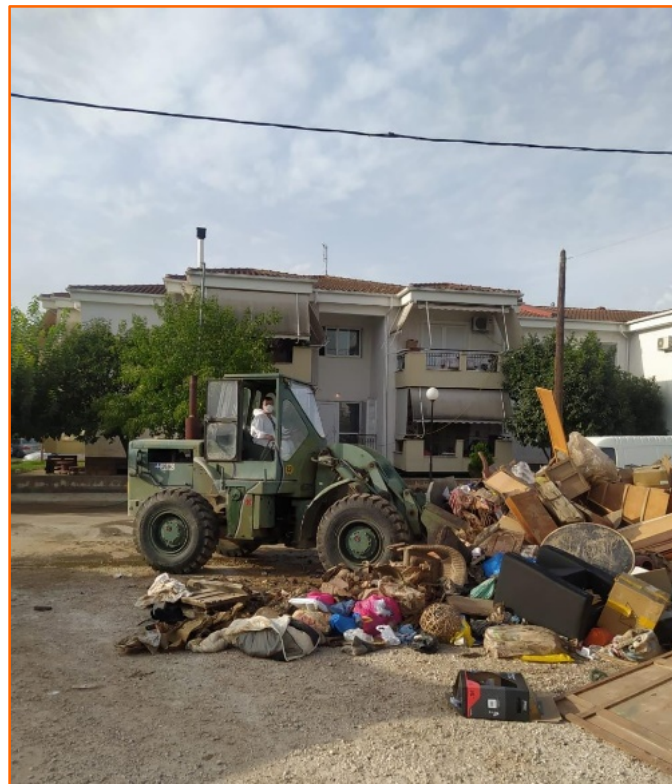
The Armed Forces also participated in the operation of removing debris from flooded houses in various affected areas of the Thessalian Plain [Giannouli in Larissa Regional Unit (RU), Farkadona in Trikala RU and Palamas in Karditsa RU). They assisted affected Municipalities especially in transporting bulky objects with heavy machinery. Photos credit: Region of Thessaly. Source:

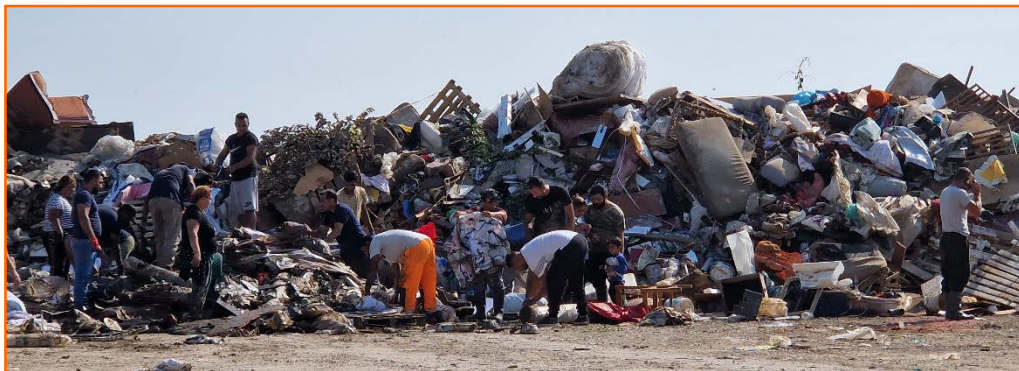
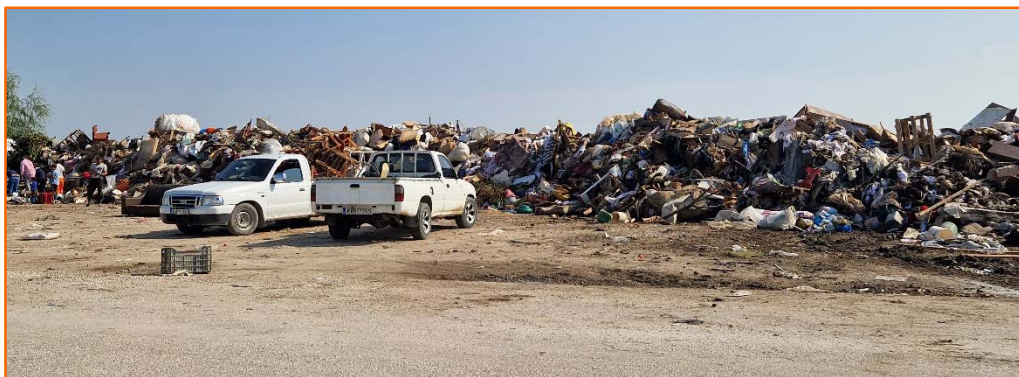
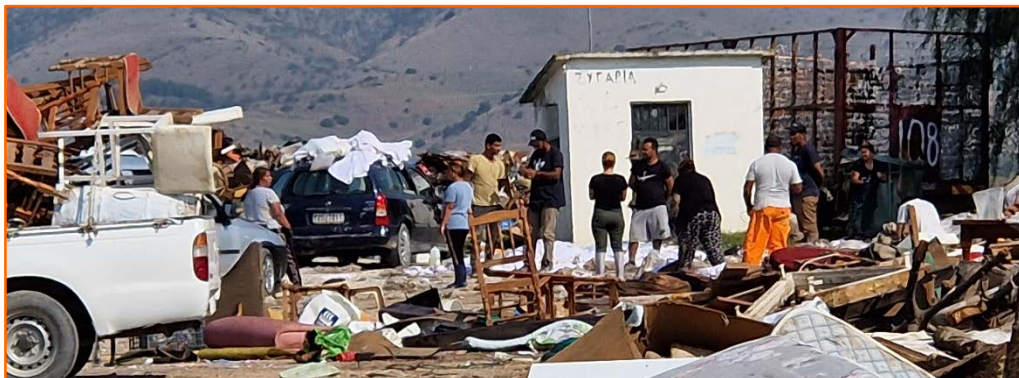
EMERGING HEALTH HAZARDS RELATED TO DISASTER WASTE MANAGEMENT SEVERAL PHASES OF DEBRIS MANAGEMENT

Threats to public health can emerge at any stage of debris management. Residents must comply with the instructions of the authorities and apply personal protective measures to avoid sporadic cases, outbreaks and epidemics of infectious diseases, and must not approach debris disposal sites or come into contact with debris piles. In uncontrolled waste disposal areas there is an increased presence not only of rodents and insects but also of harmful elements, which have the potential to be a source of threat for both the local population and people from other areas that reside and work in the disaster field and the disposal sites.
