Seismological and Engineering Effects of the M 7.0 Samos Island (Aegean Sea) Earthquake

Hellenic Association of Earthquake Engineering: Report 2020/02

Geotechnical Extreme Events Reconnaissance Association: Report GEER-069

December 31, 2020

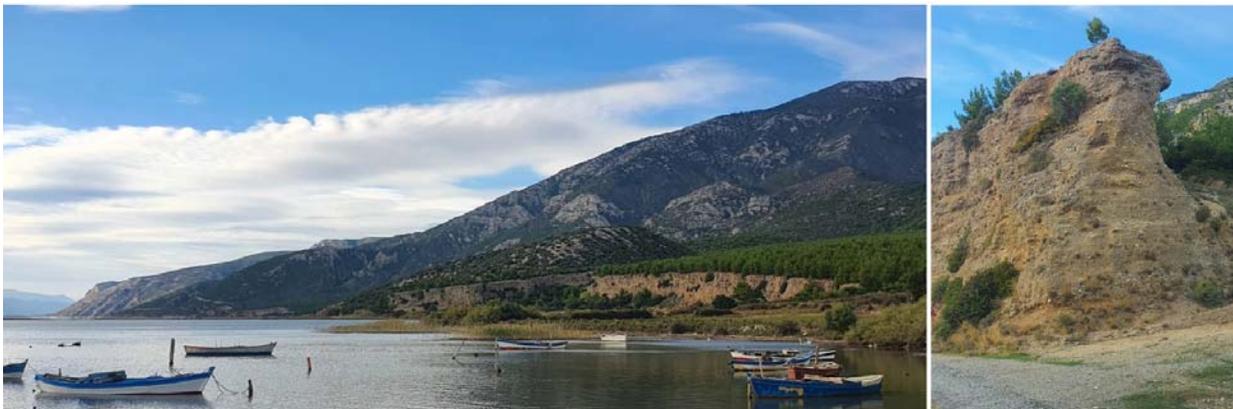
In the southern side of the Dilek Peninsula, young uplifted terraces are detected in the coast supporting a rapid tectonic uplift associated with active normal faulting (Figure 1.28). This location is near the Karina Lagoon, where different intercalations were deposited during tsunamis. To identify any coseismic ground deformation, in the Turkish side, the NE-SW oriented strike-slip Tuzla and Seferihisar, E-W oriented normal faults near Kuşadası, Gümüldür, Selçuk, Söke and Dilek Peninsula, were visited (Figure 1.27).

Figure 1.28. Photos taken at the southern side of Dilek Peninsula showing uplifted terrace deposits.

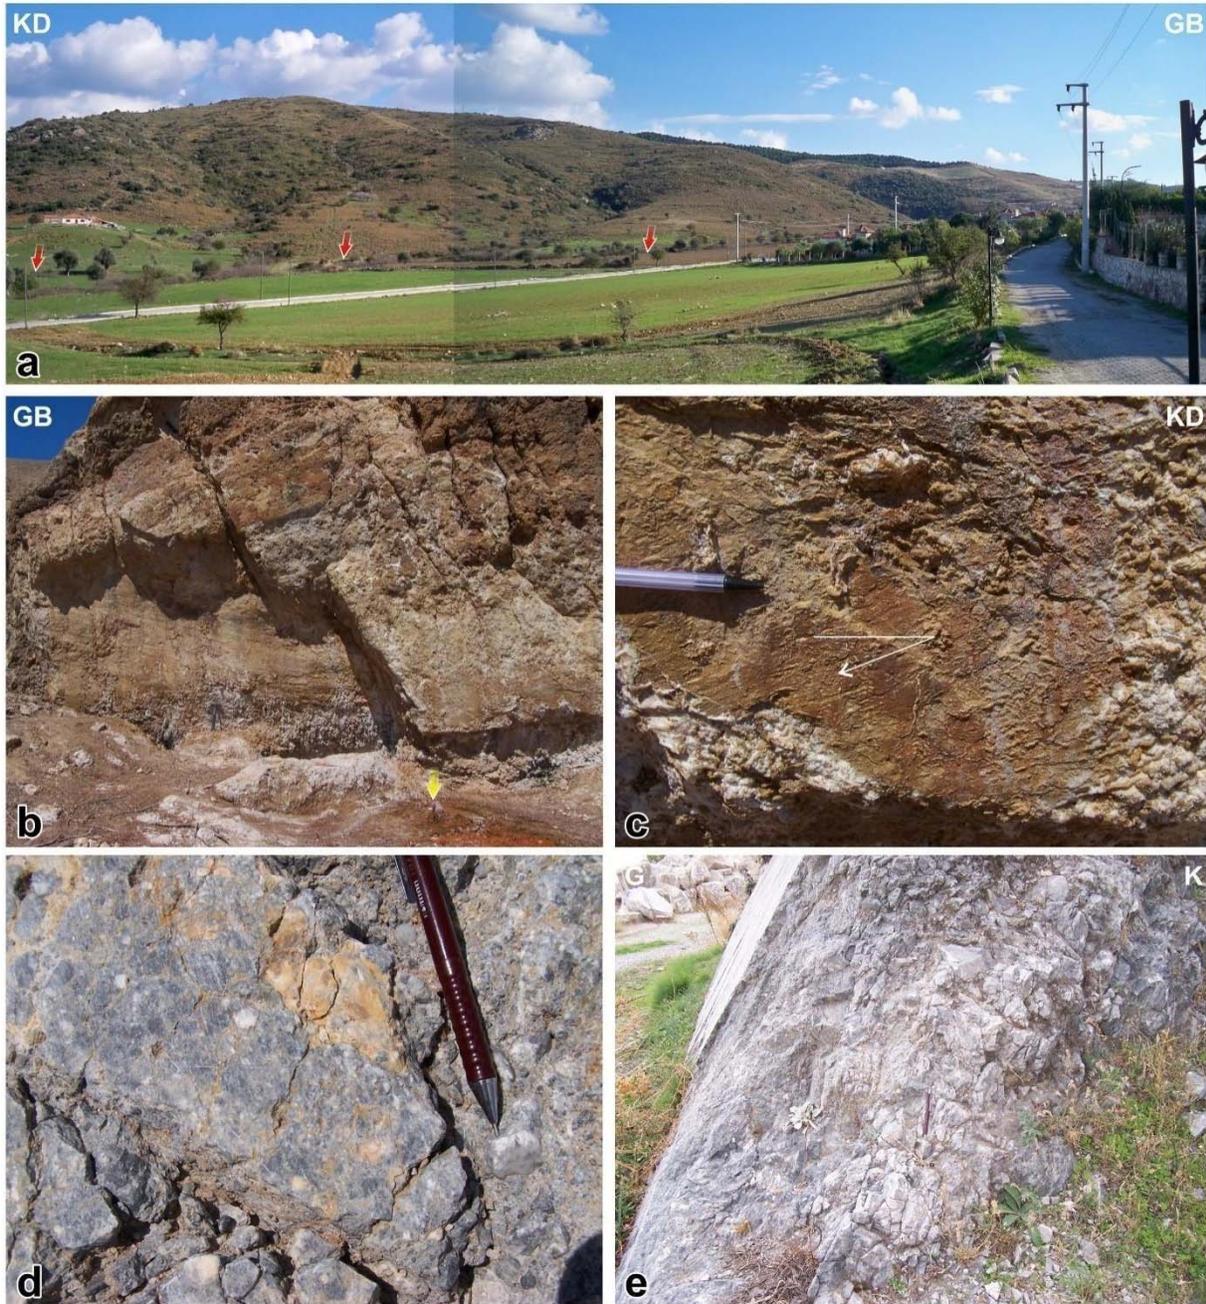
Figure 1.29 (a-e) shows the morphology of active Seferihisar strike-slip fault on land. At the Tuzla Fault site, geothermal alterations implying fault activity were detected. Moreover, the preserved striations identified on the fault scarp of the Tuzla fault revealed right lateral strike-slip motion, with a minor normal component (Figure 1.29c).

Figure 1.29. Photos of Seferihisar (a), Tuzla (b, c) strike-slip faults and Söke (d, e) normal fault. Red arrows show the fault trace, while the yellow arrow points out to geothermal fluids coming from the fault zone.

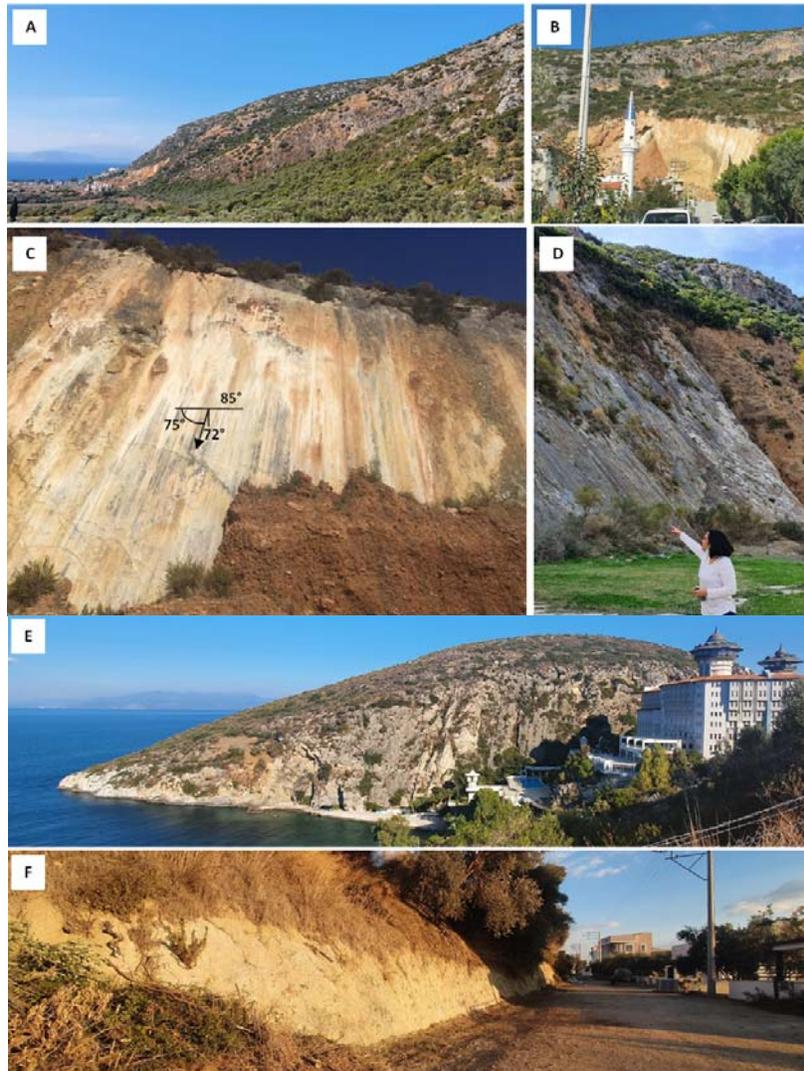
Among normal faults, active fault scarp photos of Söke Fault are shown in Figure 1.29 (a-e), while Figure 1.30 (a-f) display the observed scarps in Kuşadası Bay and Gümüldür coast, respectively. Fault measurements collected on the normal faults revealed extension with occasional minor strike-slip component, similar to the ruptured normal fault during the 30 October 2020 **M**7.0 Samos earthquake. Some of these fault scarps were quite close to residential buildings, however, no structural damage was identified in the nearby structures.

Figure 1.30. Active fault observations. Photos of south dipping normal faults near Kuşadası are given in **a**, **b**, **c** and **e**; Ephesus fault is in **d** and Gümüldür fault in **f**.

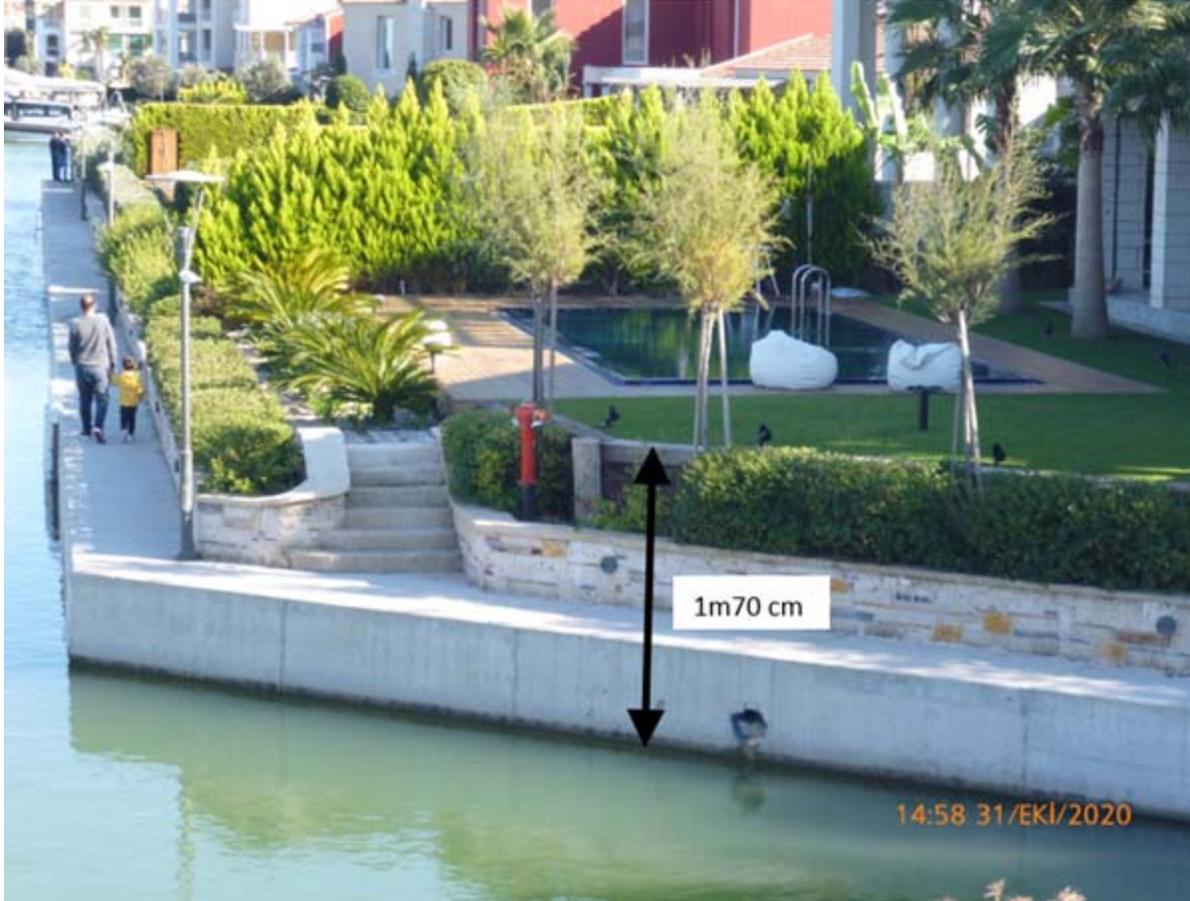
The water level increased and overtopped the garden wall of Port Alacati Houses up to 1.70 m (38.26346N 26.37304E and 38.26320N 26.37654E) (Figure 2.4). Here, the sea receded up to a depth of 1.5 m, 28 minutes after the earthquake, as seen in a security video recording.

Figure 2.4. Water level rise at the garden wall of Alacati Port Houses according to the house owner (38.26370N 26.37427E).

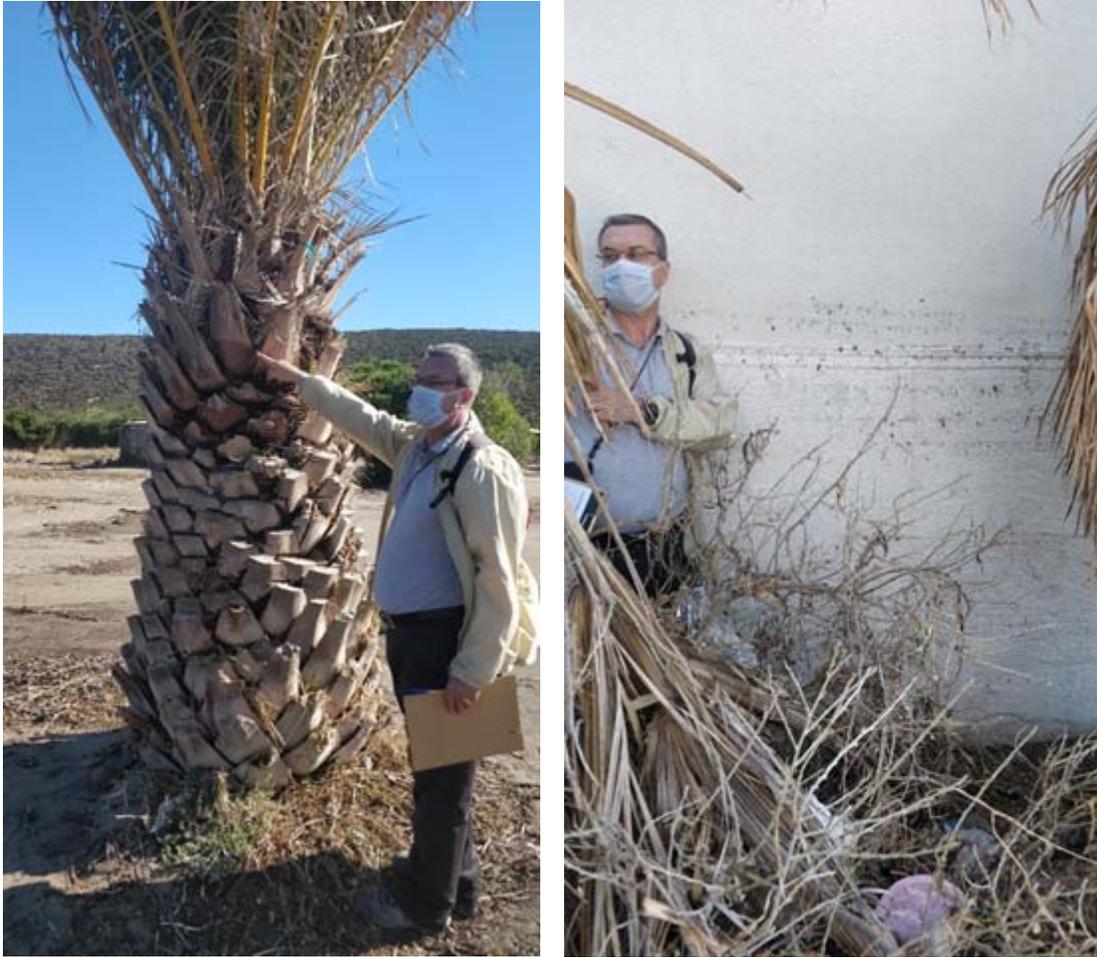
A 1.9m flow depth was measured on the palm trees, about 50 m away from the coastline (38.19600N 26.48859E and 38.19602N 26.48936E), and from debris materials accumulated at the outer wall of a house (38.19587N 26.49027E) (Figure 2.7). The abandoned summer houses along the shore were severely damaged, and debris materials accumulated on both outer walls and inside them. Additionally, tsunami boulders of concrete material (30x50x300 cm), weighing approximately 1 ton, were found transported 20-25 m inland.

Figure 2.7. (Left) Wave traces on the palm tree (1.90 m) near the coastline (38.19600N 26.48859E), and (Right) trace of debris materials accumulated at the outer wall (1.50 m) of a house (38.19587N 26.49027E).

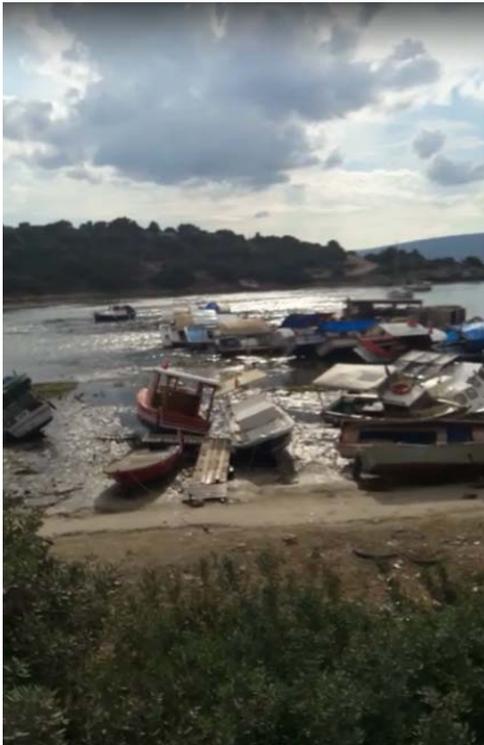
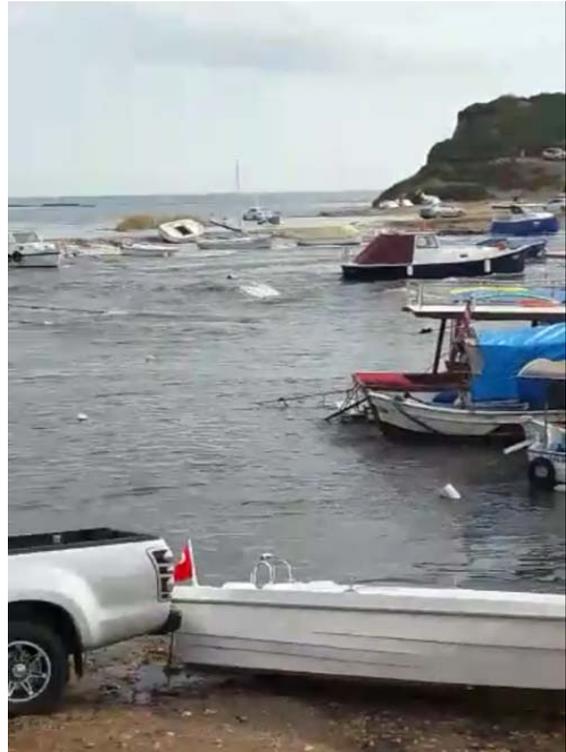
In the Demircili locality, 45m inundation was measured at the beach (38.211628N 26.676901E) on the northwestern side of the bay (Figure 2.8). However, significant damage was observed by the local people and fishermen in a narrow beach site in the southeastern part of the bay (Figure 2.9, 38.207508N 26.686378E). According to the eyewitness statements, the sea receded almost 20 min after the earthquake, and came back in 3-4 minutes. They observed this cycle of ebb and tide for about five hours. A boat moored at a depth of 1.8 m was grounded when the sea receded during the leading-depression wave (Tadepalli and Synolakis, 1994). The water level increased more than 1 m inside the local fishery port.

Figure 2.9. Highly damaged boats in a small fishery port in the Demircili locality.

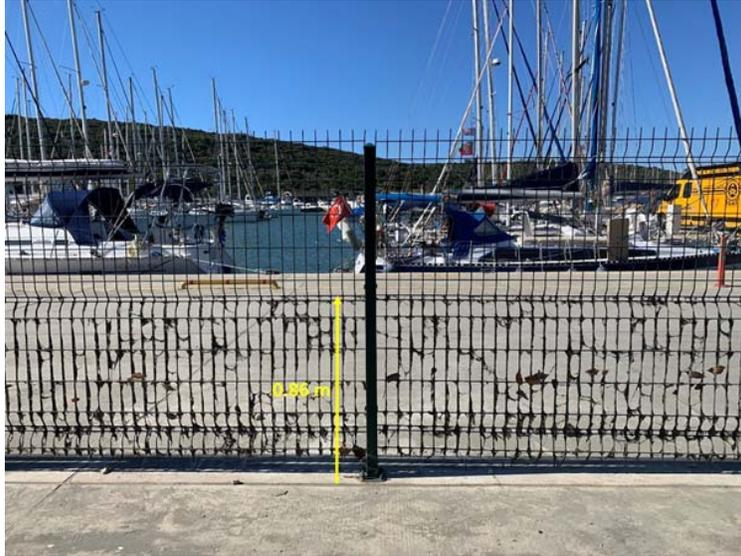
Figure 2.13. Tsunami traces on the garden fence of Teos Marina corresponding to a flow depth of 0.86 m. Classic presentation of debris “escalator” showing maximum flow depth.

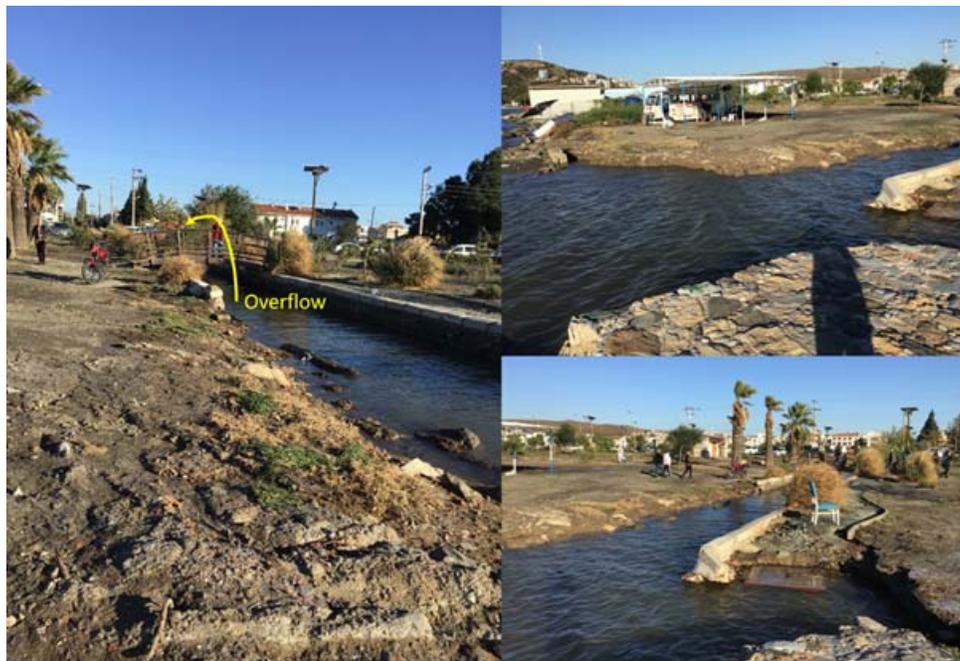
Figure 2.14. Azmak river in the East direction from Teos Marina where the tsunami overflowed the small bridge.

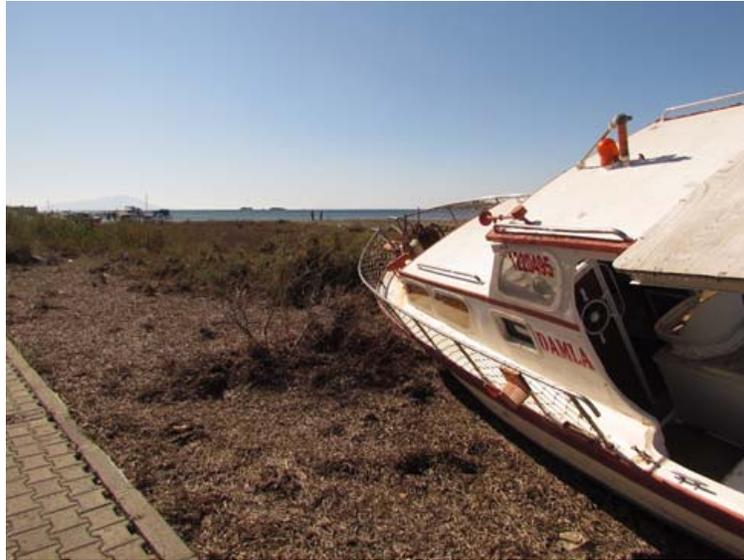
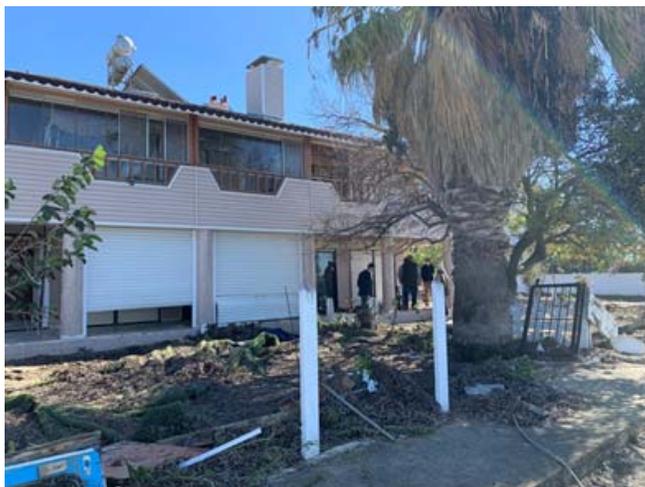
Figure 2.16. A boat dragged 90 m from the shoreline.

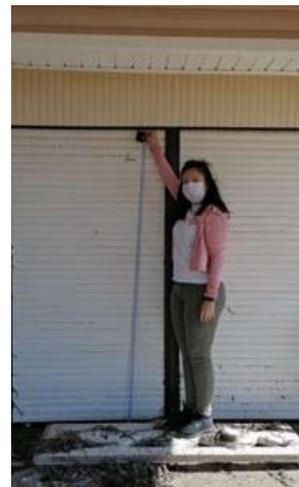
Akarca Locality. The coast in the Akarca region from 38.171062N 26.803827E to 38.168131N 26.811287E was highly impacted by the tsunami, whereas a significant reduction of impact was observed in the region after the small V shape cape in the northwestern direction. In a small fishery port in the small cape (38.164666N, 26.814649E), 20 boats sank. A boat was dragged inland by the strong currents 90 m from the shoreline (Figure 2.16). A water storage tank (half full) and a car were also dragged towards land at 38.164526N 26.814808E. A 1.9 m splash height was measured on a vertical wall of a house located just near the shore (38.164666N 26.814649E, Figure 2.17).

Figure 2.17. A damaged house located just near the shoreline where a 1.9 m splash height was measured in Akarca.

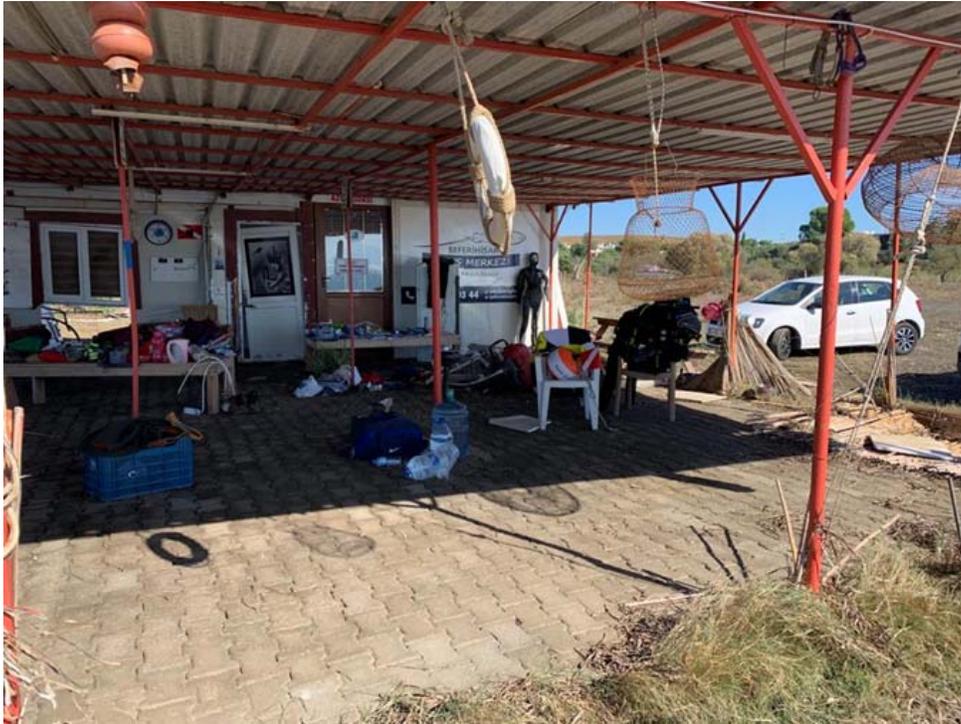
In Seferihisar Diving Center (Figure 2.18, 38.165560N 26.813708E), located in Akarca, the sea receded up to a depth of 4m and ~180m in the horizontal direction, 10 minutes after the earthquake, according to the owner of the center, Mr. Aydın Tunca. He observed the first wave arrival between 10-15 minutes. He stated that he jumped on a sofa and drifted ~200-250 m inland on the sofa until the foot of the sofa was locked on the land. He observed 4-5 waves, about 8-10 minutes apart. The inundation distance measured was 279 m and the flow depth 2.19 m.

Figure 2.18. Tsunami damage on Seferihisar Diving Center (38.165683N 26.813717E).

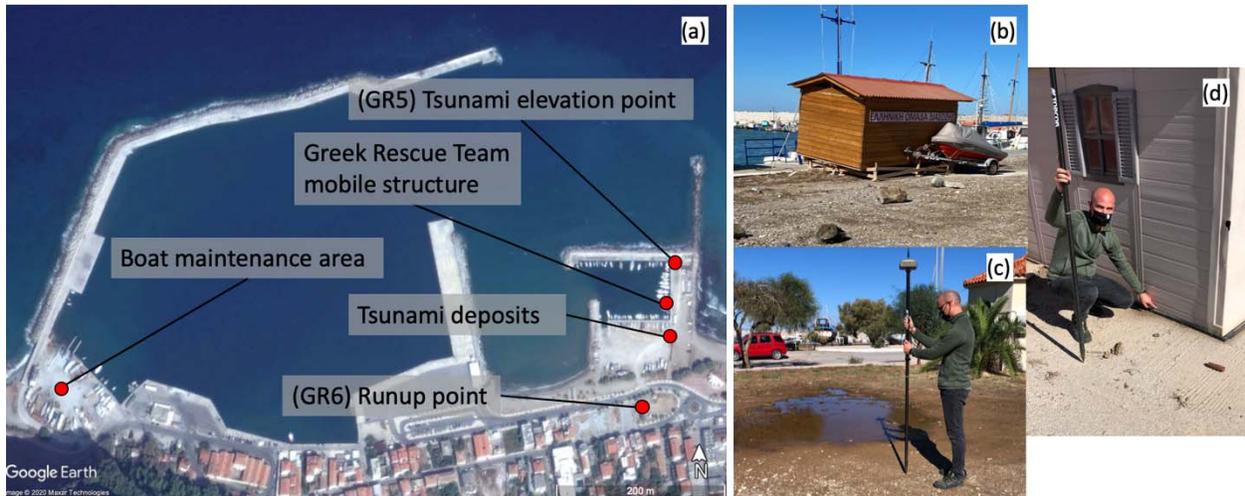
Karlovasi - Ag. Nikolaos. Karlovasi is a coastal town located on the NW side of the island, and therefore very close to the upper dip edge of the fault ruptured by the earthquake on October 30th, 2020. The tsunami reached Karlovasi within minutes after the earthquake. An eyewitness video from the area posted on Facebook live (reliable time information) shows that the sea level in the port of Karlovasi had already dropped significantly by 11:55 UTC and had begun rising again. At 11:57 UTC (~ 6 minutes after the earthquake), the risen sea level had reached the boat maintenance area (Figure 2.21a) on the western part of the harbor. At 11:59 UTC, the sea level had dropped again below the height of the quay. On the eastern part of the harbor, where the small craft marina is located, the flow depth over the quay, although not significant (of the order of 5-20 cm), was enough to suspend a mobile structure of the Greek Rescue Team and displace it from its base (Figure 2.21b). An eyewitness indicated that tsunami inundation reached an empty lot south of the marina and past the coastal road, where a water pond had formed (Figure 2.21c). This point corresponds to a wave runup of 1.84 m and 100 m of horizontal inundation.

Figure 2.21. (a) Google Earth satellite picture of the harbor of Karlovasi and the locations of tsunami observations. (b) The mobile structure of the Greek Rescue team that was displaced by the tsunami. (c) The maximum runup point location. (d) The flow depth mark on the side of a structure where tsunami elevation was measured.

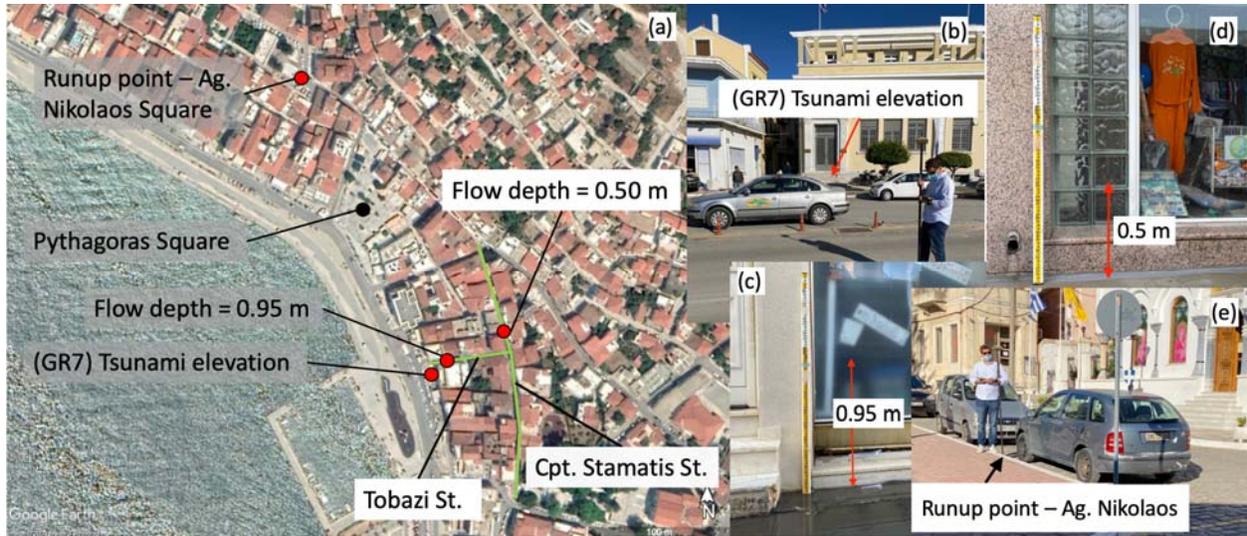
Field measurements focused on the area landward from the marina of Vathi and Pythagoras Square (Figure 2.23). An eyewitness indicated the maximum level the water reached at the entrance steps to the Bank of Greece branch, which was confirmed through videos shared on social media. This datapoint, located 62 m inland from the marina (Figure 2.23b), corresponds to a tsunami overland flow depth of 1.0 m and 1.7 m tsunami height. A flow depth of 0.95 m was measured along Tobazis St. at the side of the Bank of Greece branch that runs normal to the shoreline (Figure 2.23c). The inundating water traveled through the narrow street and

reached the commercial street of Cpt. Stamatis, where a flow depth of 0.5 m was observed (Figure 2.23d). The water entered the stores and flooded the basements of the buildings. Further north, the inundating water traveled through Pythagoras Square and reached the pavement next to Ag. Nikolaos Square (Figure 2.23e).

Figure 2.23. (a) Google Earth satellite picture of Vathi and the locations of tsunami observations. (b) The steps at the entrance to the Bank of Greece branch where tsunami elevation was measured. (c-d) Flow depth marks on store windows along Tobazi. (c) and Cpt. Stamatis (d) streets. (e) The runup location at Ag. Nikolaos Square.

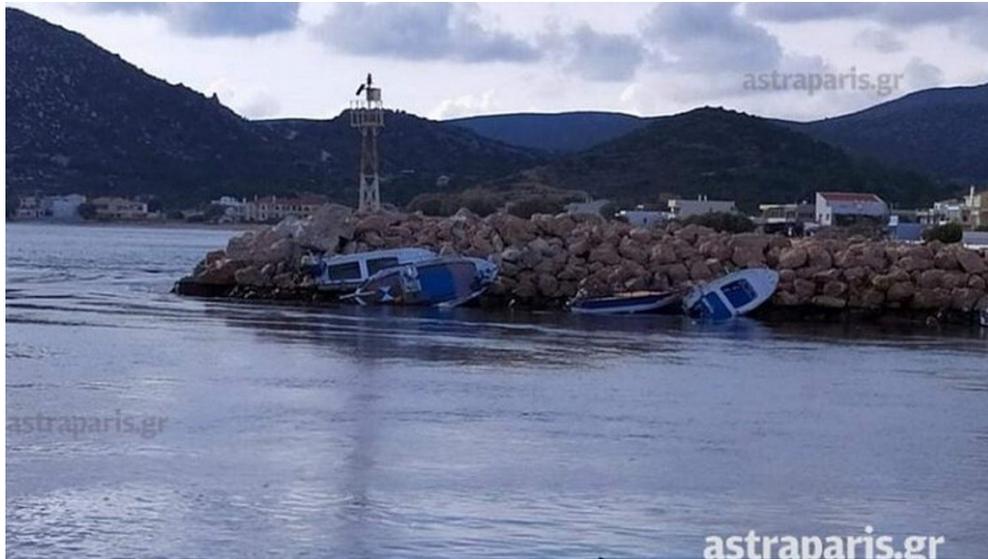
About 3 minutes later, the water level started rising again, and about an hour after the arrival of the first wave, the water level rose to ~1.10 m. above mean sea level. The water level fluctuations were intense for about 3 hours after the 1st wave arrival. Small boats that were docked in the small harbor of Komi were swept ashore along the breakwater (Figure 2.24). The eyewitness estimated the maximum horizontal inundation at the beach to be ~20 m.

Figure 2.24. Small boats were swept away and put ashore along the breakwater of the harbor of Komi, Chios (<https://15minutes.gr/>).

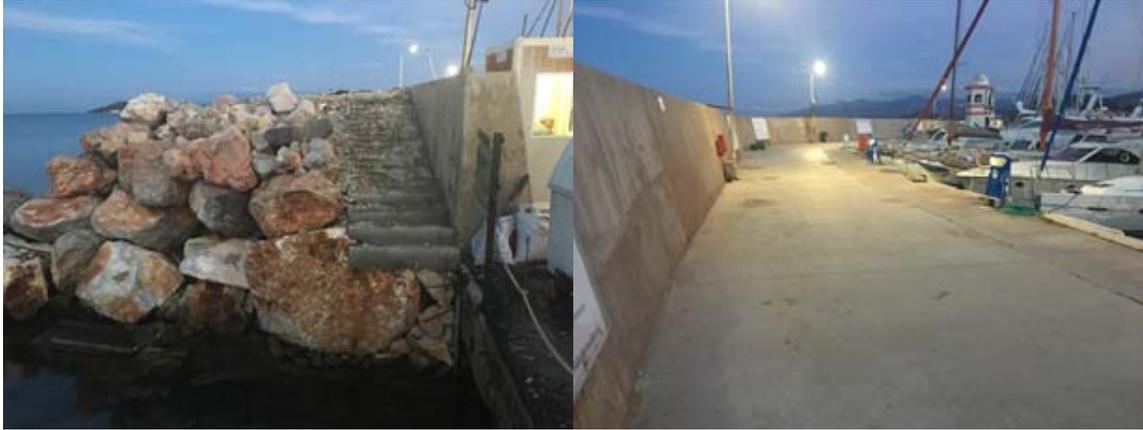
During the post-earthquake survey, no damage on the rubble mound breakwaters, i.e., settlement or damage on the armor layer of any rubble mound protection, was observed (Figures 2.25 and 2.26).

Figure 2.25. Rubble Mound Breakwater with the crown wall in Urla Fishery Harbor.

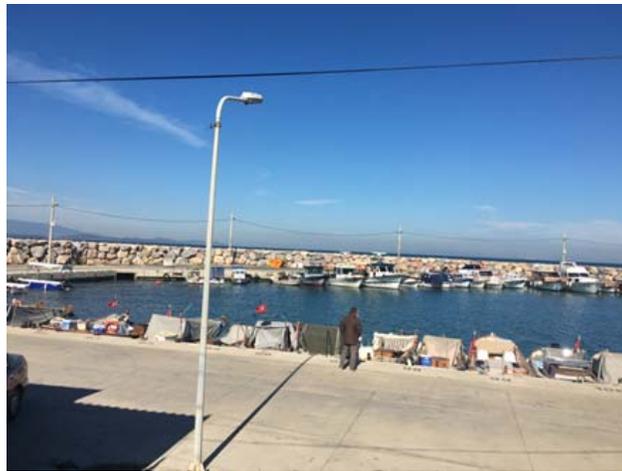
Figure 2.26. Rubble Mound Breakwater without crown wall in Guzelbahce Fishery Harbor.

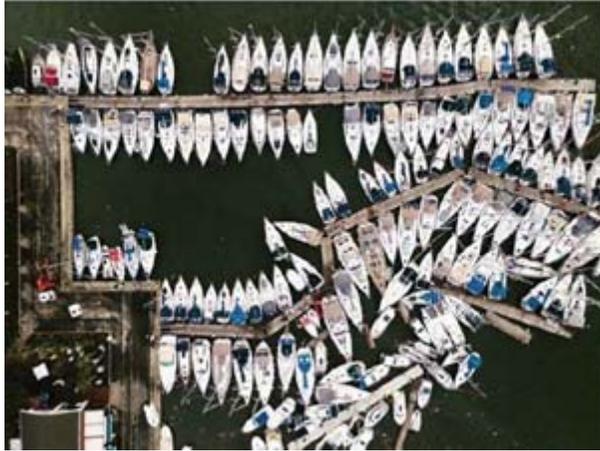
Contrary to the concrete block type, piers composed of floating pontoons in Teos Marina were the most damaged mooring structures. The damage was not due to the earthquake shaking but entirely due to tsunami hydrodynamic forces. Two dramatic photos of the floating piers shared on social media are shown in Figures 2.27 and 2.28.

Figure 2.27. Floating Piers in Teos Marina after tsunami attack.

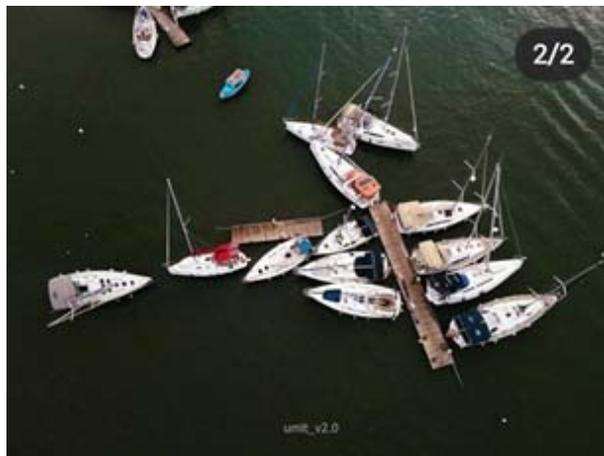
Figure 2.28. Drift of floating piers in Teos Marina after tsunami attack.

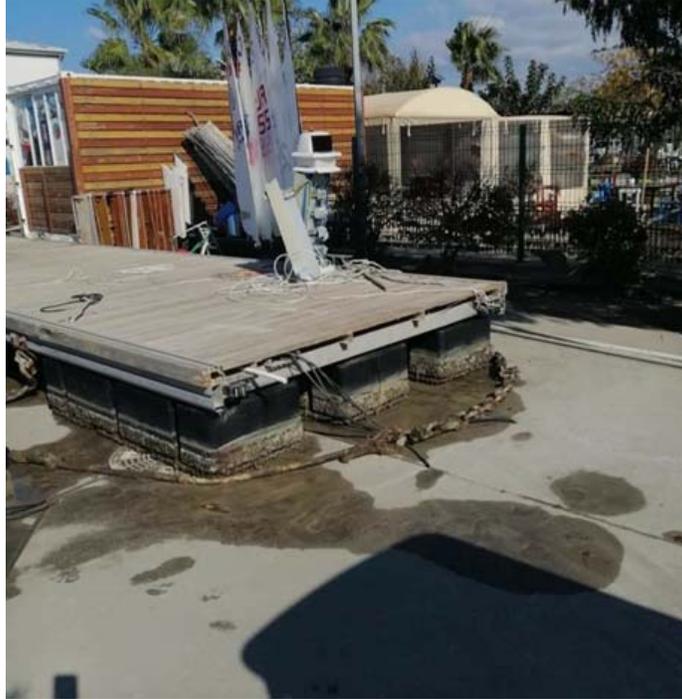
The pontoons of Teos Marina were constructed using floaters under an aluminum frame (Figure 2.29). The pontoon length and width were 20 and 2.5 m, respectively. The pontoons were connected to the gravity type anchorage at the seafloor by both steel chains and ropes. Apparently, strong tsunami currents broke the moorings, and the pontoons were dragged and detached. Moreover, aluminum pontoons and the moored ships were damaged. During the survey, the detached pontoons were moored to another location, as can be seen in Figure 2.30; these photos also show buckling in the rings at the fairlead. The ropes and the chains were broken off. In contrast to the aluminum pontoons, the concrete floating pontoon was not damaged (Figure 2.31).

Figure 2.29. One of the pontoons used in Teos Marina (floaters are at the bottom).

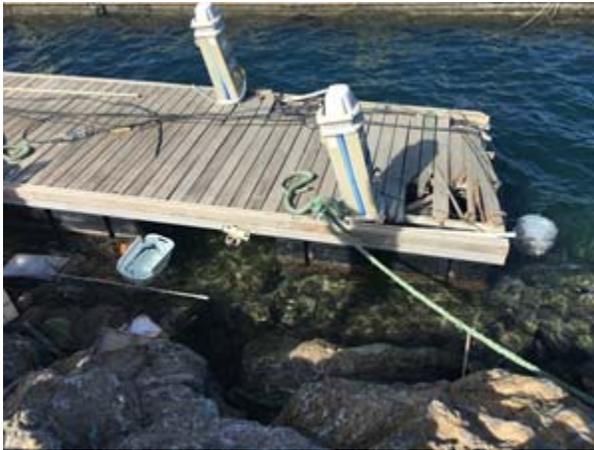
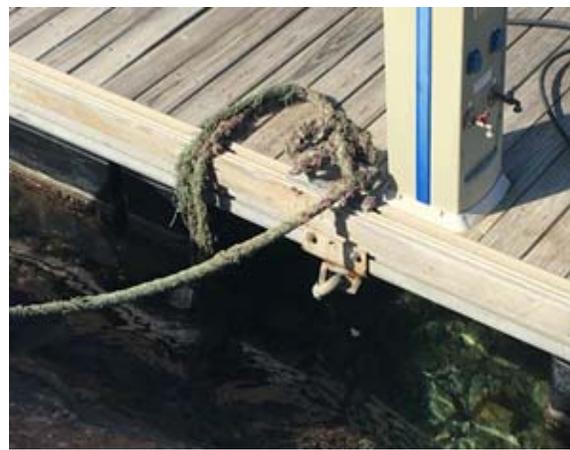
Figure 2.30. Damages in the pontoons and rings at the fairleads.

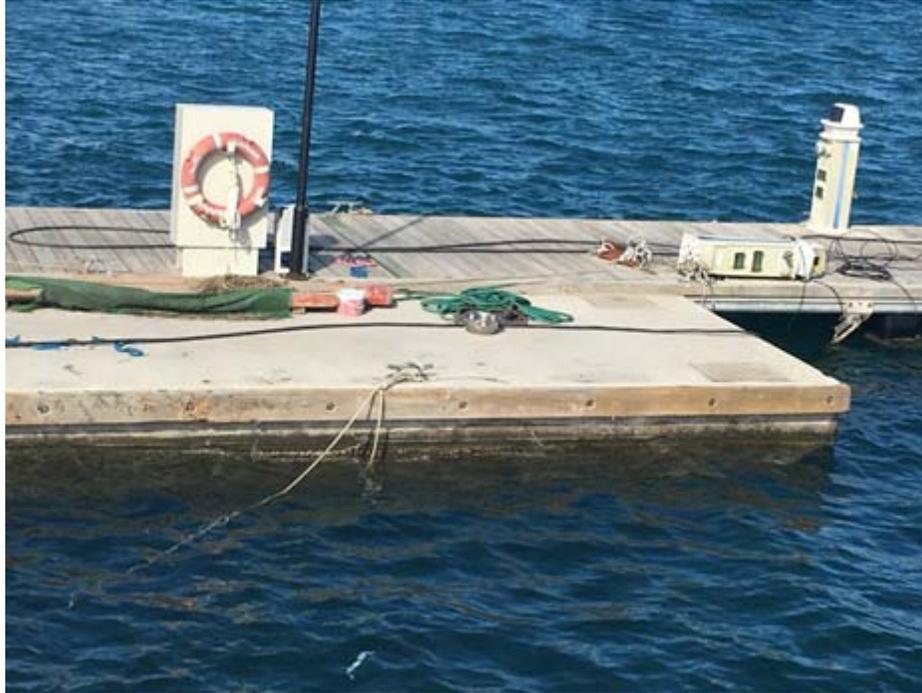
Figure 2.31. Undamaged concrete pontoon in Teos Marina.

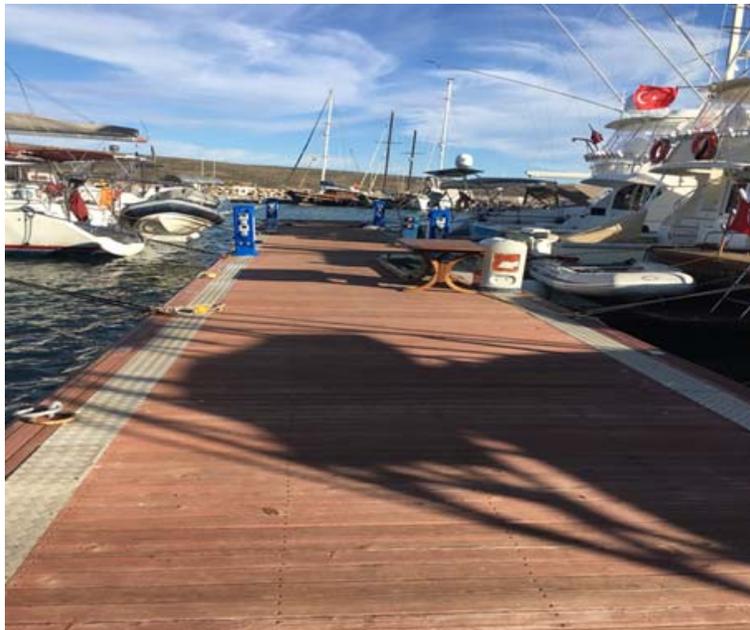
Similar observations were made for concrete pontoons in other marinas. For example, in Alacati Marina, the sea level rose by 1.5-2 m, but the pontoons sustained no damage (Figure 2.32).

Figure 2.32. Concrete Pontoons in Alacati Marina.

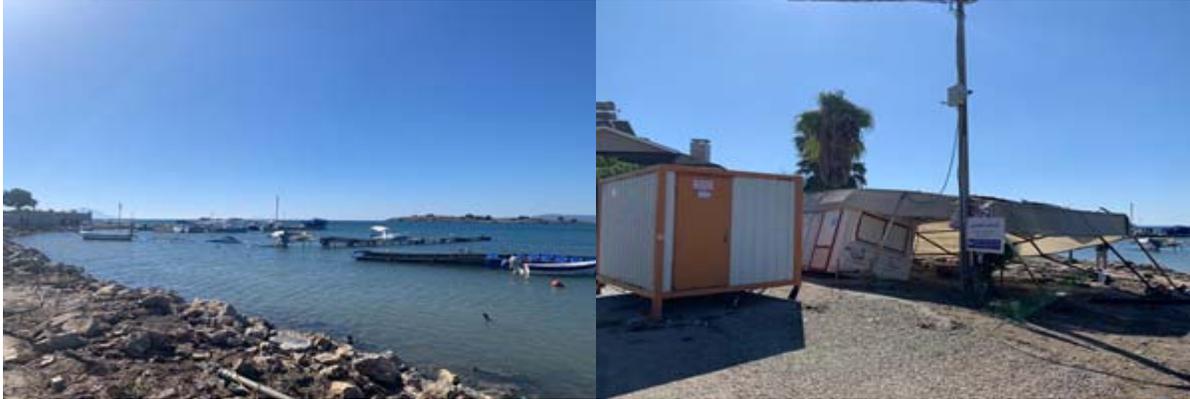
In addition to the ports and harbors previously described, the small fishery port in Akarca locality also suffered substantial damage, as all of the floating piers used for berthing and

mooring, including other seafront port facilities, were destroyed or became unusable (Figure 2.33). More than 20 boats sunk in this location, as reported by the president of Seferihisar fishery cooperative (Mr. Mustafa Gul).

Figure 2.33. Observed damage in the floating piers used for berthing and mooring and the seafront harbor facilities in Akarca fishery shelter.

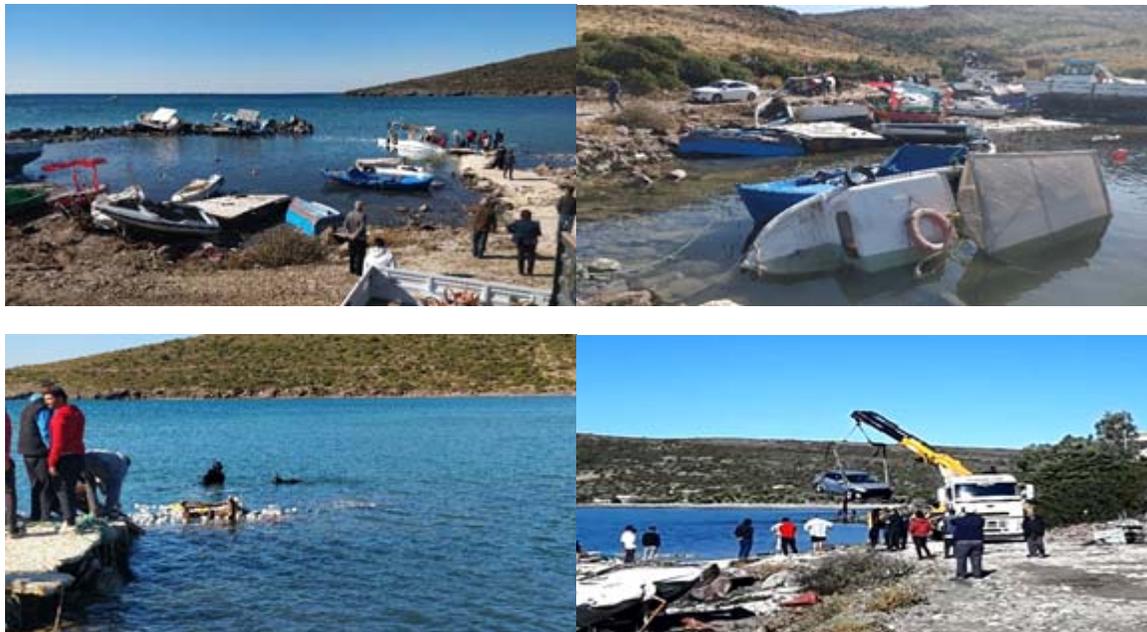
We also examined serious tsunami damage in another small fishery shelter in the Zeytineli locality (Figure 2.34). The non-engineered mooring and berthing structures and all boats in the shelter were destroyed, requiring a reconstruction. The parked cars on the shore drifted to the sea and the boats that sank also required rescue operations.

Figure 2.34. Photos showing the heavy damage and rescue operation of a car which was dragged into the water by the tsunami in Zeytineli fishery shelter (38.19336N 26.49233E); all of the boats and mooring facilities were unusable after the tsunami.

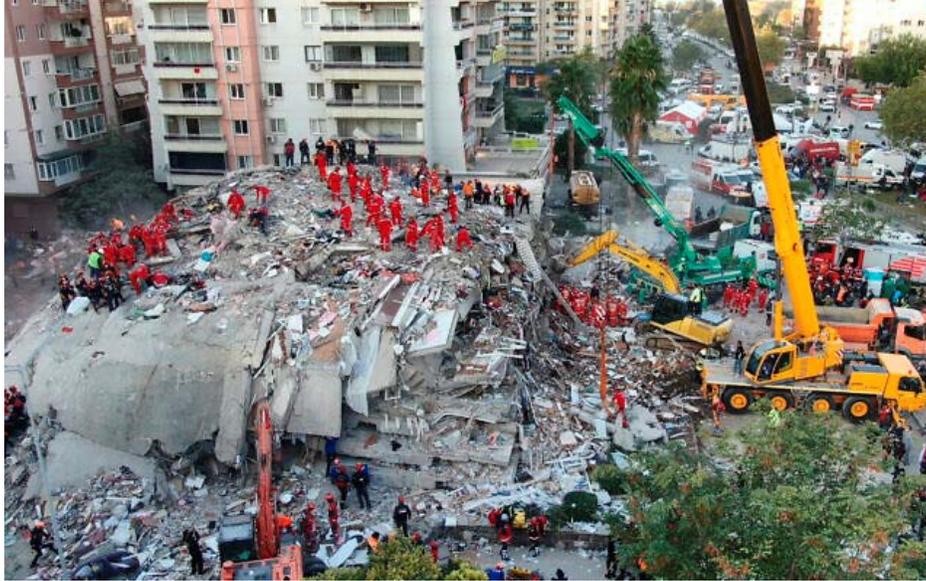
However, even these unusually amplified and prolonged seismic demand, was below the design basis response spectra. The recent event is not classified as a design basis event, but more of a 72 year return period event, and is not expected to cause structural damage, not to mention hundreds of collapsed or heavily damaged buildings, one of which is shown in Figure 4.15. There, poor structural design and detailing, along with construction practices come into the picture, which are discussed thoroughly in Chapter 7.

Figure 4.15. Doganlar residential building, fully collapsed after the event (courtesy of Ali Aksoyer)

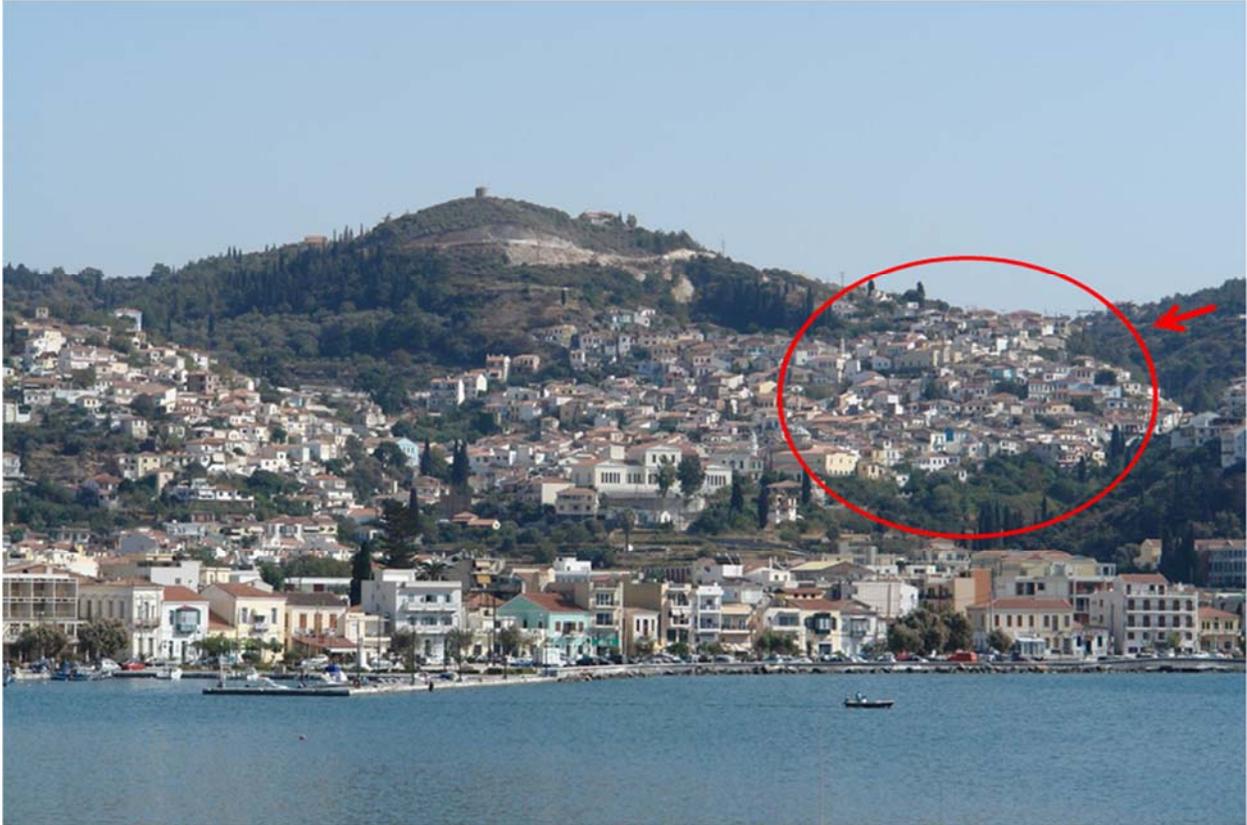
Although located only about 10 km from the ruptured area (22 km away from the epicenter), in the near fault zone, the seaside town of Vathy (Figure 4.16, from Google Earth) at the northeastern part of the island was rather lightly affected by the earthquake. Despite the tragic death of 2 high school students in Vathy, the collapsed or heavily damaged buildings were relatively few considering the magnitude of the event and the proximity to the source. Figure 4.17 shows the area of concentrated damage in the Ano Vathy district.

Figure 4.17. Ano Vathy hill (at the southeastern side of Vathy) highlighting the area of potential topographic and valley effects (Photo by Christos Giarlelis, HAEE Team).

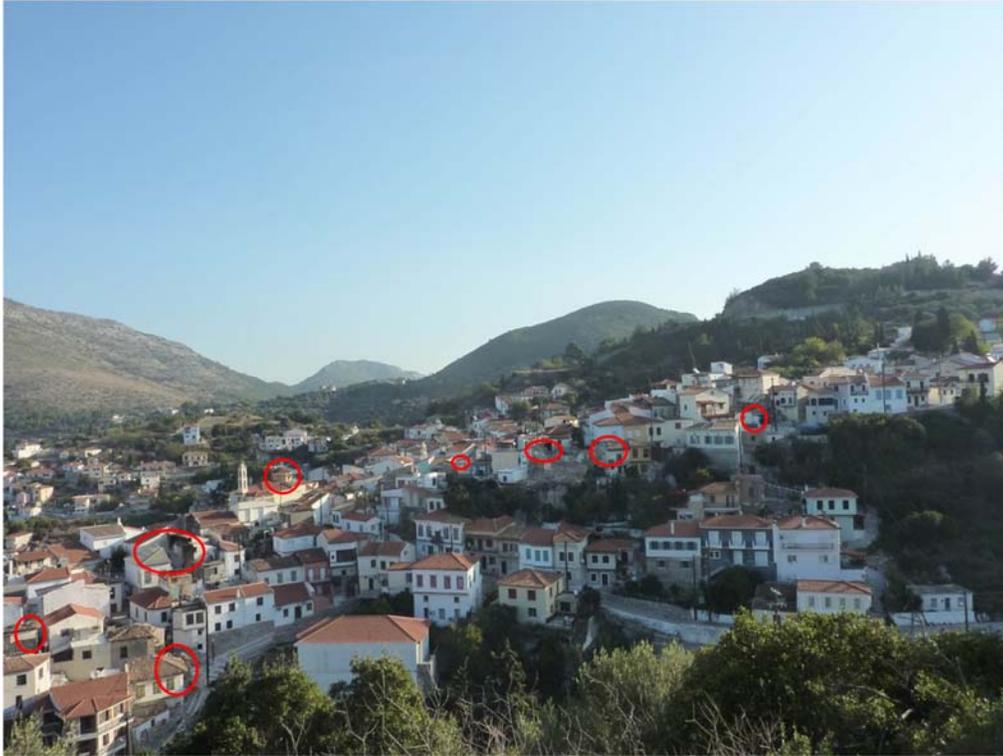
The reconnaissance efforts in the greater area of Vathy depicted a concentration of damage in the low-rise buildings of Ano Vathy, an area of about 0.1 km² resting in the southeastern side of Vathy (at a distance of 600 to 1000 m from the coastline), at an elevated location (altitude ranging from 50 to 120 m). The building stock includes several structures dating from the 19th (possibly even the 18th) century, built at a high elevation to protect the inhabitants from pirates. Examples of the observed damage are depicted in Figure 4.21 and Figure 4.22.

Figure 4.21. Ano Vathy hill: Red circles denote damaged buildings. (Photo by Christos Giarlelis, HAEE/ETAM Team).

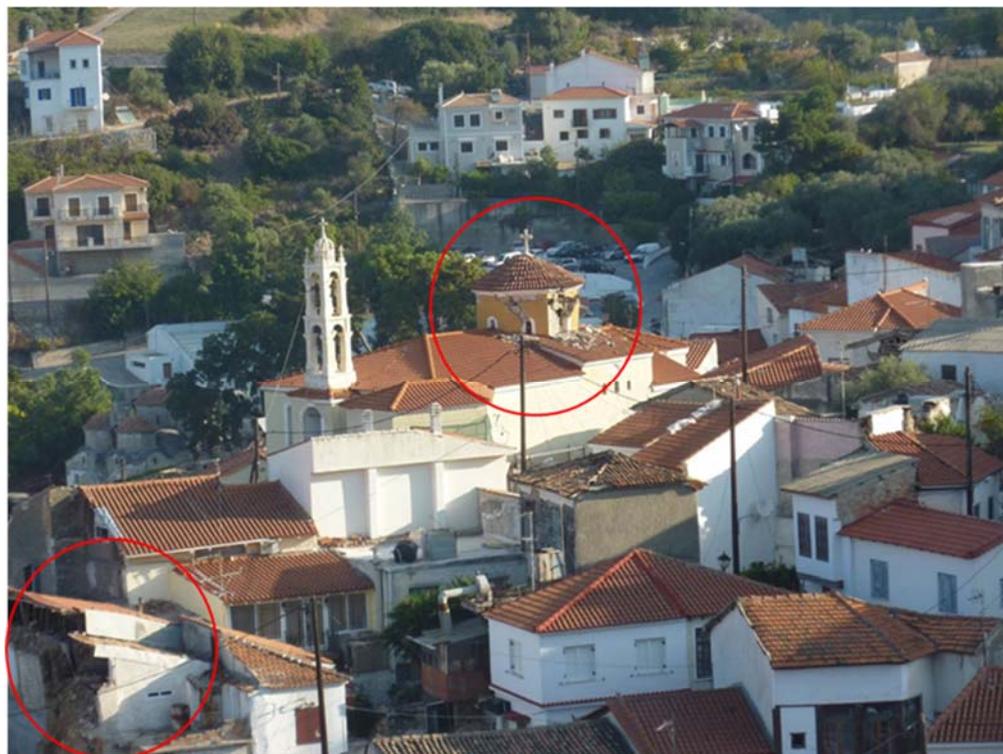
Figure 4.22. Ano Vathy: Close view of the damaged dome of the Church of Metamorphosi Sotiros and neighboring building. (Photo by Christos Giarlelis, HAEE/ETAM Team).
