Seismological and Engineering Effects of the M 7.0 Samos Island (Aegean Sea) Earthquake

Hellenic Association of Earthquake Engineering: Report 2020/02

Geotechnical Extreme Events Reconnaissance Association: Report GEER-069

December 31, 2020

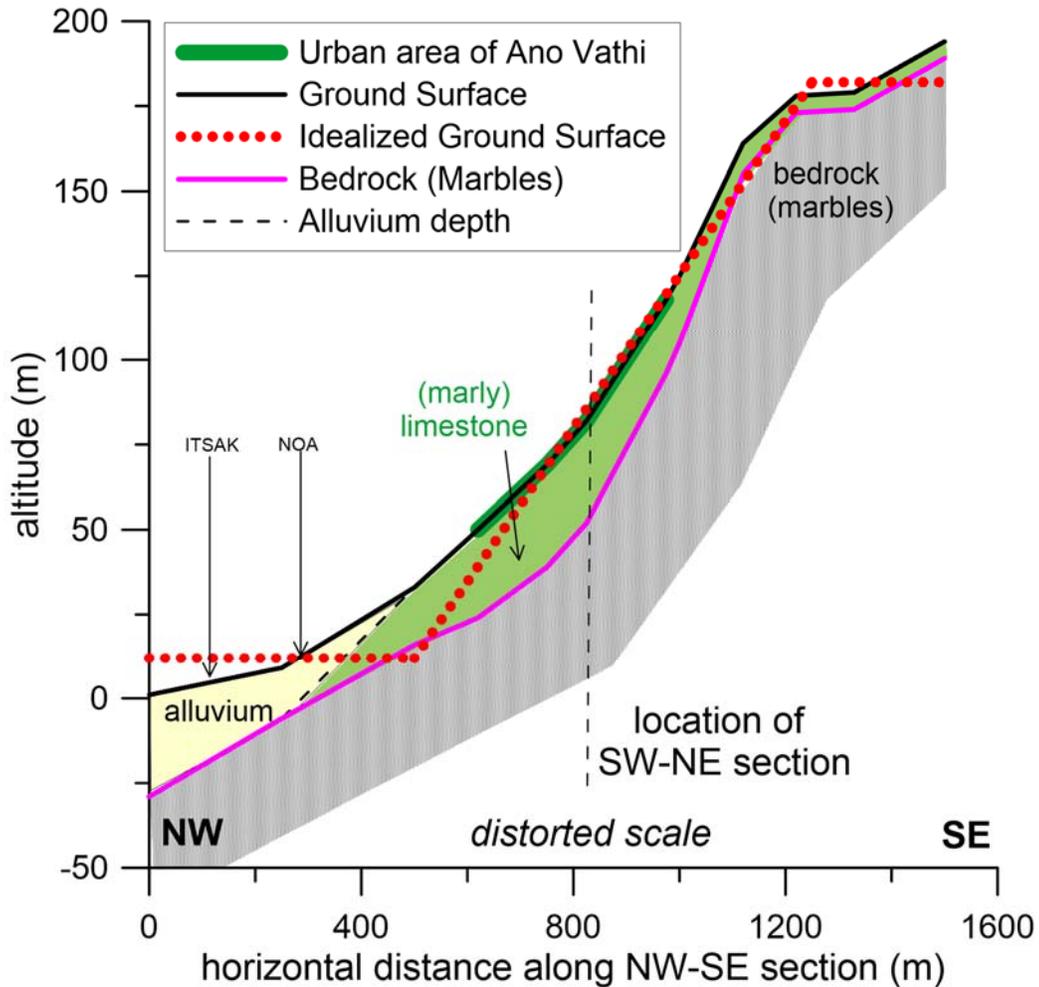
This type of ground surface topography may be marginally considered a cause of increased seismic ground motion at Ano Vathy. Specifically, according to EC8, this is possible for slopes having a height $H > 30$ m, as that shown in Figure 4.25. However, the same code prescribes that topography effects may be neglected if the inclination angle is $i < 15^\circ$. Disregarding this notion, EC8 also mentions that for ridges with crest width significantly less than the base width, a

topography factor $S > 1.2$ should be used near the top of the slopes with angles $i < 30^\circ$ (as this one). Furthermore, this S factor may be assumed to decrease as a linear function of height above the base of the cliff or ridge, and to become unity at the base. Hence, for the Ano Vathy area a factor of $S = 1.1$ may be assumed, as the average of $S = 1.2$ at $H = 170$ m and $S = 1$ at the base, given that it is located at mid-height of the slope.

Figure 4.25. Ground surface elevation and approximate geological cross section along the NW-SE section running through the damaged area of Ano Vathy. Average (idealized) inclination is 13° .

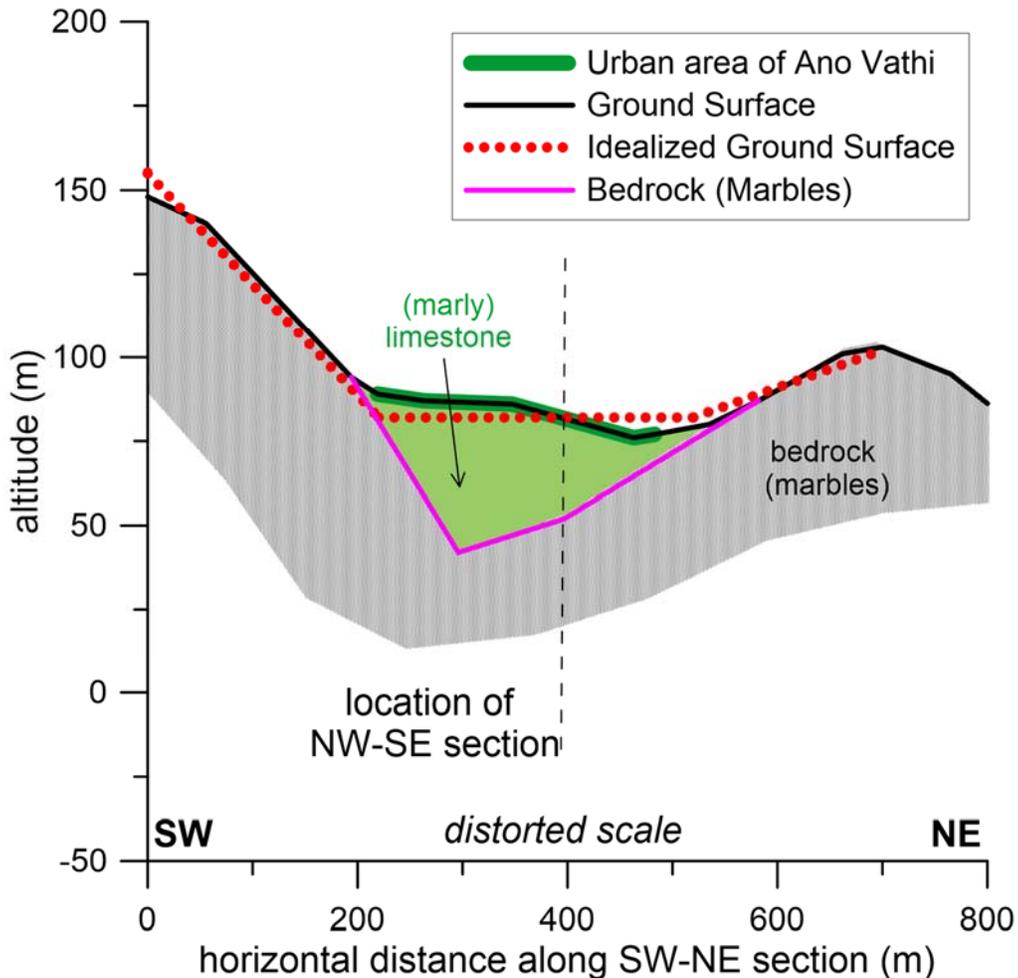
Figure 4.26. Ground surface elevation and approximate geological cross section along the SW-NE section running through the damaged area of Ano Vathy.

Figure 4.26 shows the ground surface elevation as well as the (approximate) geological layers that are to be found along the SW-NE cross section running through the urban area of Ano Vathy (see location in Figure 24). This figure also includes an idealization of the ground surface, which shows that Ano Vathy sits roughly at the top of an (approximately triangular) valley with surface width $B = 300$ m and maximum thickness $H = 40$ m at the location where the probable or covered geological fault (with a NNW-SSE direction) lies (see also Figure 4.24) at the western side of Ano Vathy. This western side of Ano Vathy exhibits the steepest bedrock inclination ($i = 28^\circ$) and

In this cross section, (ground surface) topography effects alone give negligible amplification at Ano Vathy, since it lies at the base of the canyon shaped topography where seismic strong motion is generally not significantly amplified (Papadimitriou 2019). However, the valley-shaped stratigraphy of the underlying layers may be considered a cause of increased seismic ground motion at Ano Vathy, concurrently with that due to surface topography effects that was depicted along the NW-SE direction (see Figure 4.25). It may be assumed here that the role of “soft” soil should be attributed to the marly limestone with a $V_s > 500$ m/s, that overlies the bedrock (marbles with $V_s > 800$ m/s), and consequently this valley-shaped structure is not expected to have an intense impedance contrast. Unfortunately, there are no code provisions for valley effects on seismic ground motion and any approximate estimation may only be based on the literature. For example, according to Vessia et al. (2011), this valley has a thickness over half-width shape ratio $SR = 40/(300/2) = 0.27$ (intermediate-depth valley), leading to an amplification of at least 35%, on top of ordinary 1D soil amplification. In this case, this value should be considered an upper limit, since the valley material is not soft alluvium and the horizontal acceleration has a low frequency content (predominant period 0.5 sec), thus increasing the predominant shear wavelength to values comparable with the valley width and much larger than the valley thickness (Papadimitriou 2019). However, the aforementioned 35% amplification may be considered an appropriate value if one also considers any 1D soil amplification (Ground Category B as per EC8), as well as the enhanced amplification effect due to the outcropping bedrock slopes (Papadimitriou 2019). This is especially so at its western side where the bedrock slopes are relatively tall (73m). In addition, this valley configuration may have also created low frequency (predominant period 0.5 sec) parasitic vertical accelerations, that should be in the order of 10% of the horizontal acceleration (Papadimitriou et al. 2018).

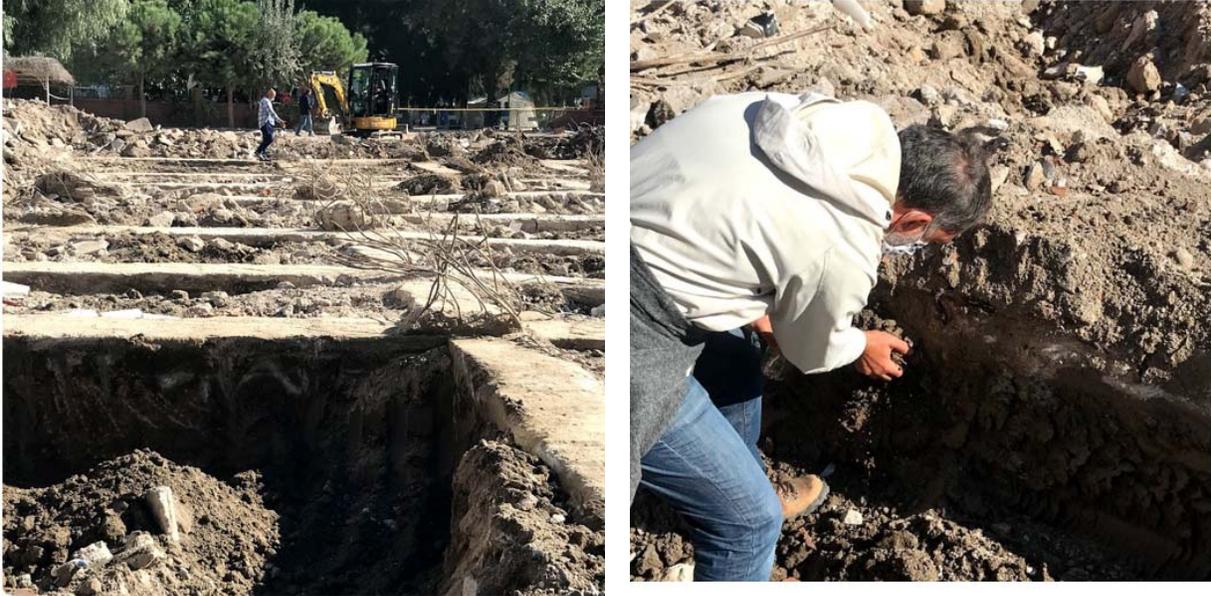
Moreover, no foundation-induced structural failure mechanisms were observed or reported for the collapsed or heavily damaged buildings in Bayrakli and Bornova districts. For residential structures up to 7-9 stories, foundation systems were mostly selected as two-way combined footings or individual footings with strap beams. Mat foundations are not very commonly used

as foundation elements of these low to mid-rise buildings belonging to pre-1995 period, despite the soft nature of underlying foundation soils. Figure 5.3 presents the foundation system of one of the fully collapsed buildings in Bayrakli.

Figure 5.3. Two-way combined footing system of a heavily damaged building in Bayrakli

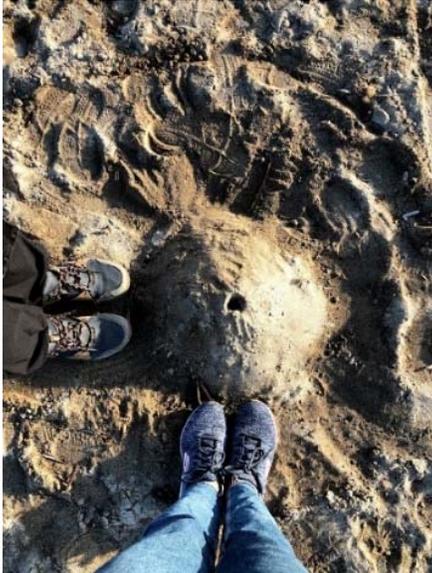
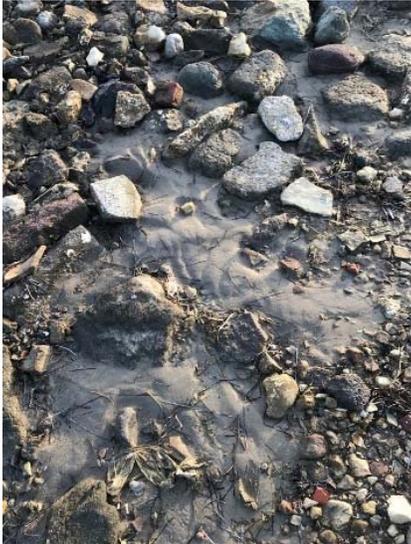
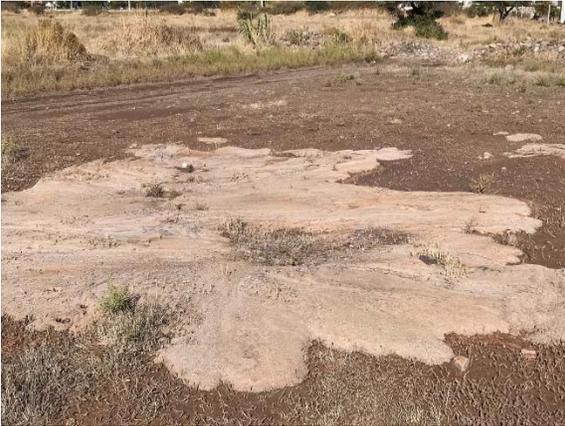
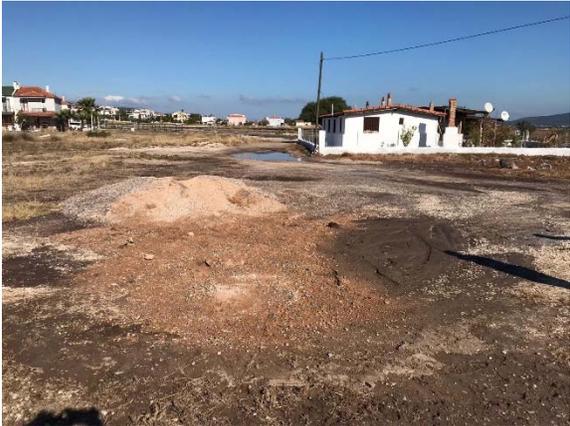
Consistent with USGS predictions, at 45-50 km away from the rupture, along the shores of Icmeler and Gulbahce districts, sand boils were observed, as shown in Figure 5.11 (a) through (d). These sites were close to Gulbahce fault zone, and artesian pressures along with hot water springs are known to be present, which are also believed to have contributed to the observed

Figure 5.11. Surface manifestations of earthquake-induced soil liquefaction in the form of sand boils at a) $38^{\circ}20'18.4''N$ $26^{\circ}38'51.0''E$ and b) $38^{\circ}18'37.3''N$ $26^{\circ}40'47.1''E$, c) and d) 38.338088 N, $26.647763E$

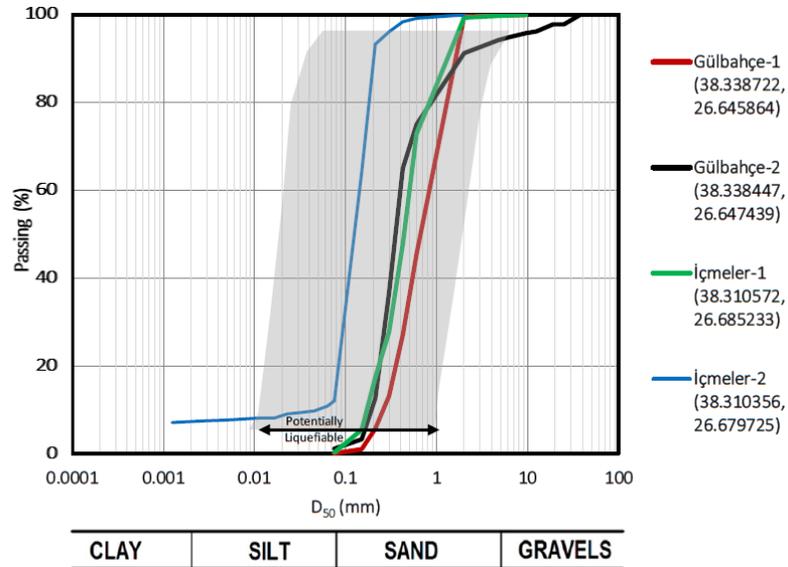
soil ejecta formation. The soil samples were retrieved from sand ejecta, and sieve analyses were performed on these samples, the results of which are presented in Figures 5.12 (a) and (b).

Figure 5.12. Grain size distribution curves of sand ejecta obtained from Gulbahce

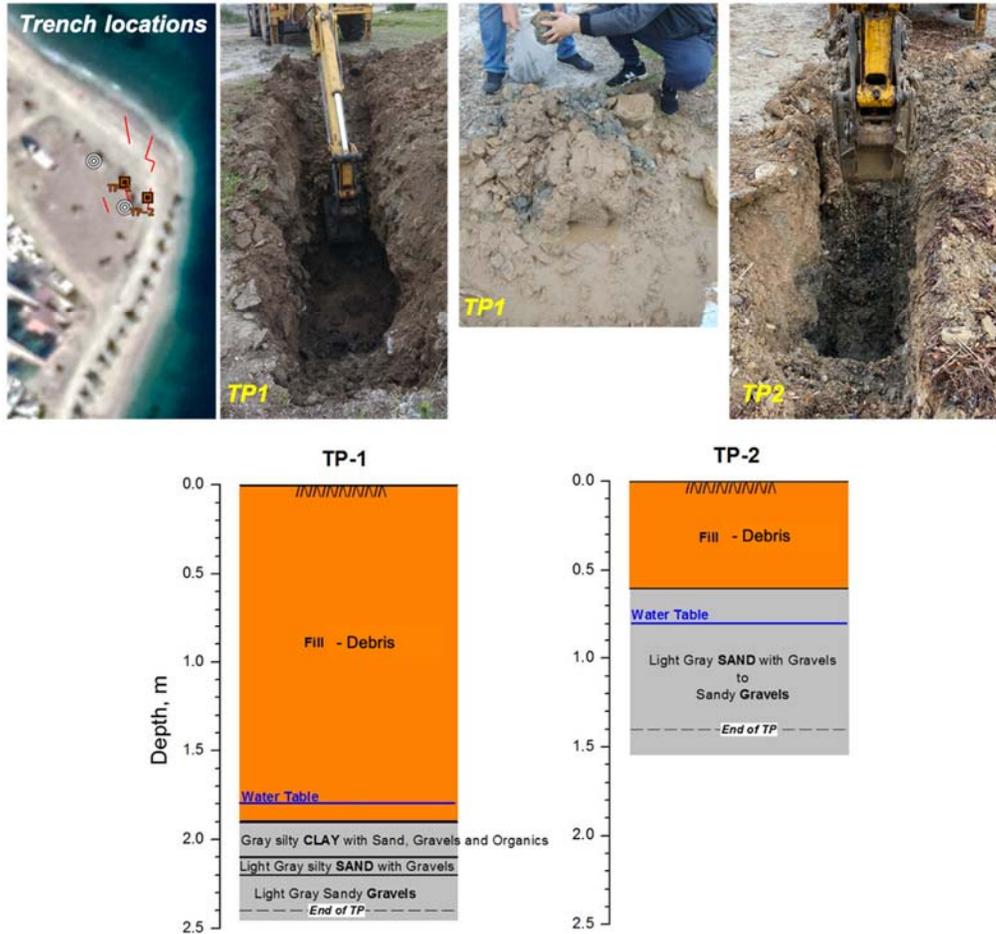
Professor Panagiotis Pelekis performed trenching and soil sampling at two locations at the Malagari site, which yielded two rough cross-sections and three grain size distributions for samples at three distinct depth intervals at the site illustrated in Figures 5.15 and 5.16 respectively. The fines portion in all three samples was found to be non-plastic.

Figure 5.15. Trenching at the Malagari liquefaction site and rough stratigraphy resulting from it (courtesy of Professor P. Pelekis).

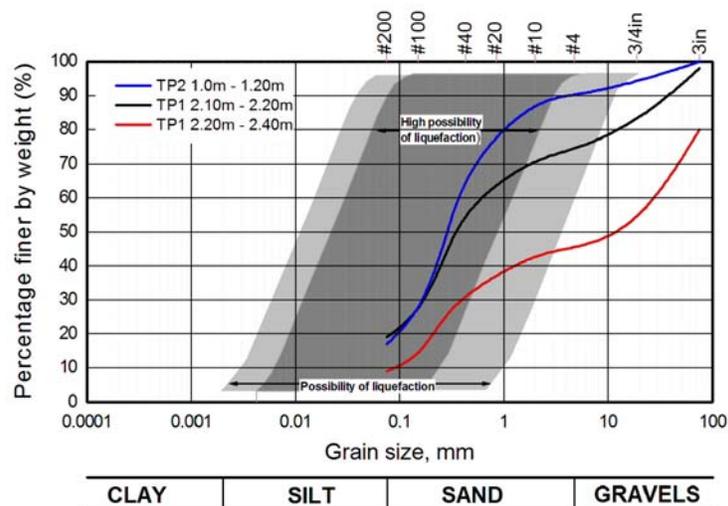
Figure 5.16. Grain size distributions of three samples retrieved from different depths at the two trenching locations at the Malagari liquefaction site. The fines were found to be non-plastic (NP).

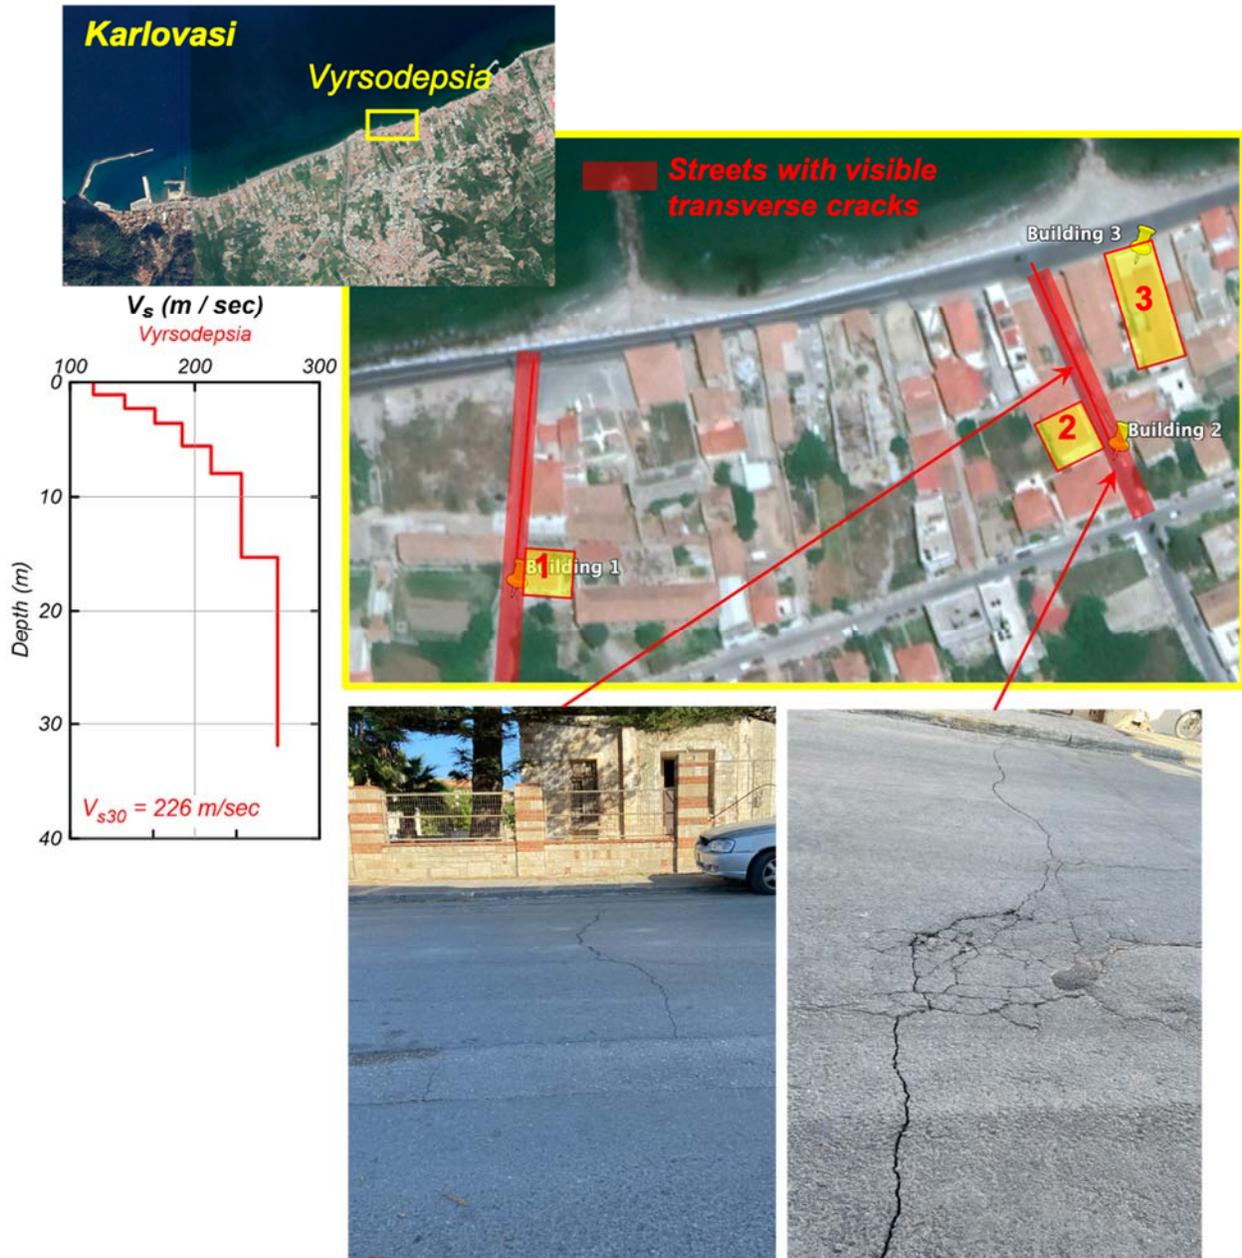
Structural damages at some nearshore locations were compatible with a lateral spreading failure mechanism. Specifically, Figures 5.18 and 5.19 illustrate three buildings and their location close to the north shore of the island, in the neighborhood Vyrsolepsia in Karlovasi. No surface manifestation of liquefaction was identified nearby, but the ground cracking crossing the street pavement and running through the buildings (the two in Figure 5.18 are about 70 m inland and the one in Figure 5.19 is about 20 m inland), in combination with the level/mildly sloping ground, the shallow water table, and the free face to the sea are all compatible with the hypothesis of lateral spreading.

Figure 5.18. Plan view of Karlovasi and Vyrsopepsia neighborhood with buildings likely affected by lateral spreading towards the seafront alongside with shear wave velocity profile of the area [data courtesy of Professor Panagiotis Pelekis]. The enumerated buildings are individually shown in Figures 5.20 and 5.21.

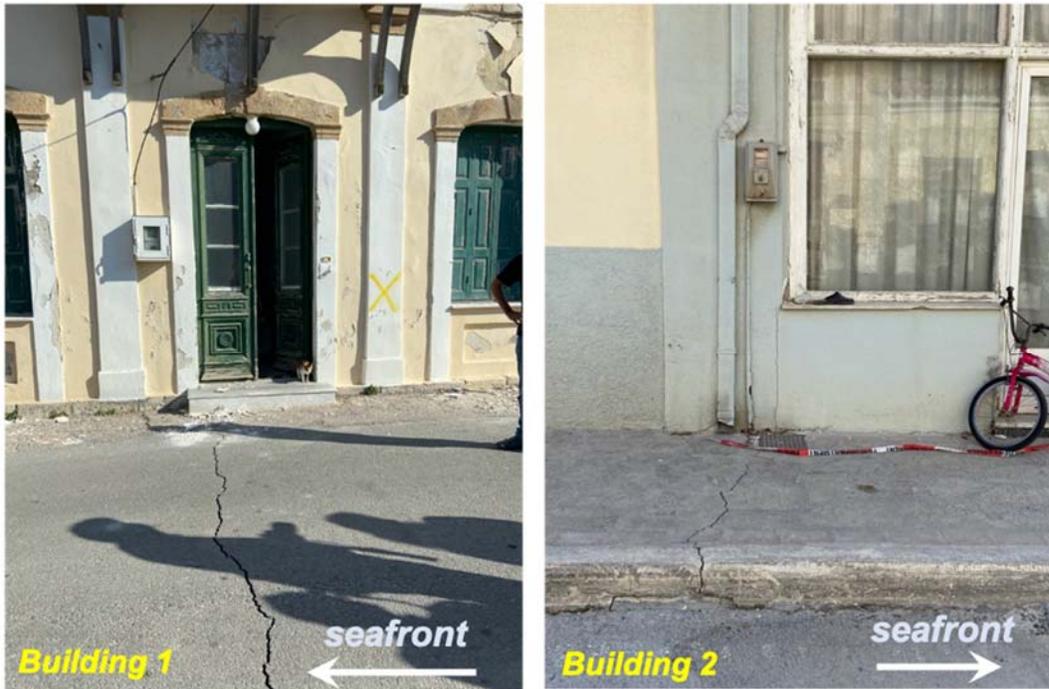
Figure 5.20. Buildings likely affected by lateral spreading towards the seafont in the neighborhood of Vyrsopepsia in Karlovasi (left: $37^{\circ}47'57.6''N$ $26^{\circ}42'12.5''E$ and right: $37^{\circ}47'59.3''N$ $26^{\circ}42'20.0''E$) [photos taken by the HAEE reconnaissance team]

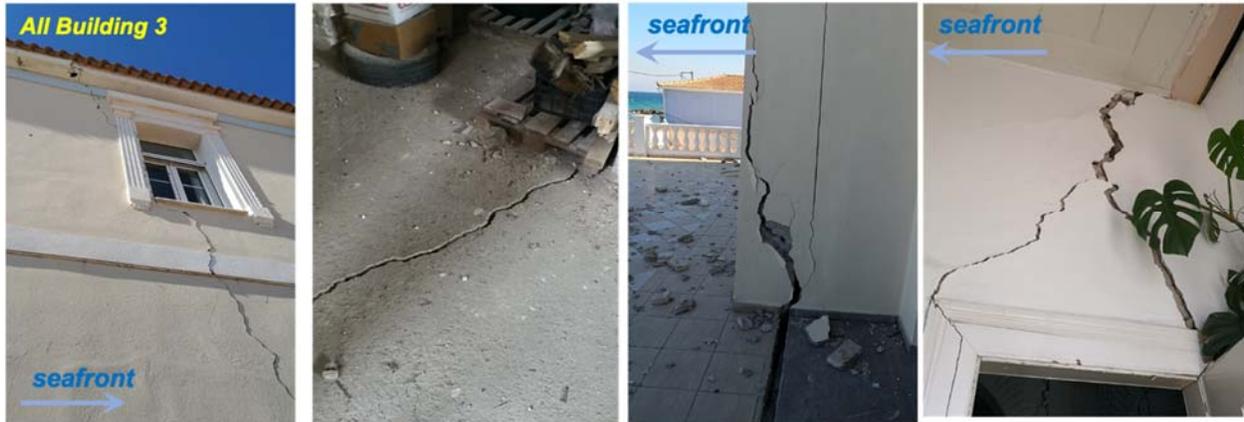
Figure 5.21. Building affected by lateral spreading towards the seafront in the neighborhood of Vyrsopepsia in Karlovasi ($37^{\circ}48'01.1''N$ $26^{\circ}42'20.6''E$). The cracks observed running across the building indicate 3-5cm of movement. [Photos courtesy of Prof. K. Antonopoulos]

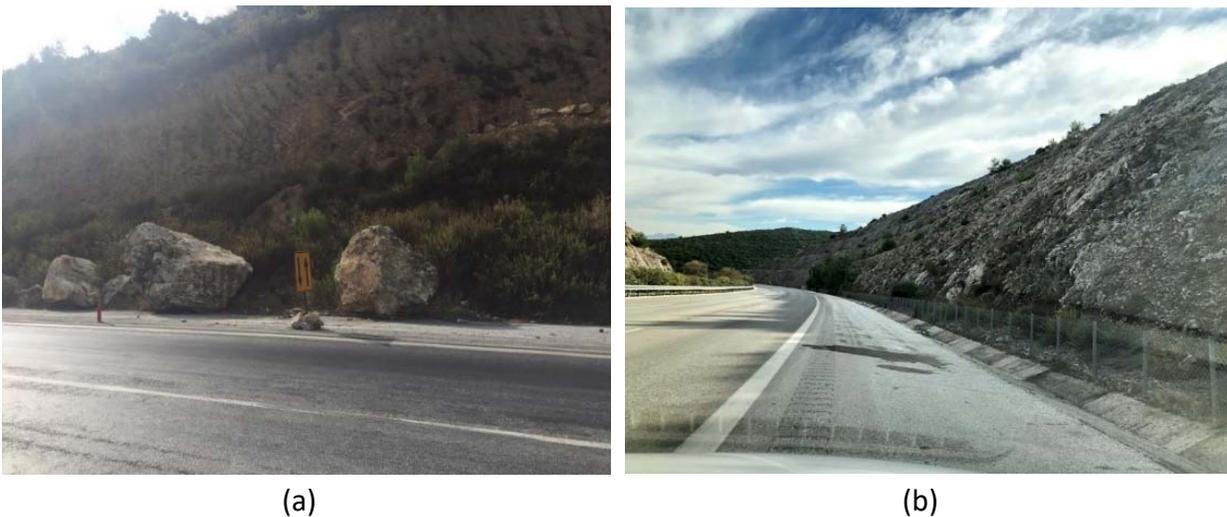
A limited number of rockfalls were observed by the benches of highways, one of which is illustrated in Figure 5.22. Some potential and existing landslide sites were also visited, but no signs of seismically induced movements were documented, one of which is shown in Figure 5.22 (b).

Figure 5.22. a) Fallen rock blocks ($37^{\circ}53'50.4''N$ $27^{\circ}22'06.2''E$, b) A view from a highway cut with potential for slope instability ($38^{\circ}17'31.6''N$ $26^{\circ}40'14.6''E$)

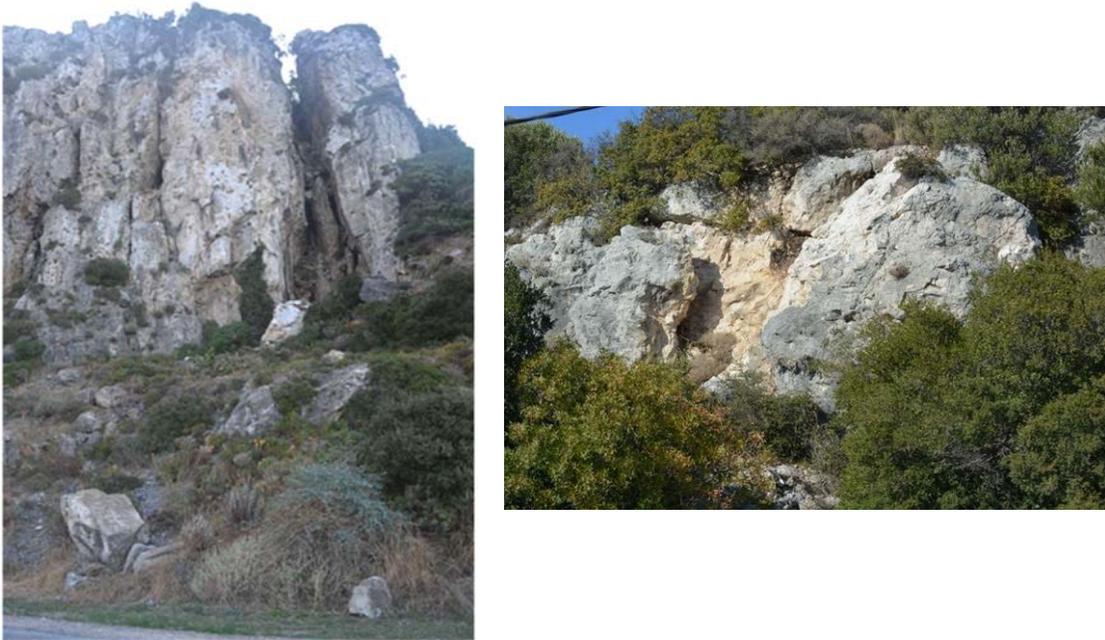
Figure 5.27. Left: Rockfalls recorded at the road network close to the village Potami ($37^{\circ}47'17.6''\text{N}$, $26^{\circ}40'00.5''\text{E}$), Right: Detachment of limestone segments close to the village Koumeika (photos taken by the HAAE reconnaissance team, $37^{\circ}42'33.7''\text{N}$, $26^{\circ}44'52.9''\text{E}$).

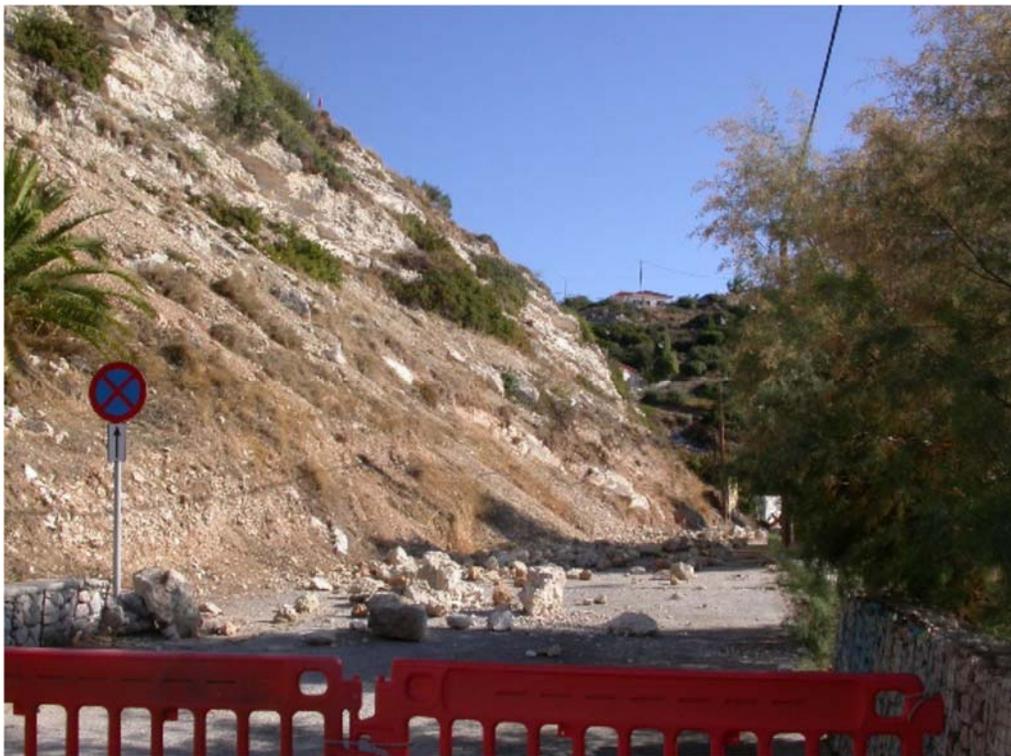
A weathered rock slide was recorded at a steep slope close to Avlakia region (Figure 5.25), which caused a temporary closure of the road. It is reiterated that the main geological formations in the above area are marbles with intercalations of schist (see Chapter 4). However, the road access was quickly recovered after a few days by temporary restraining measures with large concrete blocks placed at the slope toe (Lekkas et al. 2020). Detachments of sandy marls and marly limestones were recorded very close to a residential building in Kokkari region (Figure 5.26), while lighter failures referring to rockfalls and detachments of limestones, were observed close to the villages Potami (Figure 5.27 – left) and Koumeika (Figure 5.27 – right). Slope failures of similarly low intensity were also recorded by other reconnaissance teams. These include limestone segments falls at the area of Remataki (next to Pythagorio – Figure 5.28) or rockfalls close to the village Stavrinides (Figure 5.29).

Figure 5.28. Limestone segments falls to a provincial road in Remataki region (photo reported in Lekkas et al. 2020).

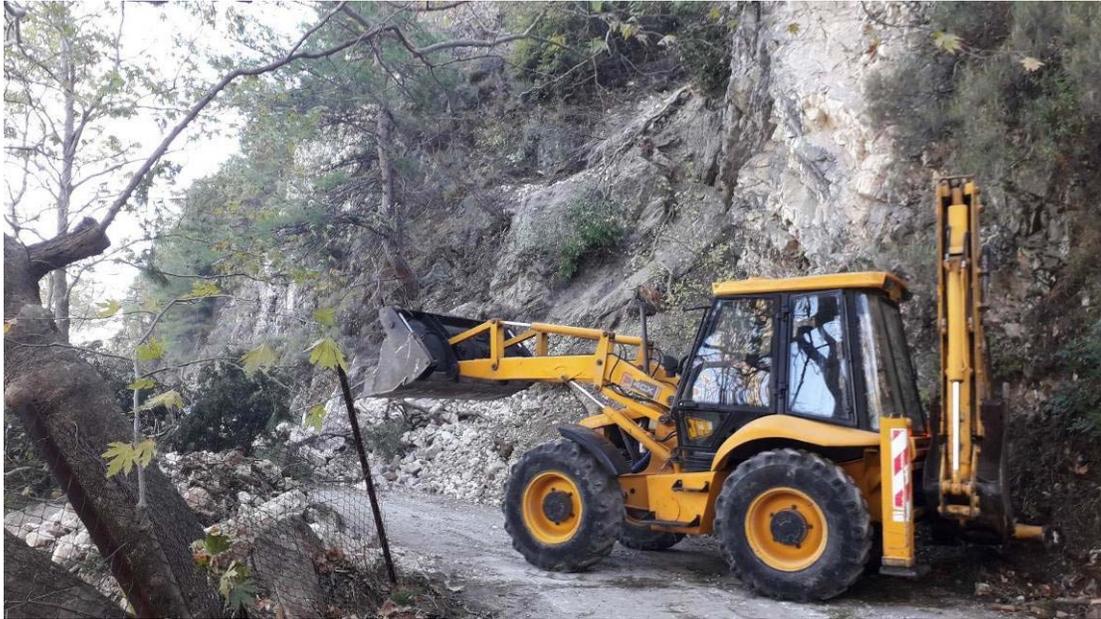
Figure 5.29. Slope failures close to the village Stavrinides (photo reported in HSGME 2020).

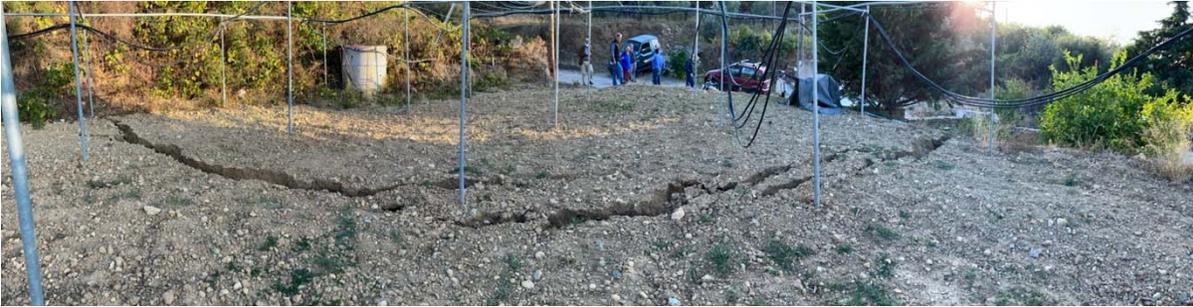
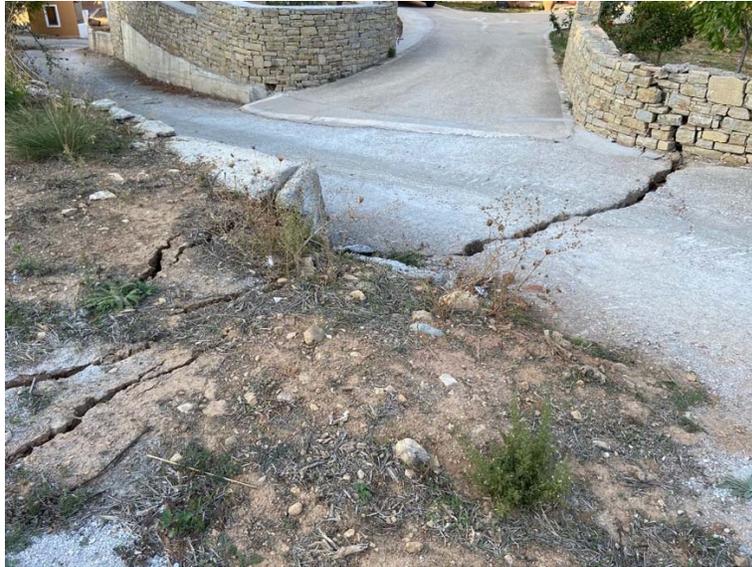
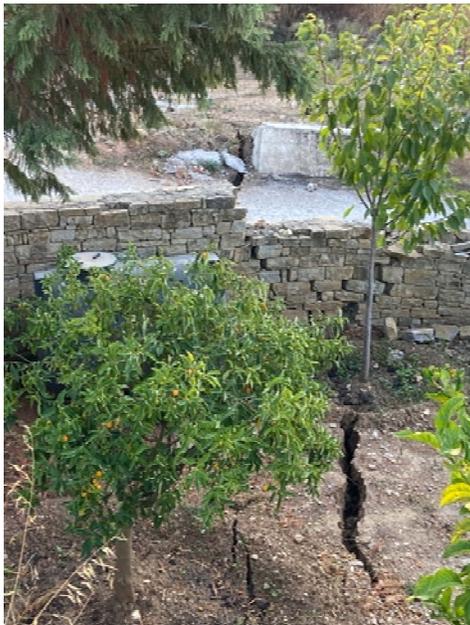
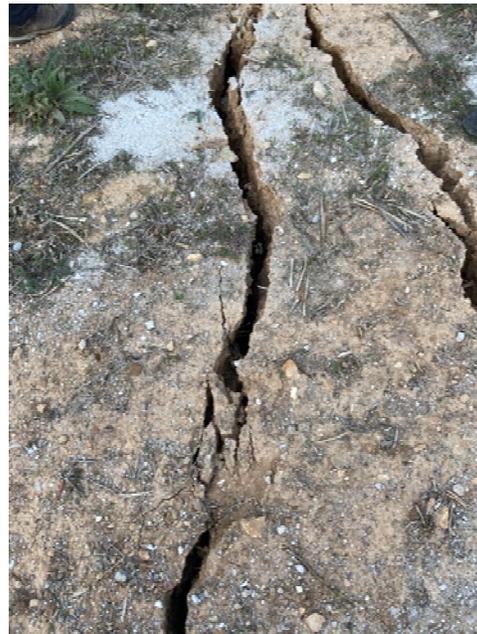
In the village of Kontakeika, extended ground cracks (openings of about 10 – 20 cm) were observed that were compatible with the mobilization of a larger, albeit very mild, slope or could be more broadly characterized as seismically-induced secondary ground failures. The HAAE team did not locate other similar indications of ground cracking in the near or extended vicinity of Kontakeika so it is hard to draw conclusions regarding the nature of this observation. (According to local engineers, the Municipality of Samos had repaired the pavement in that particular location several times in the past, which suggests a pre-existing creeping landslide that got reactivated by the earthquake.) The cracks were extending from soft soil formations, crossing the street and extending to soil formations across.

Figure 5.30. Ground and pavement cracks in the village of Kontakeika (Samos), indicative of the mobilization of an extended but mild slope or more broadly characterized as seismically-induced secondary ground failures. The cracks extended on both sides of the street through soft soil formations.

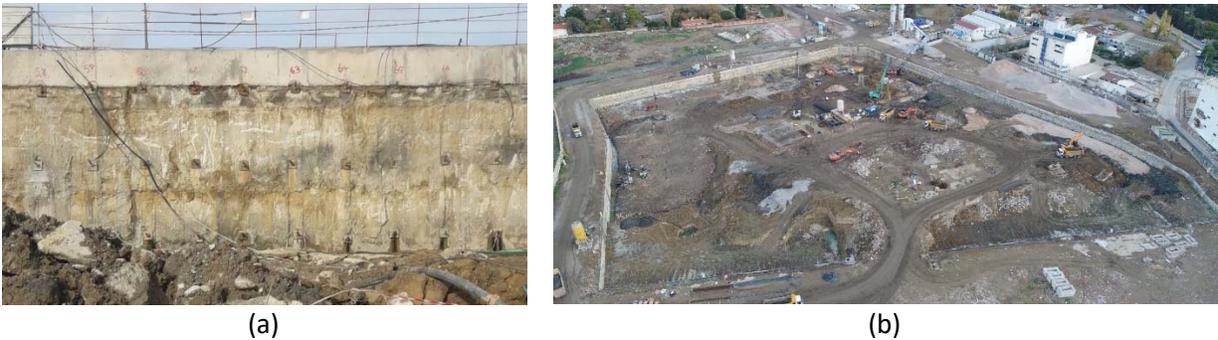
In the sedimentary district, two well-monitored deep excavation systems, which were under construction in the last three months before the earthquake, were shaken. Both of these systems reached a depth of about 9 m; their (satisfactory) performance was recorded by instruments. (Fig. 5.31). No failure or relaxation of pre-stressing loads on anchors was measured/observed. These observations are also supported by inclinometer measurements taken before and after the earthquake. The measurements suggest that the lateral displacements accumulated during the earthquake are less than 2 mm. These displacements are illustrated in Fig. 5.32.

Figure 5.31. a) A picture taken earlier from the shored deep excavation located in the “new downtown” district (37°53'50.4"N 27°22'06.2"E, b) Plan view of the site

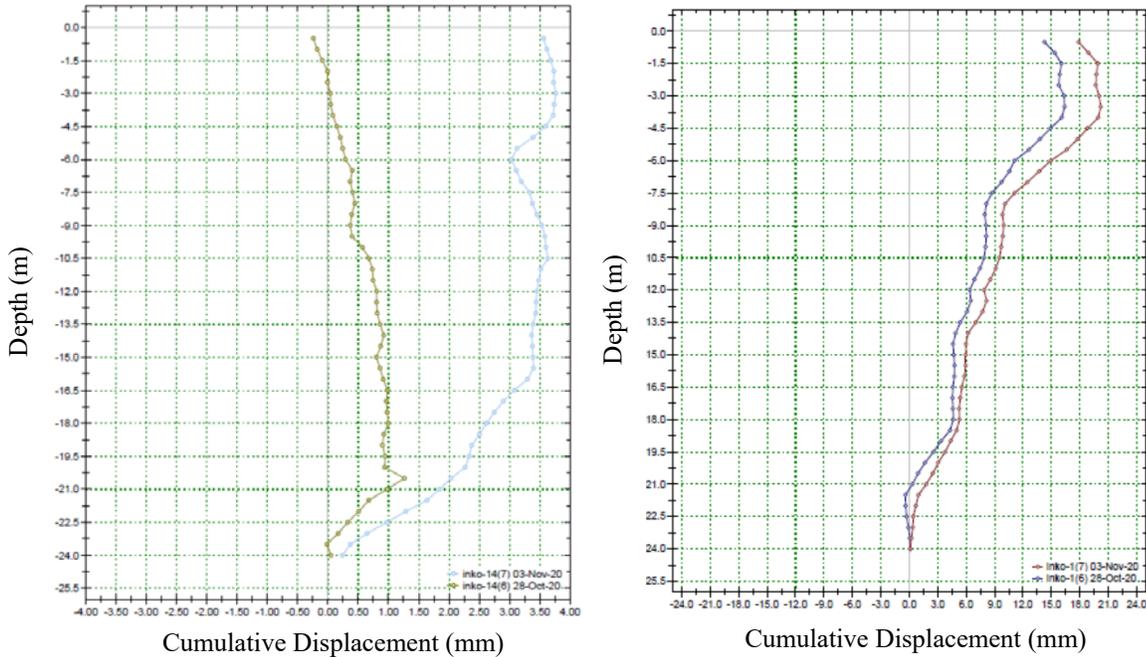
Figure 5.32. Inclinometer data covering the period of earthquake shaking, at a 9m-deep excavation, supported by diaphragm walls.

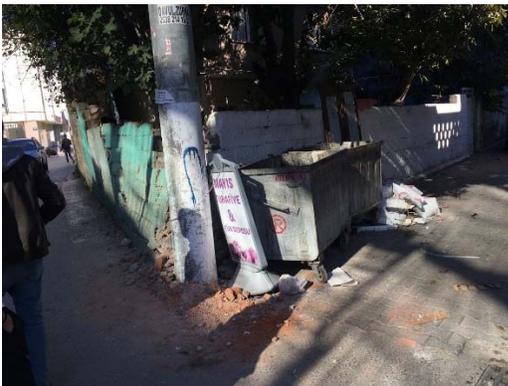
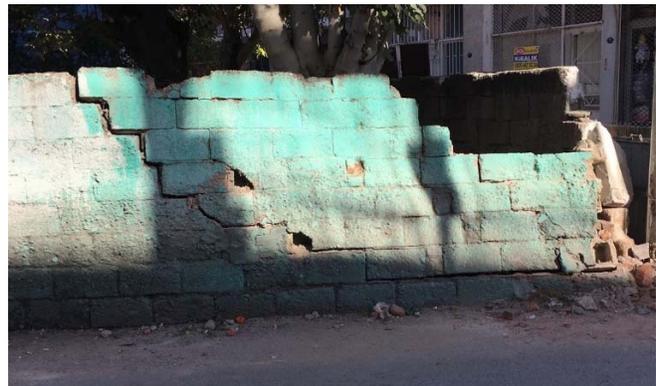
There are no reported failures of engineered retaining structures in Turkey. During the reconnaissance studies, a limited number of tilted and/or partially collapsed safety walls were observed, as documented in Figures 5.33 through 5.35.

Figure 5.33. No signs of soil liquefaction. Tilted and partially collapsed very poor safety walls (38°27'24.6"N 27°10'53.1"E/ 11:10/ 04.11.2020).

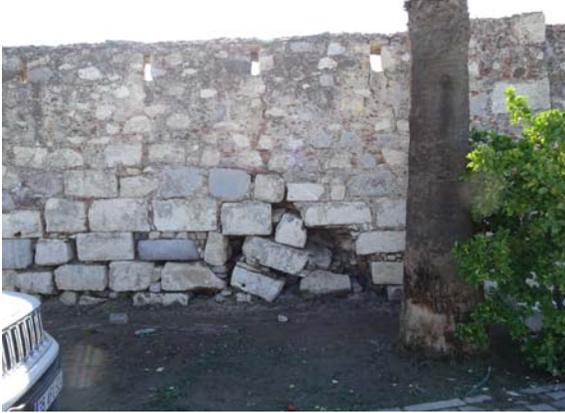
Figure 5.34. Deformed and cracked safety wall $38^{\circ}11'40.93''\text{N } 26^{\circ}47'3.47''\text{E} / 14:16 / 31.10.2020$

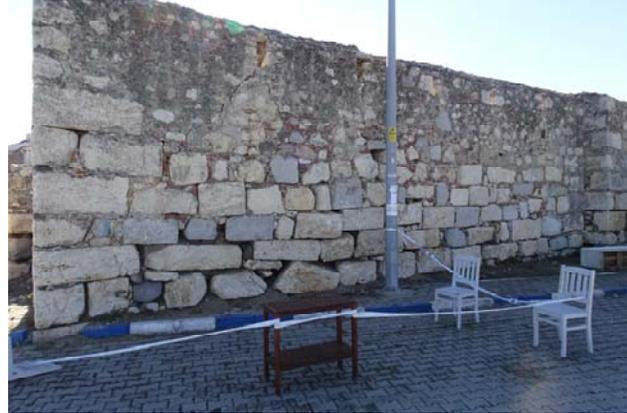
Figure 5.35. Deformed and cracked safety wall $38^{\circ}11'40.34''\text{N } 26^{\circ}47'3.22''\text{E} / 14:22 / 31.10.2020$

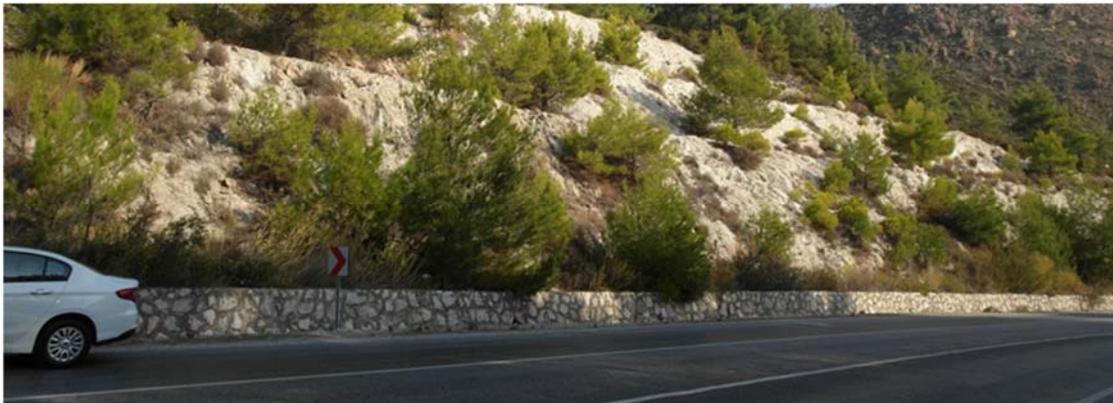
Additionally, no damage on retaining walls due to seismic shaking was likewise encountered during the reconnaissance inspections of the sites in the south of İzmir province, as shown in Figure 5.36. These stone walls are generally used to provide a buffer area between the cut slopes and highway to obstruct or retard the shallow failures to reach the highway. Regardless of the height of these stone walls, no seismically-induced deformations or failure was observed on the highway connecting Menderes to Gumuldur.

Figure 5.36. Short, stoned retaining walls on the toe of the highway cuts between Menderes and Gumuldur in the south of İzmir city center.

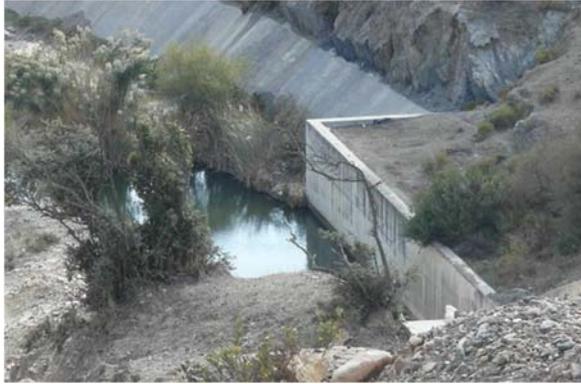
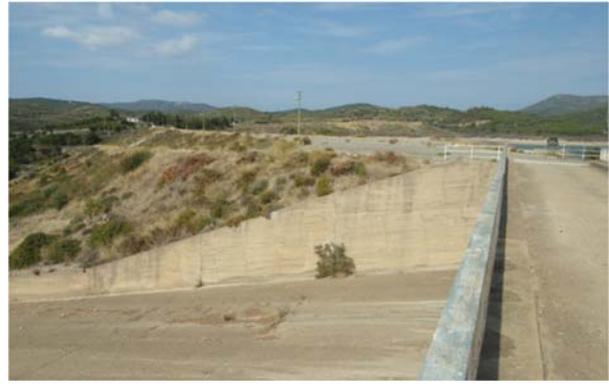
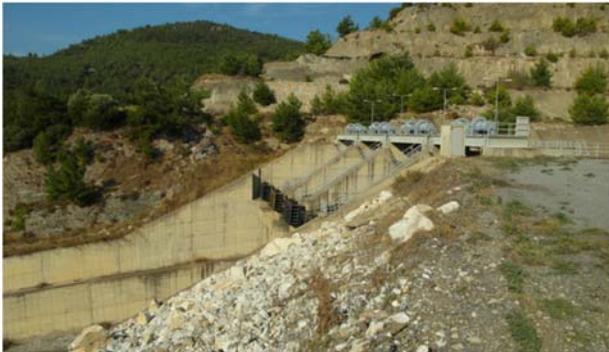
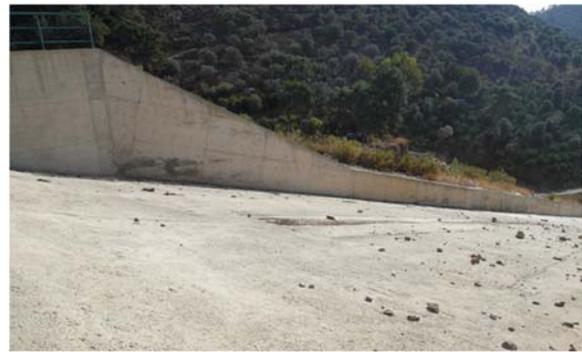
Figure 5.37 shows the sides of the spillway channels of the dams in the region. No sign of any structural damage was likewise observed on these walls.

Figure 5.37. (a) Wall on the end of spillway chute of Kavakdere Dam, and side walls of spillways of (b) Urkmez Dam, (c) Tahtalı Dam, and (d) Gumuldur Dam

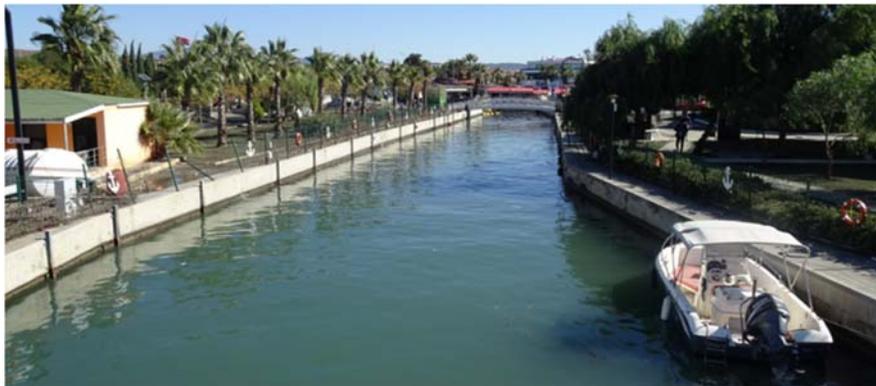
Figure 5.38 shows the sidewalls of the river canal in Sığacık Marina, hit by the tsunami after the earthquake. No structural distress can be observed on these walls, which suggests that the severity of shaking was modest despite its proximity to the rupture. Additionally, no signs of liquefaction or permanent deformations were reported.

Figure 5.38. Sidewalls of the river canal in the Sığacık Marina (Photo: Courtesy of Gurel Özdemir). (38°11'33.86"N 26°47'4.07"E 14:16 / 31.10.2020)

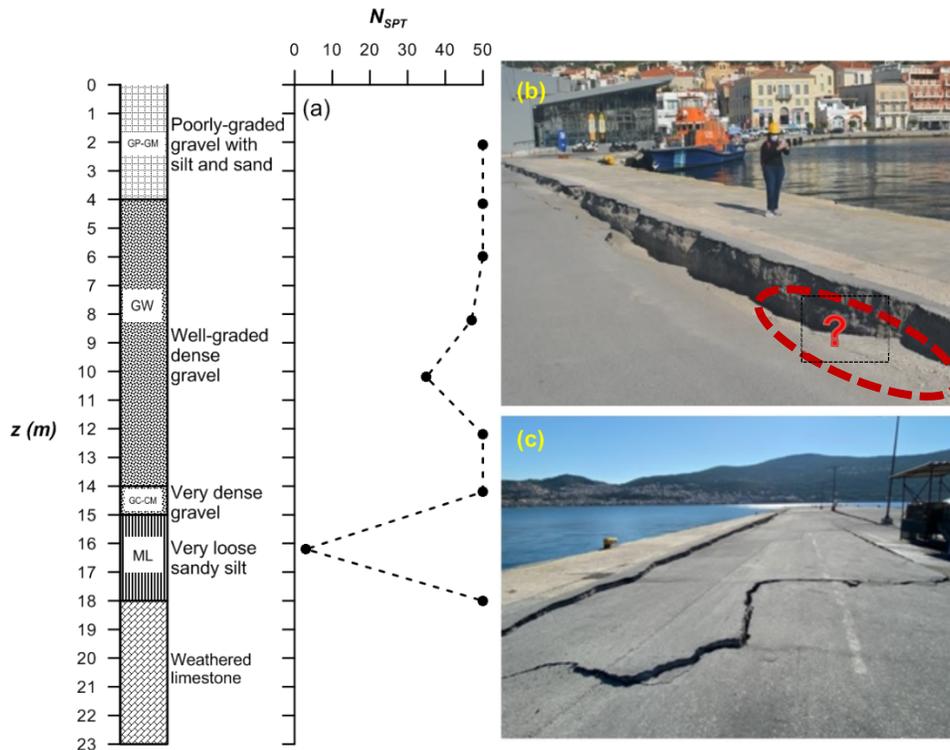
The jetty of the eastern (old) port experienced extensive longitudinal and transverse open cracks - several centimeters wide - whilst the backfill behind the quay wall experienced a subsidence that locally exceeded 50 to 60 cm (Fig 5.42). In the upper part of the figure, traces of gravels and sand are visible behind the quay wall. These might be remnants of ejecta partially washed out by the tsunami. The presence of ejecta could be the result of liquefaction of a very loose sandy silt layer located 15 to 18 m deep, right beneath the backfill material (Fig. 5.42). Similar observations of ejecta behind quay walls have been made in many previous earthquakes (Professor G. Bouckovalas – *personal communication*), even in the absence of any native liquefiable soil layer. As such, any observed ejecta may be due to liquefaction and wash out of a loosely deposited fine silty-sand phase which fills the voids of a typically much coarser backfill gravel skeleton that does not participate in the load-carrying capacity of the wall (Professor G. Bouckovalas – *personal communication*). This could explain the lack of excessive displacements and rotations of the wall towards the sea. Construction records from the said ports and further investigations can elucidate this further.

Figure 5.42. Top right (b): subsidence of backfill material behind the quay wall at the eastern (old) port, measuring up to 60 cm. Down right (c): 10 – 15 cm wide longitudinal and transversal open cracks, located on the pavement over the backfill material, in contact with the quay wall. Left part: a crude log of borehole S-1 located at the jetty of the old port where the liquefiable layer of the very loose sandy silt layer is located at a depth of 15 m (*borehole kindly provided by G. Millionis - elaboration by Em. Rovithis*)

On the basis of the above data, it is possible that the upper 15 m of borehole BH1 is material that has been superimposed over the layer of very loose sandy silt, which most likely is the preexisting natural layer (often found in ports and bays). This material appears highly deformable, with very low bearing capacity, so that cracks and deformations might have already existed. Discussions with the local port engineers, revealed that the pavement was mildly cracked prior to the earthquake (pers. communication with Mrs. Sechioti). If this is indeed the case, then most probably the cracks might have simply further opened/intensified after the earthquake. Also, it

needs to be verified whether the traces of sand and gravel shown in Fig. 5.42 are 1) ejecta from a distinct layer that liquefied, 2) ejects from a finer sand portion in the coarser skeleton of the backfill, or 3) just a natural product of friction and bouncing between the backfill material and the quay wall following their detachment. Given the preliminary observations and the experience for other earthquakes in the broader area and their effects on similar infrastructure, it is more likely that the latter two explanations are the most plausible ones.
