Seismological and Engineering Effects of the M 7.0 Samos Island (Aegean Sea) Earthquake

Hellenic Association of Earthquake Engineering: Report 2020/02

Geotechnical Extreme Events Reconnaissance Association: Report GEER-069

December 31, 2020

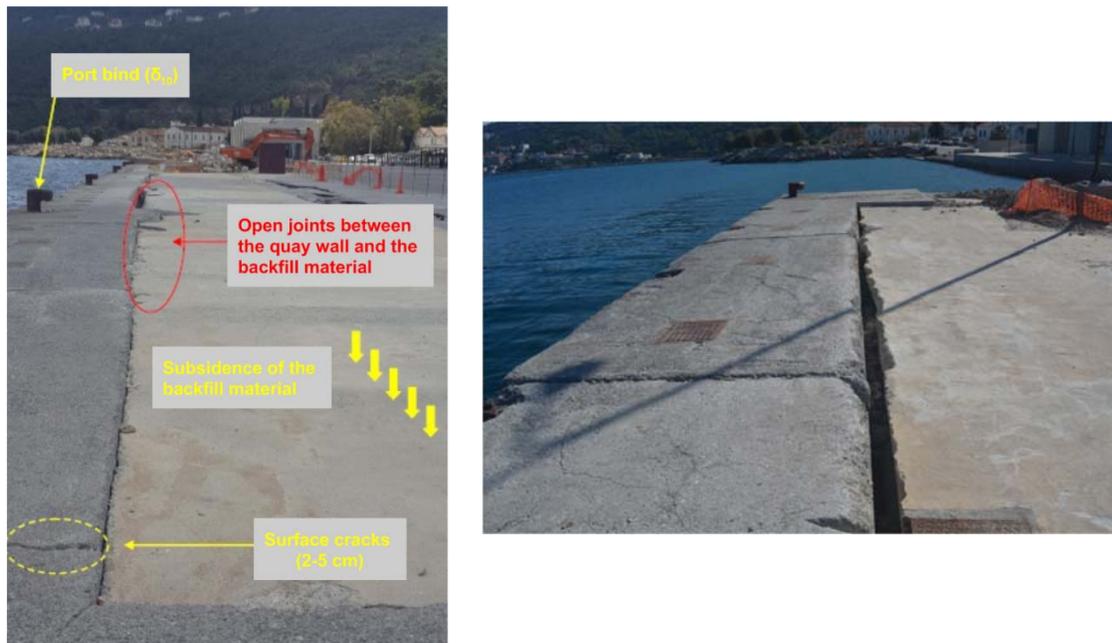
Figure 5.45 illustrates (a) a view of the pre-existing open joints between the quay wall and the backfill material and the subsidence of the backfill material behind the quay wall about 3 years ago (Triton, 2017), and its comparison to (b) its condition immediately after the earthquake (HAEE reconnaissance report, 2020). Interestingly, the earthquake damage observed are quite similar but most probably intensified by the earthquake. At the time the site was visited by the HAEE team, the construction operations in response to the Triton (2017) study were ongoing.

Hauled construction materials did allow the team to delineate between those and any potential liquefaction-induced ejecta at the site. Nevertheless, given the geotechnical data (see Fig. 5.41) liquefaction might have taken place on a rather limited scale and probably worsened the already existing damages. In addition, the quay walls at this particular site are massive and consequently subject to large inertia forces mostly due to their own mass and not due to seismic earth pressures from the backfill. Consequently, it is likely that the quay walls at the Malagari port rotated somewhat outwards during the earthquake, thus widening any pre-existing gaps (Triton 2017) and also leading to some settlement of the backfill next to the wall. As such, it is rather unlikely that the present picture of the quay wall damages can be attributed entirely to liquefaction and dynamic settlement.

Figure 5.45. View of the quay wall at new (Malagari) port, Vathy, from NW to SE direction: (left) photo taken 3 years before the earthquake (Triton, 2017); (right) photo taken a few days after the earthquake (HAEE reconnaissance report, 2020)

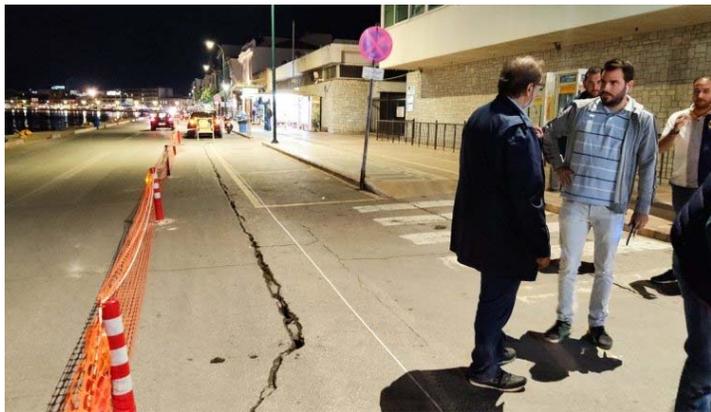
Port of Chios Island. Earthquake-induced failures were observed in the port of Chios island, situated approximately 80 km from fault, referring mainly to surface cracks of considerable width and depth (Fig. 5.50a), as reported in the post-earthquake preliminary report by Pelekis and Roumelioti (2020). At specific locations these cracks were about 10-15 cm wide and about 40 cm deep (Fig. 5.50b). Such type of failures in the port of Chios may indicate soil liquefaction that was marginally triggered during the earthquake, and ensuing lateral spreading effects towards the shoreline, as suggested by Pelekis and Roumelioti (2020). The existence of inclined strata below the filling material of the quay walls and pre-earthquake damage due to gravity loads (e.g. scour of its foundation) should be considered when interpreting the observed seismic behavior.

Figure 5.50. (a) Earthquake-induced surface cracks parallel to the quay wall front in the port of Chios; (b) Close view of 10-15 cm wide and 40 cm deep surface cracks.

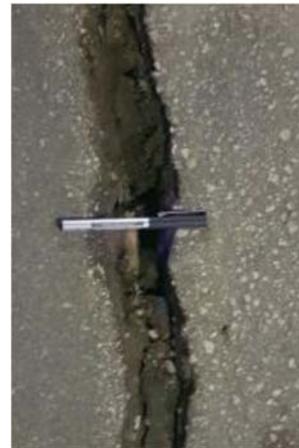
- vi) Significant movements, including cracks on the pavement, were observed on the quay wall in the port of Chios island, about 80 km from fault. Again, it is unclear if the movement can be attributed soil liquefaction or the inertia of the quay walls per se.

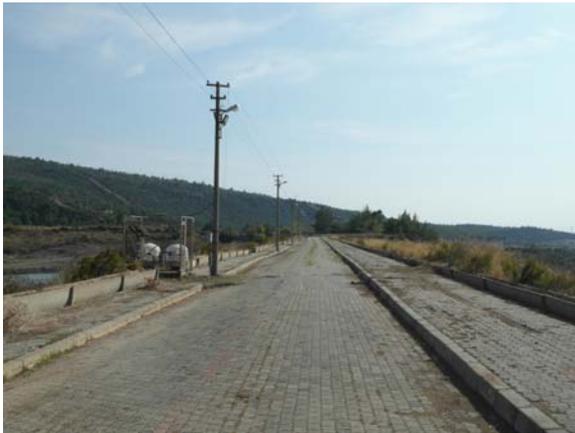
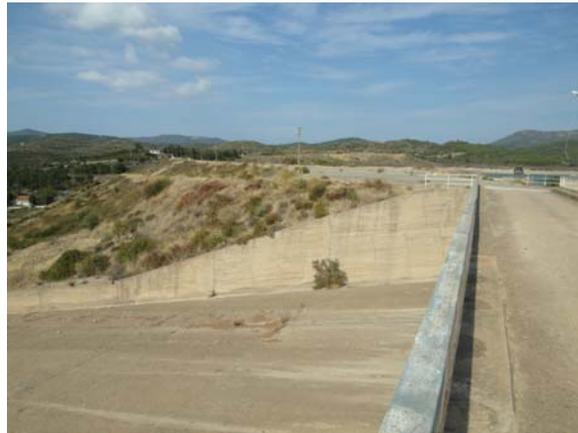
After the event, no damage or settlement was observed on the lightning poles and bollards located on the crests. Any falling rocks, bulge, or settlements were observed over the both upstream and downstream slopes. No signs of seismically induced permanent deformations along the dam crests and at the abutments.

Figure 6.6. Urkmez Dam a) typical cross-section (Courtesy of DSI), b) crest and spillway view on November

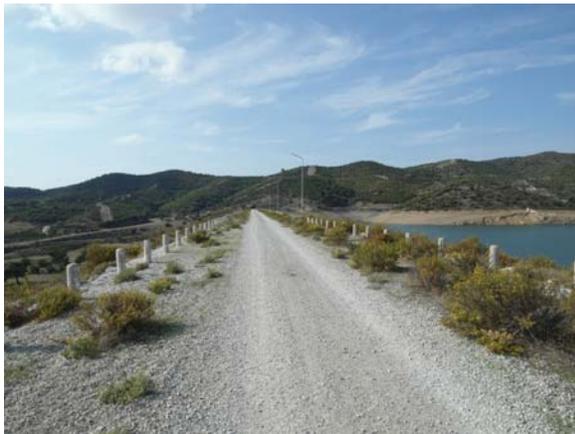
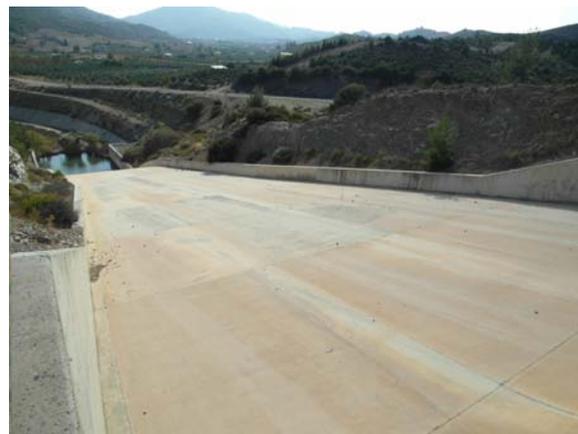
Figure 6.7. Kavakdere Dam a) typical cross-section (Courtesy of DSI), b) crest and spillway view on November 6

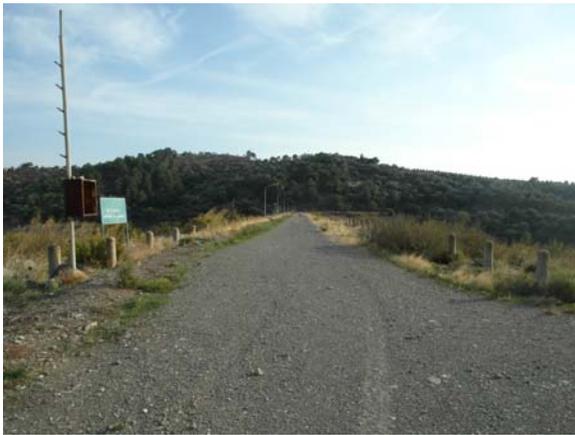
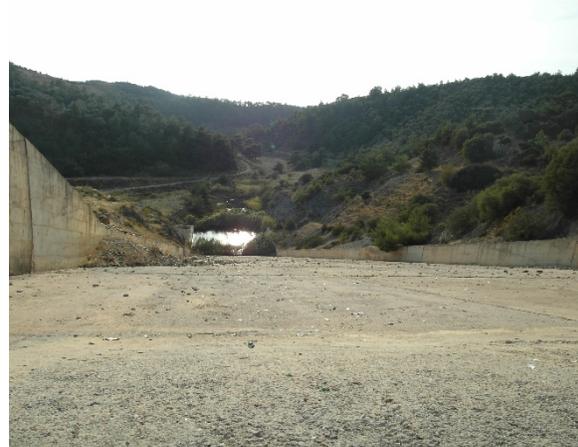
Figure 6.8. Seferihisar Dam a) typical cross-section (Courtesy of DSI), b) crest and spillway view on November 6

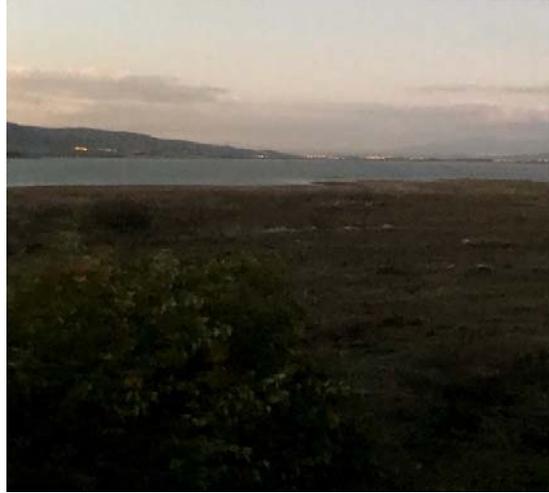
Figure 6.11. Tahtali Dam a) reservoir site, no damage observed ($38^{\circ}07'48.7''\text{N}$ $27^{\circ}06'13.3''\text{E}$ / 18:34/ 04.11.2020) b) crest and spillway view on November 6

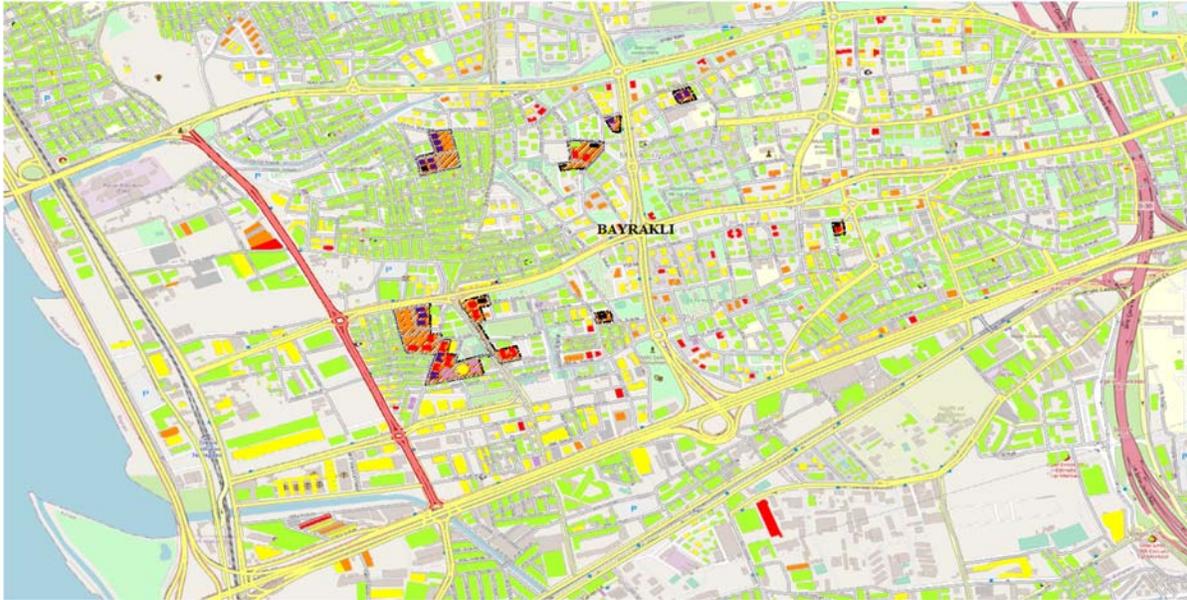
The structural damage was mostly concentrated in the Bayraklı, Bornova, Karşıyaka and Konak Districts of İzmir. These are among the most densely populated, central regions of the city. The distribution of damage in these districts as obtained from AFAD and the Ministry of Environment and Urbanization are shown in map form in Figures 7.4-7.7. It should be noted that green, yellow,

Figure 7.4. Damage distribution in the Bayraklı district of Izmir (green, yellow, orange and red colors indicate buildings with no, slight, moderate and heavy damages, respectively. The black and pink indicators show the buildings that have totally or partially collapsed during the earthquake)

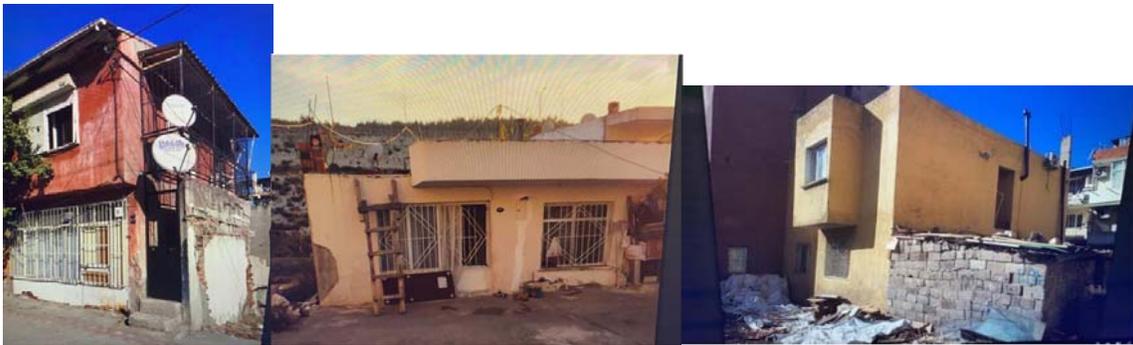
Figure 7.10. Examples of one- and two-story buildings designated as heavily damaged even though the damages due to earthquake are not severe

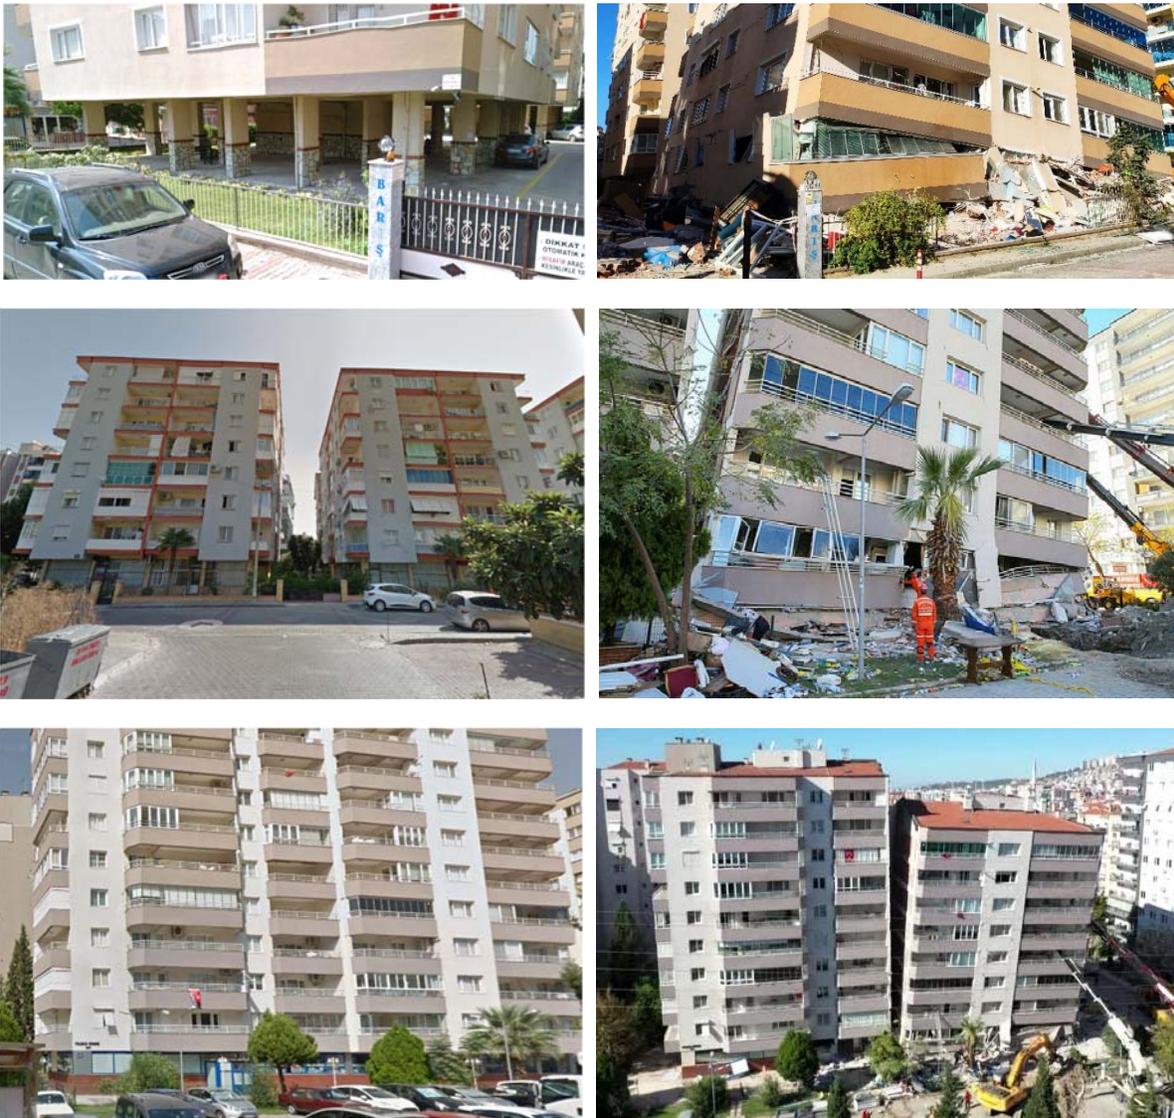
Soft / Weak Story Damage. A number of buildings have suffered damage or partial collapse at their first stories. A typical feature of the buildings in Turkish city centers is the presence of shops at the ground levels. In order to create wider space, infill walls are generally removed in those stories where the seismic demands are maximum (Figure 7.11). In addition, poor beam-column connections and the presence of weak columns are the key reasons for the development of soft-story mechanisms. Due to the soft/weak stories, building collapses occur partially in the ground story in some cases, whereas total collapse was observed in some other buildings.

Figure 7.11. Soft / weak story failure (without infill walls)

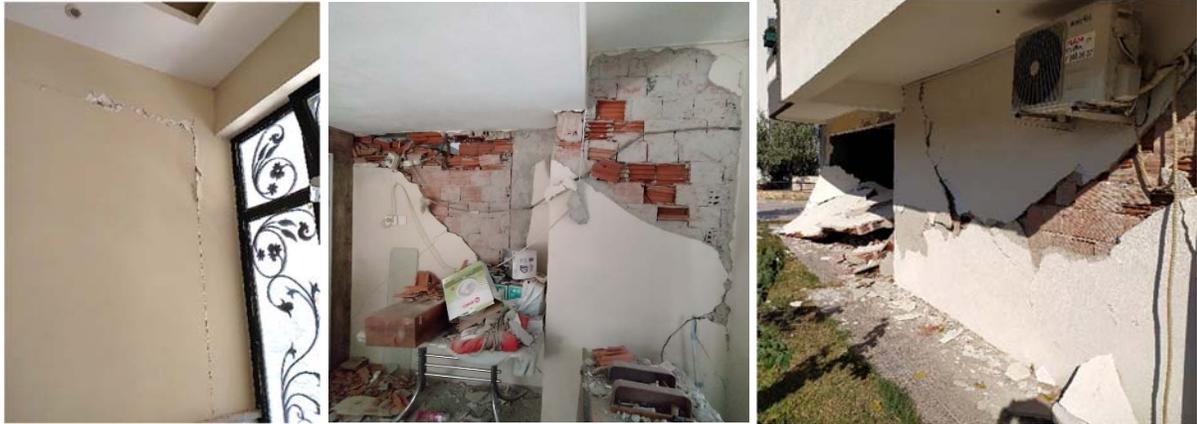
Infill Wall Damage. The most widespread damage type observed in İzmir is infill wall damage. The most common infill material was hollow-core clay bricks in the Bayraklı Region. Infill wall damage consisted of interface cracking at frame-boundary interfaces, diagonal cracking, and crushing (Figure 7.12). The structural benefits and weaknesses of the infill walls were similar to those observed in previous earthquakes such as Kocaeli 1999, Bingöl 2002, Van 2011, and Elazığ 2020. In some buildings, the infill walls appeared to stiffen the building and reduce the lateral deformation demands. In one of the eight-story apartment complexes comprised of four buildings, the benefit of infill walls was clearly observed. In one of those buildings, there were extensive infill walls in the first story (Figure 7.13). In the other buildings, this floor had no infill walls at all (Figure 7.11, top row). Three of the buildings without infill walls were either heavily damaged or collapsed, resulting in nine fatalities. The one with the infill walls in the first story, on the other hand, experienced moderate infill wall damage without any significant structural damage (Figure 7.13). It can be viewed as a striking example of the “unintended” benefit of infill walls contributing to lateral stiffness, strength, and axial capacities. Our assessments revealed that the presence of infill walls and the difference in the quality of construction might have increased the building base shear capacity, also reducing soft/weak story irregularity. The past observation on the effect of infill walls to help the buildings survive small to medium-sized earthquakes by contributing to their lateral load-carrying capacity was confirmed.

Figure 7.12. Infill wall damages

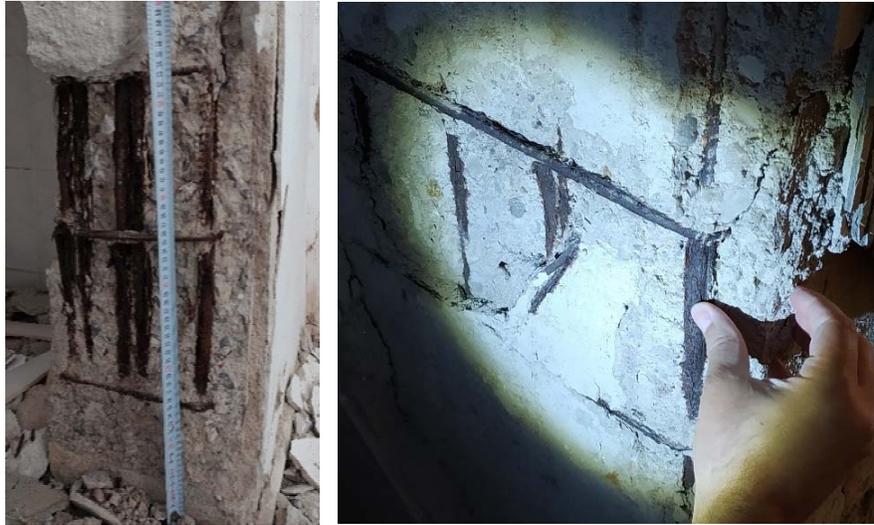
Corrosion induced damage. Our investigations showed that corrosion in reinforcement is a widespread problem in İzmir (Figure 7.16). Excessive corrosion was especially observed at the bottom of columns in the basement or ground floors. The loss in the cross-sectional area of reinforcement due to corrosion was significant in some instances, reaching ratios of 25 to 65 percent. The critical problems associated with corrosion in building columns are reduced moment and shear capacities, loss of bond strength, and concrete spalling leading to premature rebar buckling. Hence, addressing problems related to corrosion detection and protection remains critical for seismic risk reduction.

Figure 7.16. Corrosion damages

- 7- Excessive corrosion was observed in the bottom ends of columns located at the basement and ground floors of the examined buildings in Bayraklı, İzmir (similar effects are anticipated elsewhere). Corrosion levels accelerate the loss of bond, cover spalling and deformation capacity of RC columns.

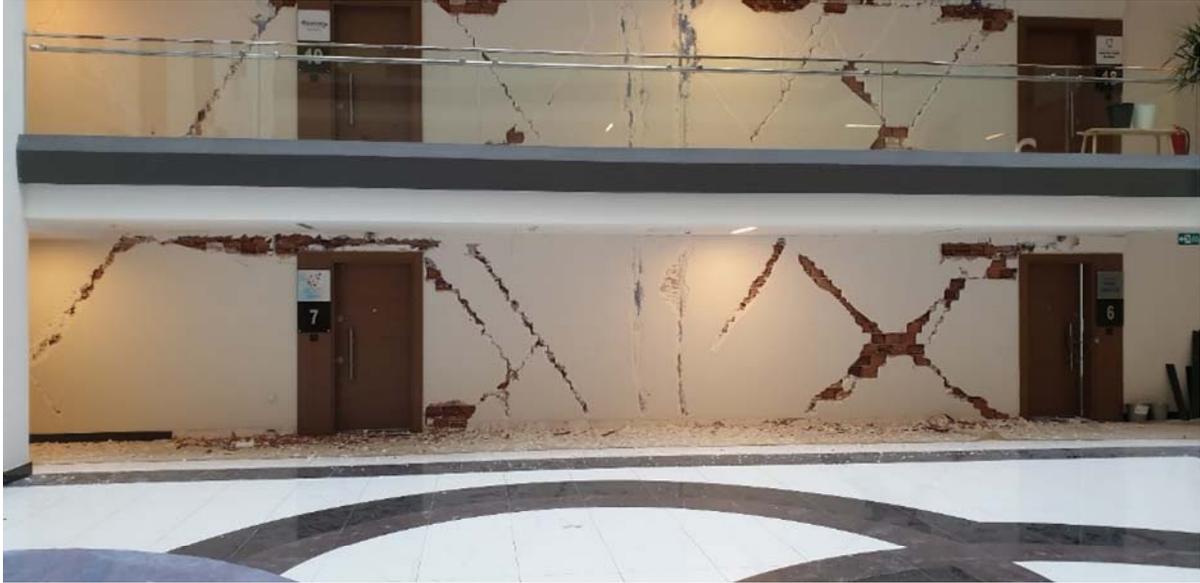
Design Problems. The aforementioned damage occurred mainly in buildings constructed in the 1990's, before the publication of TEC 1997 (CSCDA 1997) and before the Kocaeli and Düzce Earthquakes (1999), which increased awareness of the importance of construction quality and control. However, some examples of design errors leading to heavier non-structural damage than expected were encountered. The widespread non-structural damages that were observed in a recently constructed commercial center reveals some noteworthy design mistakes. Figure 7.17 shows a 10-story commercial center with a shear wall core and a large opening in the center of the slab. All offices are located around the opening. Although no damage was observed in the shear wall, wide shear cracks were observed in the infill walls. It is surprising to see such heavy infill wall damage in a recently constructed building under an earthquake ground motion with intensity well below the design earthquake level. It is believed that due to the lack of diaphragm action, the core wall was unable to limit the inter-story drifts. It appears that improper modeling due to lack of diaphragm action and poor design led to excessive drift of office areas, and the infill walls around offices suffered heavy damage. This observation emphasizes the importance of slab openings (slab discontinuity) and ways for developing proper load transfer mechanisms to the shear walls.

Figure 7.17. Non-structural damage due to large openings in slabs

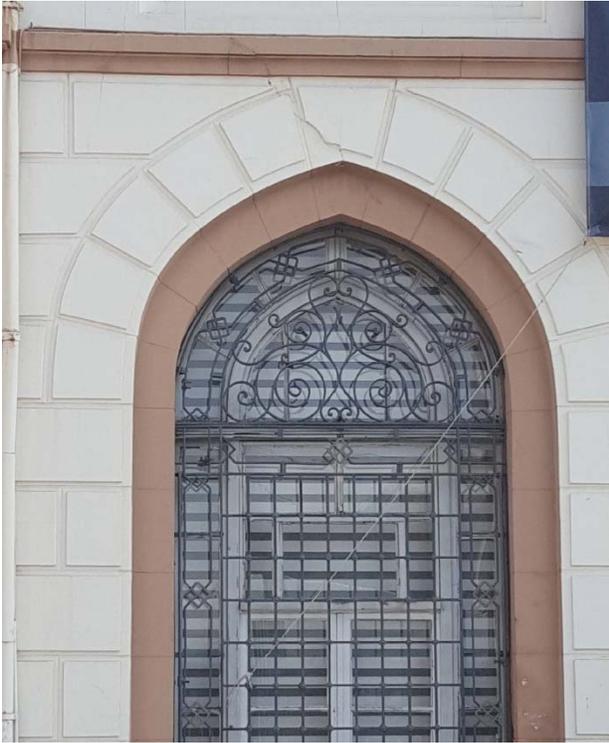
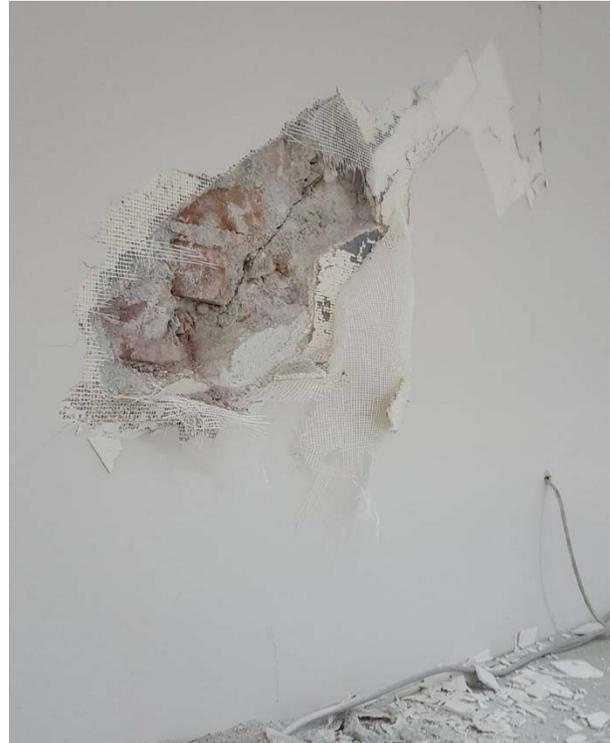
The building suffered both structural and nonstructural damage. It is reported that the disruption of the original frame due to the partial stories added by dividing the stories with high headspace inside the building is the root cause of the damage. The plan of the ground story is presented in Figure 7.21. Some structural damage observed in the structure is presented in Figures 7.22 and 7.23.

Figure 7.22. İzmir Commerce Building, observed damages; both outside and inside

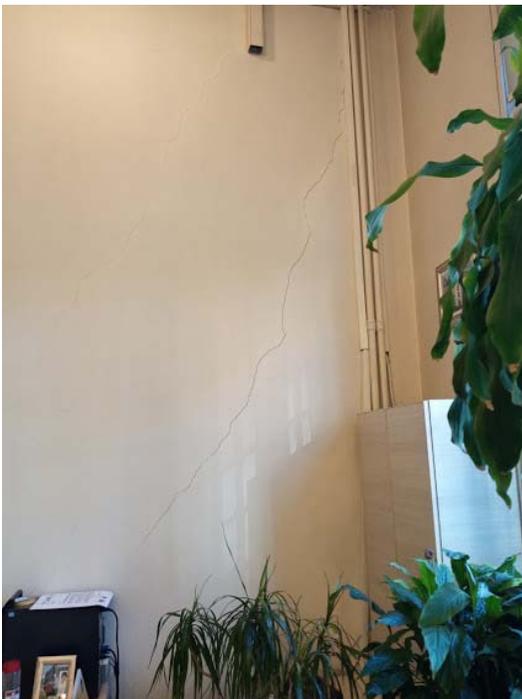
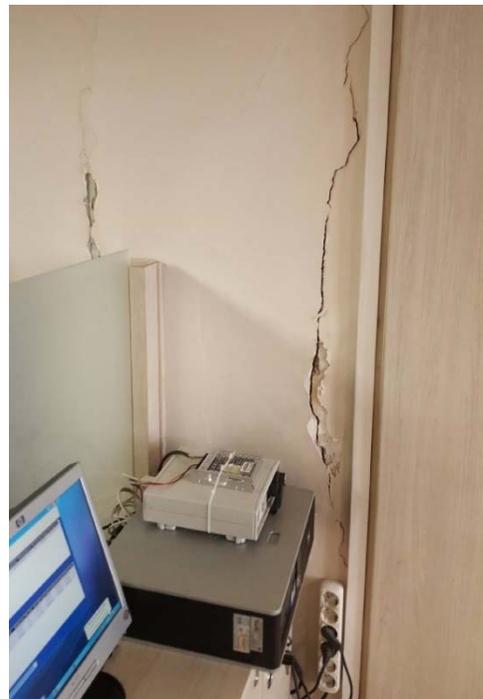
Figure 7.23. İzmir Commerce Building. Observed damages from inside the structure

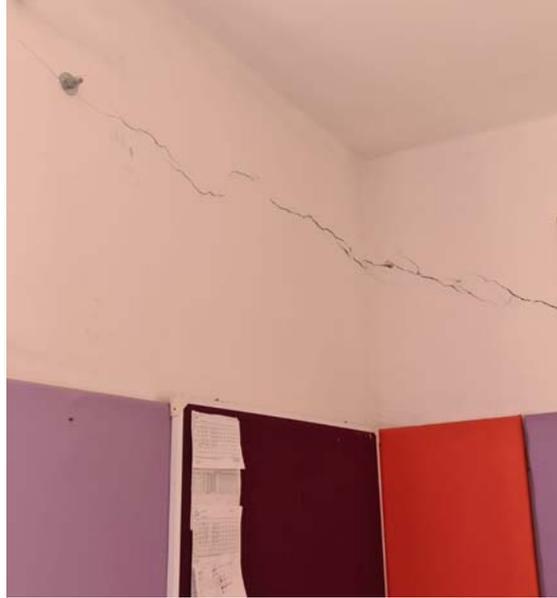
Another example in the Konak district is a school building. It is a two-story masonry structure. Detailed information about the structure is not available yet. The observed damages clearly show that the structure reached its capacity levels, as evidenced in Figures 7.24 and 7.25.

Figure 7.25. Interior wall damages in the school building

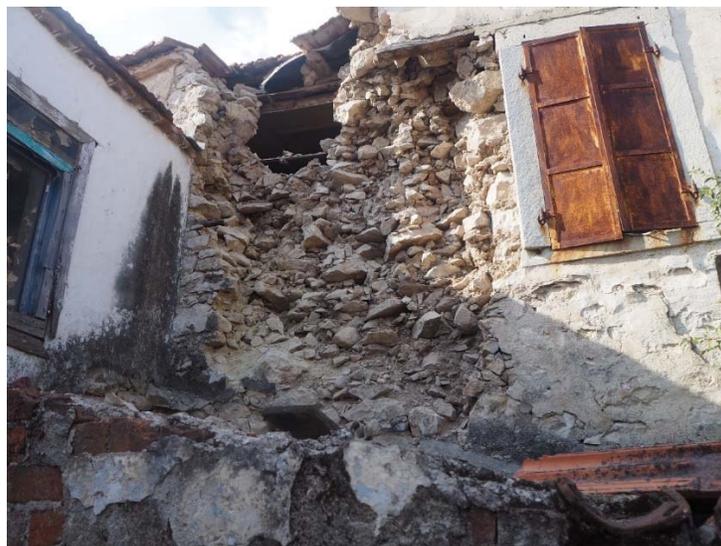
Figure 7.28. Collapsed portion of a wall

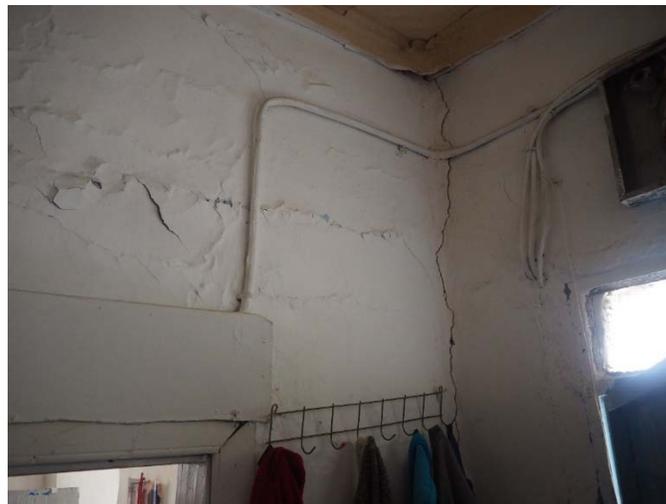
Wall damage developed as separations at the wall-to-wall connections (Figure 7.29), cracks in wall bodies (Figure 7.30), and at the window/door openings (Figure 7.31). Due to cracking, the

Figure 7.29. Separation at a wall-to-wall connection

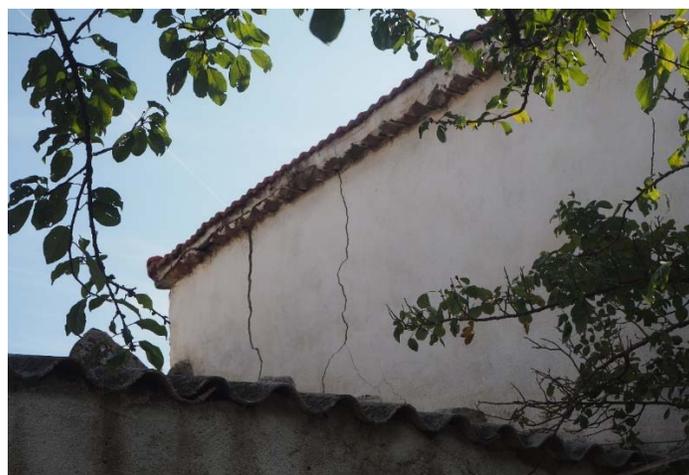
Figure 7.30. Cracking in the body of a wall

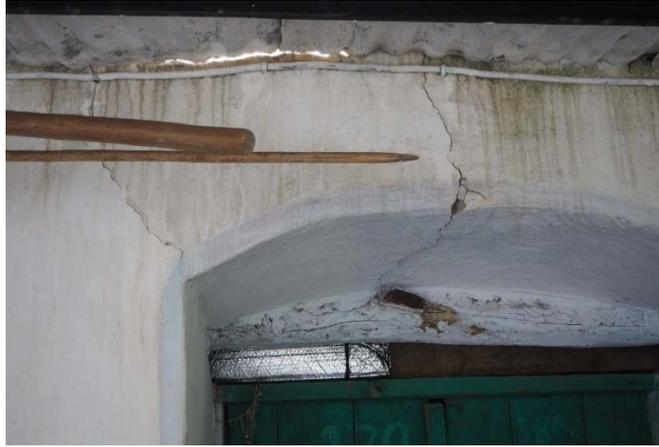
Figure 7.31. Cracking at the door opening

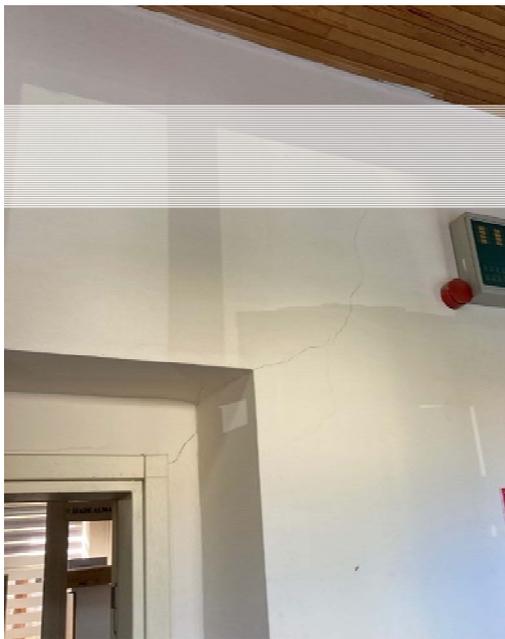
There are individual masonry structures that sustained damage during the earthquake. There is a police station building in the Alaçatı neighborhood of Çeşme. The building is about 55 km away from the epicenter, and about 2 km to Alaçatı strong motion station of AFAD. It is again a two-story structure with a wooden floor and roof framing. Walls are composed of two layers of stone with rubble infill. Soft Alaçatı stone is the wall material. This structure was originally constructed as a mill, later converted to a school, and finally became a police station. It is estimated as 70-80 years old. It suffered shear cracks in the interior and exterior wall bodies (Figures 7.32 and 7.33).

Figure 7.32. Cracking at the door opening

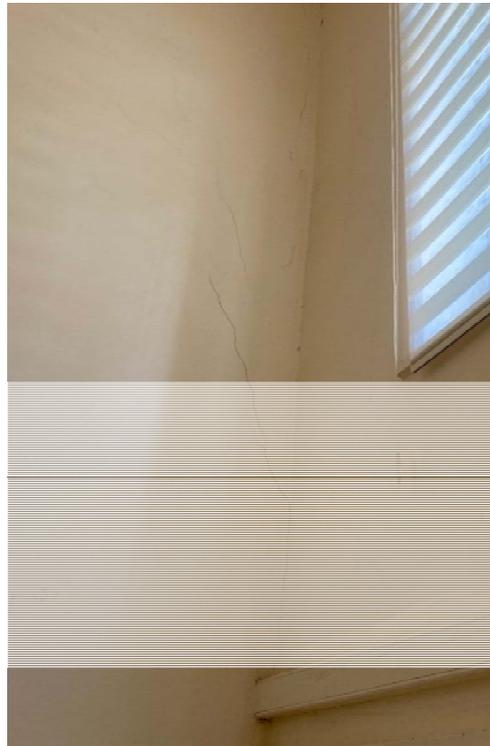
Figure 7.33. Interior to exterior wall connection

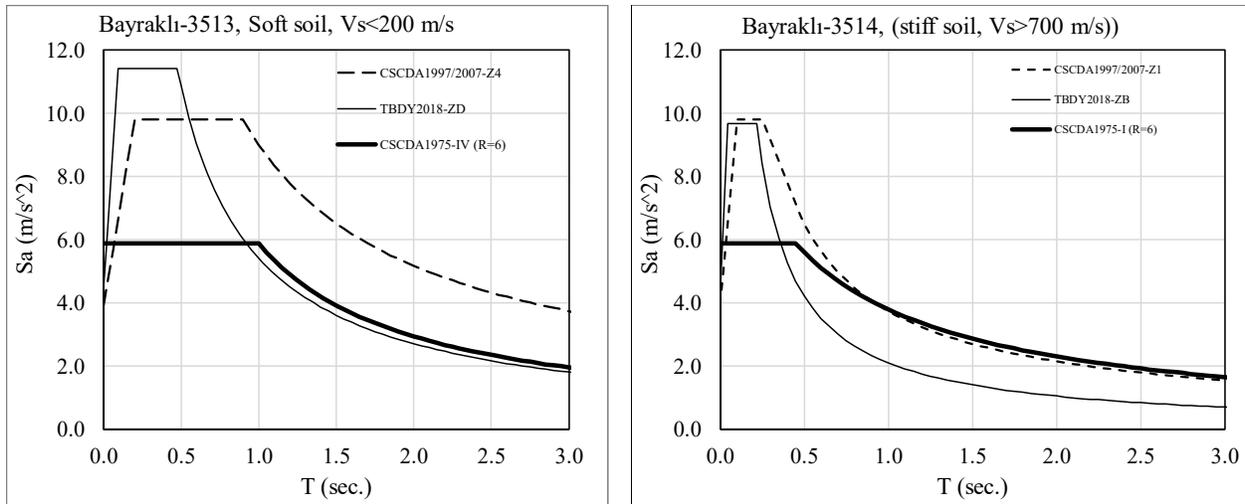
The elastic response spectra of all four codes are compared for soft and stiff soil sites of Bayraklı station in Figure 7.42. The 1975 code spectra are converted to elastic spectra by assuming a moderate ductility level. Although there is no explicitly specified R factor in the 1975 code, the requirements given for detailing, reinforcement and sizes imply an inherent R factor in the buildings designed per the code. Thus, a value of R=6 that corresponds to moderate ductility defined in the recent codes is assumed to be reasonable. The relative ductility factor K is taken as 1.0. As mentioned before, all code spectra are above the recorded values, even in the 0.6-1.5 second period range where significant amplification is observed. Figure 7.42 reveals clearly that corner periods of TBEC 2019 are shorter than in the other codes implying that it is less conservative in the period range of 0.6-1.5 second as compared to the 1997 and 2007 codes.

Figure 7.42. Comparison of Design Spectra

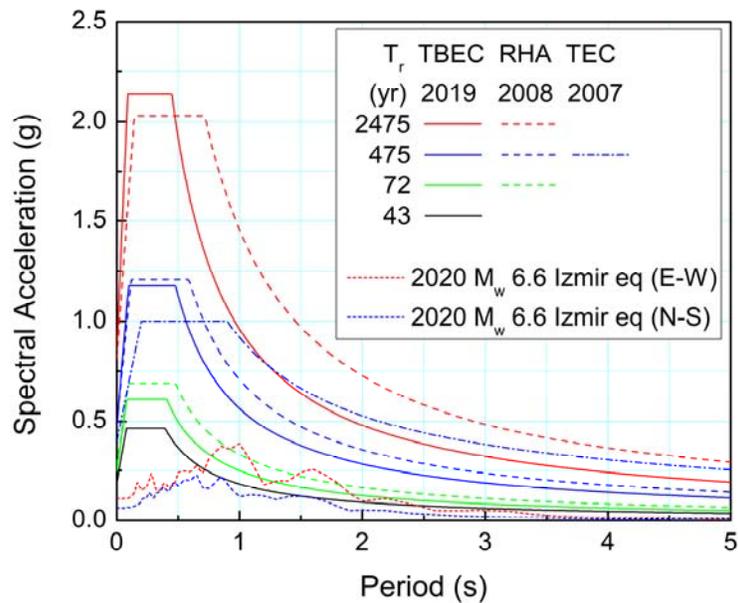
Figure 7.46 compares the 5% damped elastic response spectra for the building base motion recorded during the earthquake with the spectra defined in the Earthquake Code for Railway, Harbor and Airport Structures (RHA; Ministry of Transportation, 2008), Turkish Earthquake Code at the time of construction (TBEC 2007; Ministry of Public Works and Settlement), and the current Turkish Building Earthquake Code (TEC 2019; AFAD). Although the building base motion contains kinematic interaction, the comparison is given to have an idea about the level of ground motion measured at the base with respect to the code spectra. Spectral acceleration amplitudes for the building base motion are less than those for the design earthquake (return period, $T_r = 475$ years) at all periods. The mainshock can at most be considered as frequent/service earthquake ($T_r = 72/43$ years) given that the natural periods of the building are around 4 s and 1 s for the first and second modes, respectively, along both the E-W and N-S axes (Gumus and Celik, 2019). Hence, the nearby tall buildings would not be anticipated to suffer structural damage during the earthquake.

Figure 7.46. Building base motion versus code spectra

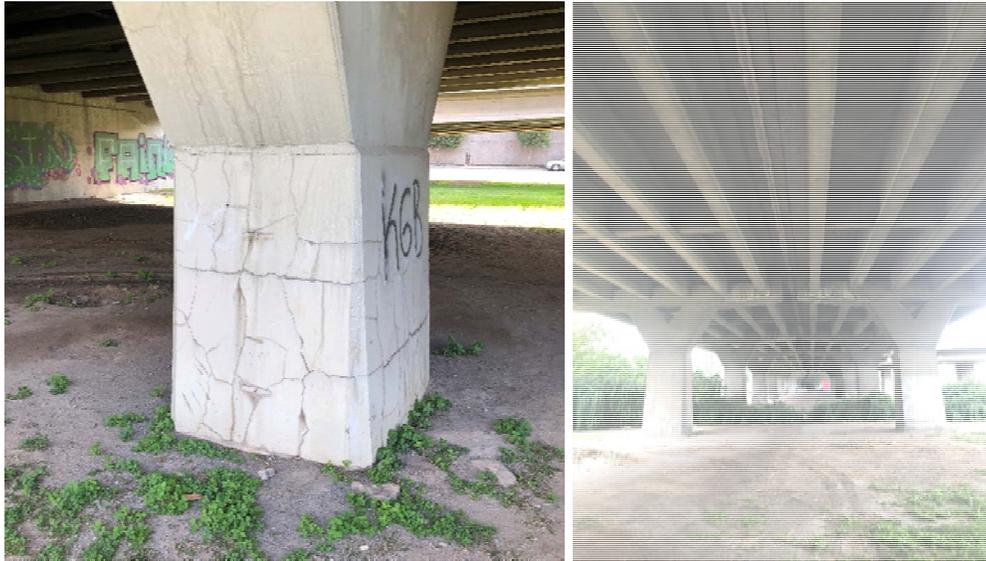
The structural history of the bridges cannot be traced after the transfer of ownership from KGM to İzmir municipality. Mürselpaşa-Zafer Payzın highway line rehabilitation project began in September 2019, and includes the maintenance, repair and identification of seismic performance of the bridges, highway, connection and roads. Improvement and strengthening studies continue within the scope of the strengthening projects. Most of the cracks observed since the beginning of the project were caused by rainwater and are ASR (Alkali-Silica Reaction) cracks, which are the result of a chemical reaction that occurred years ago in the bridge elements. These chemical

cracks did not grow after the earthquake. The repair of these cracks will be carried out within the scope of the related project (Figure 7.50).

Figure 7.50. ASR based cracks (non-seismic) and general view

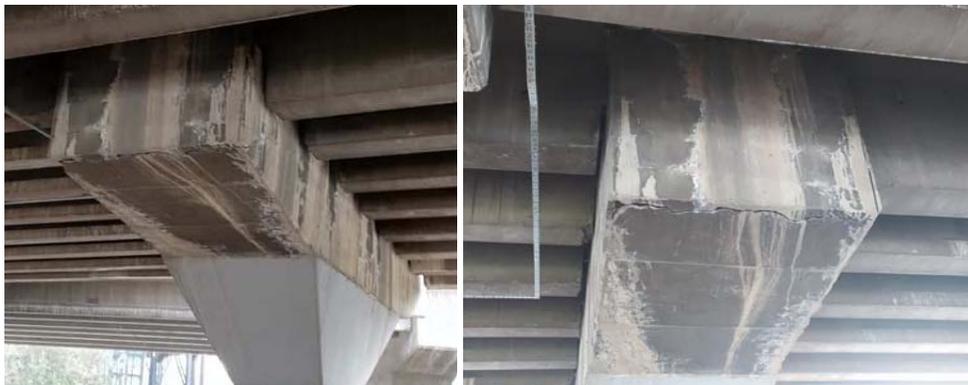
Bridges were available for use right after the earthquake. As a result, it was determined that bridges that performed successfully during the earthquake were serviceable without a need of emergency intervention (Figure 7.51).

Figure 7.51. A typical before-and-after earthquake photo (December 2019 and November 2020)

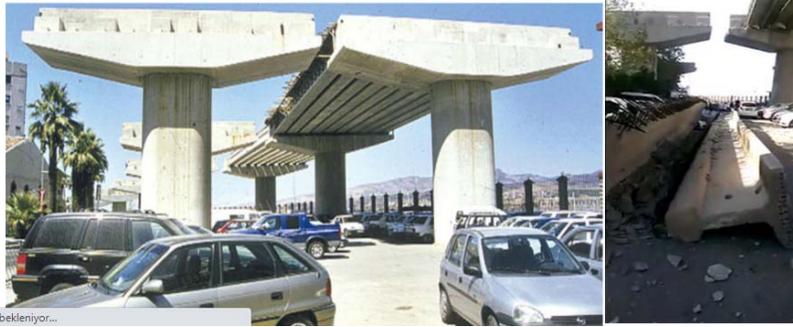
Bridge girders, which were started to be built 20 years ago and discontinued because of a plan change, fell during the earthquake because their lateral stability has not been provided for the last 20 years (Figure 7.52). These bridges were not on the highway line for service.

Figure 7.52. An incomplete bridge construction 20 years ago without providing a lateral girder stability at the site (10 years ago and now)

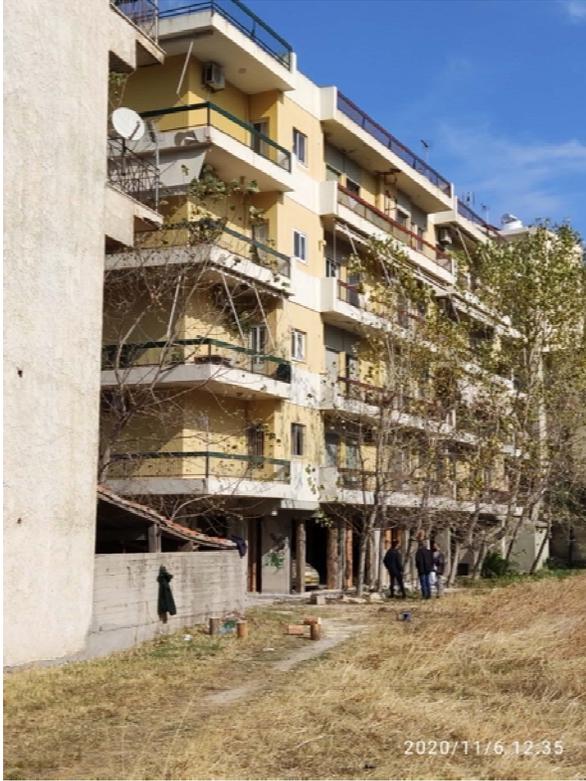
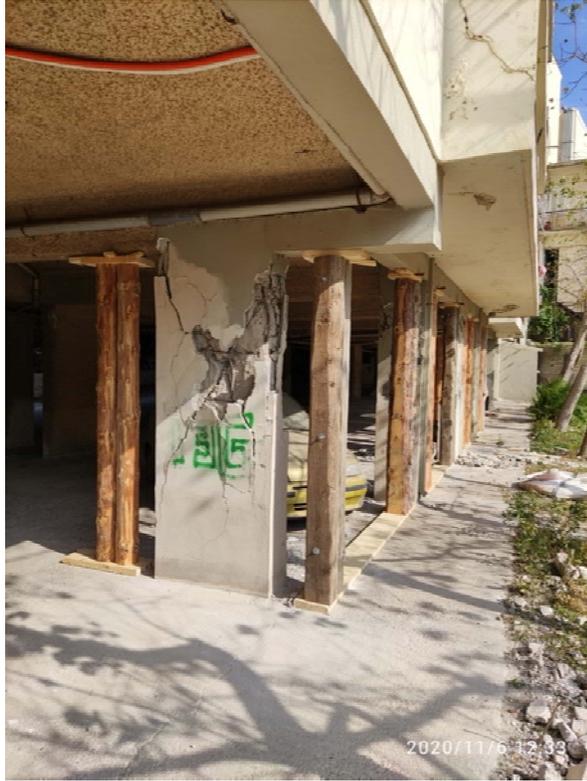
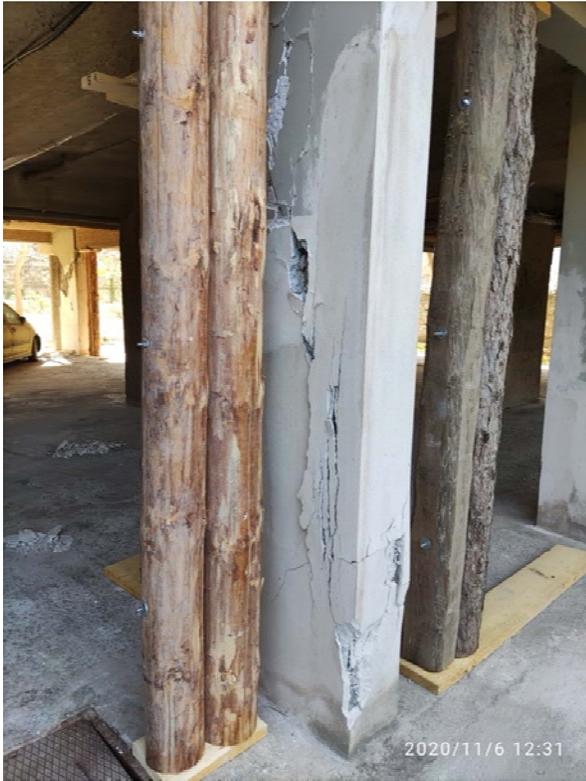
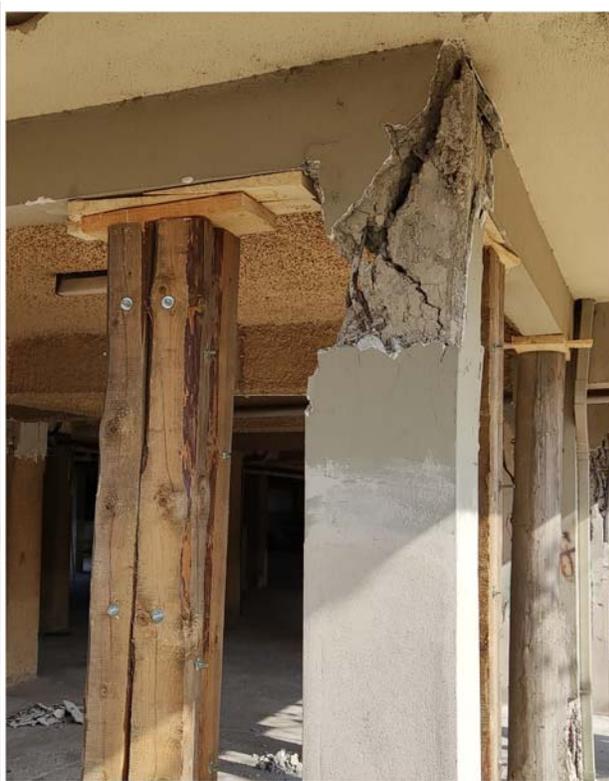
As already reported, the damage observed in RC buildings was rather limited, and no collapse occurred. Typical damage was related to soft (open) ground floors, in buildings designed and constructed before 1985. The lack of adequate stiffness at the ground floor, combined with scarcity of shear reinforcement, led to shear failures of columns, walls and beam-column joints, as shown in Figure 7.59, where buckling of longitudinal reinforcement is also visible. Short column failures were also observed (e.g., Figure 7.60), while diagonal cracking of shear walls occurred, especially in soft stories (Figure 7.61). The tallest RC building on the island, a seven-story residential building, did not experience any damage, despite its irregularities (Figure 7.62). Quite common was the damage in non-structural elements, mainly in infill walls made of brickwork (Figure 7.63). The most common types of damage observed was: (a) separation of the infill wall from the concrete frame and in some cases overturning, (b) out-of-plane movement and cracking due to out-of-plane bending (Figure 7.64).

Figure 7.59. Soft-story failure of a five-story residential building in Karlovasi.

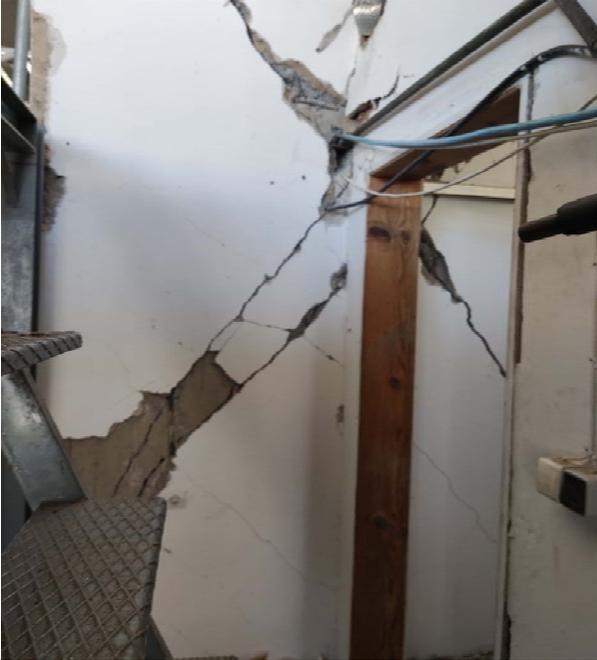
Figure 7.61. Shear failure of a shear wall in a soft story.

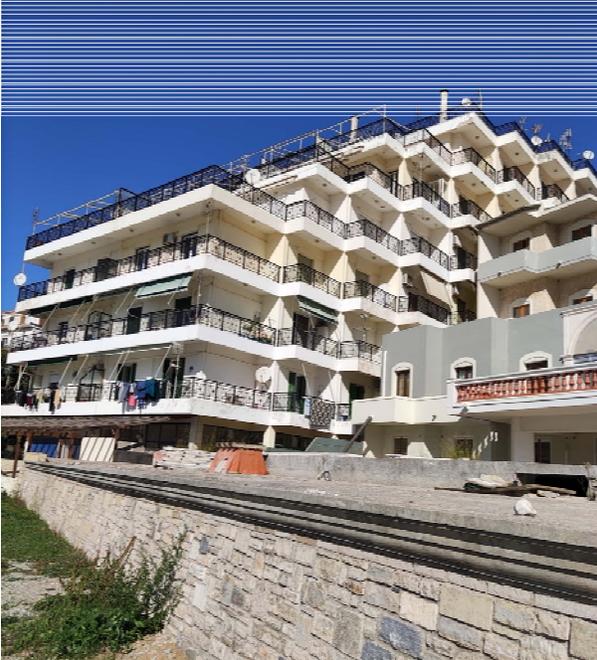
Figure 7.62. Irregular 7-story residential building without any damage.

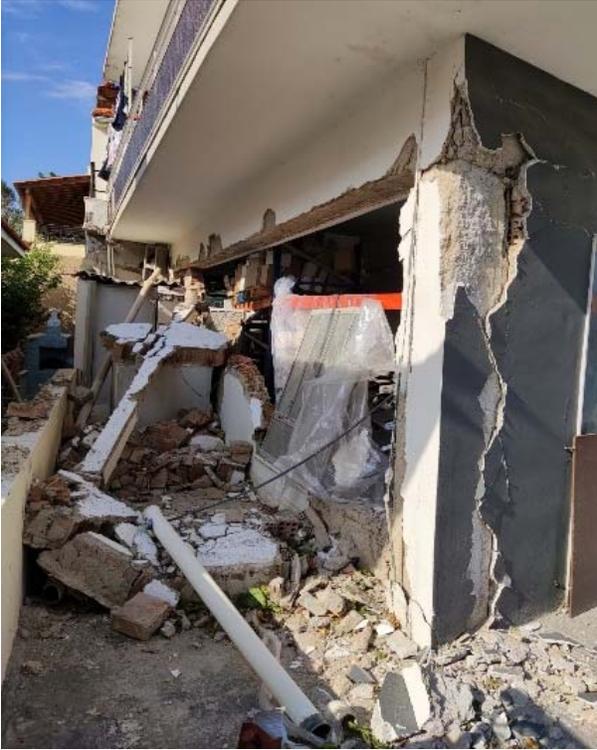
Figure 7.63. Separation and overturning of infill walls.

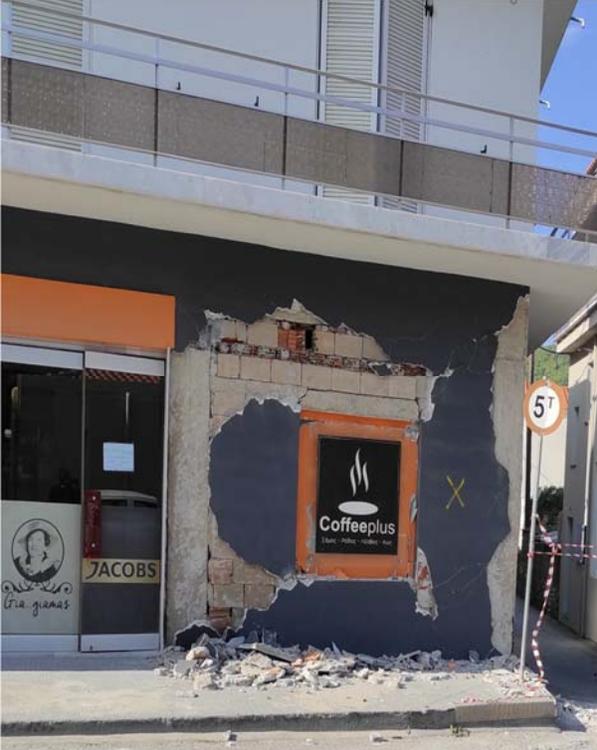
Figure 7.64. Cracking of infill walls due to out-of-plane bending.

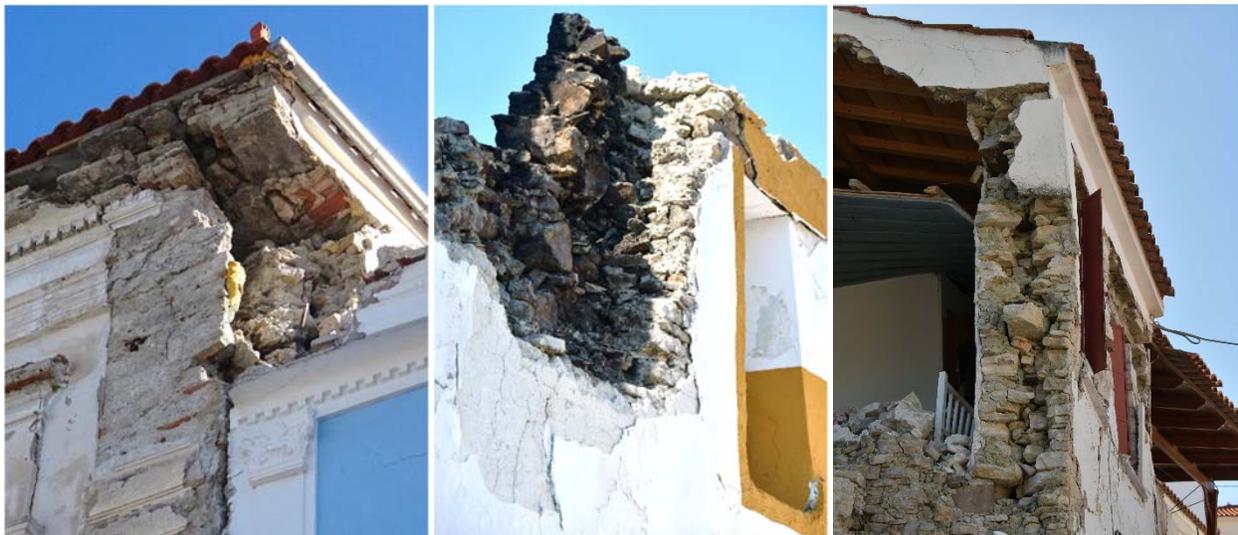
Figure 7.65. Poor-quality, three-leaf stone masonry building.
