Seismological and Engineering Effects of the M 7.0 Samos Island (Aegean Sea) Earthquake

Hellenic Association of Earthquake Engineering: Report 2020/02

Geotechnical Extreme Events Reconnaissance Association: Report GEER-069

December 31, 2020

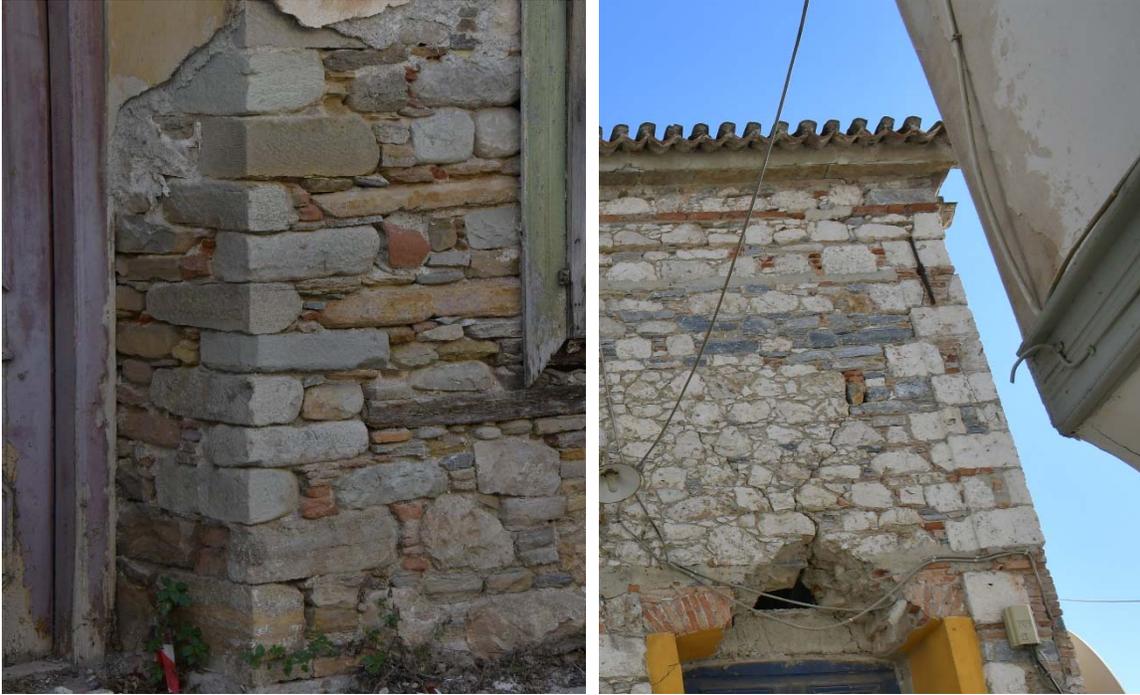
An important detail in the construction of masonry structures is the corners, and we encountered different construction styles and different levels of performance (Figure 7.66). Openings (doors and windows) represent on average one fourth to one third of the buildings' perimeter (Figure 7.67). Their lintels are either horizontal (supposedly, made of timber) or arched (Figure 7.68). In several cases the arches were rather squat.

Figure 7.66. Connection of transverse walls.

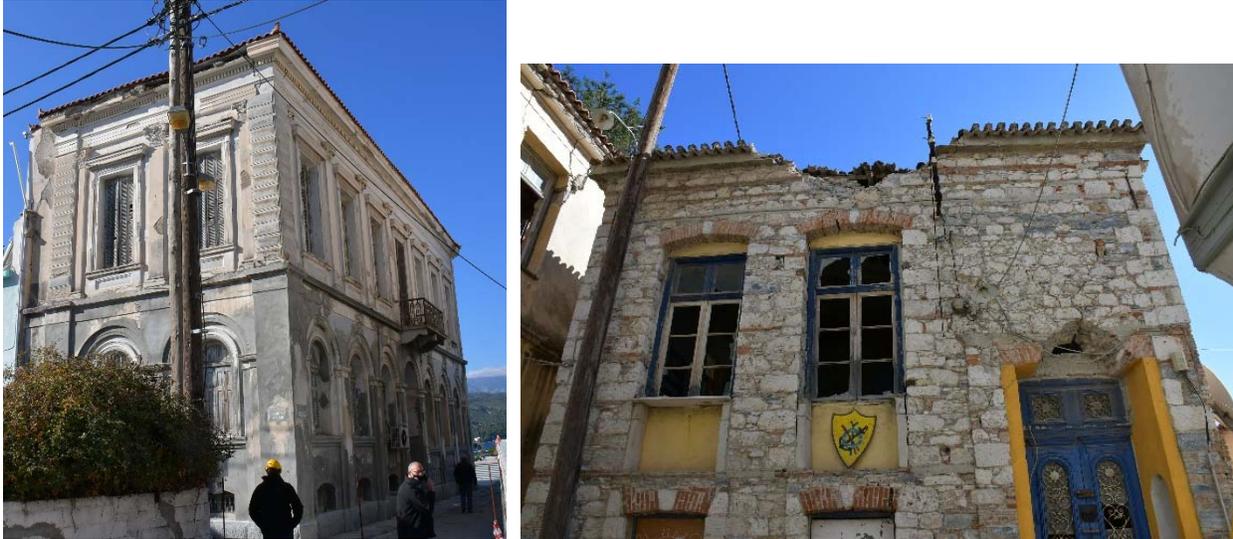
Figure 7.68. Horizontal and arched lintels. Presence of steel ties (right).

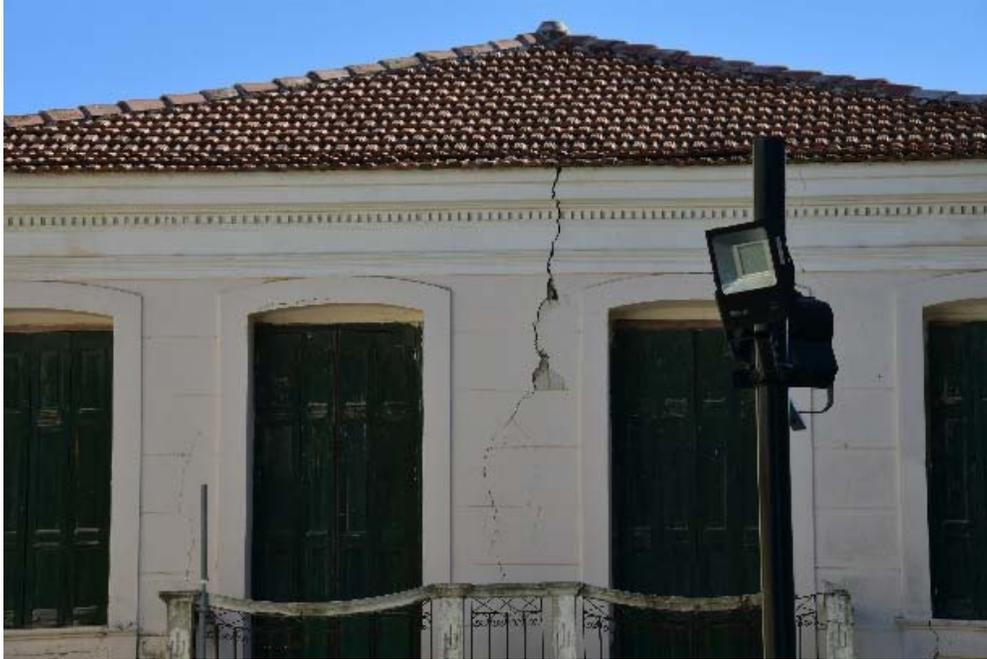
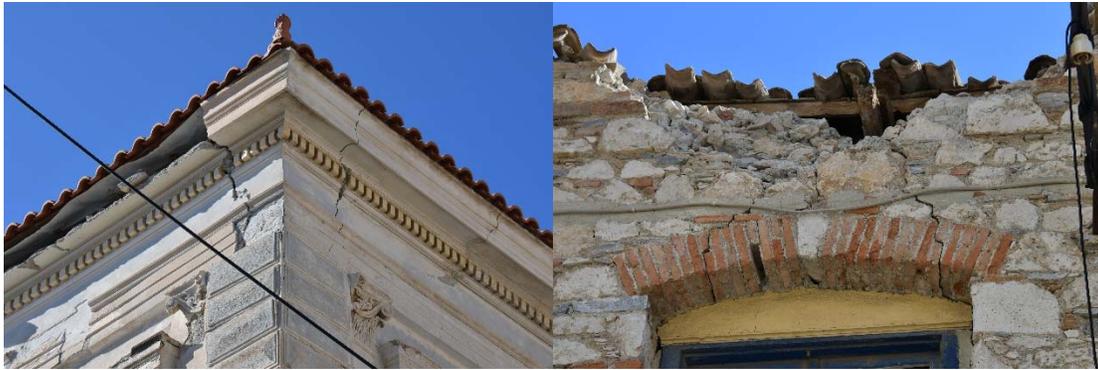
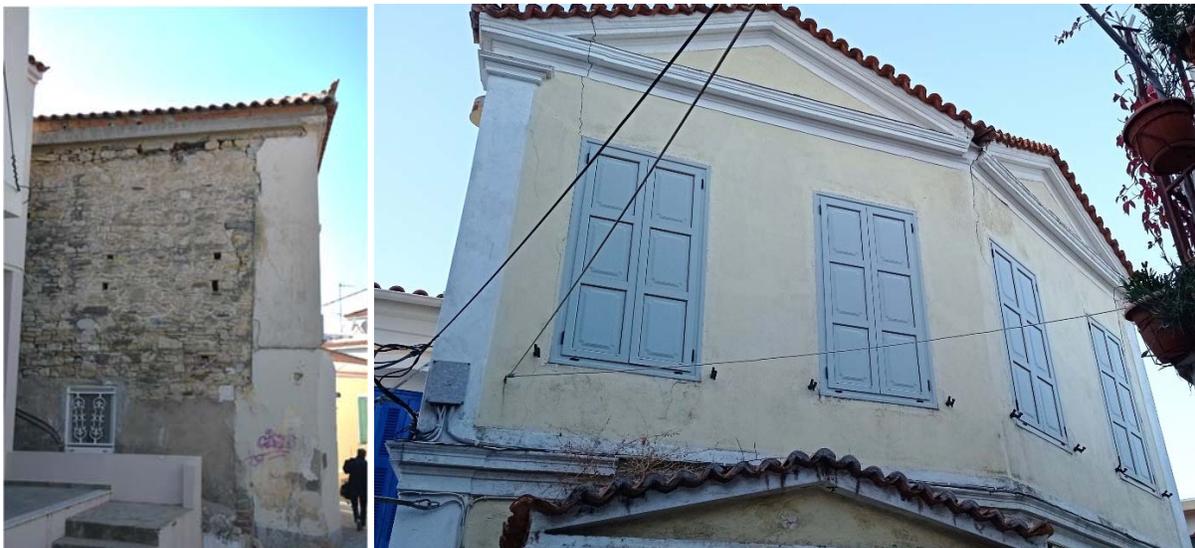
Figure 7.70. Shear cracks at mid-length of the walls and corner failures.

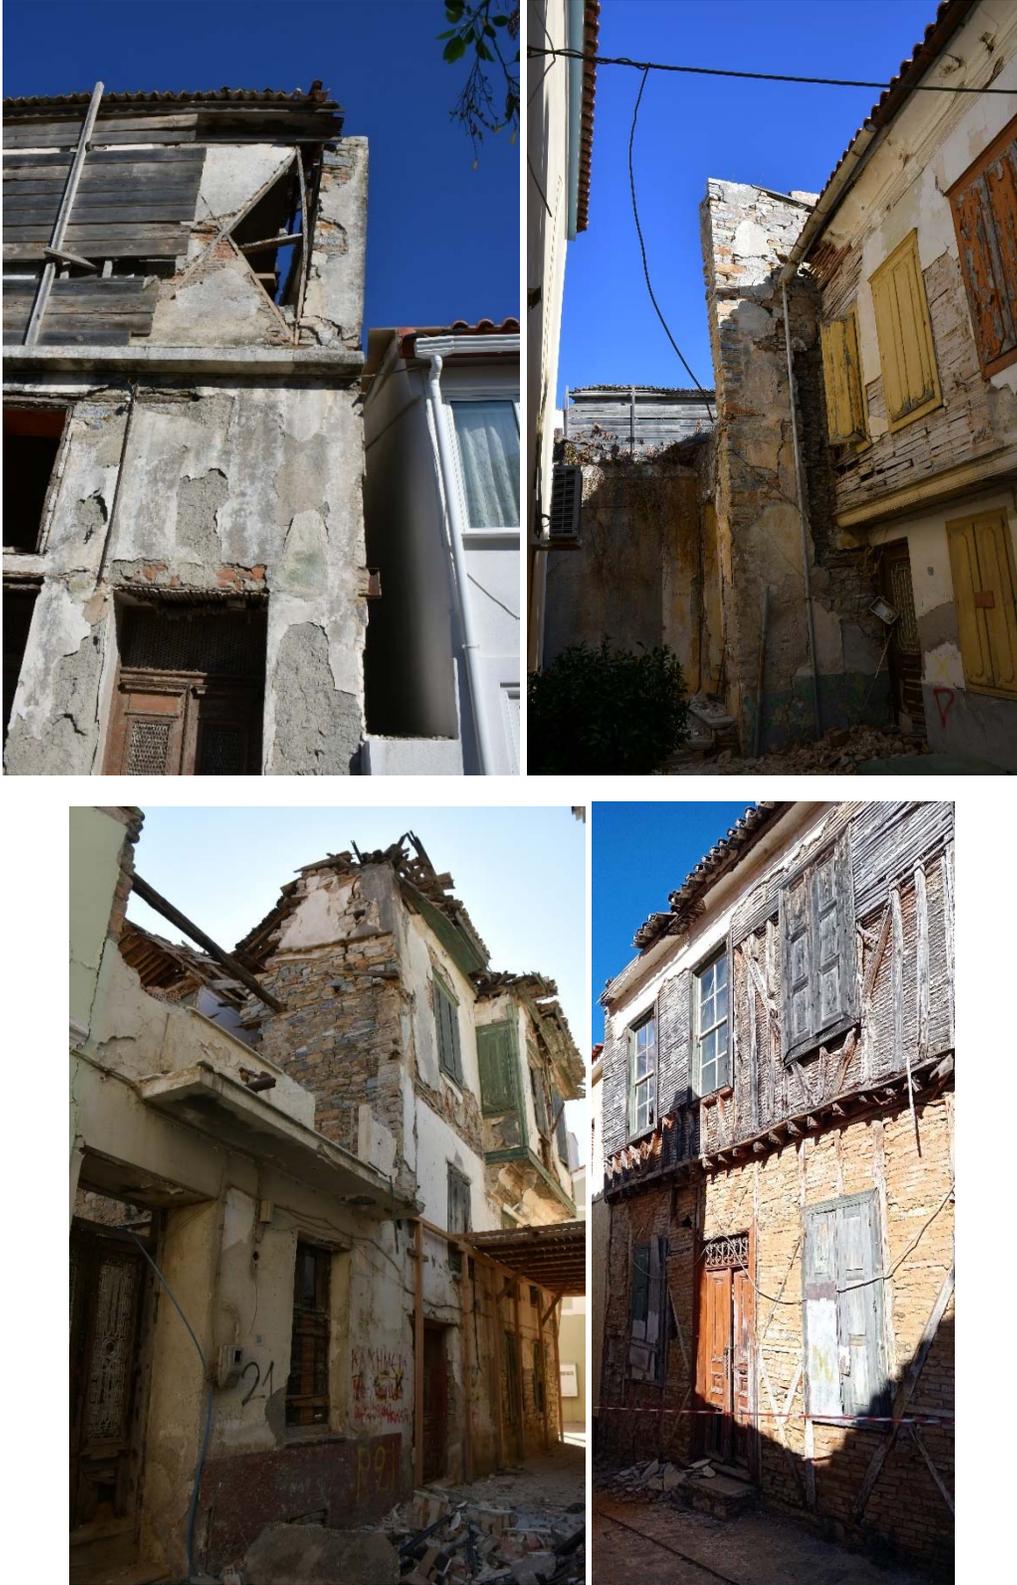
Figure 7.72. Buildings in which the ground floor is made of masonry and the upper story is made either of timber-framed masonry or timber walls.

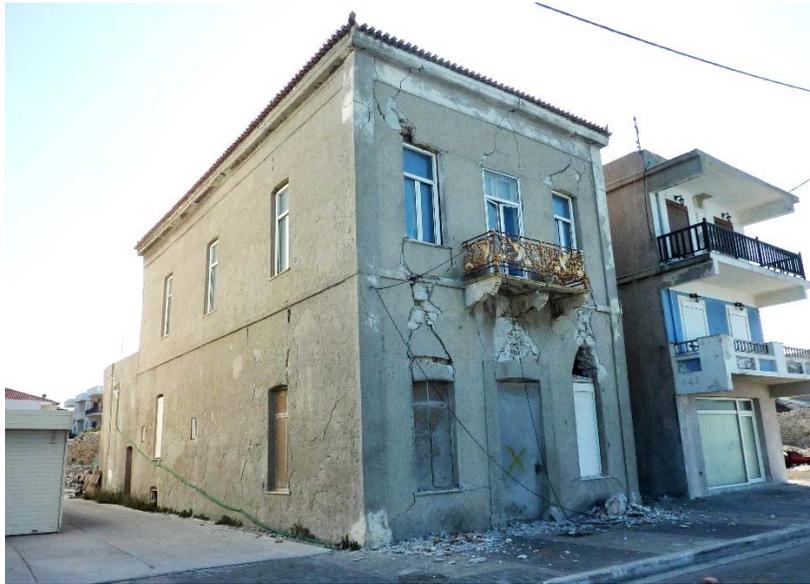
Figure 7.73. Masonry building with extensive damage adjacent to a concrete building with no damage.

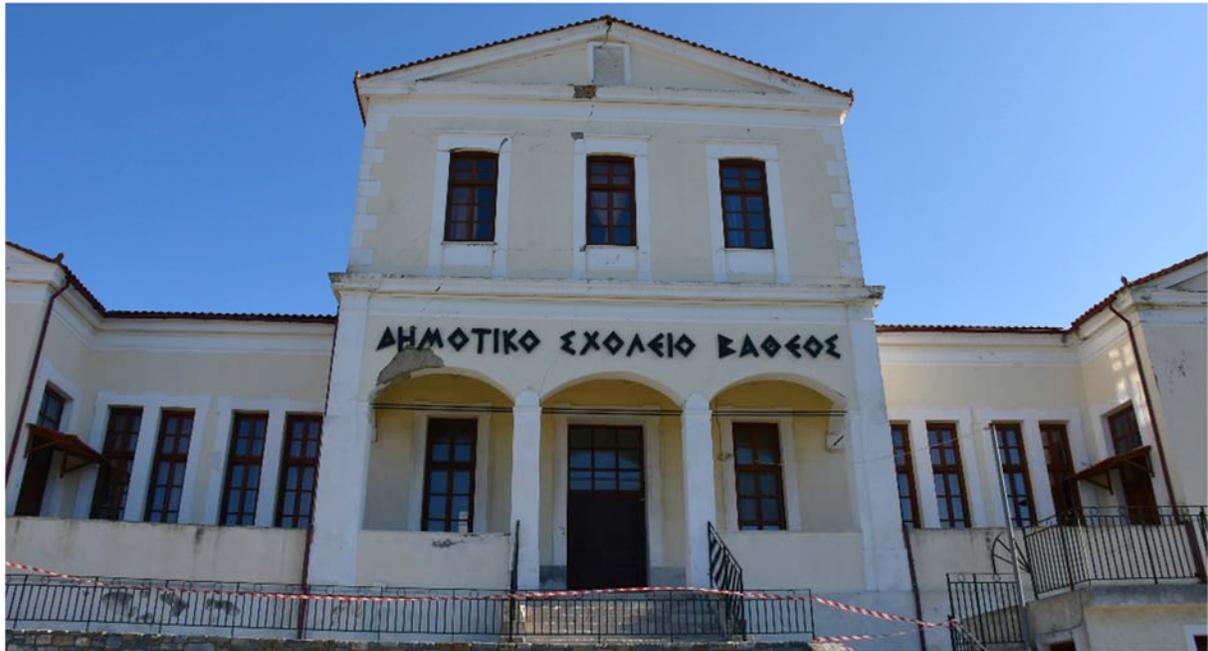
Figure 7.75. Damage to the primary school at Vathy.

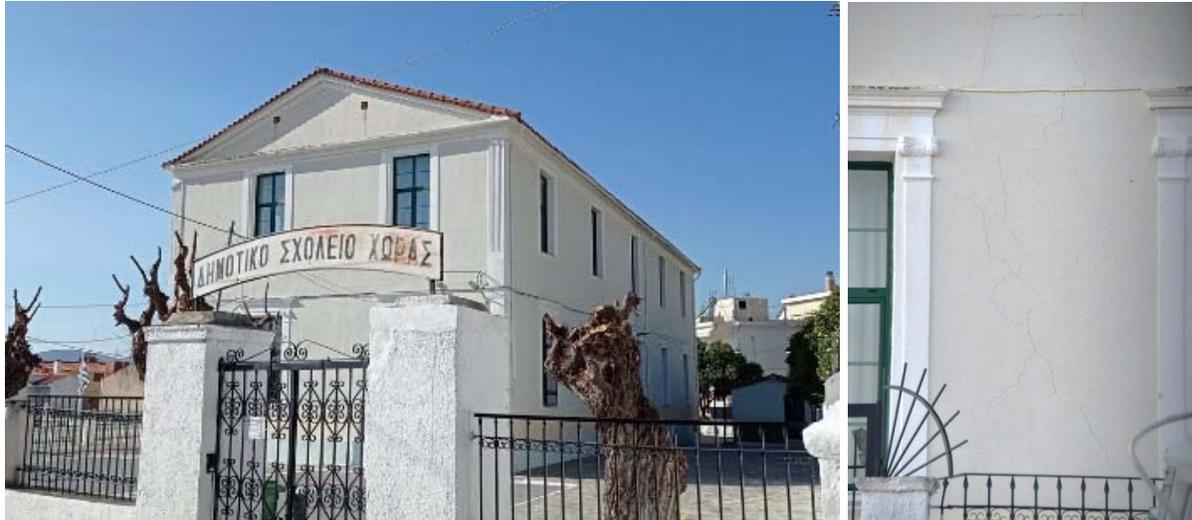
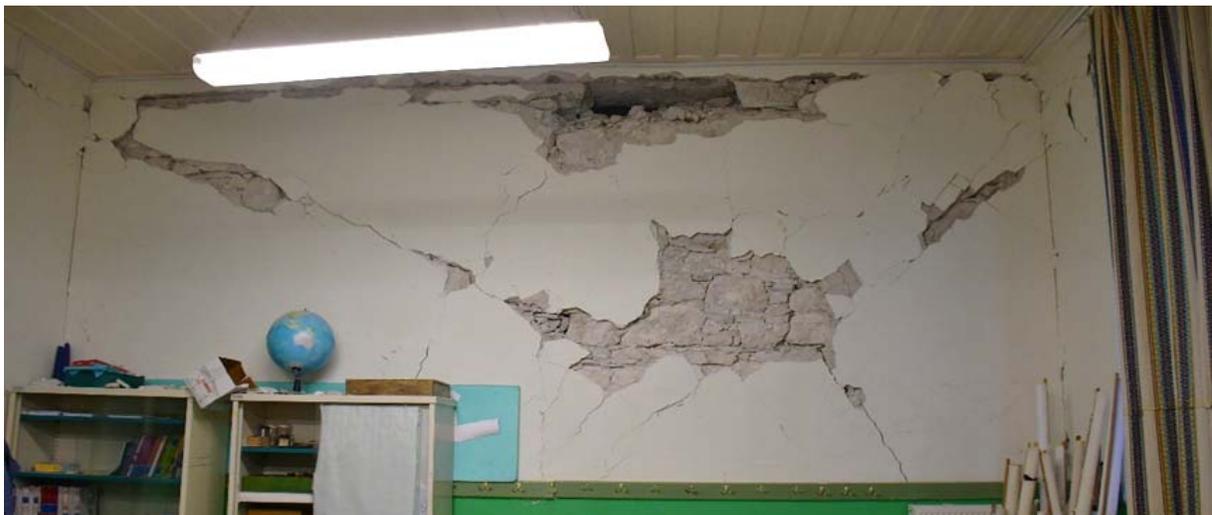
Figure 7.76. Primary school at Chora: Shear failure of masonry wall.

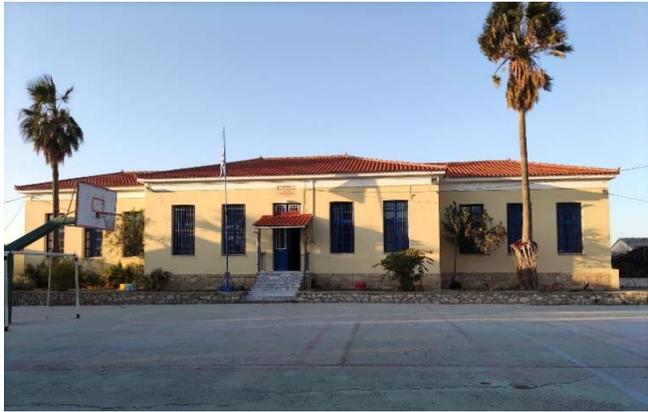
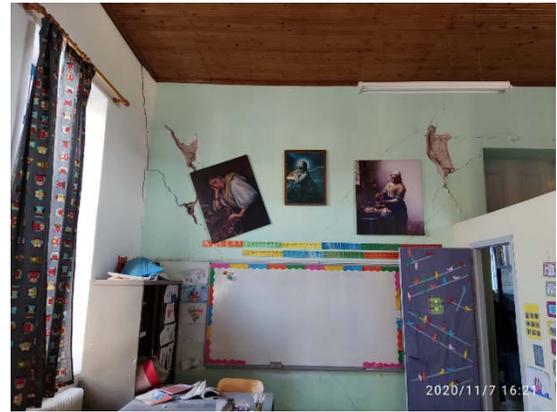
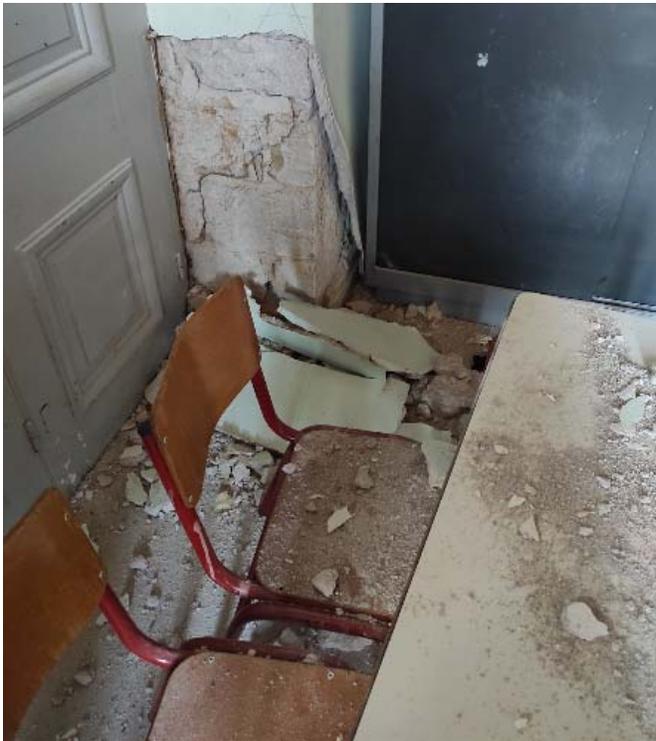
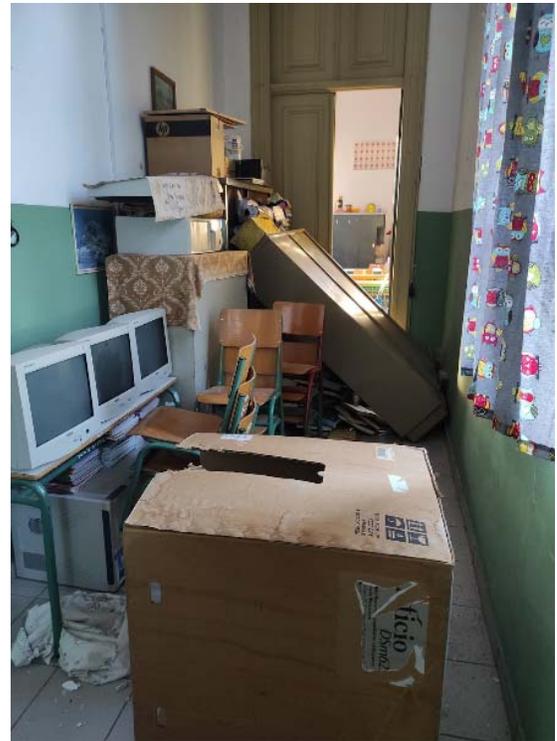
Figure 7.77. Primary school at Kontakeika: Major shear failure at the masonry walls, delamination of coating and overturning of equipment.

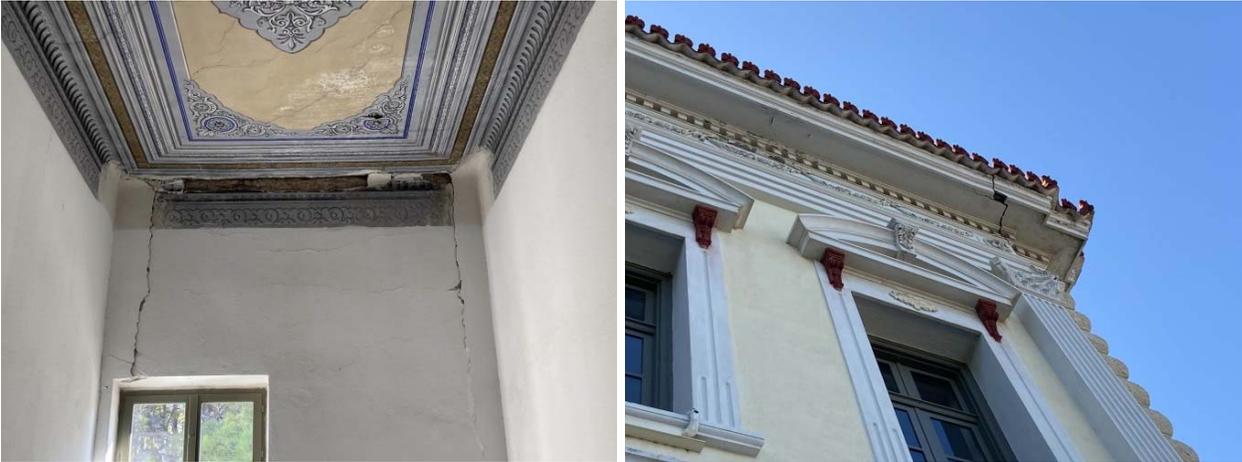
Figure 7.79. Out-of-plane masonry wall failure and corner detachment at the Lyberi building of the University of Aegean (School of Sciences).

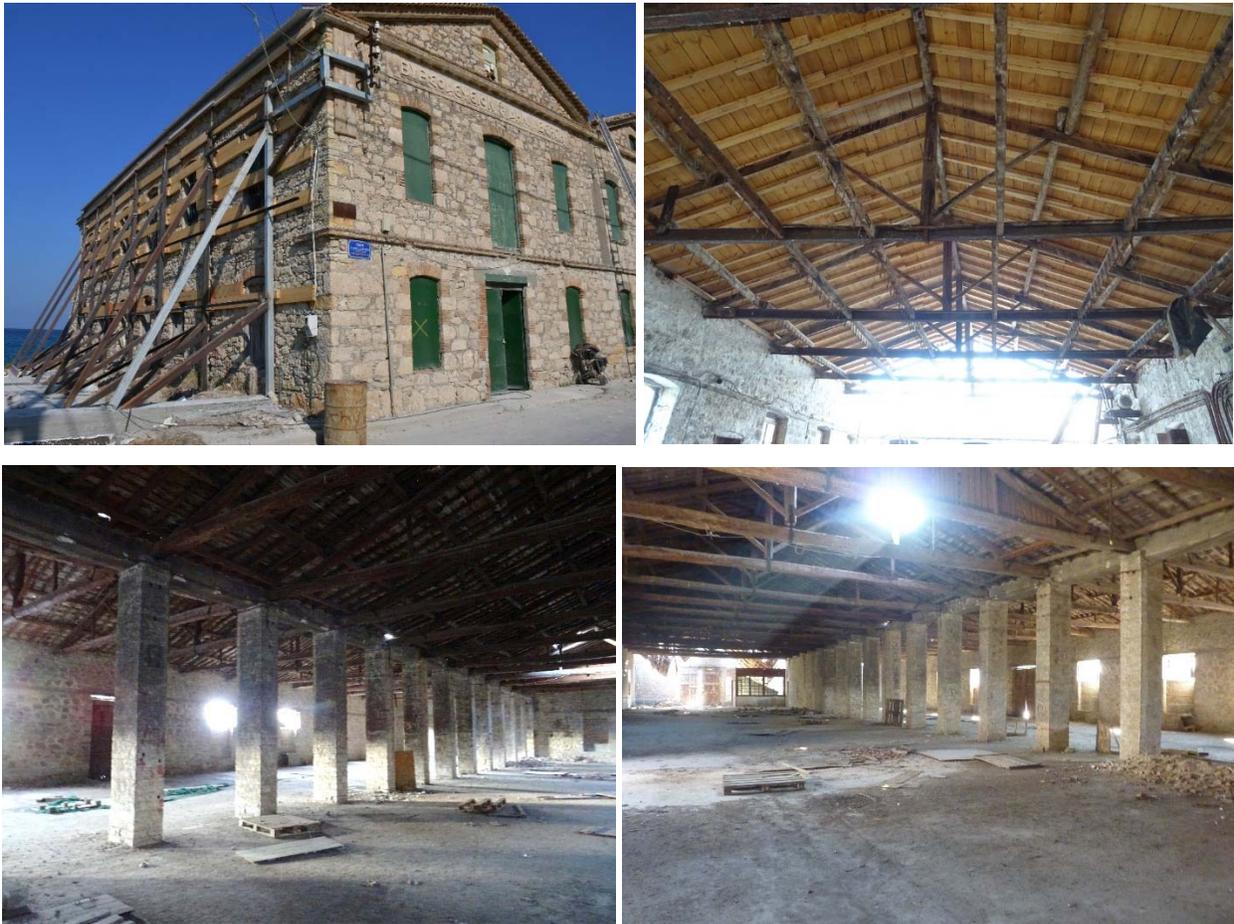
The buildings exhibited typical damage, mainly out of the plane of their long walls. For the tanneries closer to the sea, some of the damage observed could also be attributed to the lateral spreading of the soil, as further discussed in Chapter 5.

Figure 7.80. Typical tannery buildings at Karlovassi. Temporary out-of-plane support (top left).

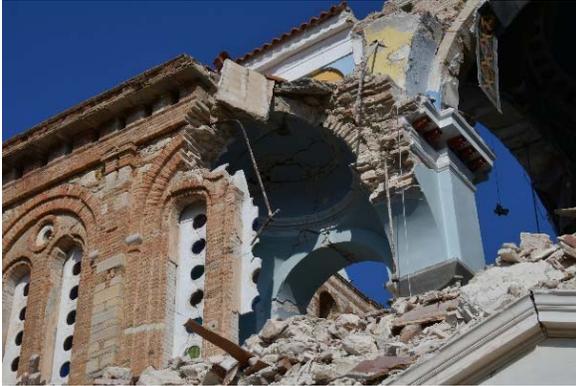
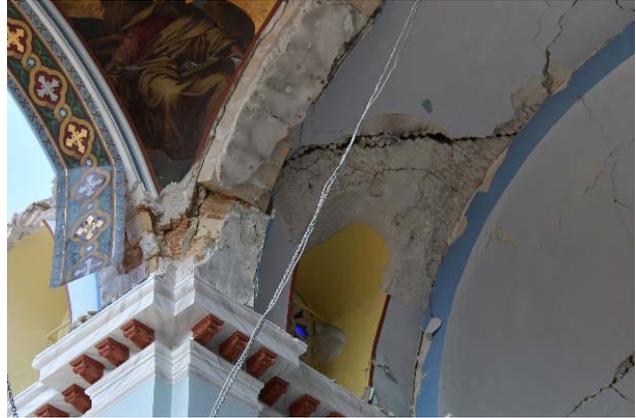
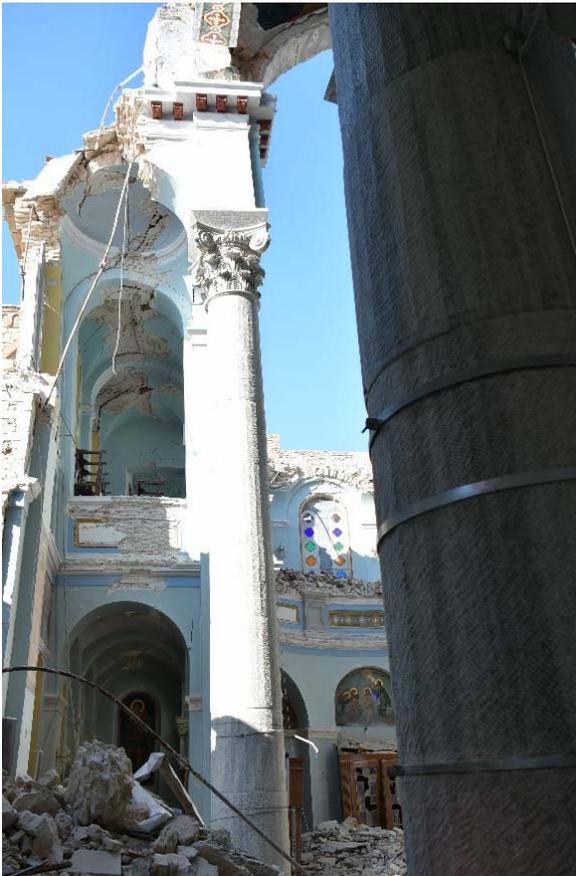
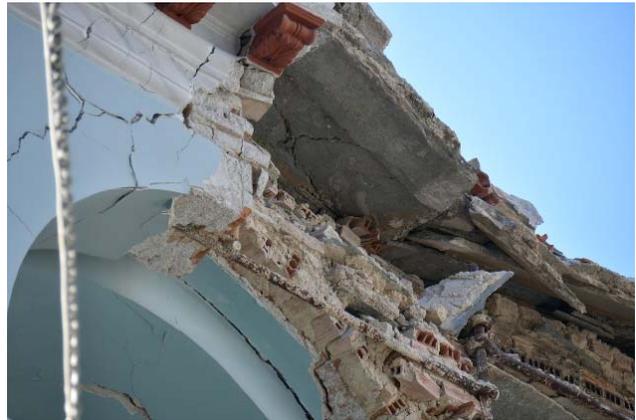
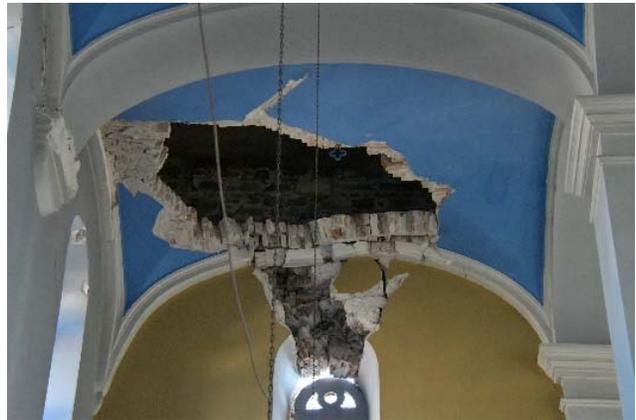
Figure 7.83. Poor construction of the dome-and-arches system.

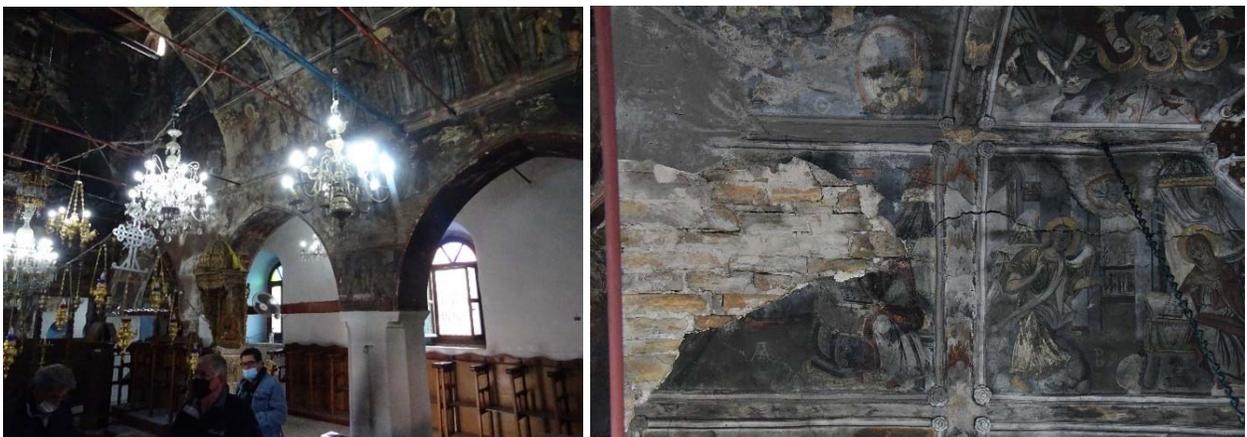
In cases where interventions were applied and the dome-and-arches system was provided with steel ties (Figure 7.85), collapse was avoided, although significant damage was not prevented. Of special interest is the seismic response of bell towers. These structures generally exhibit seismic behavior dissimilar to other masonry structures, because of their unique characteristics such as the slenderness and the shape. Damage in bell towers is shown in Figures 7.86, 7.91 and 7.92.

Figure 7.85. Steel ties were installed to alleviate the effect of the thrust of dome-and-arches roofs.

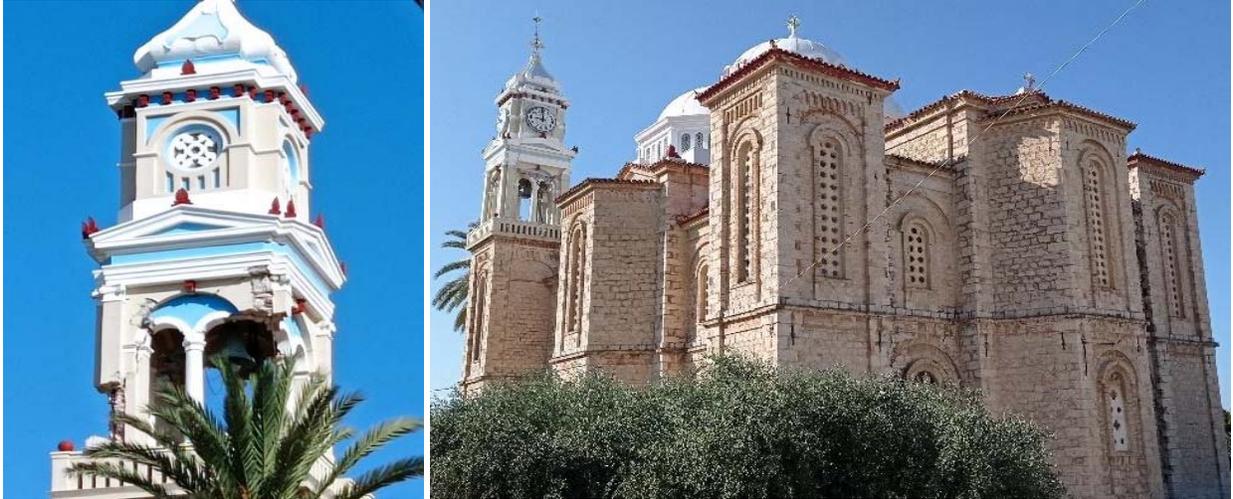
Figure 7.86. Cathedral of the Assumption of the Virgin Mary in Karlovasi. Heavy damage observed in both bell towers which were not built at the same time as the main part of the temple but were added afterwards.

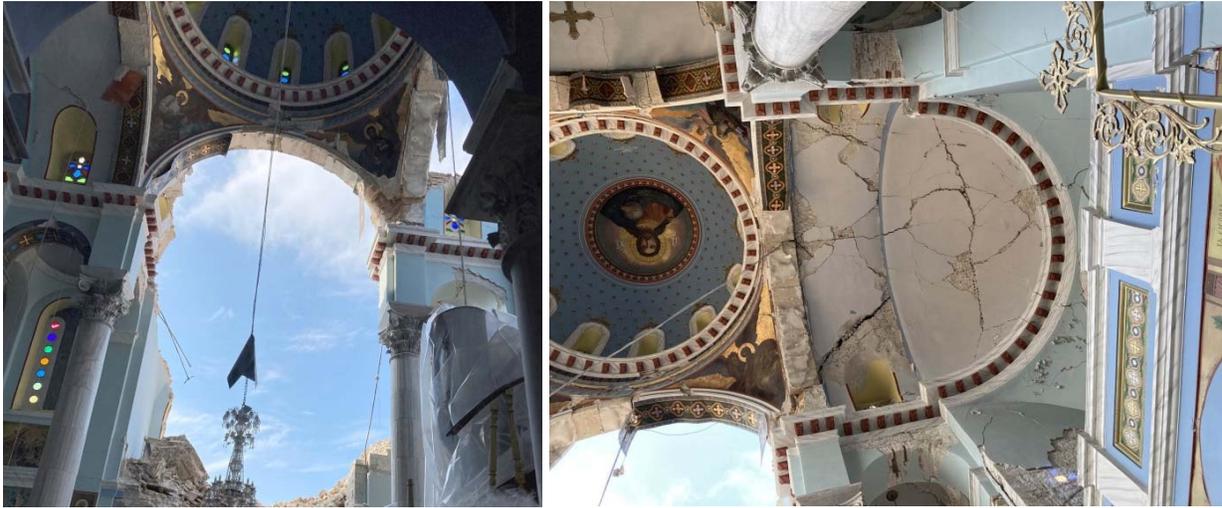
Figure 7.87. Roof failure on the west side of the Cathedral of the Assumption of Virgin Mary in Karlovasi.

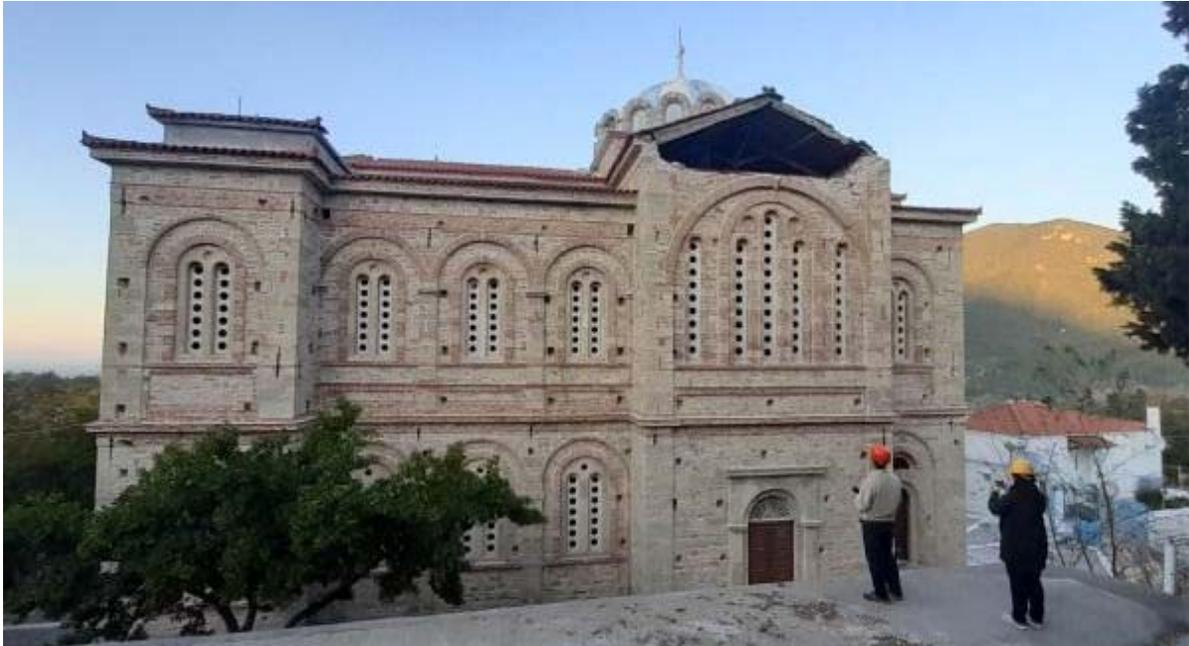
Figure 7.90. Out-of-plane failure of the gable below the roof of the Church of Genesis of Virgin Mary at Konteika, which dates back to the 19th century.

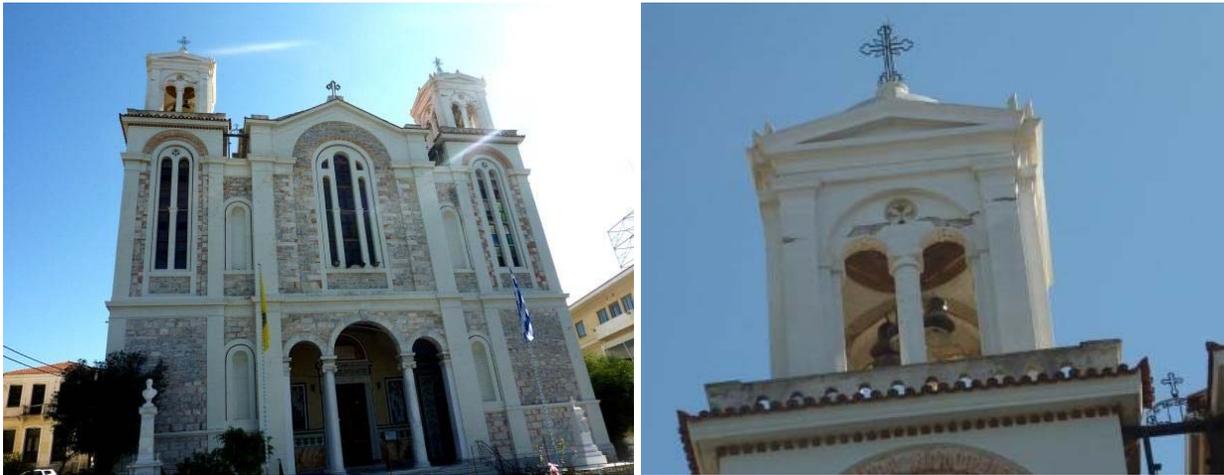
Figure 7.91. Shear failure at the bell tower of the Agios Spyridon Cathedral at Bathi.

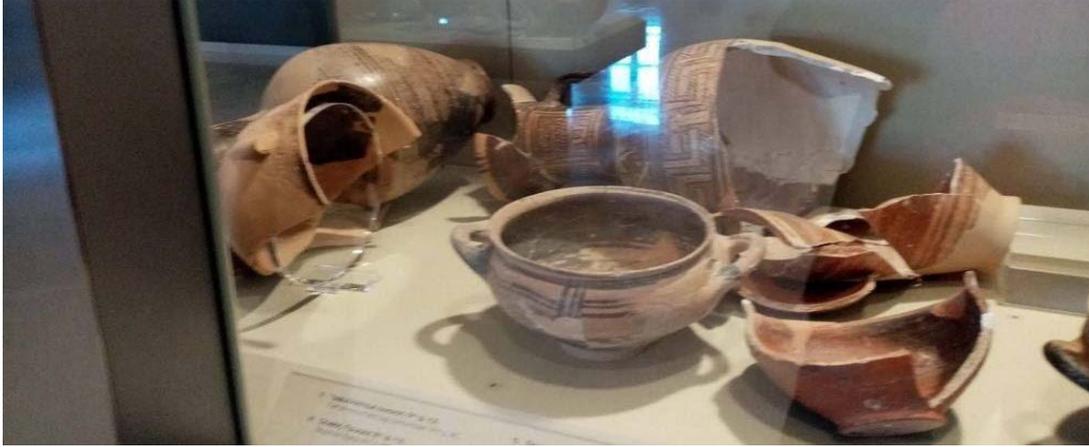
Figure 7.93. Breaking of ancient vessels in the Archaeological Museum of Pythagorion in Samos due to overturning.³

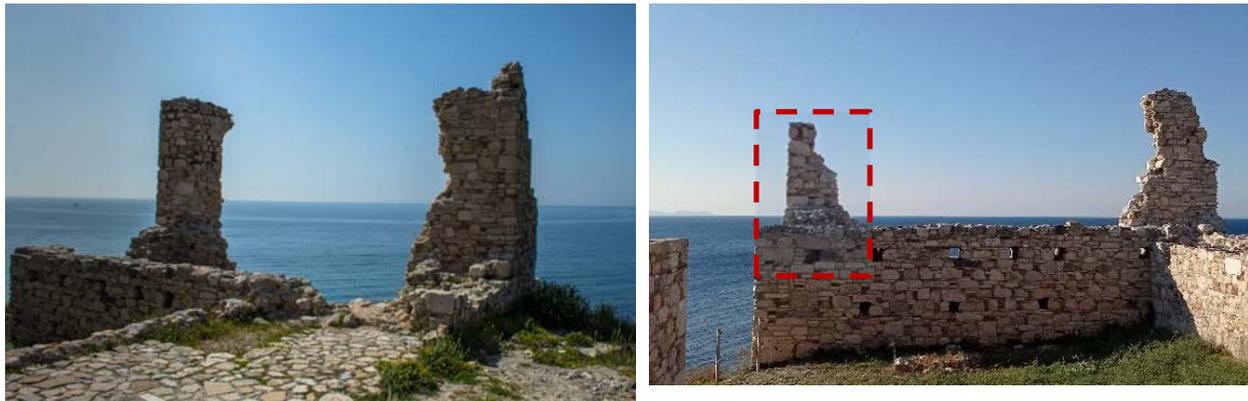
Figure 7.94. The Castle of Lykourgos Logothetis (a) before the earthquake⁴, (b) after the earthquake of the October 30th 2020, showing the partial collapse of the perimeter walls into the sea.

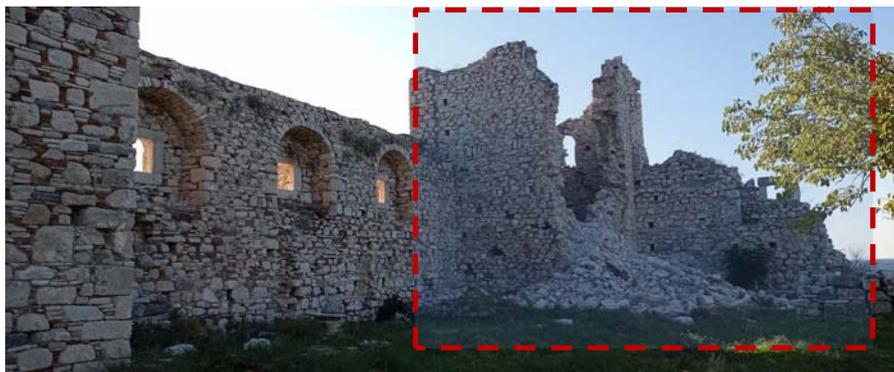
Figure 7.95. Partial collapse of the perimeter walls of the Castle of Lykourgos Logothetis.

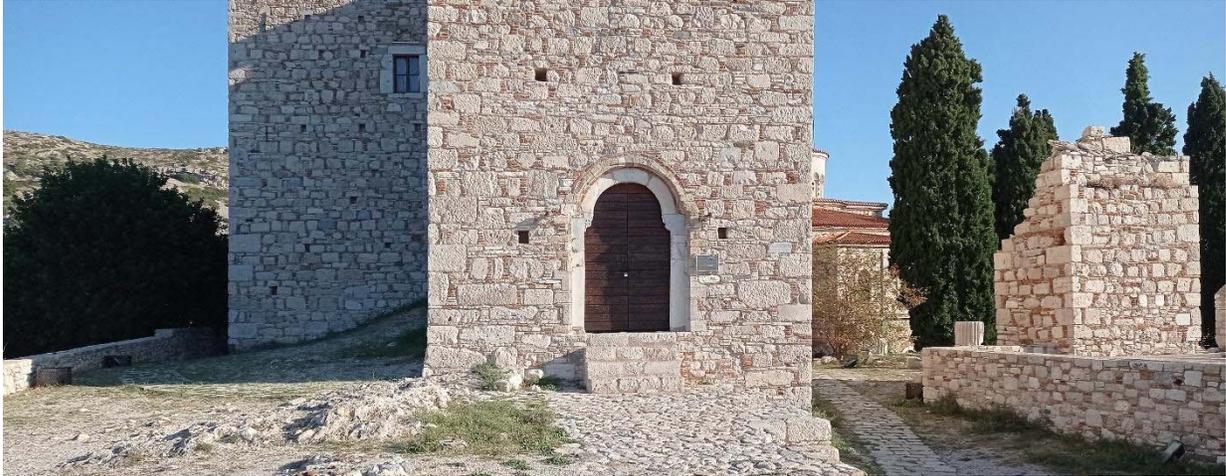
Figure 7.97. The Castle of Lykourgos Logothetis. No damage was observed; the seismic behavior of the structure was very good due to fact that it has been recently seismically rehabilitated.

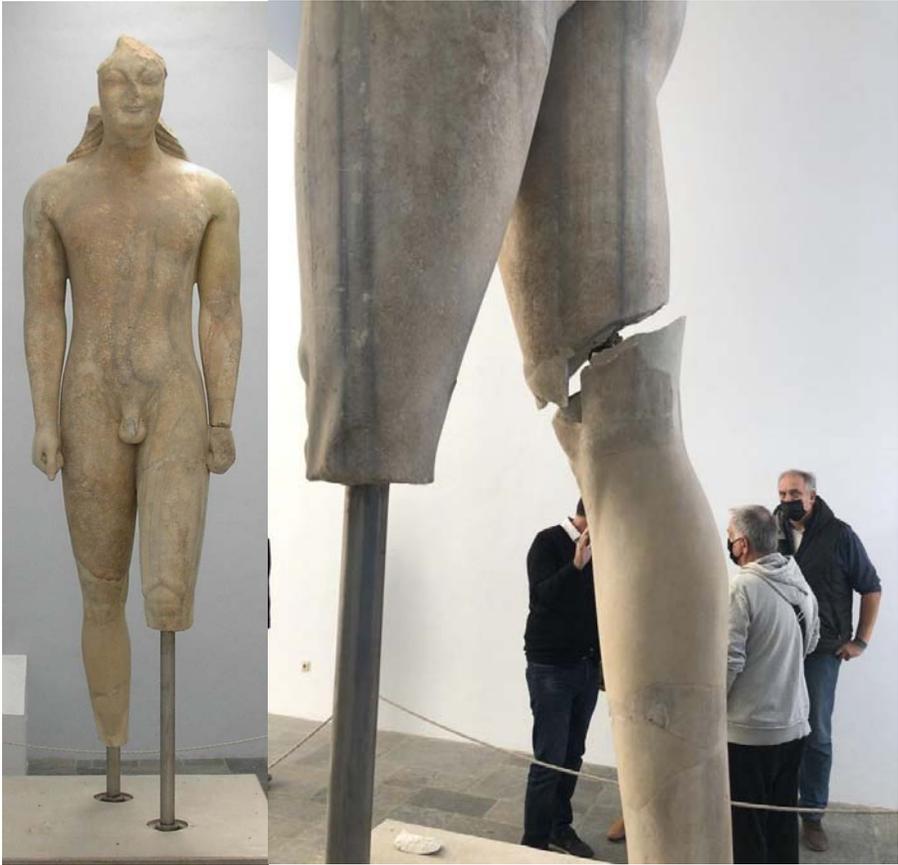
Figure 7.98. Overview of the sculpture of Kouros at the Archaeological Museum of Vathy in Samos (the largest Kouros in Greece) before the earthquake (left) and crack in the thigh of the sculpture as a result of the recent earthquake (right)⁶

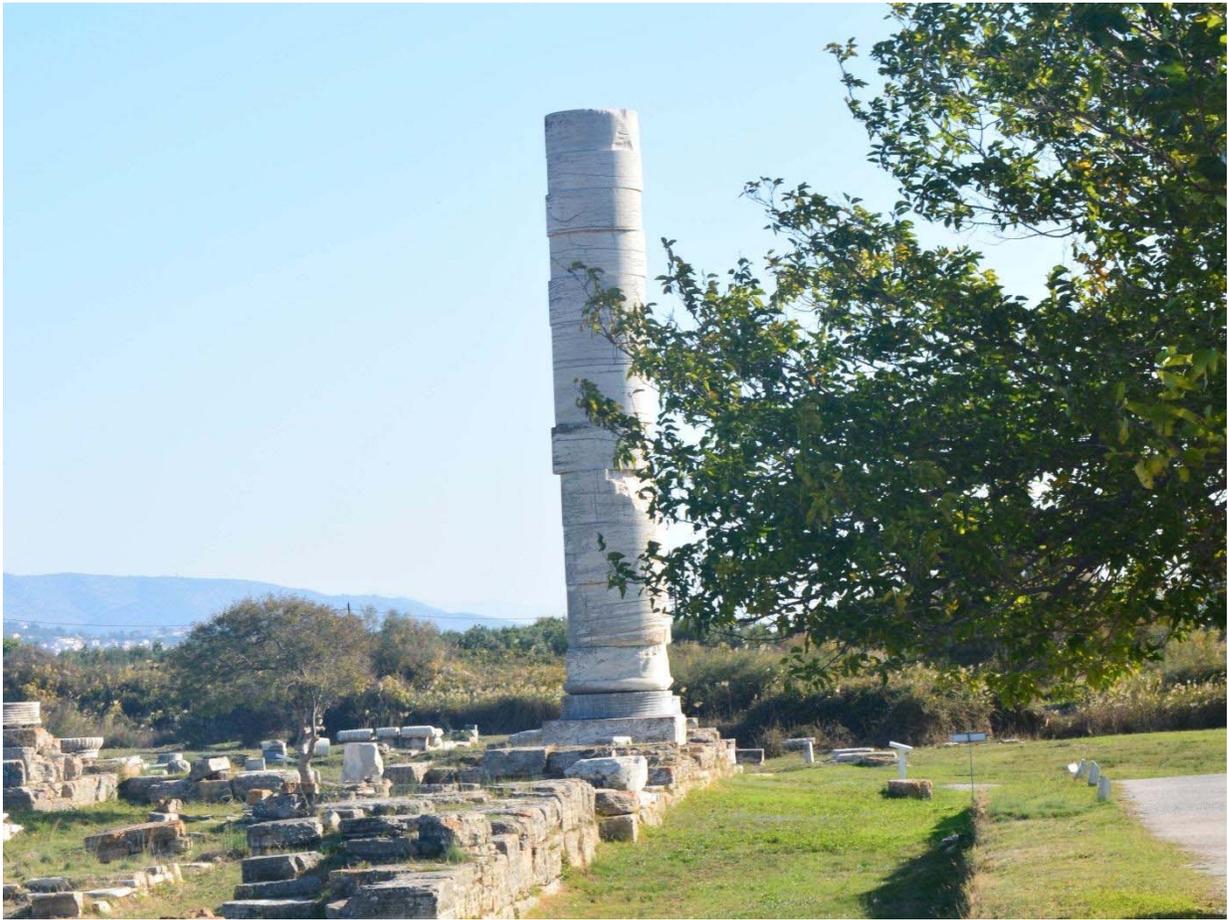
Figure 7.99. Archaeological site of Heraion of Samos. No evident displacement was observed on the single upright multidrum column (though minor displacements could be possible).

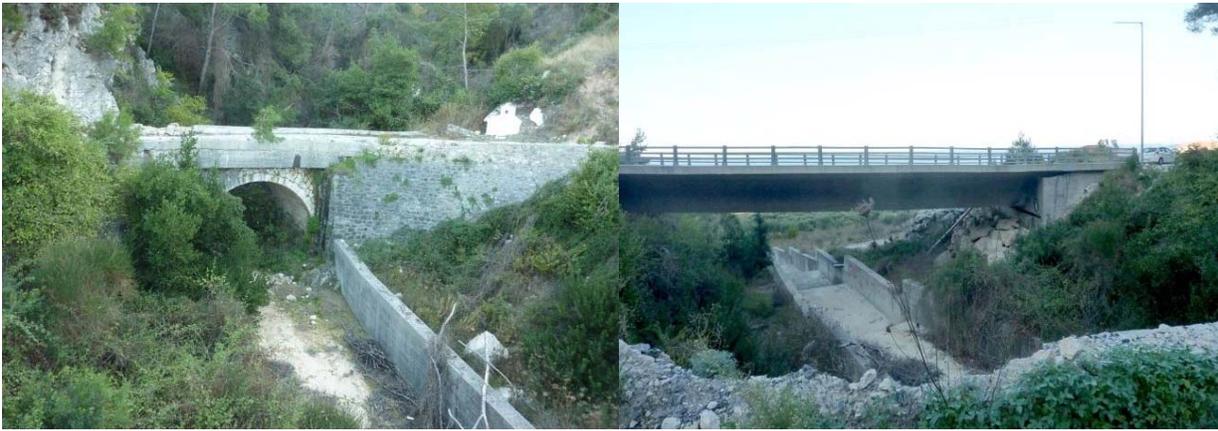
Figure 7.100. Stone and reinforced concrete bridges along the roadway network of Samos

Given the size and the topography of the island of Samos, the number of bridges is limited. No damage was observed or has been reported to any of the bridge structures.

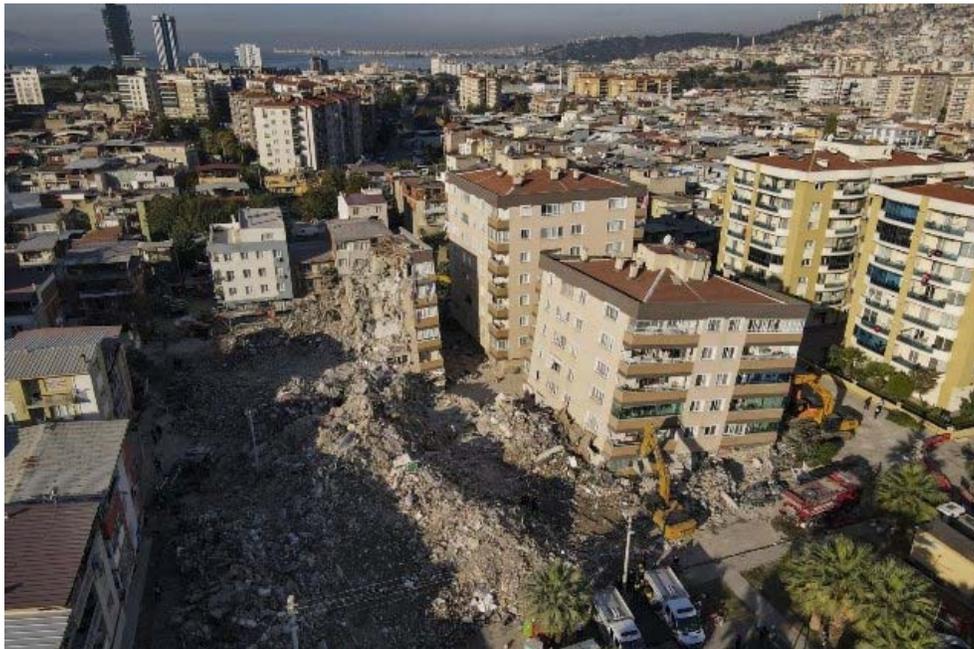
Figure 8.17. Collapsed buildings in Izmir on Friday, Oct. 30, 2020.

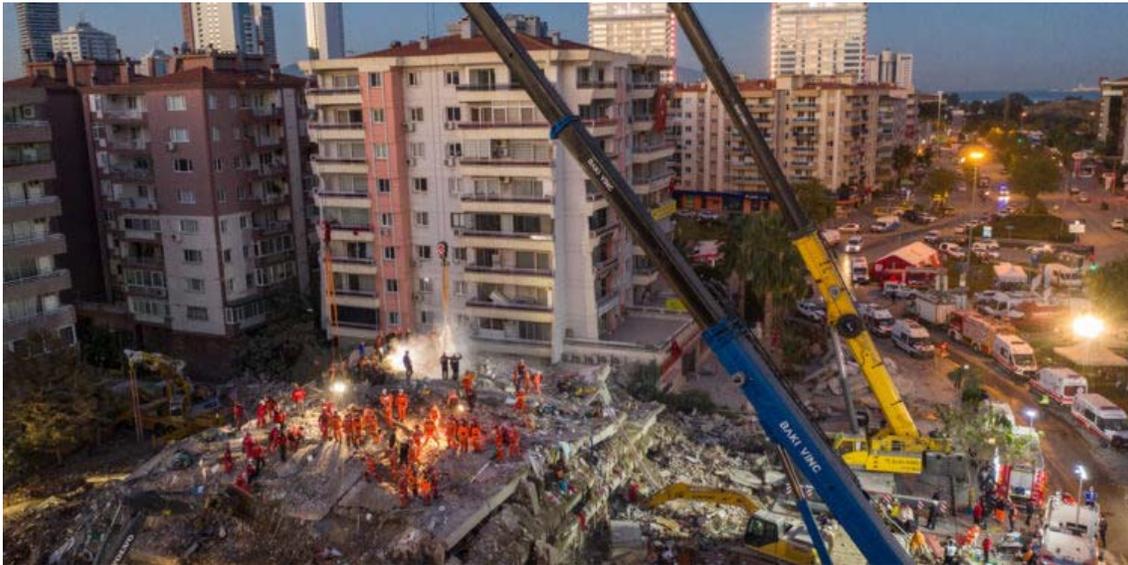
Figure 8.23. Search and rescue teams on a collapsed building
